# SJ Stephens Associates

## Re: Tree at 4 Lake View

DRAWING TITLE  
TREE SURVEY

DRAWING NUMBER  
1536-01

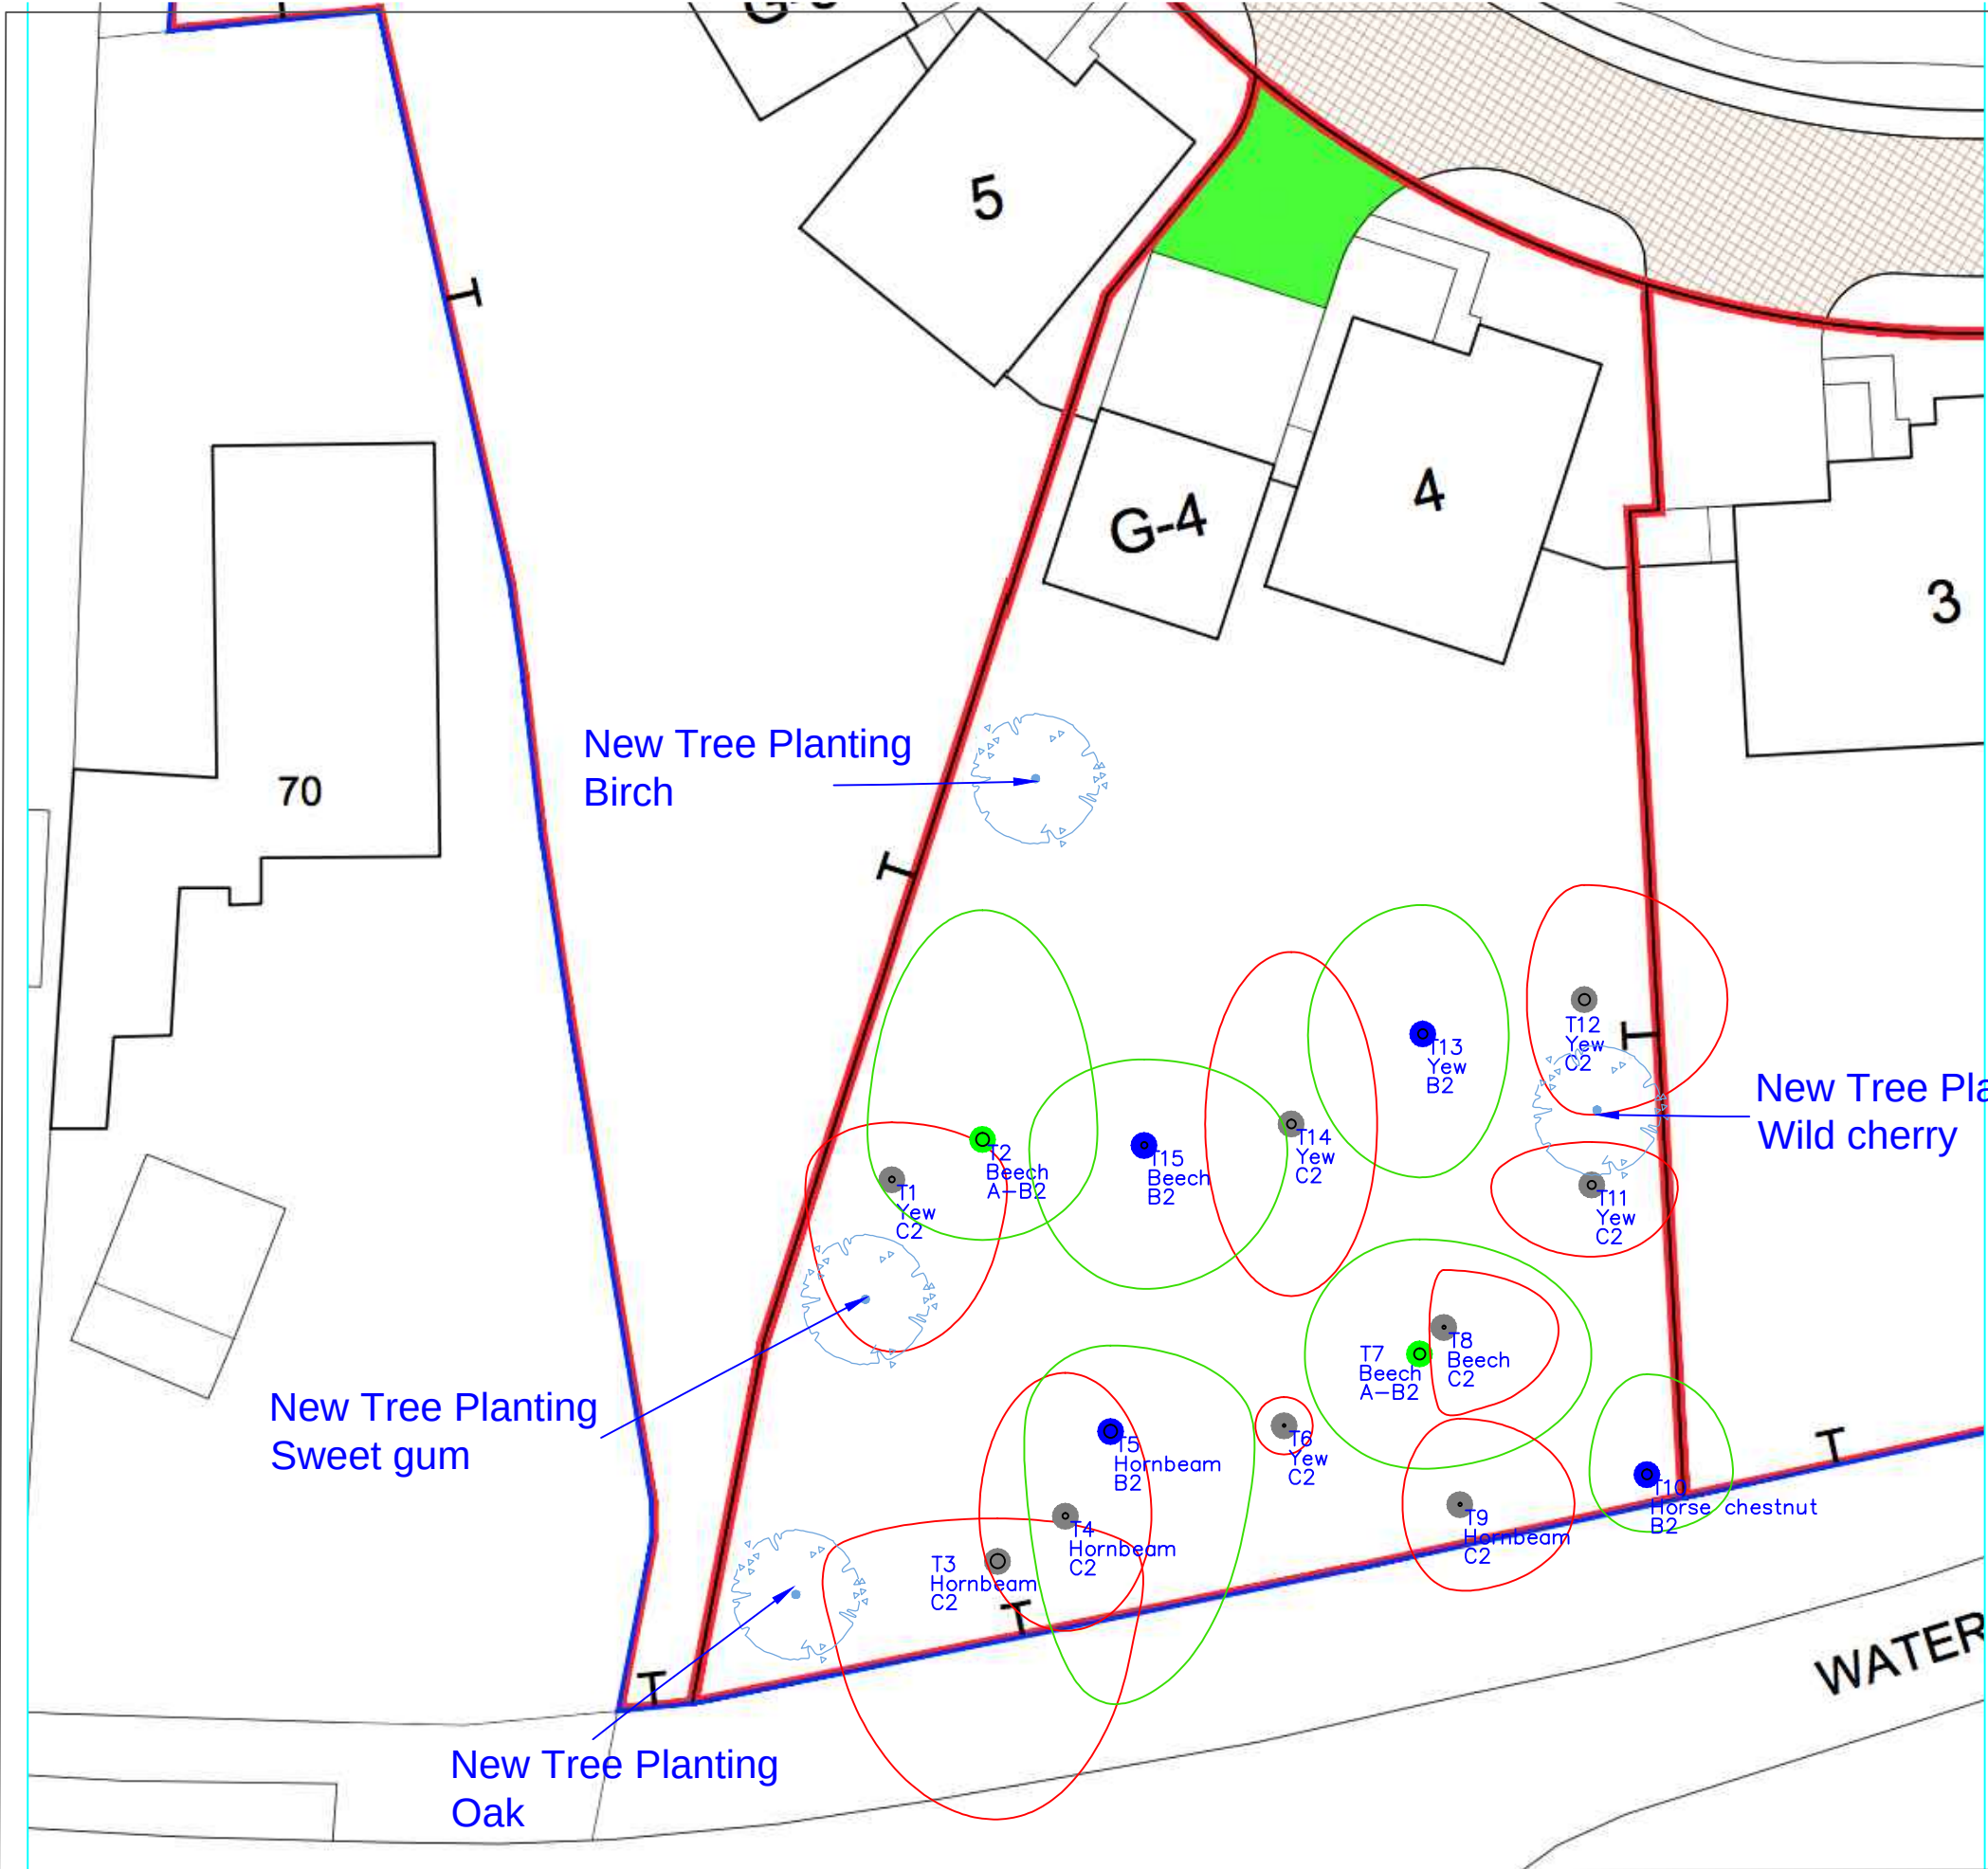
There are 15 trees in the back garden, including yew, beech and hornbeam. These are of mixed quality and it is proposed that lower-quality trees are removed to allow better quality trees to develop, to open up the garden and the to allow additional new tree planting around the perimeter. Nine trees are proposed for removal including T3 a mature hornbeam, leaning over the Waterloo Road, which is showing basal decay and should be removed to reduce safety risks.

The garden has recently been soiled and turfed/seeded by the developer. Soil levels have been raised around the stems of some trees which is likely to lead to basal decay and failure. For retained trees, soil levels should, therefore, be reduced to underlying ground levels around the base of retained trees and graded up to current levels.

Four new trees are proposed where indicated on the plan attached. These should be 8-10cm girth, container grown, standard trees. If any fail within 5 years, they should be replaced with trees of the same species and size.
