# **BS-5837 – Arboricultural Report**

## **Wargrave Tennis Club**

February 2026

TE10769

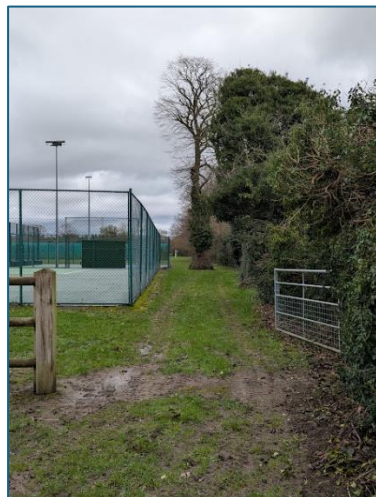
*View of access track from west*

Appropriate tree protection measures will be required to safeguard retained vegetation. The Root Protection Areas (RPAs) of H001 and T001 to T008 extend into the grassed access track along the southern boundary, which will be used to facilitate construction for the proposed extension of the paddle courts. T005 is in the middle of the track; however, historic modifications to H001 provide sufficient clearance to allow safe access without impacting retained trees. In accordance with BS 5837:2012, suitable ground/floor protection will be installed along the full length of the track (as shown on Tree Protection Plan) to prevent compaction or damage to roots during construction activities.

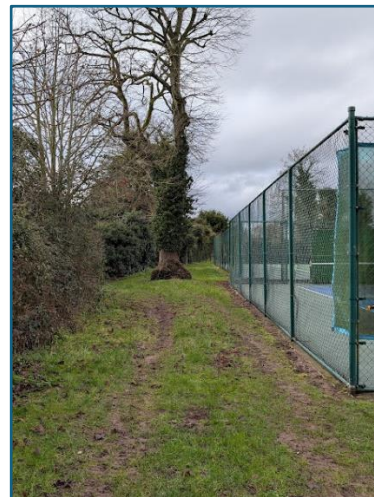
*View of access track from east*

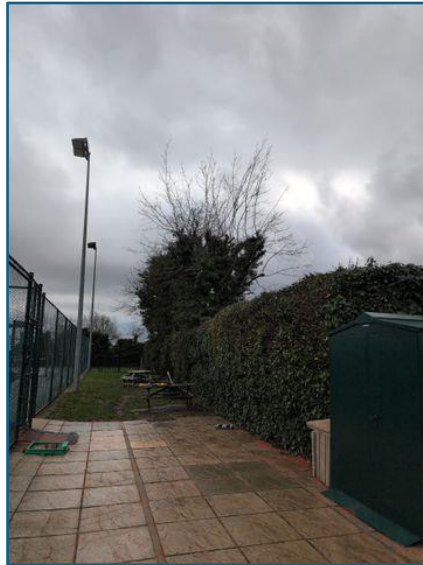
*Hawthorn hedge to be removed between current storage unit and edge of hard standing, Protective fencing to be installed during construction to protect RPA T012 and retained hedge.*

This phase of the works will require the removal of approximately 4m of Hawthorn hedge from the northern end of H002. The proposed works do not extend into the Root Protection Area (RPA) of T012. Protective fencing will be installed at the edge of the existing hardstanding on the northern boundary of T012's RPA, and along approximately 6 m of the western side of the remaining hedge (in accordance with Tree Protection Plan). This is to ensure that construction activities and site access do not encroach into the RPA and afford the remainder of the hedge protection.

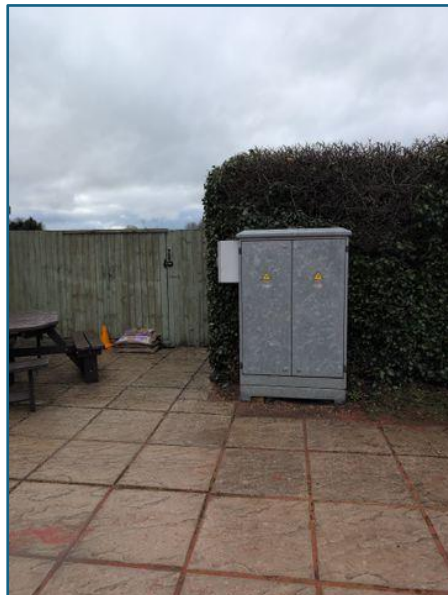
*Upto 0.5m of hedge removed to allow construction, protective fencing to be installed during construction to protect retained hedge.*

Up to 0.5 m of the southern end of hedge H003 will need to be removed to facilitate construction. To safeguard the retained section of the hedge during works, protective fencing will be installed along approximately 6m of both the western and eastern sides of H003 (in line with Tree Protection Plan). This fencing will prevent encroachment into the Root Protection Area and minimise the risk of root or stem damage during construction activities in accordance with BS 5837:2012.
