**Arboricultural Proof of Evidence on the Proposed Access  
for the Residential Development  
at  
Land North of Reading Road,  
Arborfield.**

**Prepared for Dandara Southern Limited and Elstree Land.**

**Prepared by  
Peter Wilkins BA (Hons) MArborA MIEnvSc CEnv  
Ruskins Tree Consultancy (A trading name of RG Consultancy Ltd)  
Our Ref 1025-100810  
November 2025 Rev 1**

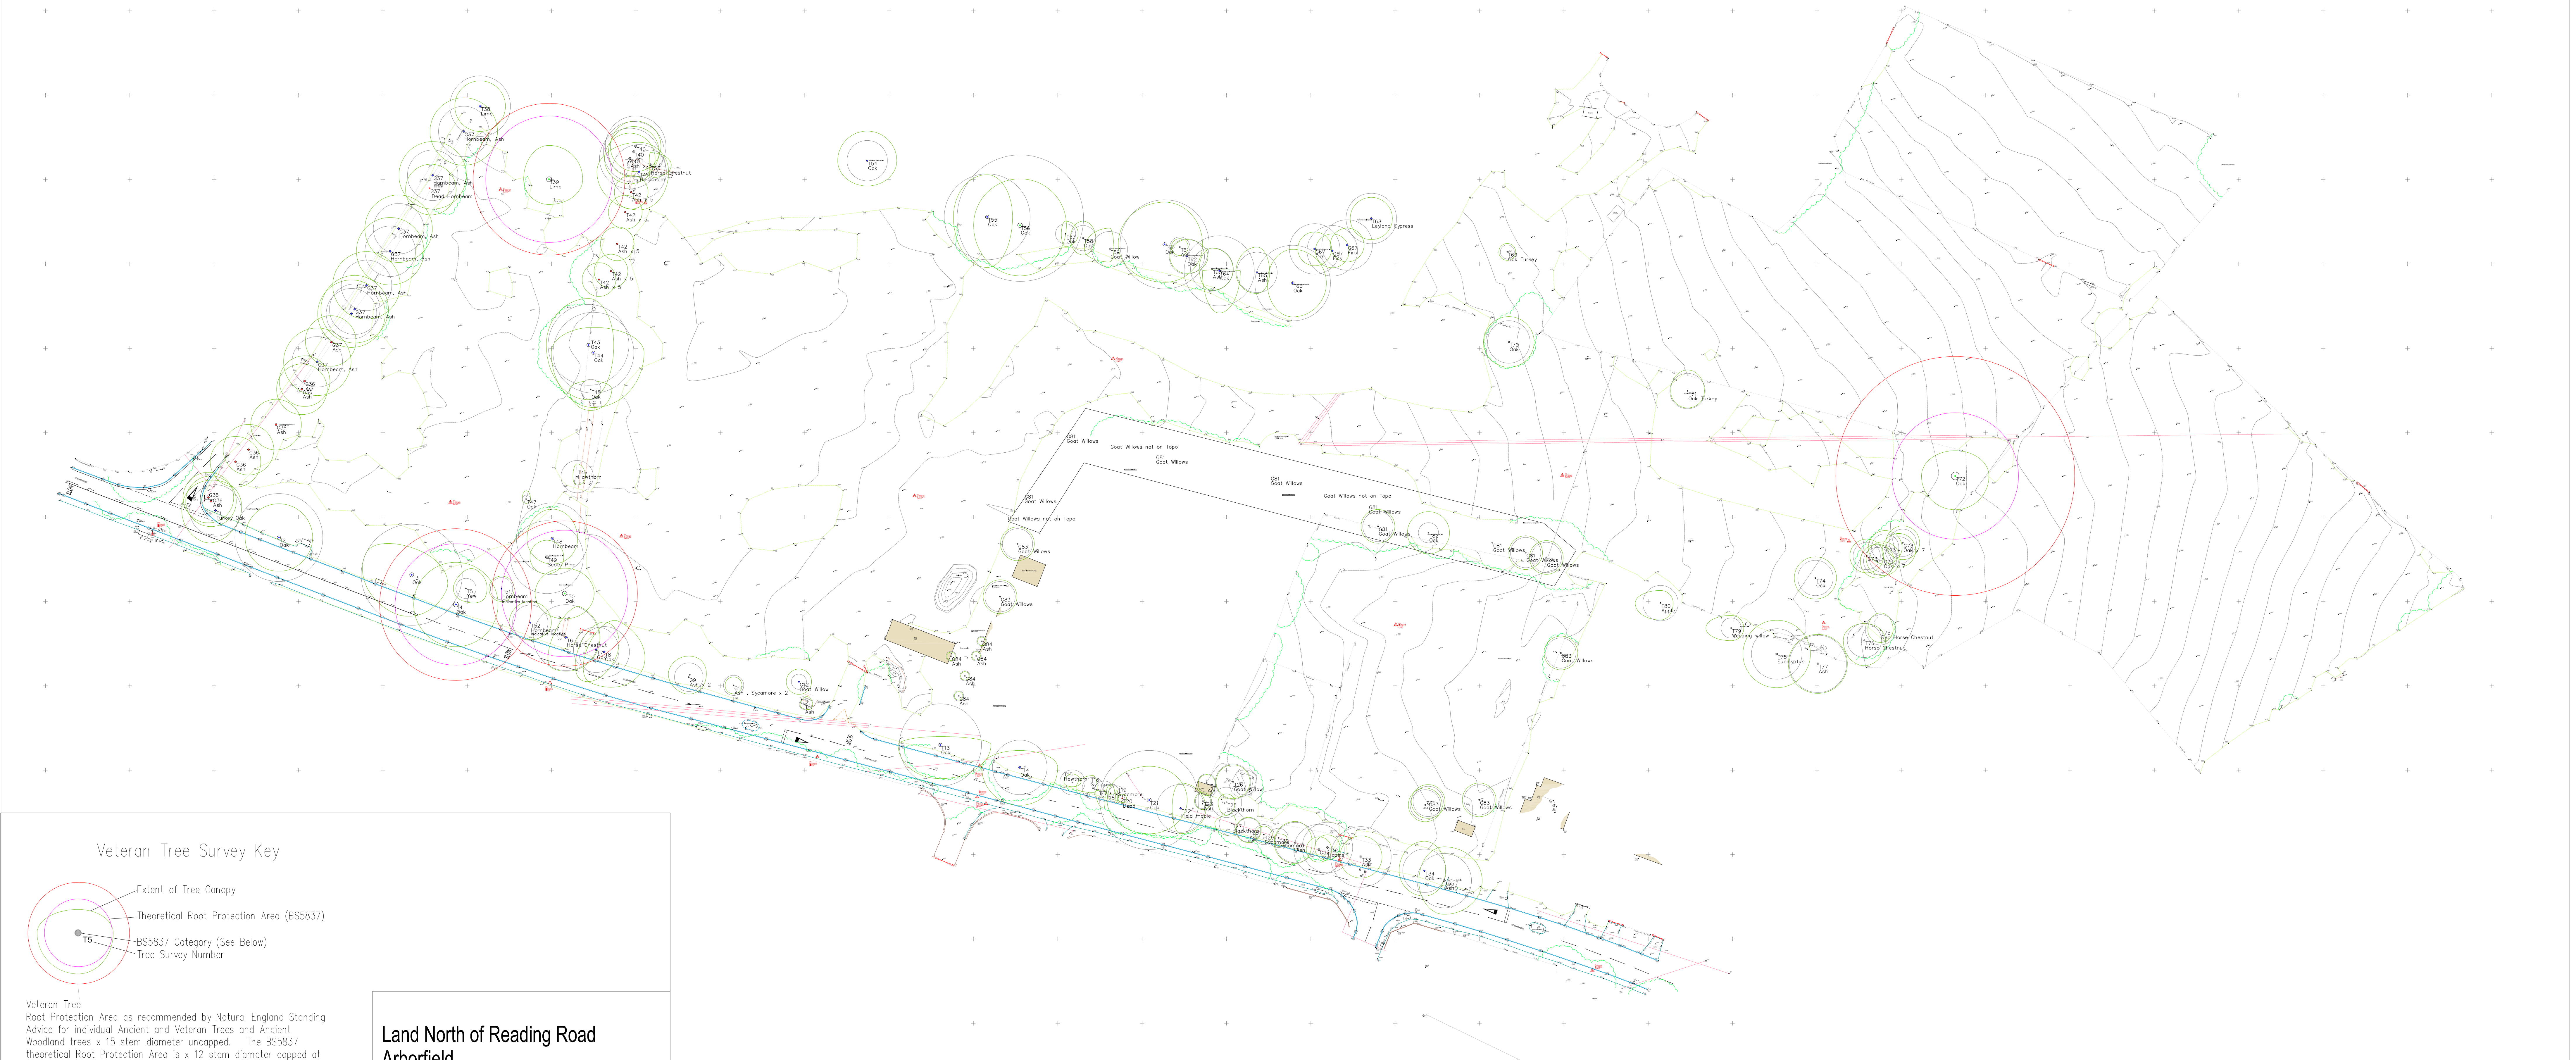
## **Tree Survey Plan**

The location of the trees is shown on the attached drawing. A detailed inspection of individual trees with respect to decay, defects and hazard is not included. However, trees found to be in a structurally dangerous condition are identified.

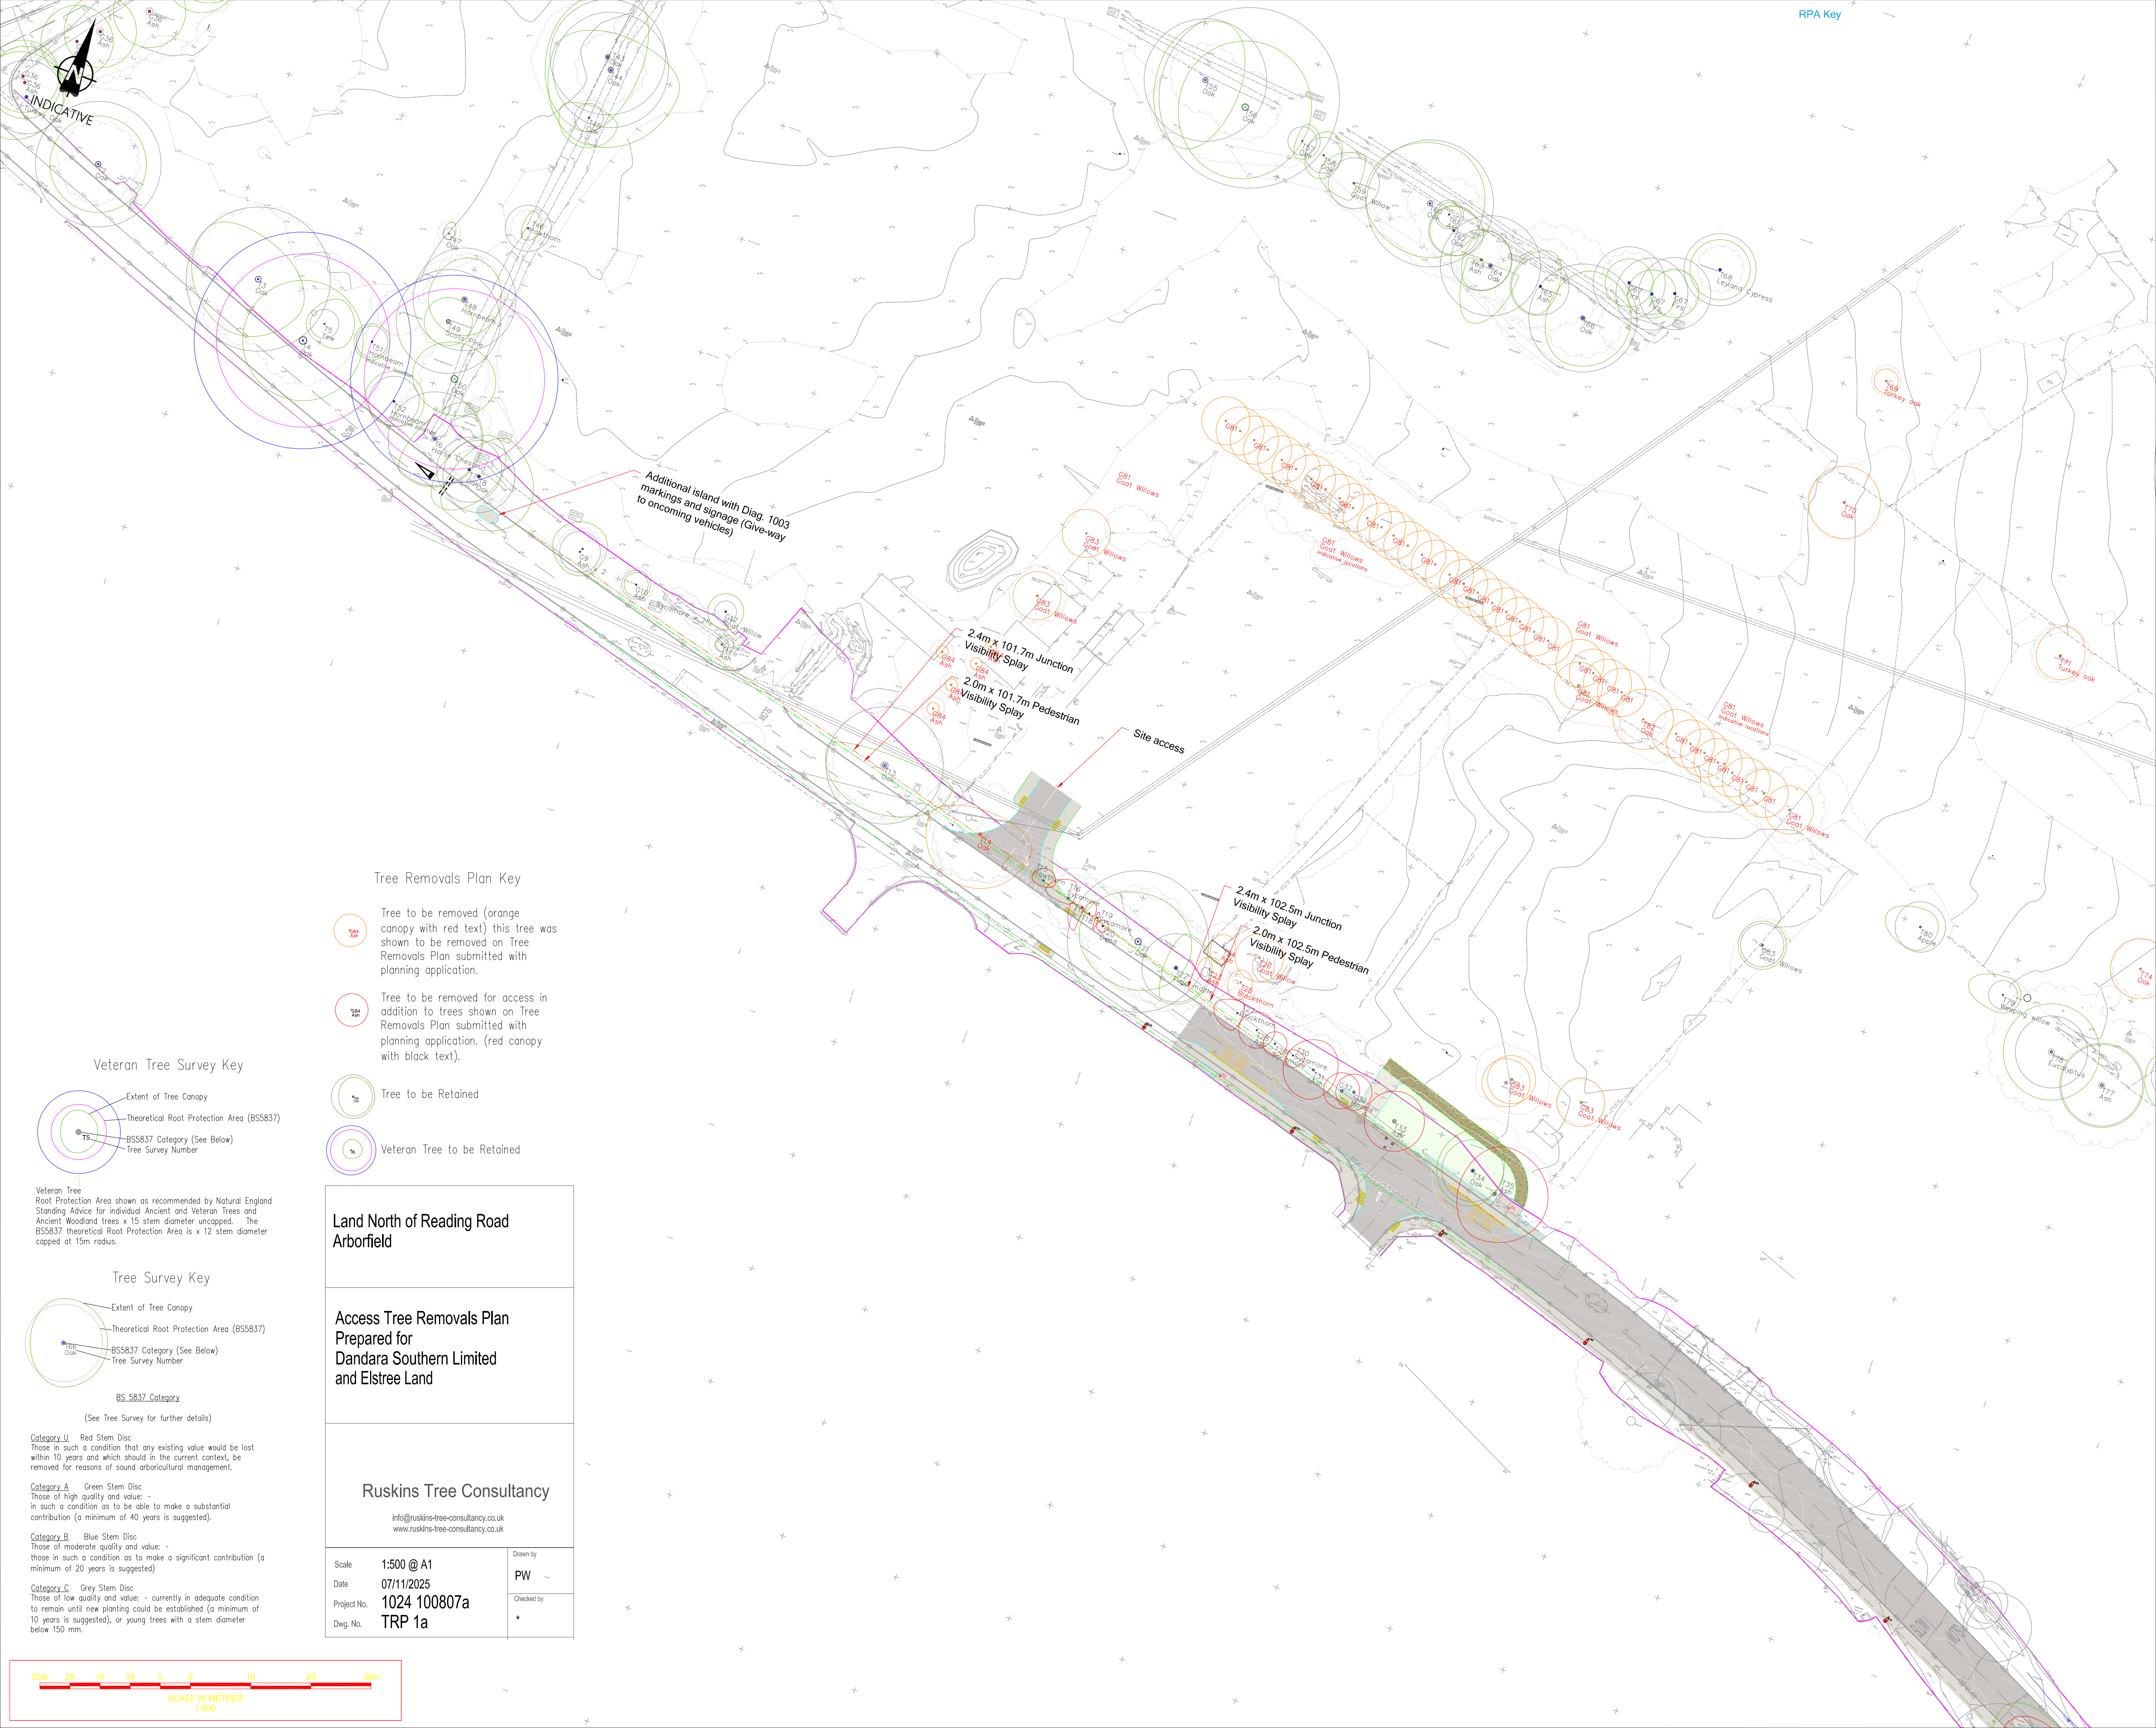
## **Proposed Access Tree Removals Plan**

- 3.12 The trees to be removed for the proposed access, emergency access and bus stop improvements on the northern side of Forest Road are shown in Table 1 below. For full details of the trees please refer to the Tree Survey and Tree Removals Plan in the Appendix.

- 3.13 It should be noted that the trees to be removed are dominated by ash and sycamores with some blackthorn, hawthorn and hazels all this vegetation is BS5837 (2012) low quality 'C' category and a dead tree T20, BS5837 Category U poor-quality. The oak T14 is the only BS5837 (2012) Category B 'moderate quality' tree to be removed for the proposed access works. There are no Category A 'good quality' trees to be removed for the proposed access works.
