## **VISUAL TREE INSPECTION AND DECAY DETECTION AT THORNBURY GREEN TWYFORD**

**Prepared for:**  
**Thornbury Green Management Co Ltd**  
**C/O Homes Property Services (UK) Ltd**  
**2-4 Broad Street**  
**Wokingham**  
**RG40 1AB**

**Ref: SPH/DD-24/16.05**

**22 May 2024**

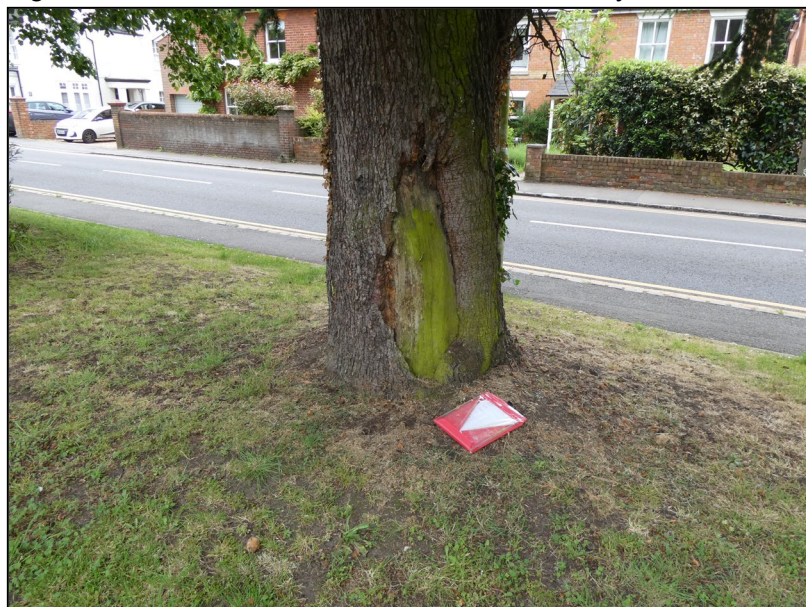
- 3.2.1 The root zone was visually inspected, and no exposed roots or signs of root plate instability (cracking or soil heave) were observed. A large wound 1.2 metres tall was visible on the north side of the stem (see Figure 1 below), with a second wound of similar dimensions on the south side, see Figure 2 on page 6. Wound wood can be seen developing on the right-hand side of the north facing wound. We tested the stem with a nylon mallet, both dead and loose bark were detected at ground level between the wounds (clockwise), see Figure 3 on page 6. A small area of decayed wood was observed at ground level on the east side, see Figure 4 on page 6.

Figure 1. Wound, north side, Cedar 7 Thornbury Gardens. 16.05.2024

- 4.1.1 The bark wounds are substantial, but do not appear to have had any significant effect on the vascular system or tree vitality at the time of inspection. They are old and the extensive wound wood that has formed alongside the northern wound corroborates this opinion.

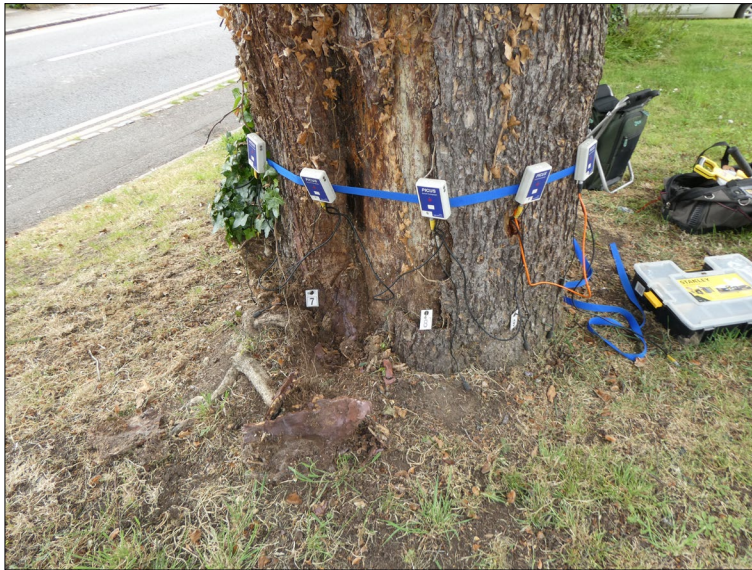
Figure 2. Wound south side, Cedar 7 Thornbury Gardens. 16.05.2024

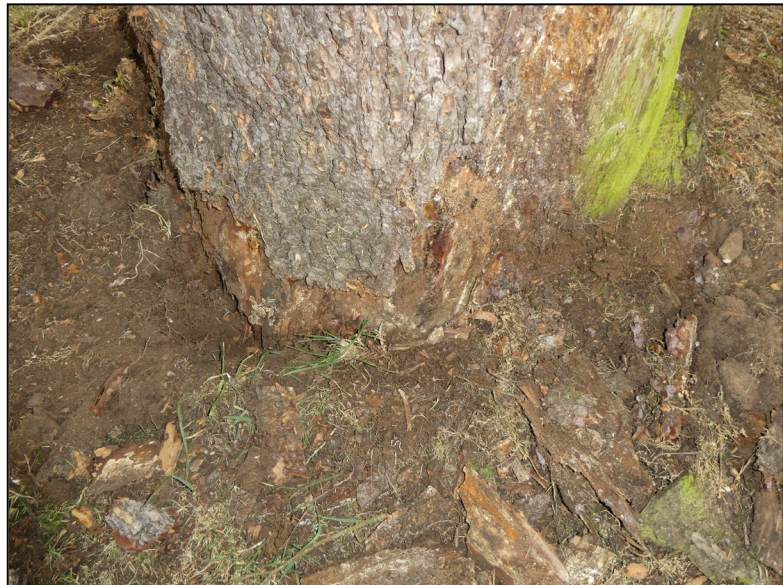
Figure 3. Dead bark, Cedar 7 Thornbury Gardens. 16.05.2024

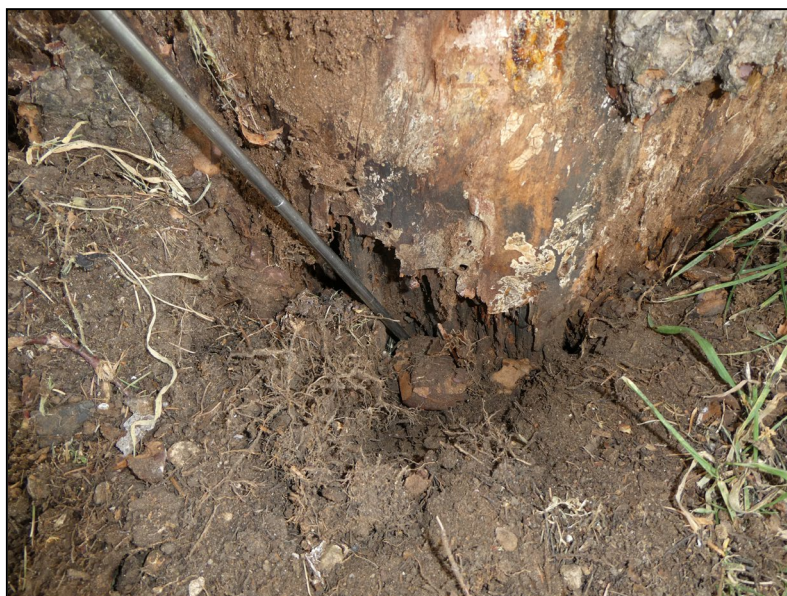
Figure 4. Decay, east side, Cedar 7 Thornbury Gardens. 16.05.2024

- 4.1.4 The combined evidence from manual sounding, probing and the decay detection indicates that the tree has a low level of decay, and that this appears to be centred around the south side of the stem at the root collar and incipient decay may be present in a small cross section of the stem at ground level.

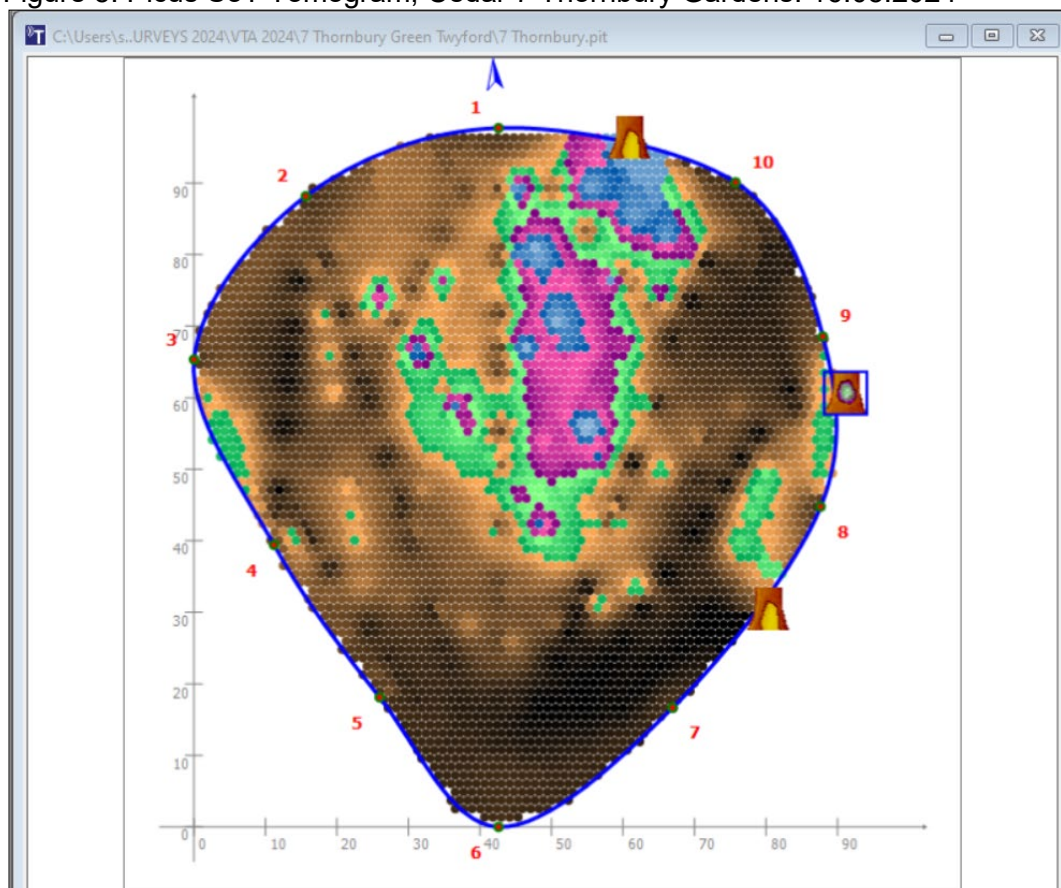
The Picus Tomogram indicates a small cross section exhibiting the early stages of decay (blue/purple pixels) between sensors 1 and 10 that may be linked to the wound observed encircling the north side of the stem. The Resi drillings test results show normal wood density (amplitude) with the exception of drilling 3 on the south side. There appears to be a sudden change in amplitude at 28 centimetres and this may be associated with incipient decay. Cedar are noted for their low wood density and the test results show no significant loss of wood density other than that produced at the start of the drillings as a result of the bark.

- 3.2.4 The results from the SoT can be seen in Figure 5 below. Black and brown pixels are normally associated with dense (sound) wood. Green pixels in species such as lime may indicate decay or incipient decay in other tree species. Decay or hollowing may be indicated by pink, blue and white pixels. North is indicated opposite sensor 1, with the bark wounds and decay indicated by graphics.

Figure 5. Picus SoT Tomogram, Cedar 7 Thornbury Gardens. 16.05.2024

- 4.1.3 The SoT does show some unusual activity (blue and purple pixels) that are indicative of slow sonic velocity (low wood density). Slow velocity may also be caused by other internal defects, radial wood cracks or wood shake and bark anomalies such as inclusions.

- 5.1.1 We recommended that the physiological and structural condition of this tree is monitored on a regular basis.
- 5.1.2 The tree should be visually inspected by a suitably qualified arboriculturist every 12 months, and the physiological condition recorded. It should also be inspected for evidence of root plate movement following any severe weather events, for example storm force winds.
- 5.1.3 The main stem should be re-tested to monitor the extent of decay by a suitably qualified arboriculturist in 3 years (June 2027).

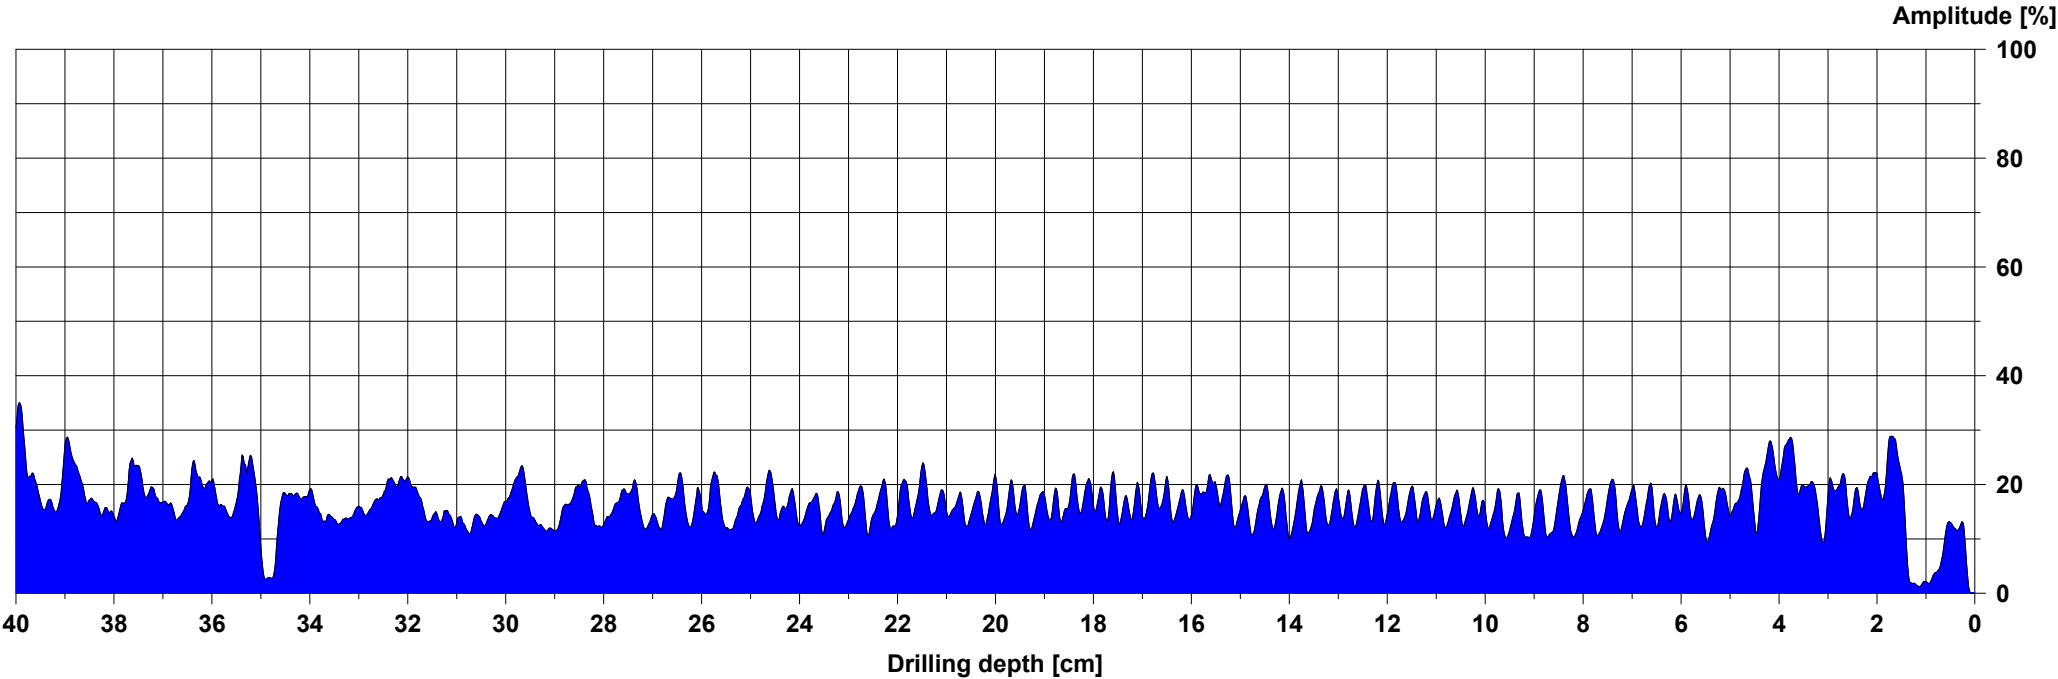
Control drilling north side, 1.5m AGL no significant decay or hollowing at the test location.

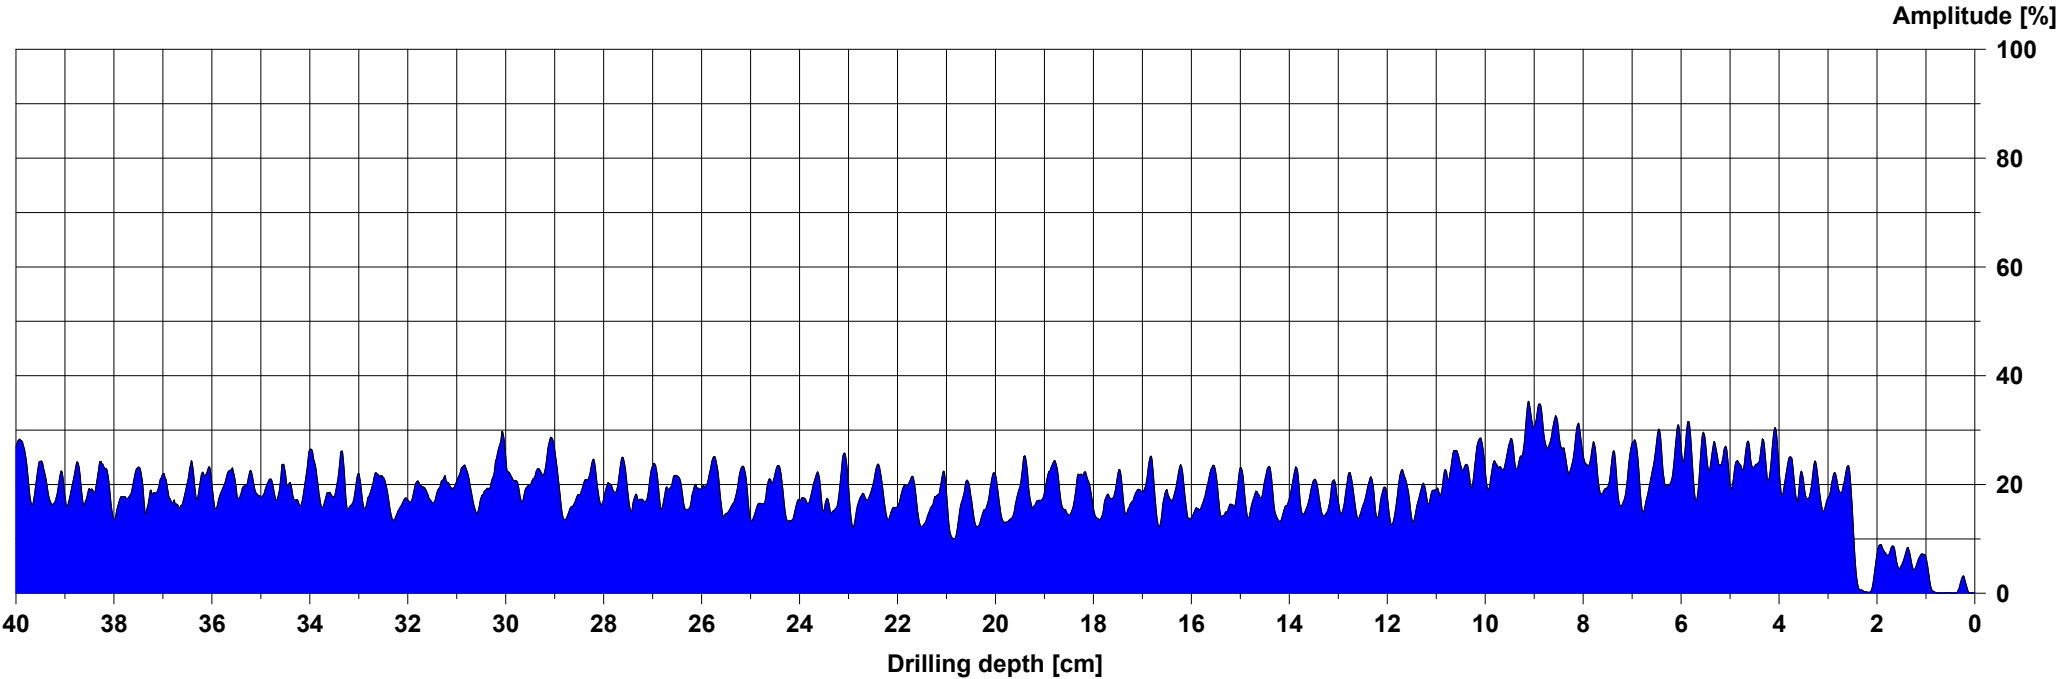
Control drilling south side, 1.5m AGL no significant decay or hollwoing at the test location.

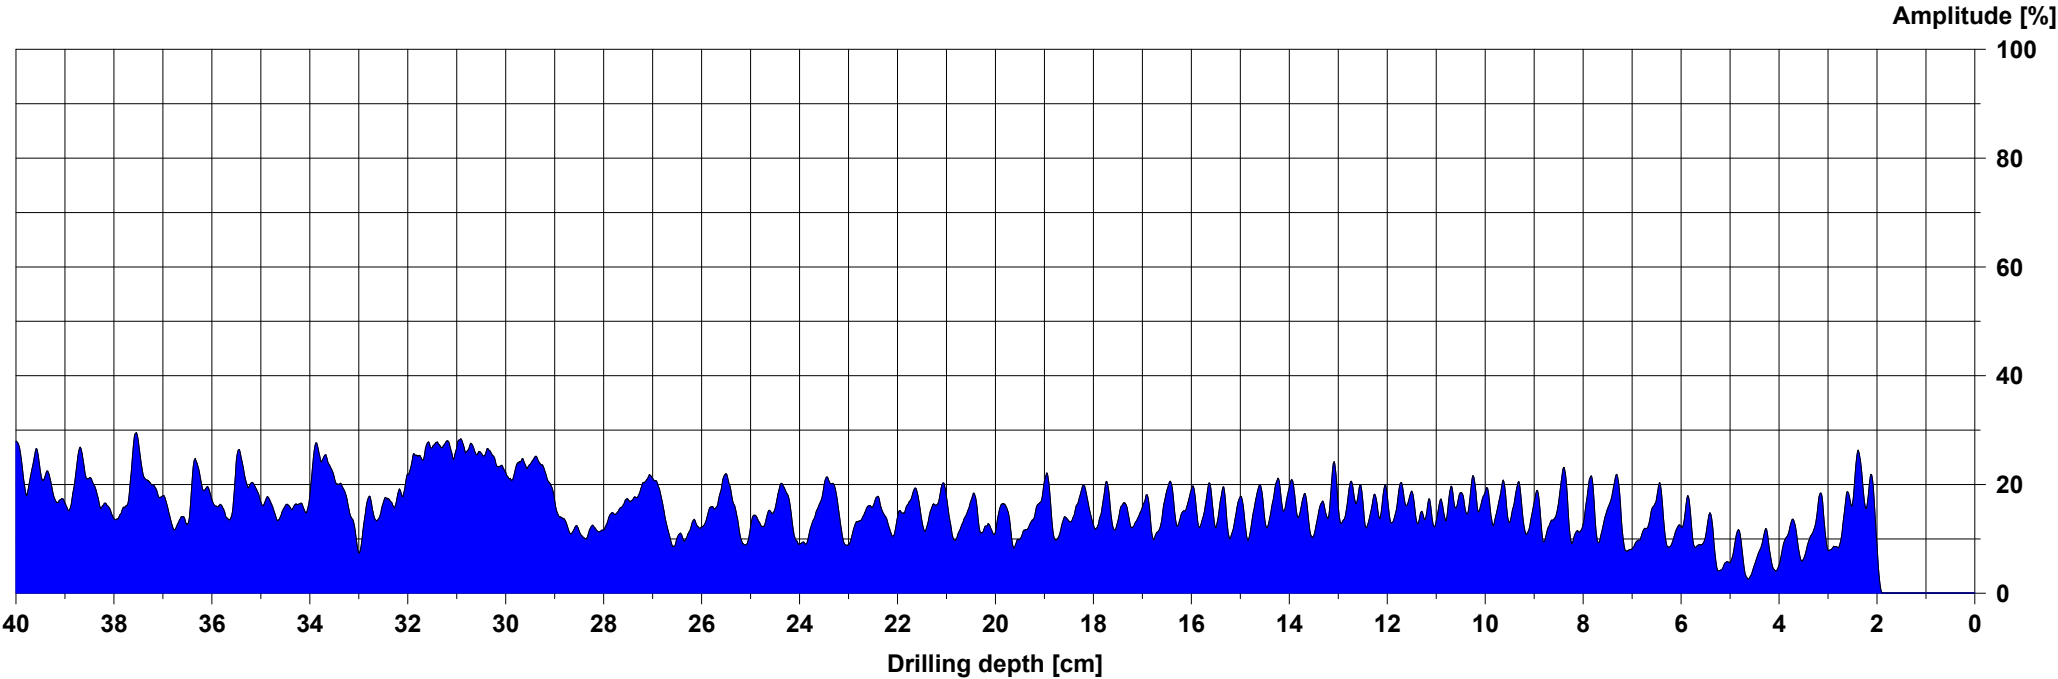
East side, no significant decay at the test location.

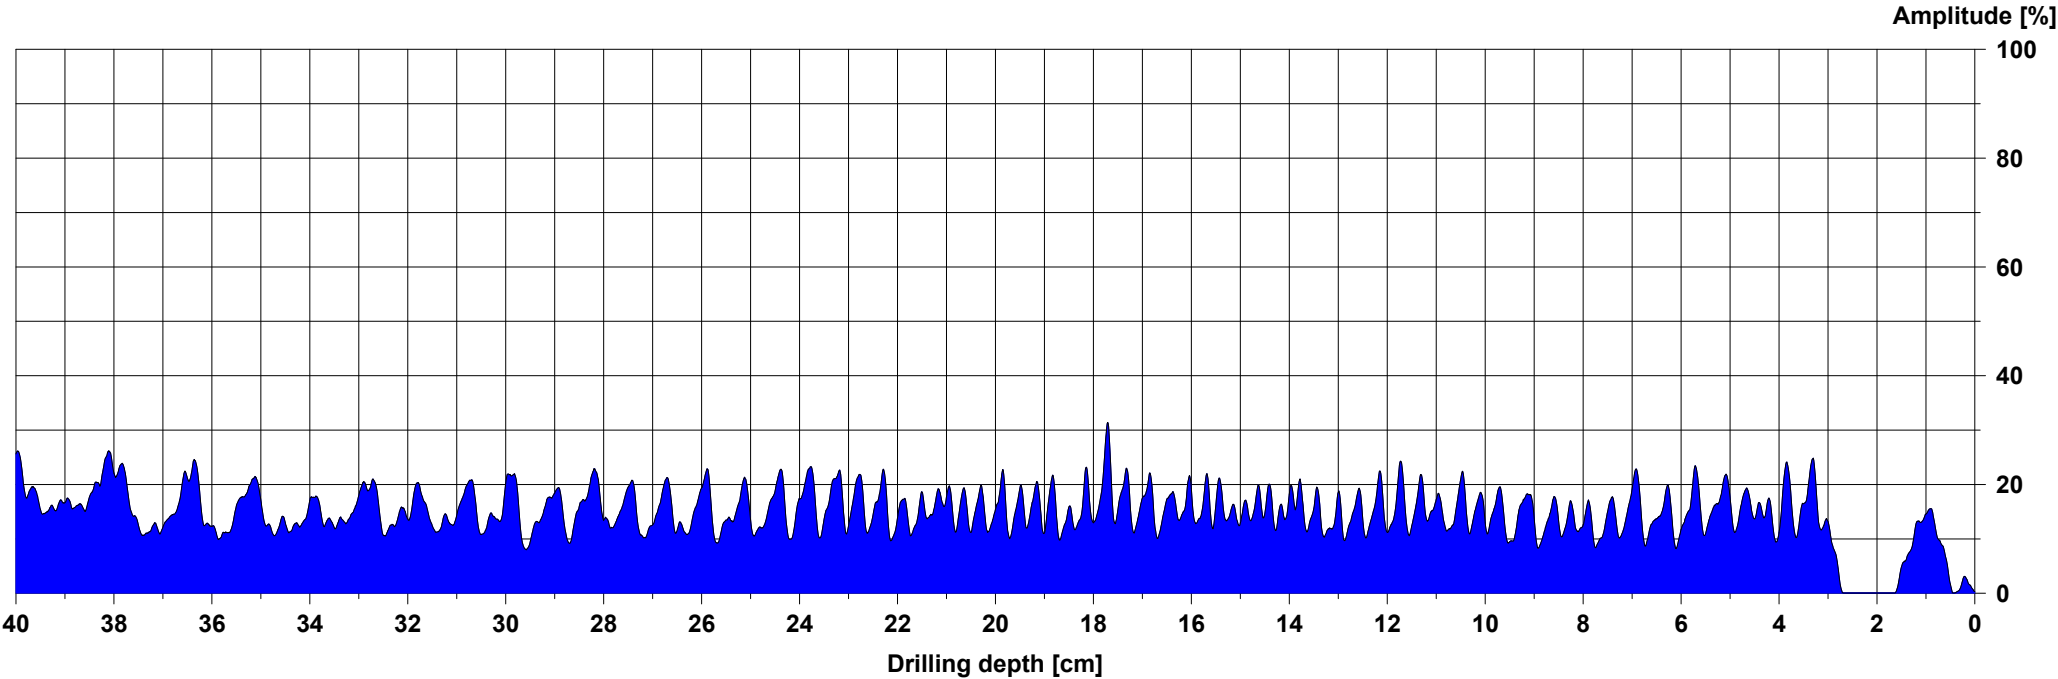
North side, no significant decay at the test location.

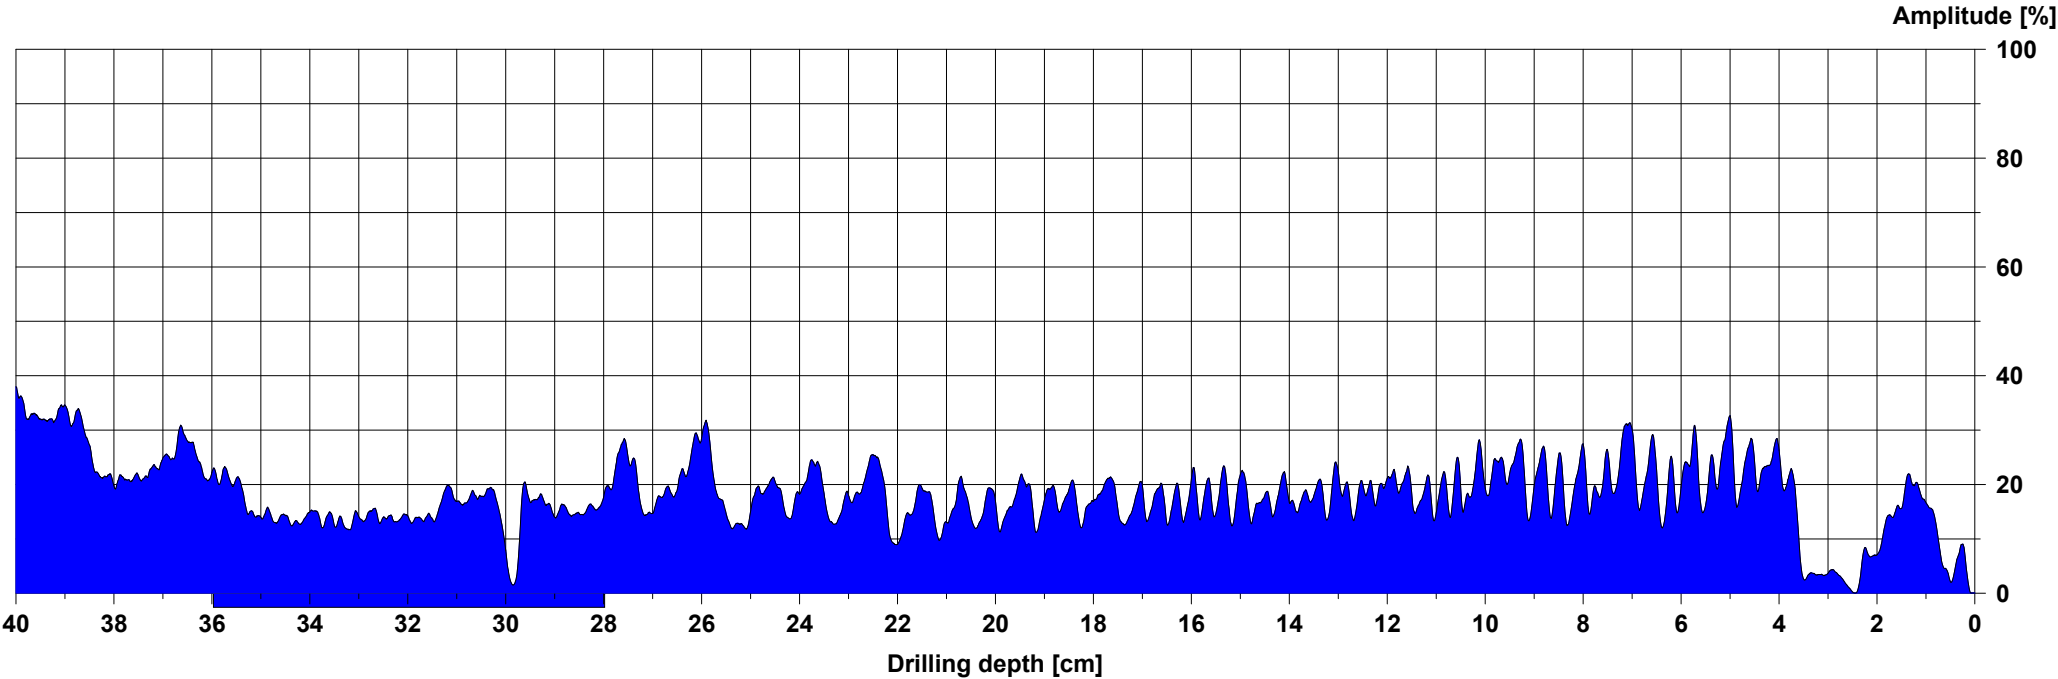
- 3.2.3 Results from the micro drillings did not detect any significant cavities or advanced decay at the test locations. A sudden change in amplitude was detected in the south drilling at 28 centimetres, and this may be associated with the drop in wood density observed in the Picus SoT, indicating the early (incipient) stages of decay.

- 4.1.2 The Resi micro drillings indicate the stem is free from advanced decay or hollowing at the test locations and the change in amplitude observed in the south drilling may be indicative of incipient decay or internal defect.

From 27,98 cm to 35,97 cm : Incipient decay

South side, change in amplitude at 28cm and irregular pattern may be associated with incipient decay however there is no evidence of significant decay or hollowing at the test location.

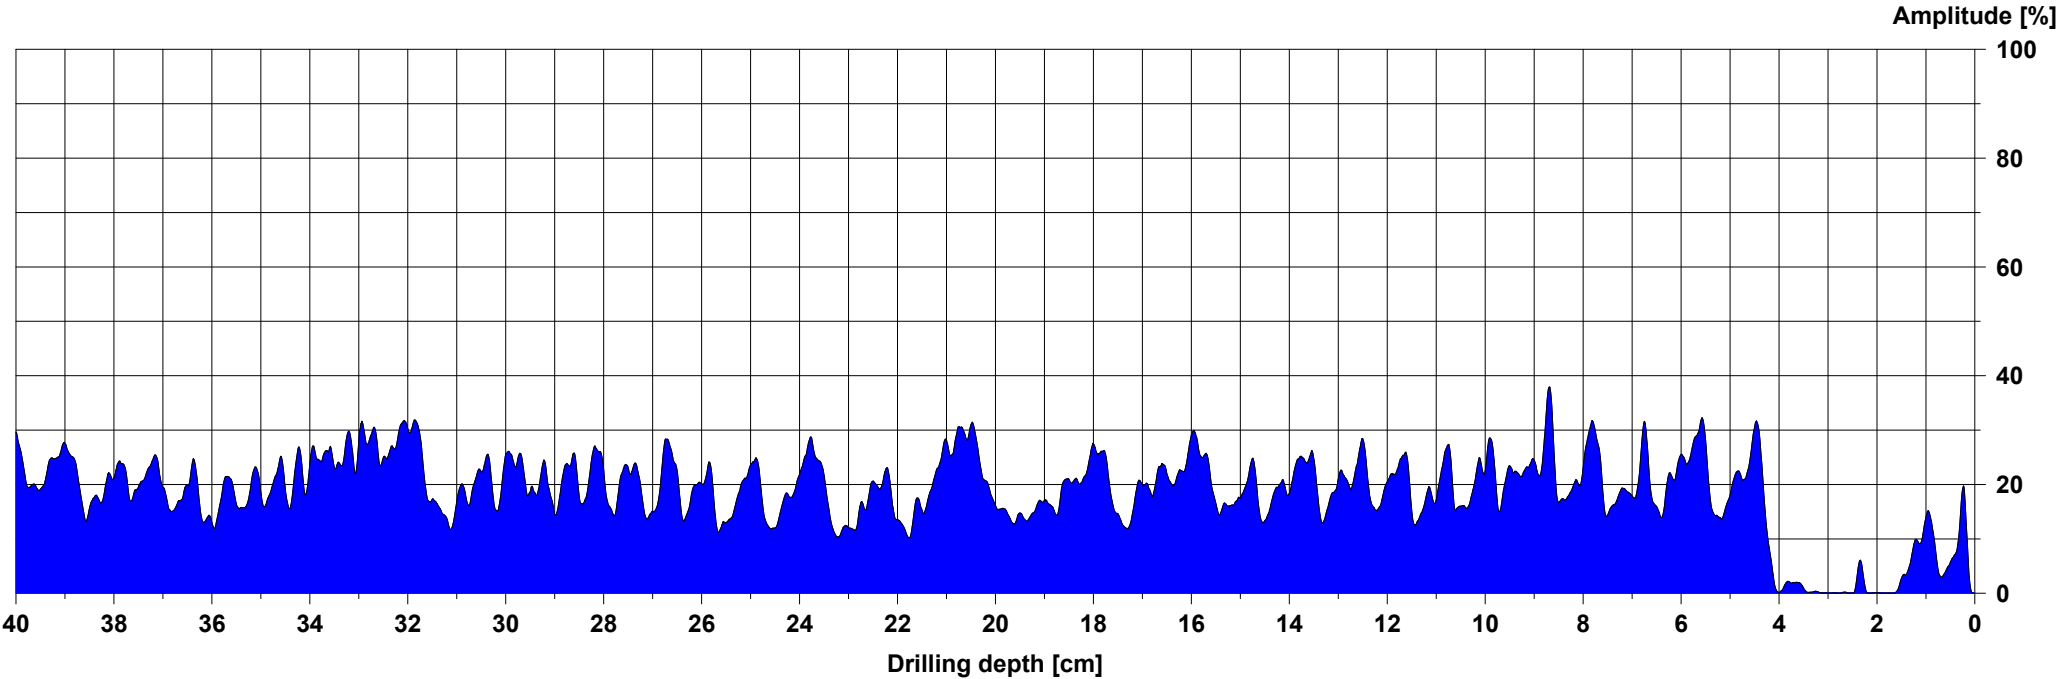
West side, no significant decay at the test location.
