## **Tree Condition Survey**

# **Lawnwood Wargrave**

**July 2026**

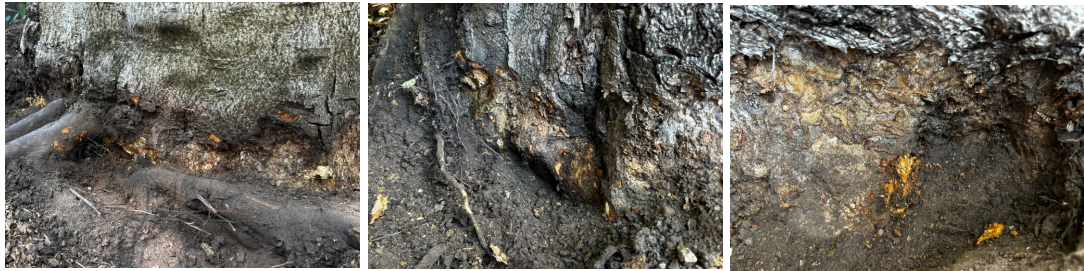
7.6 Beech [T17]. This tree has been historically buried and had a rockery built around it. This has been cleared and some minor excavation has revealed a complete ring of bark dysfunction and death around the circumference of the trunk that was buried.

It was not possible to excavate down to the original buttress flare. The tree has attempted to respond to that with a small number of new roots being produced above the dysfunction. One is dysfunctional and plays no part in maintaining vascular process. The few roots that are functional cannot support the needs of the tree and there is an obvious decline in vitality throughout the crown. The lower, dysfunctional area of the tree shows the typical mottling and colonisation of the trunk of *Armillaria* (Honey Fungus). The main fork at 4.0m is of narrow formation with only minor adaptive growth developing. The main sections of the crown have a minor skyline developing as the leverage on those sections begins to allow them to subside. The tree does not have the spare energy to manage that load. This tree is in major irreversible decline. The tree, due to group crown dynamics, is of asymmetric form with the crown developed directly over the office building. As the tree inevitably continues to decline the ability to remove it safely over the building, and gardens, will become increasingly difficult. It is my firm opinion that this tree must be removed relatively quickly to manage safety for all.

| No. | Species | Heights [m] | Age Class | Physiology | Comments | Works | Priority (months) |
|---|---|---|---|---|---|---|---|
| T17 | Beech ( <i>Fagus sylvatica</i> ) | 22 | Mature | Normal | Historically buried with clear dysfunction and mottling on inner dead bark typical of <i>Armillaria</i> colonisation. Isolated new upper rooting developed but not sufficient to maintain vitality. One root east dysfunctional. Main fork at 4.0m narrow formation minor adaptive growth developing east. Minor evidence of crown separation in upper crown. Major irreversible decline in vitality. Tree directly over office building | Fell to ground level | 3 |
