## Tree Condition Report

## Tree Work Application

| OUR REFERENCE | AC.2026.1111 |
| SITE | 46 Silverdale Road, Reading, Berkshire, RG6 7LS |

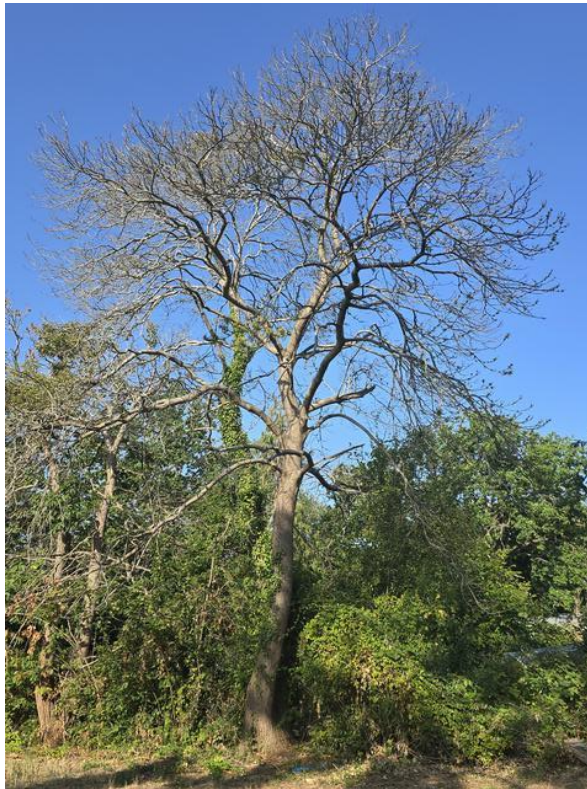
**3.1.2** T01 is a sweet chestnut (*Castanea sativa*), twin stemmed from the ground, with stems of 51 cm and 48 cm diameter. The trunk is covered in ivy extending into the crown. The tree is dead and collapsing, with large branch failures, see Image 1 in Appendix III.

- 4.11** The sweet chestnut tree T01 is dead and collapsing, with large branch failures. This tree is recommended for removal, subject to local authority approval because the tree is covered by a TPO. This is a moderate priority, with a three-month timescale.

**Image 1**      **T01 a dead twin stemmed sweet chestnut tree.**

- 6.1.2** The sweet chestnut tree T01 is dead and collapsing and is recommended for removal, subject to local authority approval. This is a moderate priority, with a three-month timescale.

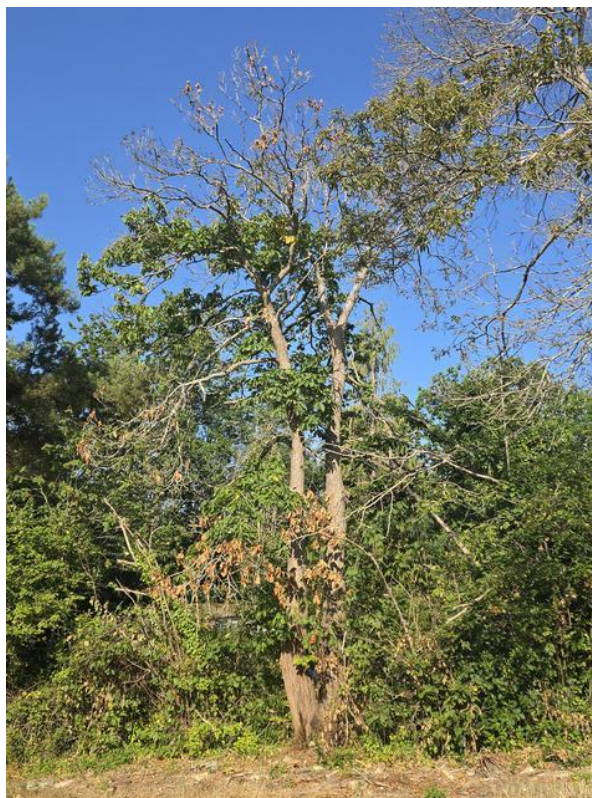
**3.1.3** T02 is also a sweet chestnut, twin stemmed from the ground, with stems of 50 cm and 46 cm diameter. Its trunk is likewise covered in ivy extending into the crown. The tree is all but dead and is collapsing, with large branch failures, see Image 2.

- 4.12** The sweet chestnut tree T02 is all but dead and is collapsing, with large branch failures. This tree is recommended for removal, subject to local authority approval because the tree is covered by a TPO. This is a moderate priority, with a three-month timescale.

**Image 2**      **T02 an all but dead twin stemmed sweet chestnut tree.**

- 6.1.3** The sweet chestnut tree T02 is all but dead and collapsing and is recommended for removal, subject to local authority approval. This is a moderate priority, with a three-month timescale.

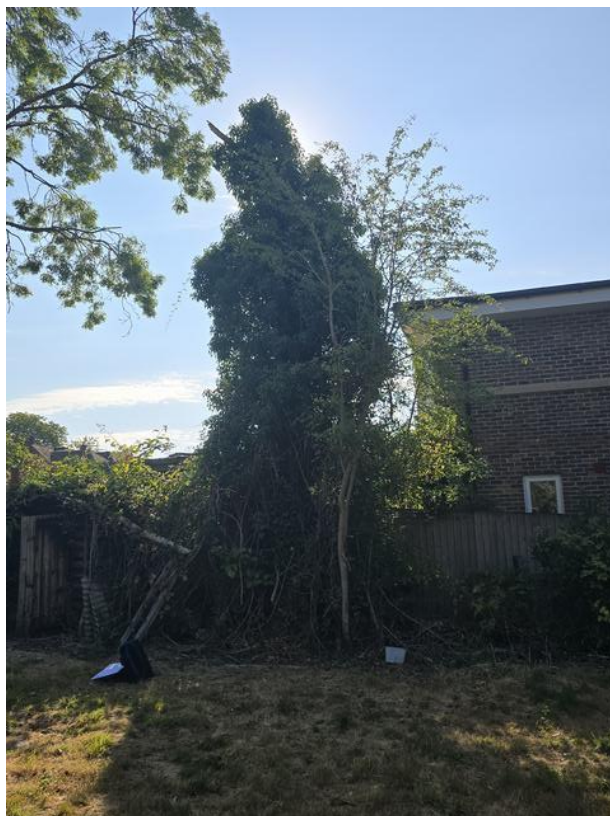
**3.1.4** T03 is a silver birch (*Betula pendula*), with an ivy-covered dead stem with decay. The tree is dead and collapsing, see Image 3.

- 4.13** The silver birch tree T03 is dead, with a decaying, ivy covered stem and is collapsing. This tree is recommended for removal, subject to local authority approval because the tree is covered by a TPO. This is a moderate priority, with a three-month timescale.

**Image 3**      **T03 a dead ivy-covered silver birch stem.**

- 6.1.4** The silver birch tree T03 is dead and collapsing and is recommended for removal, subject to local authority approval. This is a moderate priority, with a three-month timescale.

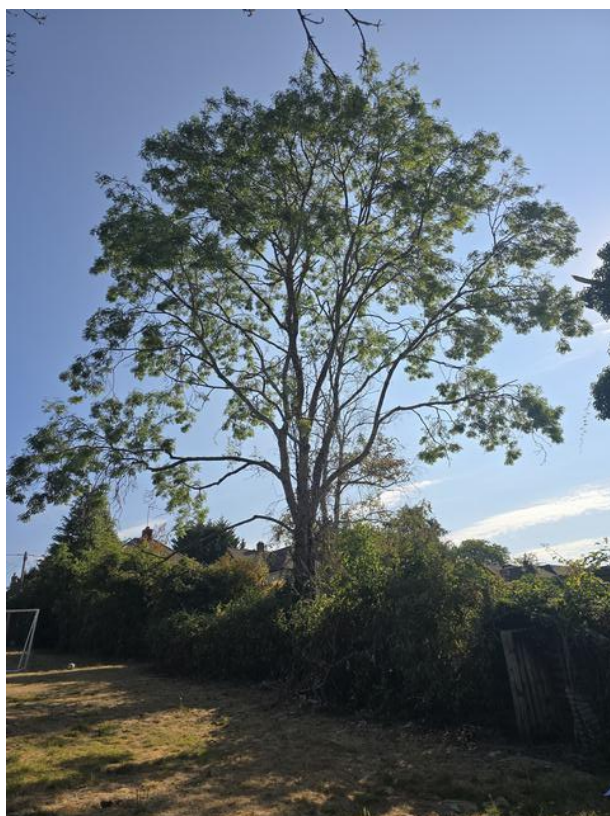
**3.1.5** T04 is a common ash (*Fraxinus excelsior*), located just inside the boundary fence. The tree is dying and collapsing, with large branch failures. There is clear evidence of ash dieback disease (ADB), in the form of not just dieback and deadwood but also stunted regrowth, see Images 4 to 10.

- 4.6** Ash dieback disease (caused by the fungus *Hymenoscyphus fraxineus*) results in a progressive decline of affected trees. As the disease progresses the timber becomes increasingly brittle, making affected trees more hazardous to work on and more prone to sudden branch failure, so removal should not be delayed.

- 4.14** The common ash tree T04 is dying and collapsing, with large branch failures, and shows clear evidence of ash dieback disease. This tree is recommended for removal, subject to local authority approval because the tree is covered by a TPO. This is a moderate priority, with a three-month timescale.

**Image 4**      **T04 a large ash tree with significant deadwood and dieback from ADB.**

- 6.1.5** The common ash tree T04 is dying and collapsing, with clear evidence of ash dieback disease, and is recommended for removal, subject to local authority approval. This is a moderate priority, with a three-month timescale.

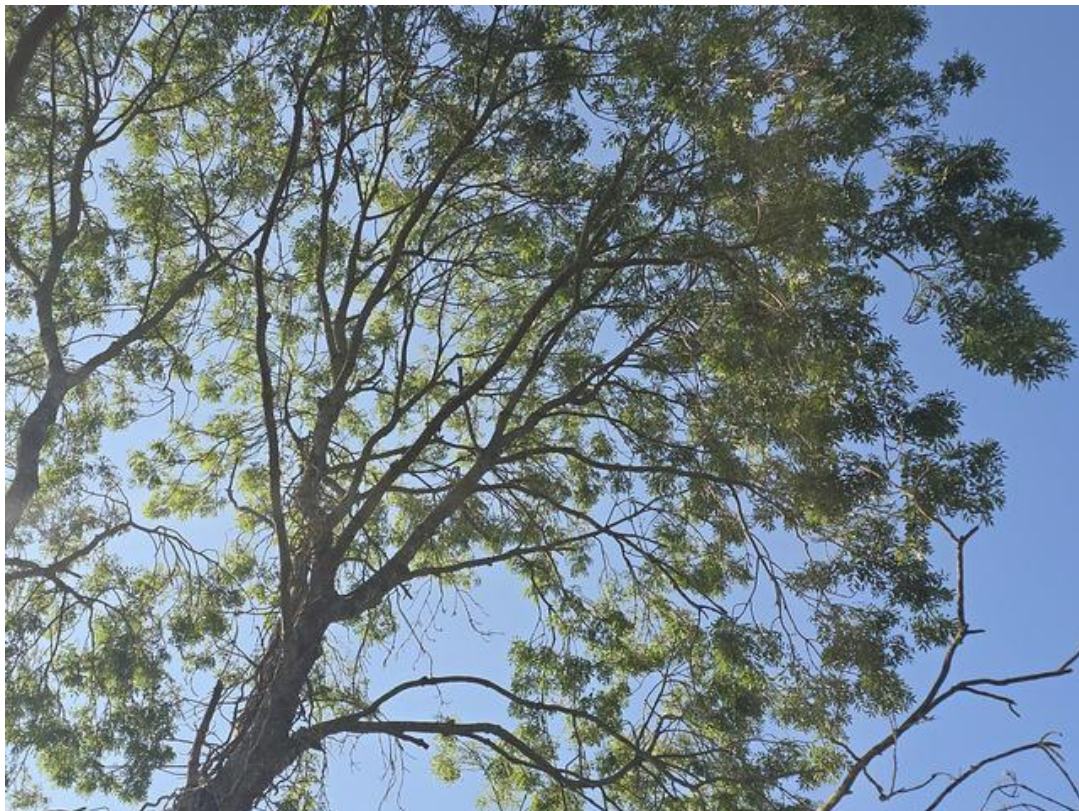
**Image 5** Very sparse crown on T04, with dieback, deadwood, and stunted regrowth.

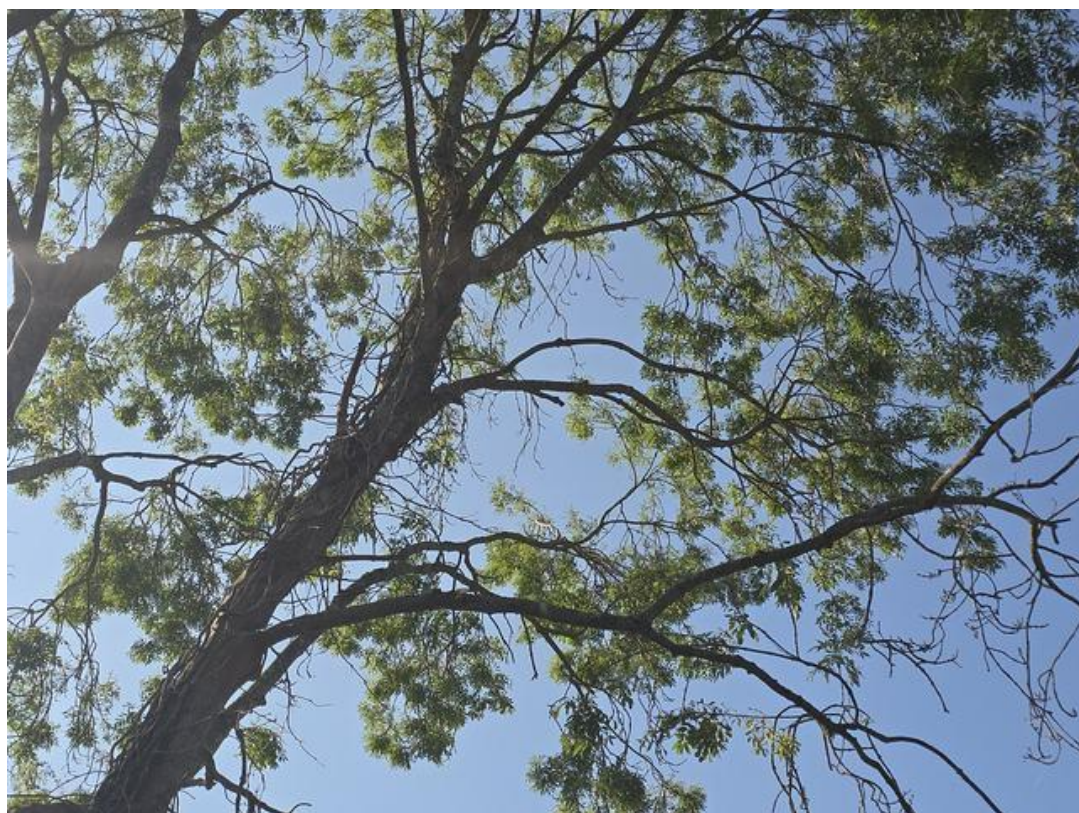
**Image 6** Very sparse crown on T04, with dieback, deadwood, and stunted regrowth.

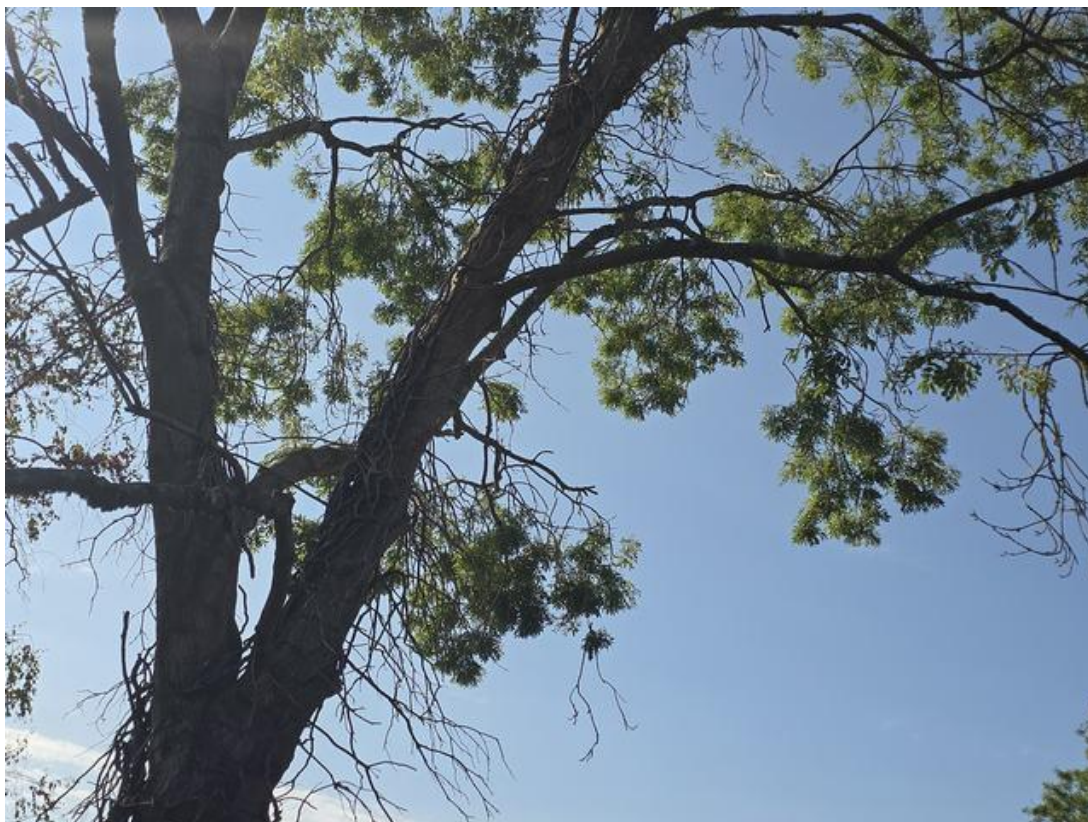
**Image 7** Very sparse crown on T04, with dieback, deadwood, and stunted regrowth.

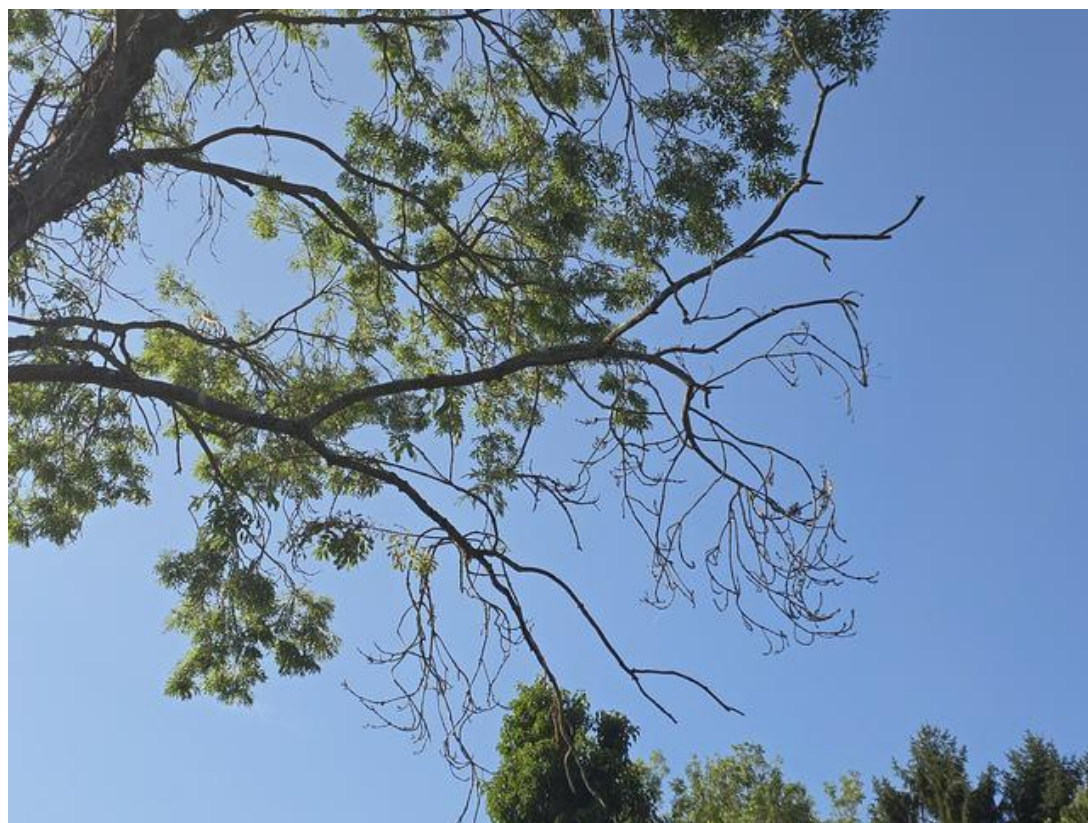
**Image 8** Very sparse crown on T04, with dieback, deadwood, and stunted regrowth.

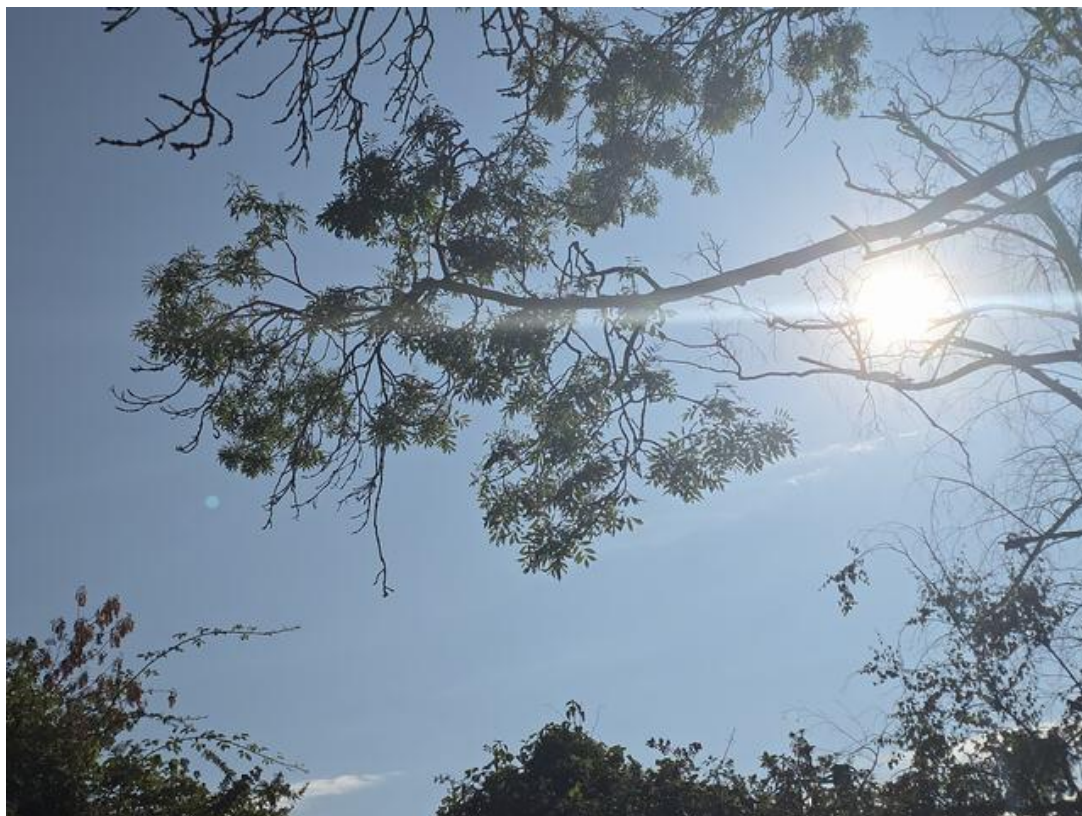
**Image 9** Very sparse crown on T04, with dieback, deadwood, and stunted regrowth.

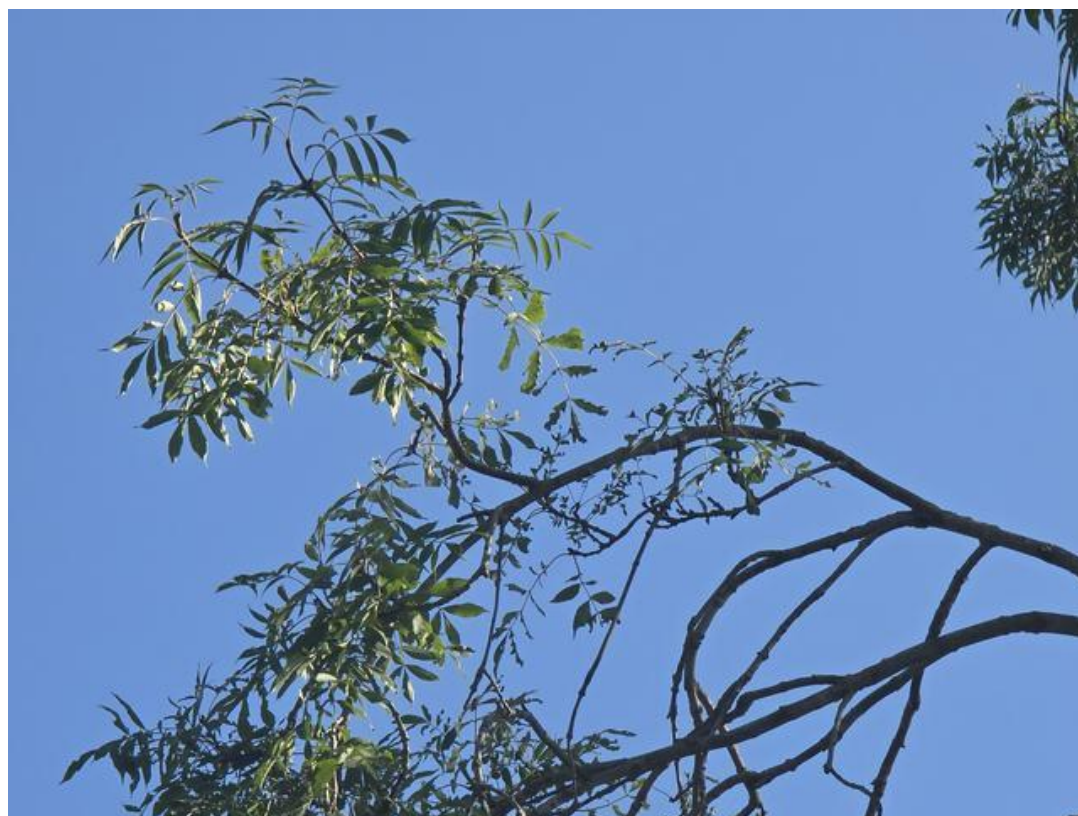
**Image 10** Very sparse crown on T04, with dieback, deadwood, and stunted regrowth.
