Refurbishment /Demolition  
Asbestos Survey Report  
AT  
105 Colemansmoor Road  
Woodley  
Reading  
RG5 4DA

Produced For  
**Colemans Moor Heights Ltd**

**Report Number:** 244098

**Survey Date:** 16/09/2024

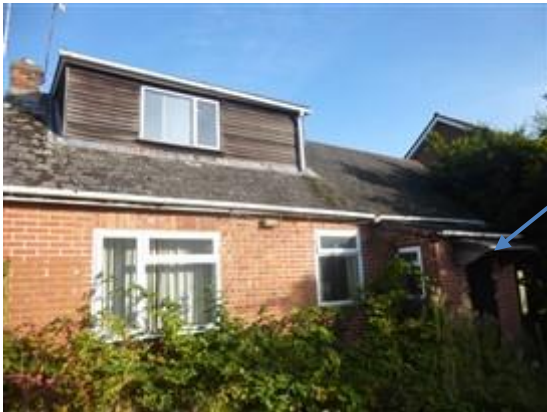
| <b>Component</b> | Slate | <b>Amount</b> | |
| <b>Asbestos Type</b> | No asbestos detected in sample. | <b>Access</b> | |
| <p style="text-align: center;">Photo</p> | | <p style="text-align: center;">Notes</p> <p style="text-align: center;">No action required</p> | |

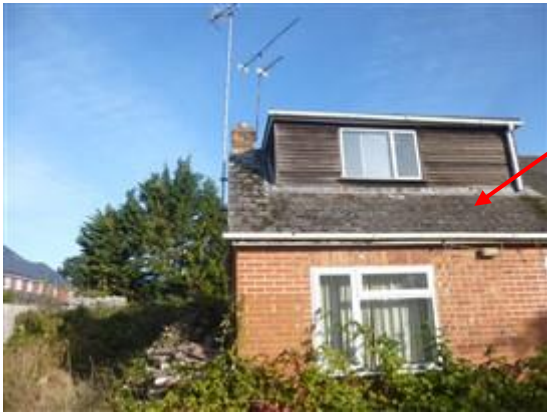
| <b>Component</b> | Slate | <b>Amount</b> | 400m <sup>2</sup> |
| <b>Asbestos Type</b> | Chrysotile | <b>Access</b> | High |

| <p style="text-align: center;">Photo</p> | | <p style="text-align: center;">Notes</p> <p style="text-align: center;">Removal and disposal at licensed waste site by trained competent contractors</p> | |

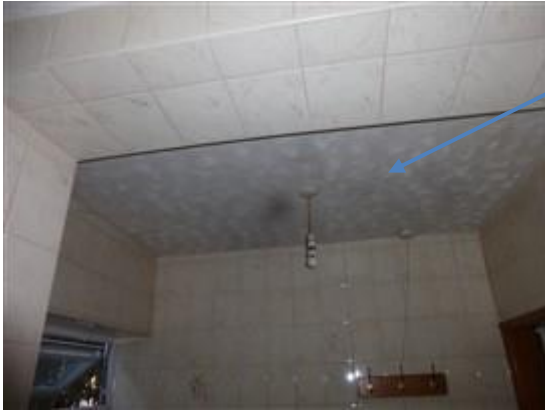
| <b>Analysis Date:</b><br>17/09/2024 | <b>Bulk Cert No:</b><br>AA30756 | <b>Sample No:</b><br>MC/244098/S03 | |

| <b>Component</b> | Textured Coating | <b>Amount</b> | |
| <b>Asbestos Type</b> | No asbestos detected in sample. | <b>Access</b> | |
| <b>Photo</b><br> | | <b>Notes</b><br><br>No action required | |

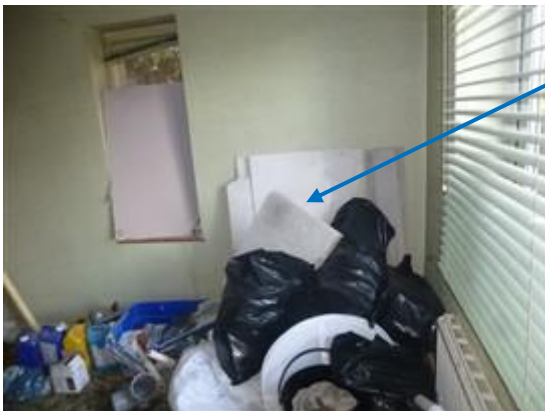
| <b>Analysis Date:</b><br>17/09/2024 | <b>Bulk Cert No:</b><br>AA30756 | <b>Sample No:</b><br>MC/244098/S04 | |

| <b>Component</b> | Loose Boards | <b>Amount</b> | |
| <b>Asbestos Type</b> | No asbestos detected in sample. | <b>Access</b> | |
| <b>Photo</b><br> | | <b>Notes</b><br><br>No action required | |

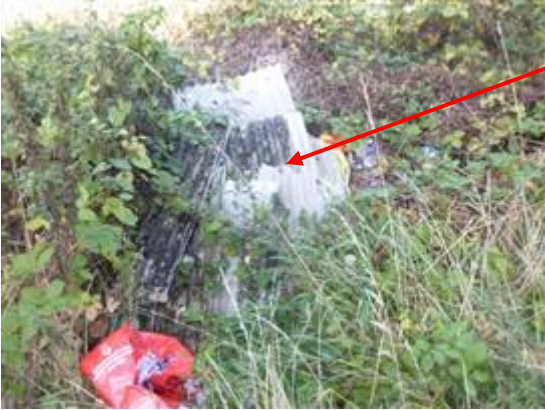
| Sample / Item Reference | Location. | Material | Asbestos Type/ Analysis | Amount<br>m <sup>1</sup><br>m <sup>2</sup> | Comments |
|---|---|---|---|---|---|
| MC/244098/S05 | Loose Sheets in Garden | Cement Sheets | Chrysotile | 10 sheets | Removal and disposal at licensed waste site by trained competent contractors |

| <b>Component</b> | Corrugated Sheets | <b>Amount</b> | 10 Sheets |
| <b>Asbestos Type</b> | Chrysotile | <b>Access</b> | Fair |
| <b>Photo</b><br> | | <b>Notes</b><br><p>These sheets were accessible, but it is possible due to the extremely overgrown garden, that more could be hidden. Require removal and disposal at licensed waste site by trained competent contractors.</p> | |
