# The Old Cottage

Pearson Road, Sonning, RG4 6UH

## Condition 4: Method Statement RE: Listed Building Consent 232278

Date: 21.04.26

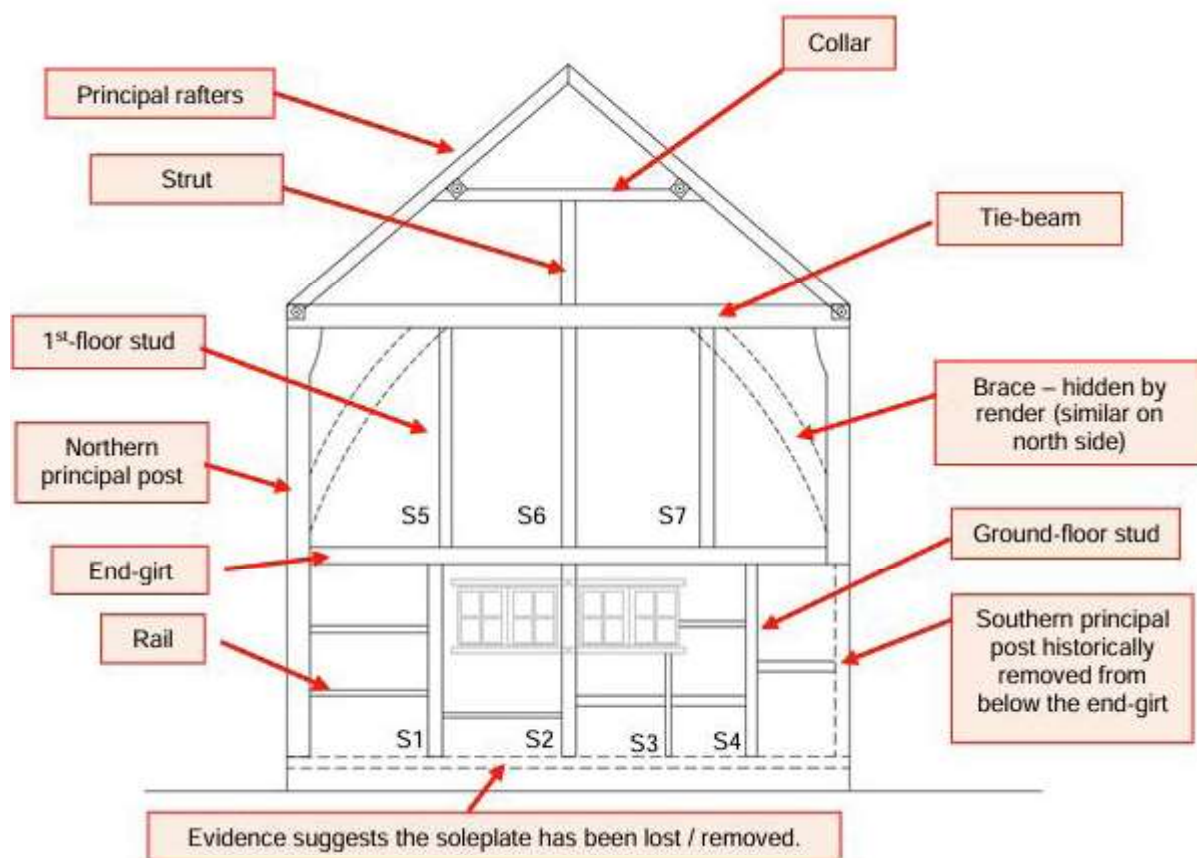
Fig. 1: Extract from the Clive Hudson Associates' structural report on the west gable

The Clive Hudson structural report on the west gable identifies secondary studs 1-4 as the vertical timber studs at the ground floor between the 'end girt' (see Fig.1 for reference).

Figure 6. Elevation of the west gable with constituent elements of the timber frame indicated

In order to repair the timber and re-create the load paths of the original timber frame, three new studs are proposed to replace S1-S4, directly below the first floor studs S5, 6 and 7. The original peg holes on site provide evidence of the original arrangement of vertical posts proposed (refer also to paragraph 4.5.2) ie: the current locations are not the original locations.

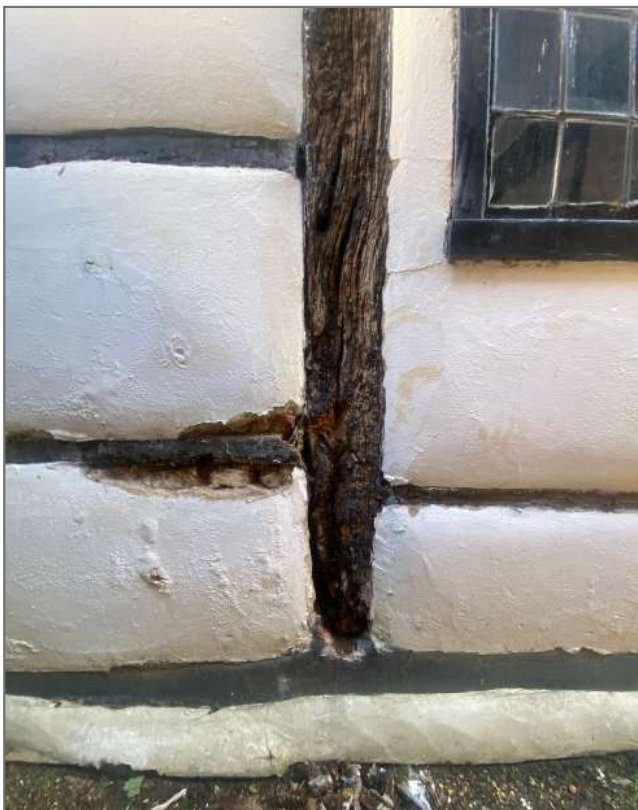
The window insertion to the west gable has clearly disturbed the horizontal timber rails. With the replacement ground floor studs the horizontal rails are proposed to be replaced to pick up the adjusted gaps between the studs. The cleaned timbers have revealed the rails to be in a poor condition, however, if any material can reasonably be salvaged and re-used it shall be: David Evans has confirmed the rails do not provide structural support and could readily be removed, however it is suggested these are retained to respect the historic evolution of the timber frame. The studs shall be inspected for evidence of a rebate or coving to their edges which would suggest an early date for the brick infills.

Fig. 2: Close up of S1 stud and three rails

- The replacement, scarf repairs and face repairs to structural timbers shall be carried out as specified on drawing 246714-02-P2, using appropriate air dried/ well-seasoned oak sections.

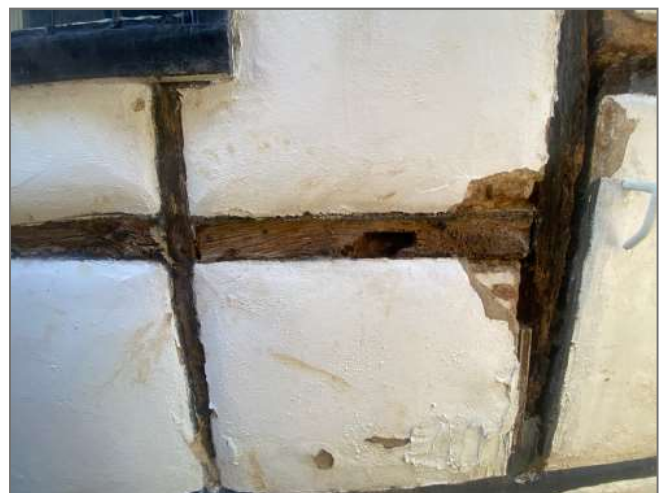
Fig. 3: Close up of S3 stud and two rails
