20th December 2024

Our ref: GE22937/SA02/241220

RE: South Wokingham – Site Walkover Inspection

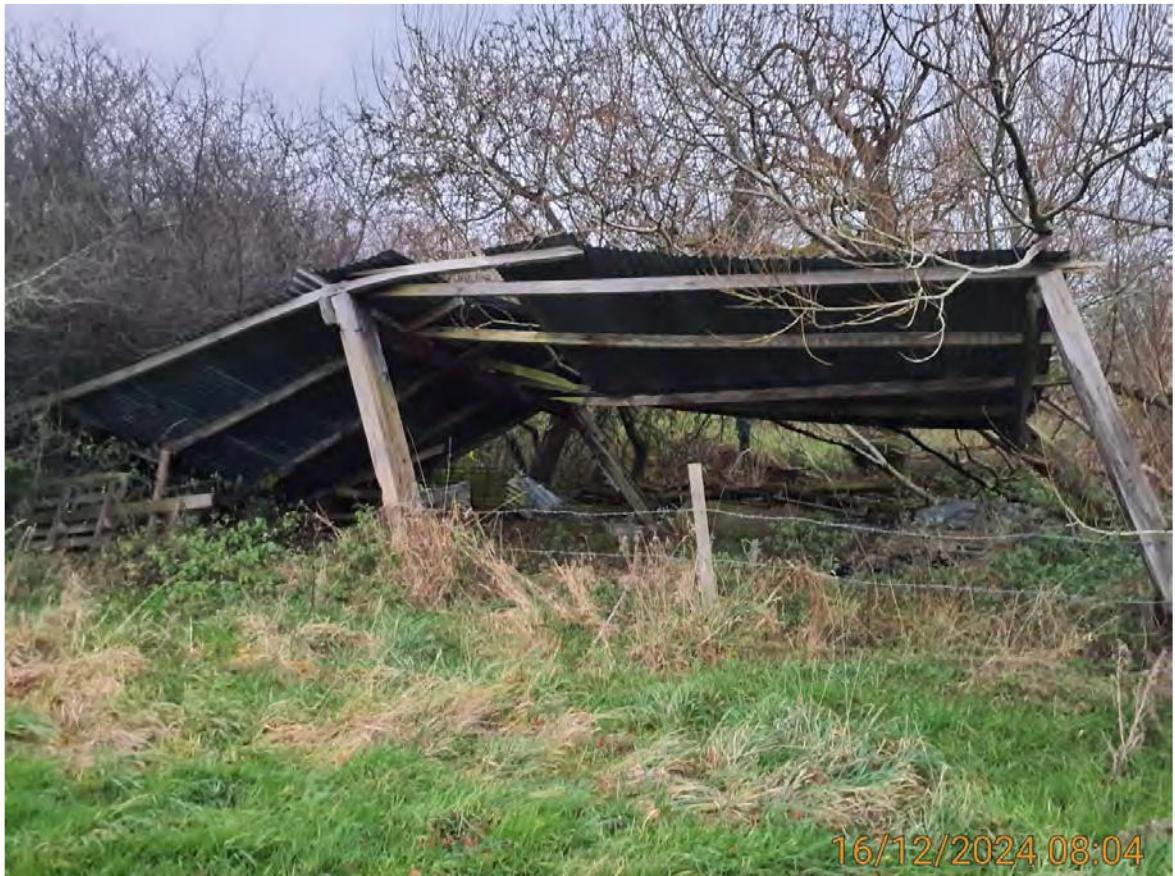
Plate No.: 1	Title.: Ref 01 Collapsed animal shelter
--------------	---

Parcel / Area	Feature Reference	Description	Recommendations
Fields south of R5	01	Collapsed animal shelter constructed from timber and corrugated metal. No potential asbestos materials noted although structure not safe to enter.	Suitable R&D asbestos survey by competent person where works to or demolition of building proposed. Secure building to prevent access.
	02	Rusted metal machinery in scrub vegetation.	Consider removal and disposal.
	03	Old trailer and tyres in scrub vegetation.	
	04	Metal water tank and cattle feeder in scrub vegetation.	
	05	Animal shelter constructed from timber and corrugated metal. No potential asbestos materials noted.	Suitable R&D asbestos survey by competent person where works to or demolition of building proposed. Consider securing building to prevent access.
	06	Animal shelter (possibly off-site). No potential asbestos materials noted although structure not safe to enter.	If within site boundary – Suitable R&D asbestos survey by competent person where works to or demolition of building proposed. Secure building to prevent access.

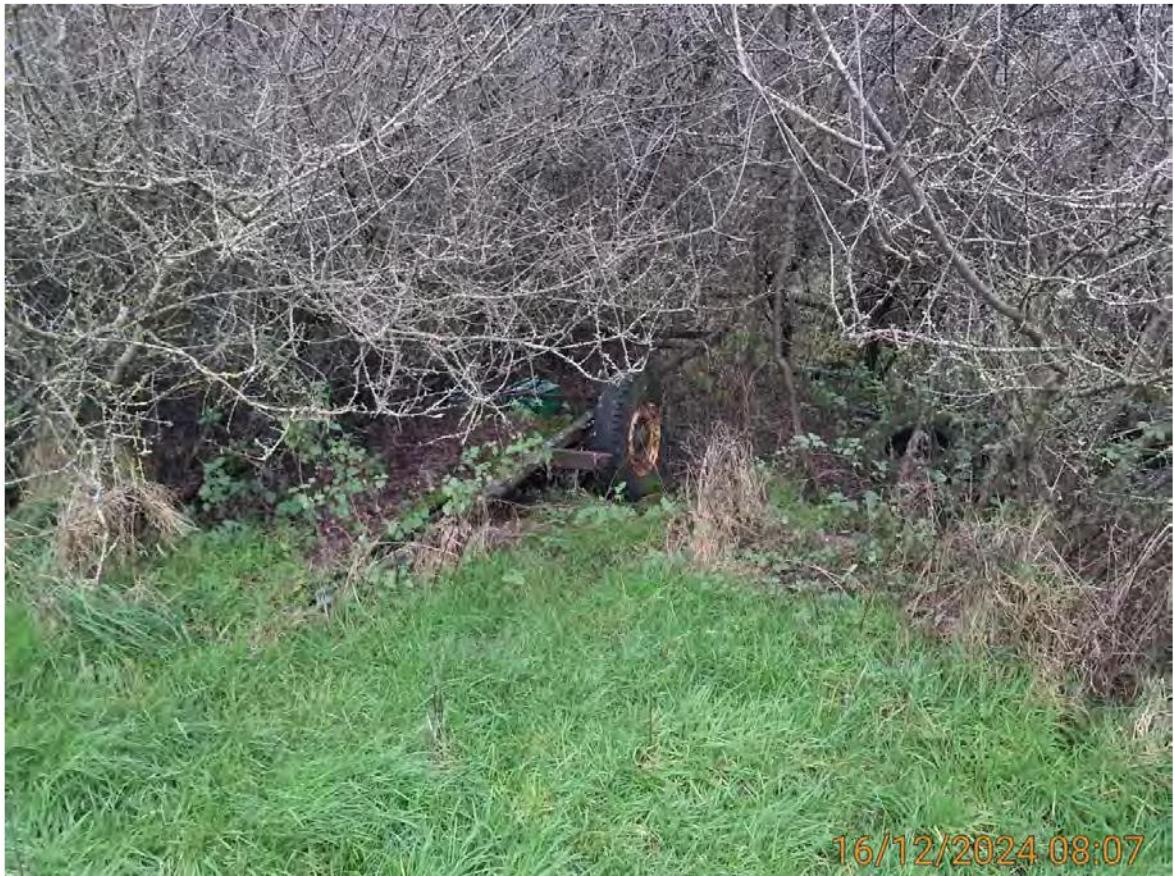
Plate No.: 3

Title.: Ref 03 Old trailer and tyres

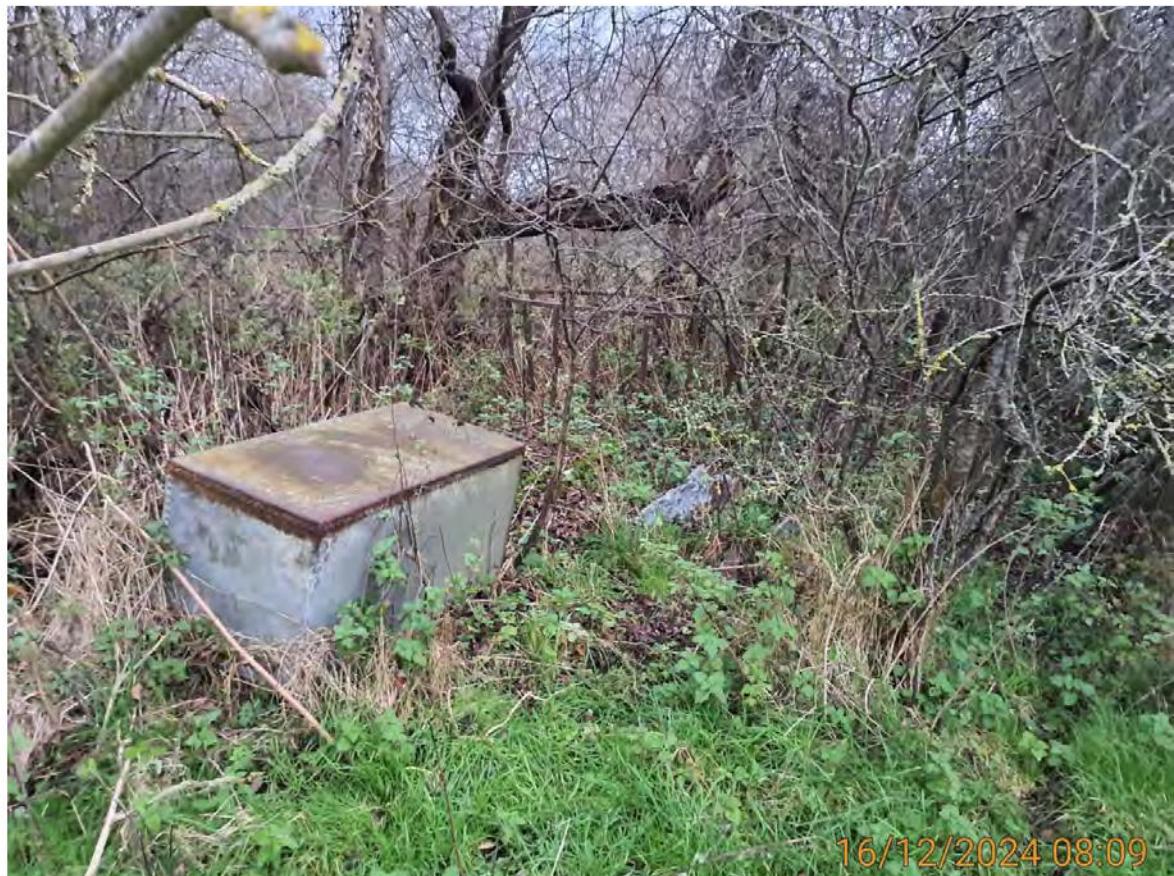
Plate No.: 4

Title.: Ref 04 Metal water tank and cattle feeder

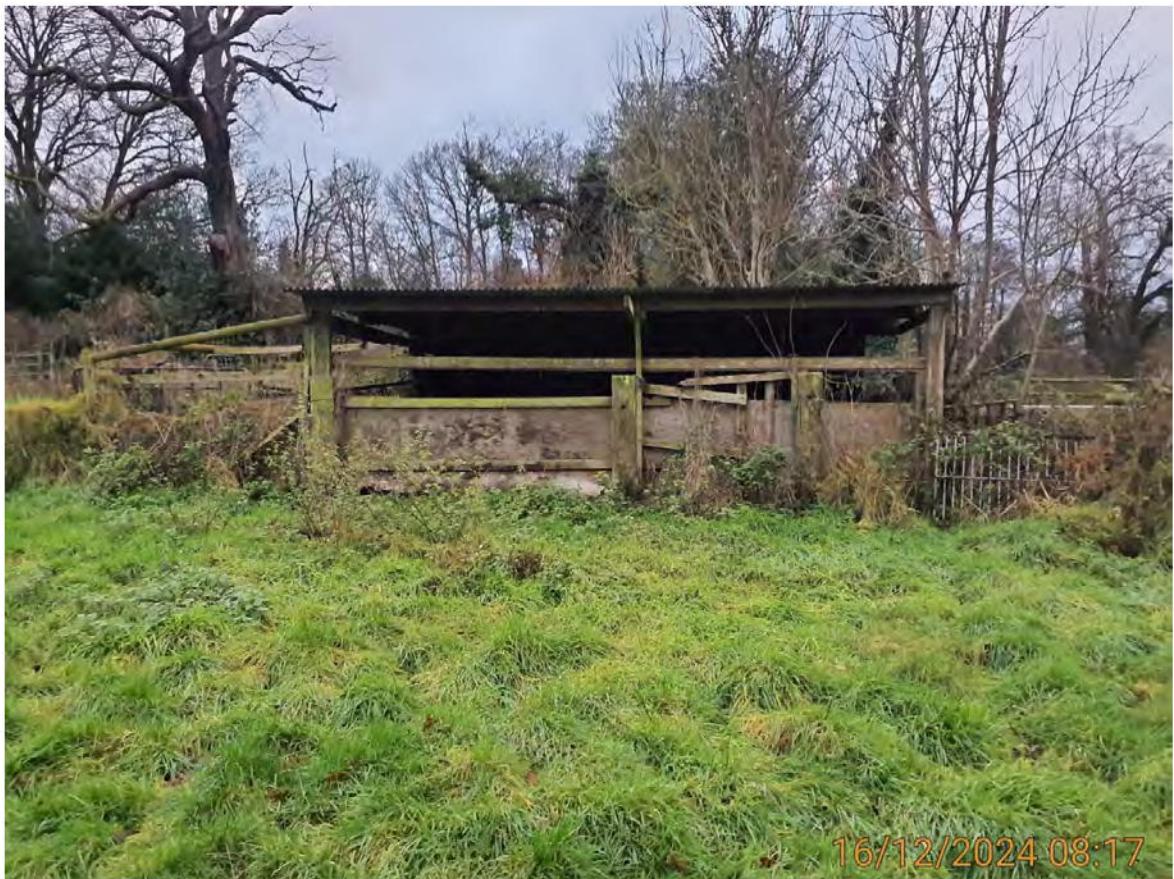
Plate No.: 5

Title.: Ref 05 Animal shelter

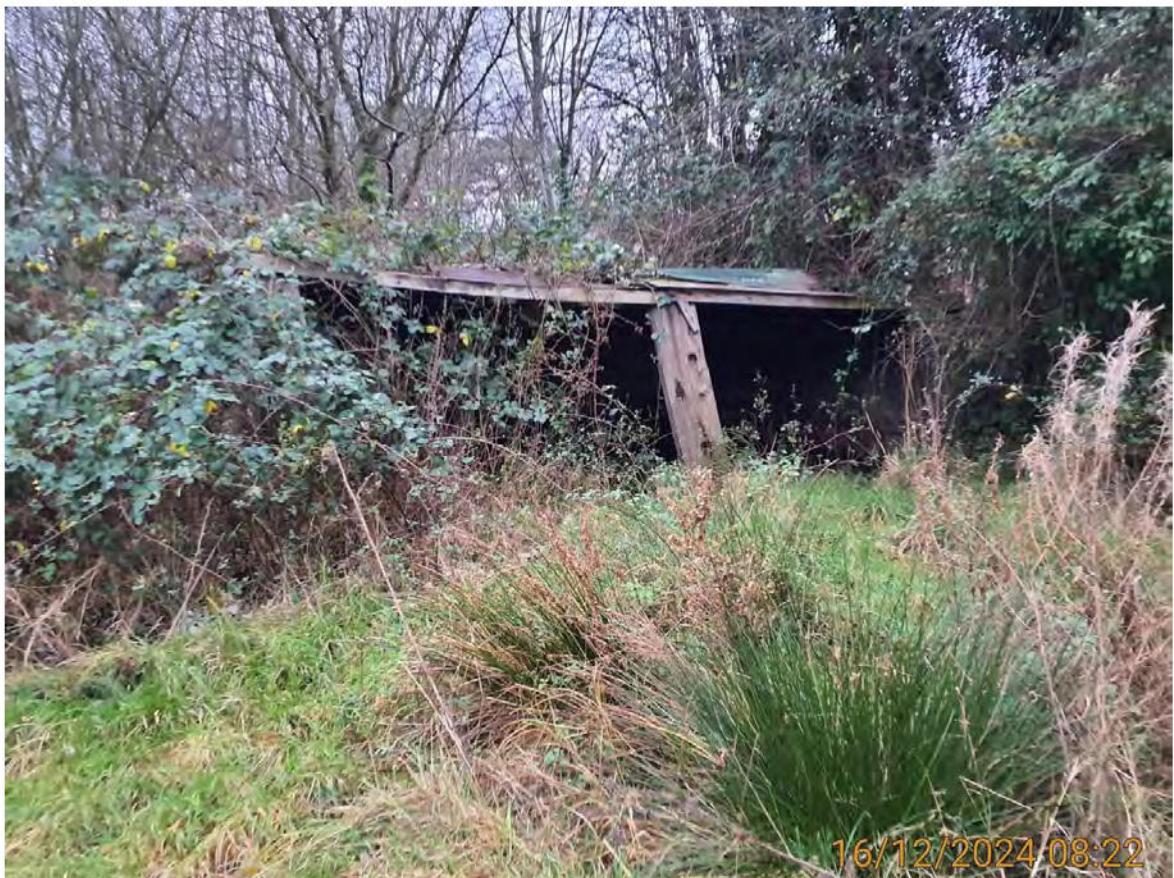
Plate No.: 6

Title.: Ref 06 Animal shelter (possibly off-site)

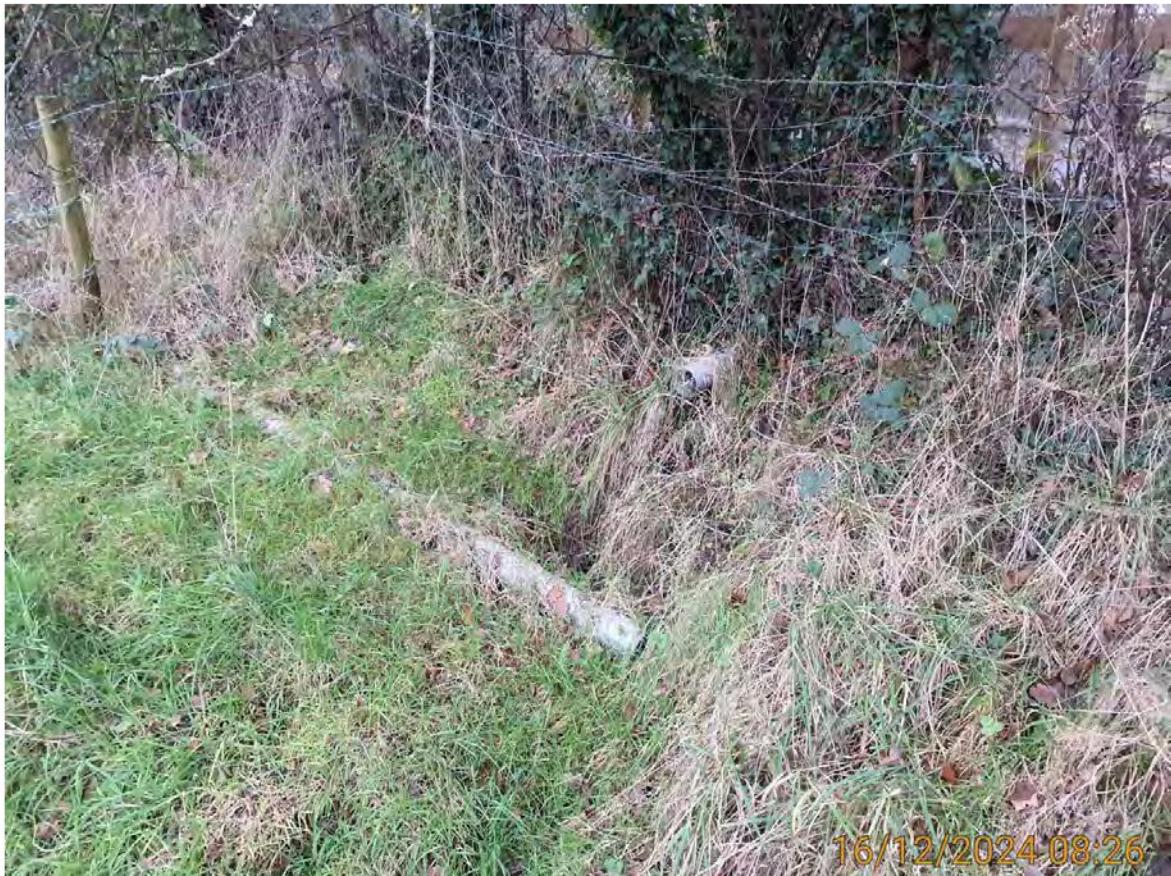
Plate No.: 7

07	Overflow pipe from off-site pond to the south which discharges onto the site surface towards Emm Brook.	Consider culverting to Emm Brook if this area is to be developed.
	08	Mound of unknown soil/material. No potential asbestos materials noted.	Consider investigation and testing if mound is to be disturbed.
Land southeast of R5	09	Bonfire ash including wire	Localised removal and disposal.
R5	10	Caravan	Removal prior to development.

Title.: Ref 07 Overflow pipe from off-site pond

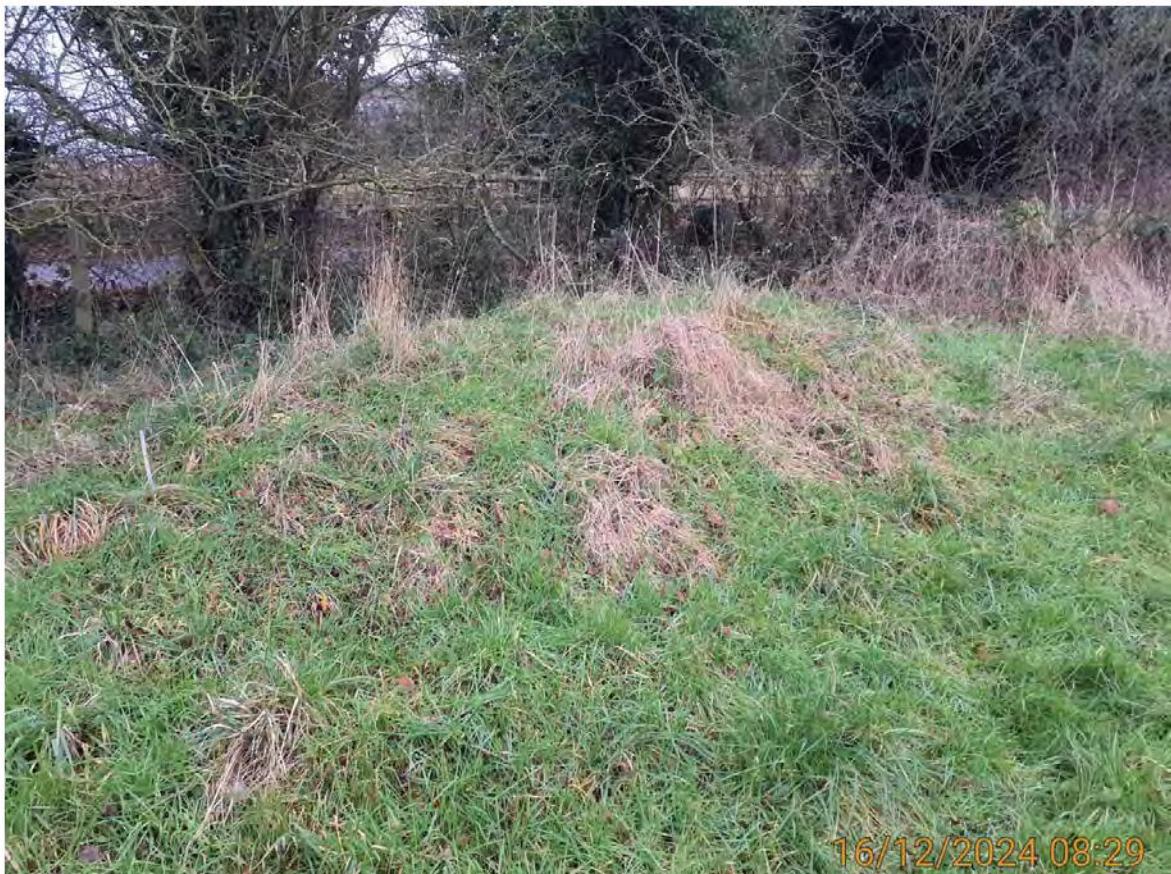
Plate No.: 8

Title.: Ref 08 Mound of unknown soil/material

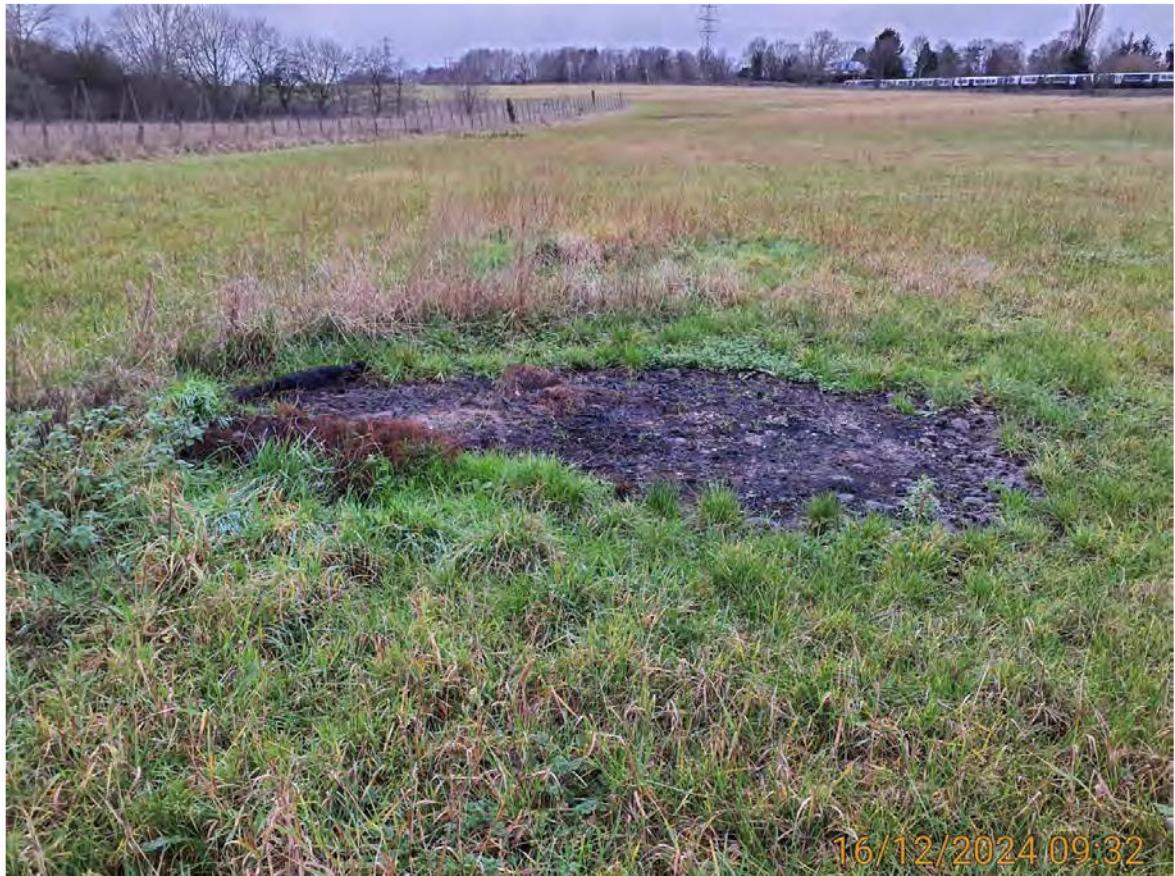
Plate No.: 9

Title.: Ref 09 Bonfire ash including wire

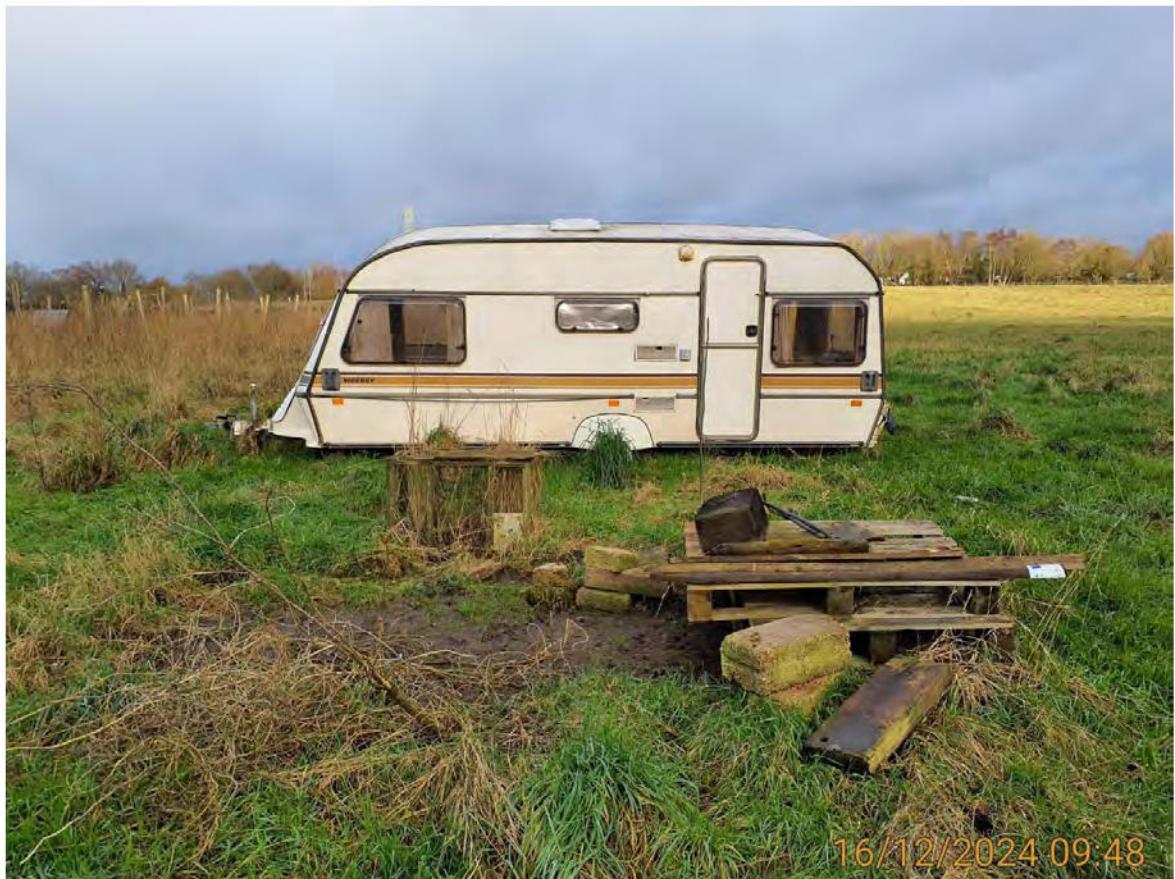
Plate No.: 10

Title.: Ref 10 Caravan

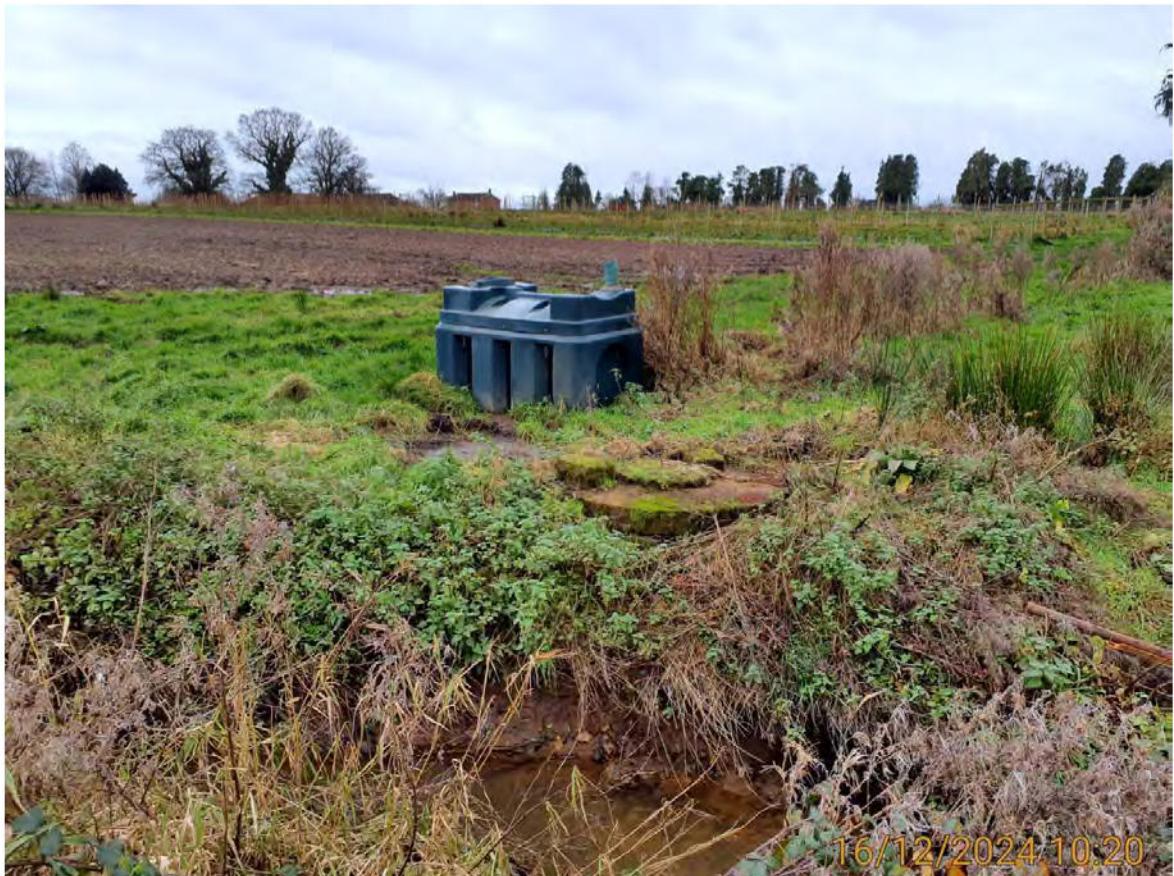
Plate No.: 11

Parcel / Area	Feature Reference	Description	Recommendations
West of Emm Brook and proposed basin	11	Water tank and concrete chamber. Chamber may be associated with farm buildings to the west. No potential asbestos materials noted.	Removal of tank.
Land north of Brittons Farm	12	Discarded bonded asbestos cement corrugated sheets and fragments of bonded asbestos cement. Confirmed as containing chrysotile asbestos fibres by Casa Environmental Services Ltd report ref. J086214.	Removal of bonded asbestos cement sheets and fragments by suitable, competent contractor.
	13	Area of dense vegetation (no inspection possible). Further asbestos containing materials may be present in this area.	Clearance of vegetation ideally with handheld machinery with watching brief for further asbestos containing materials.
	14	Green/garden waste spread over area. Area is potentially being used to dispose of waste. Waste may also cover potentially contaminated soils.	Removal and disposal of green waste and watching brief.

Title.: Ref 11 Water tank and concrete chamber

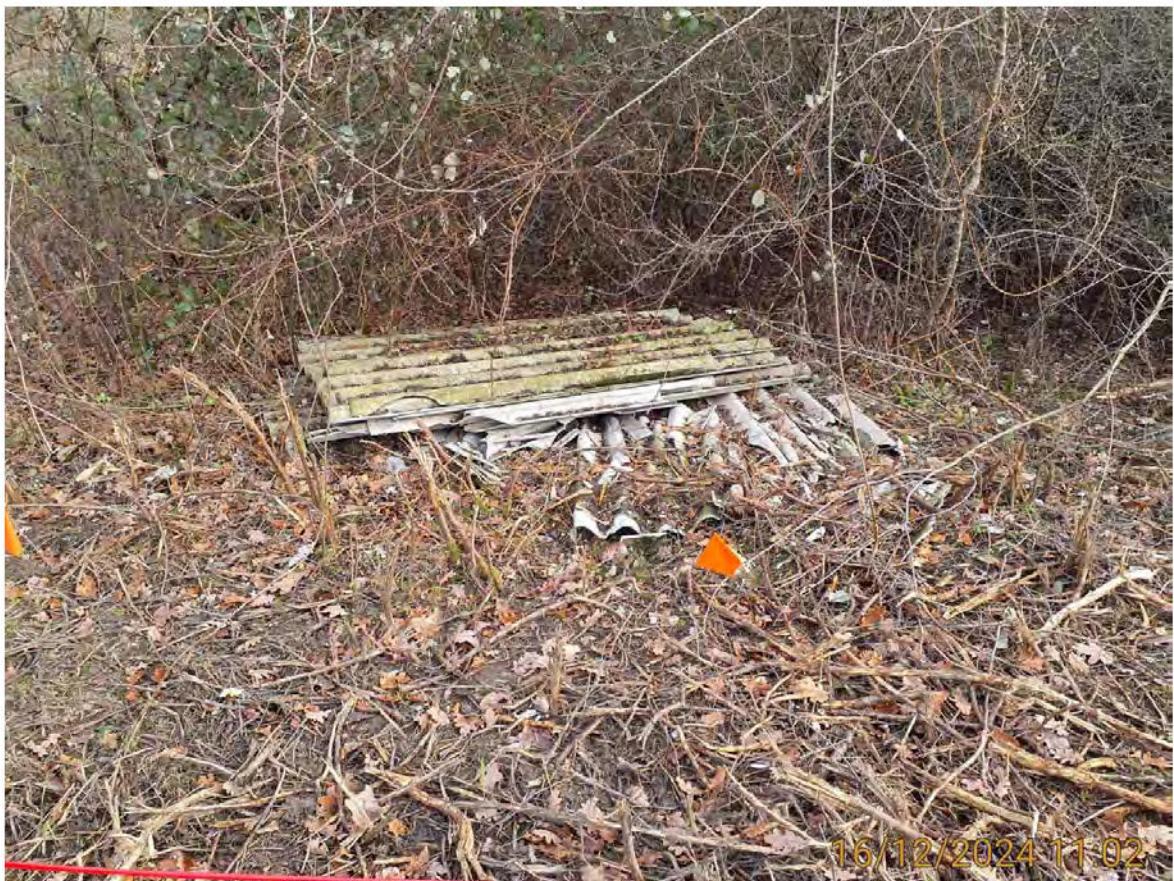
Plate No.: 12

Title.: Ref 12 Discarded asbestos cement corrugated sheets

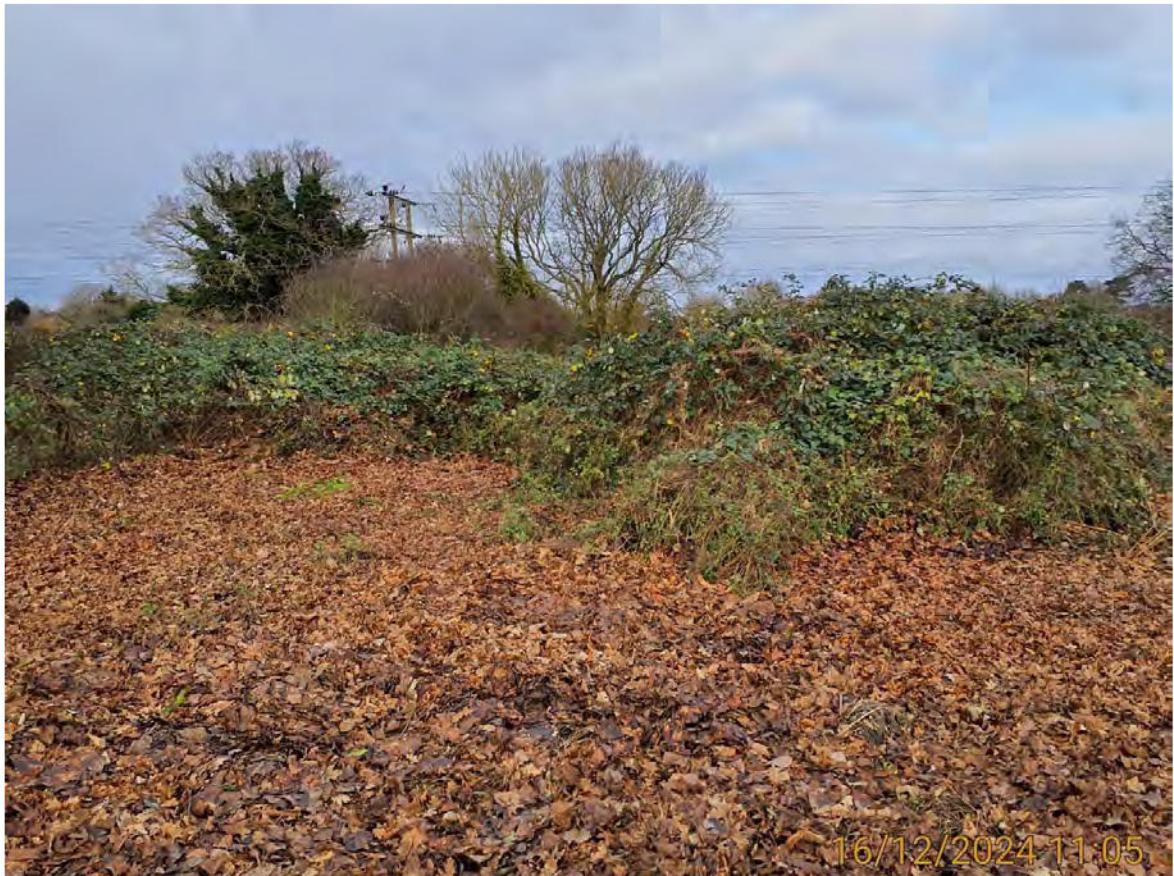
Plate No.: 13

Title.: Ref 13 Area of dense vegetation (no inspection possible)

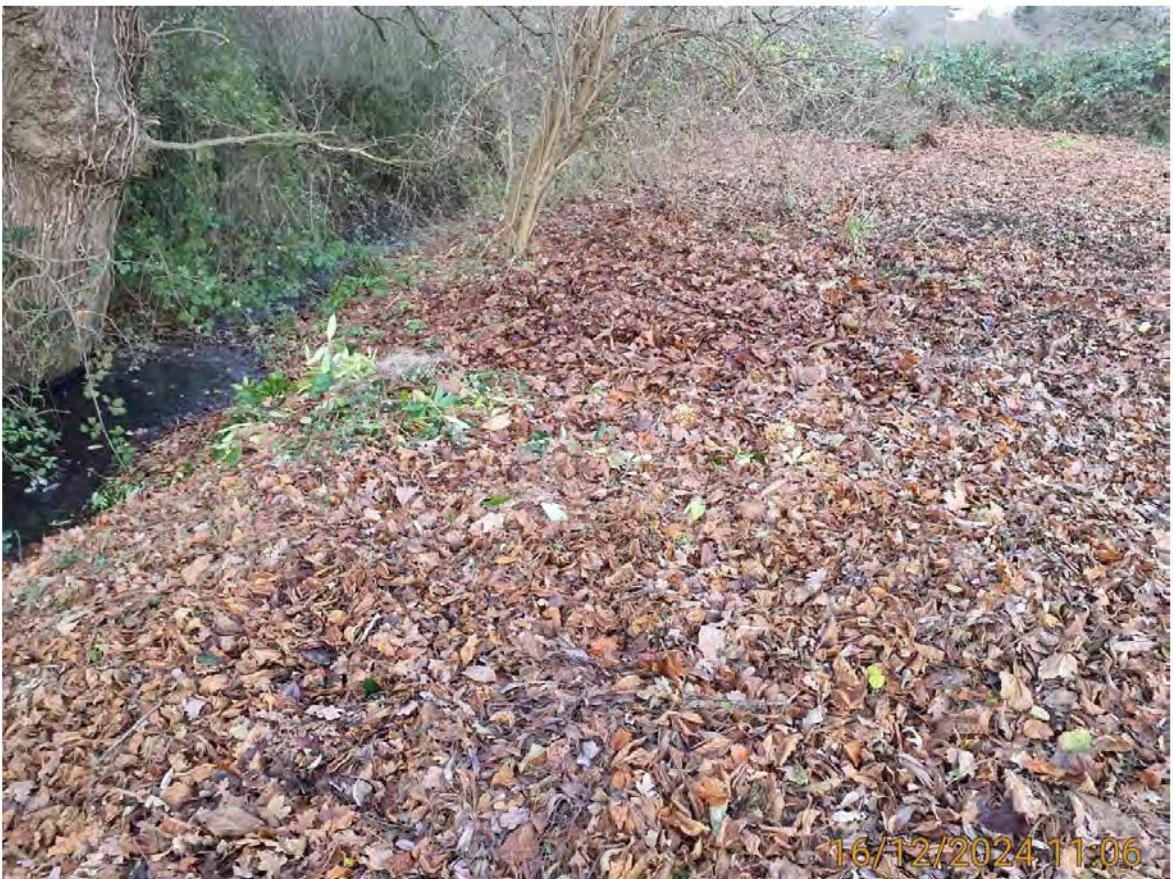
Plate No.: 14

Title.: Ref 14 Green waste spread over area

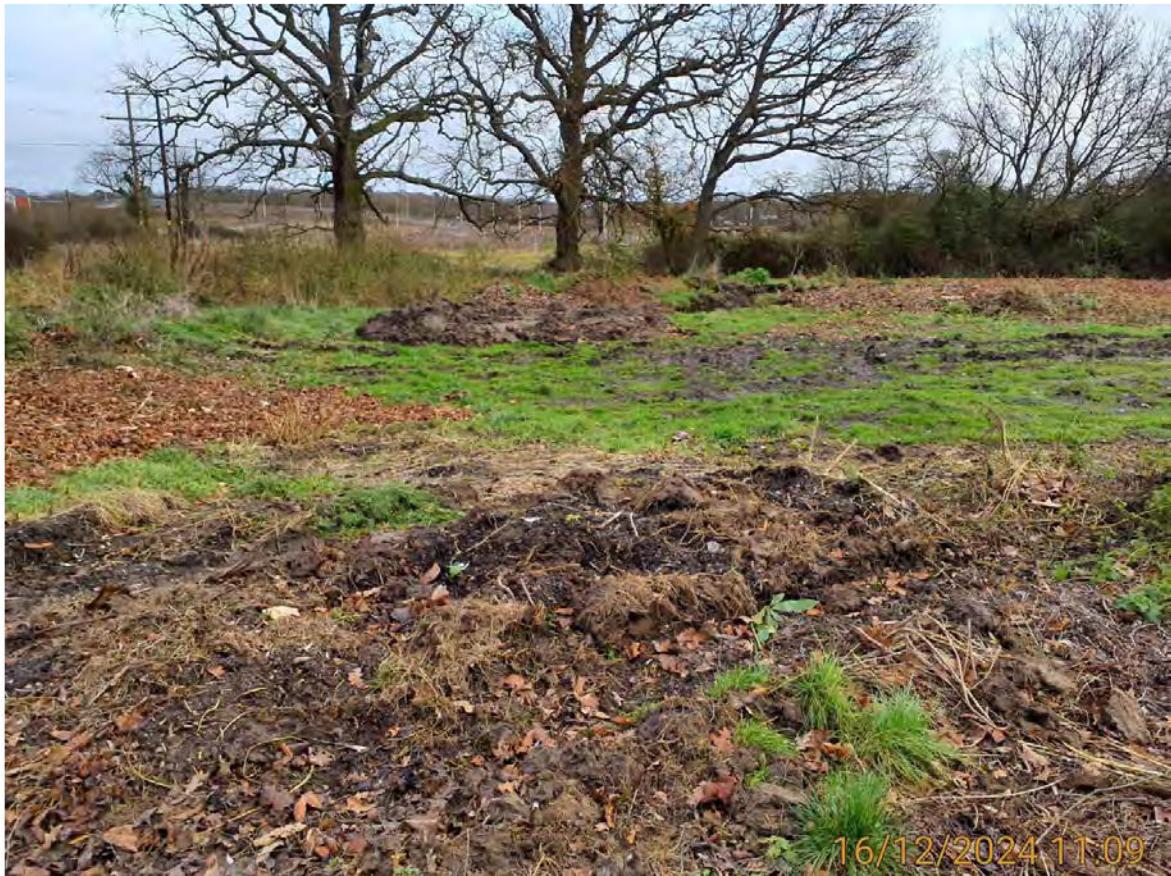
Plate No.: 15

15	Discarded soils which appeared to contain ash. Area is potentially being used to dispose of soil waste.	Testing, waste classification and disposal of soils.
	16	Bonfire remains including treated sleeper fragment.	Localised removal and disposal.
	17	Open barn with possible bonded asbestos cement sheet roof	Suitable R&D asbestos survey by competent person where works to or demolition of building proposed.
R13	18	Heaps of leaves and brash	Removal and disposal of green waste
Land southeast of R8	19	Area of burnt-out vehicle	None
Woodland east of R11	20	Fly tipping (soils, plastic, stone and timber shed)	Removal and disposal. Presence of asbestos cannot be ruled out so watching brief recommended.
R11	21	Fly tipping (children's bikes, insulation, timber and carpet)	
R10	22	Fly tipping (Heras fence bases and marble and concrete garden ornaments)

Title.: Ref 15 Discarded soils

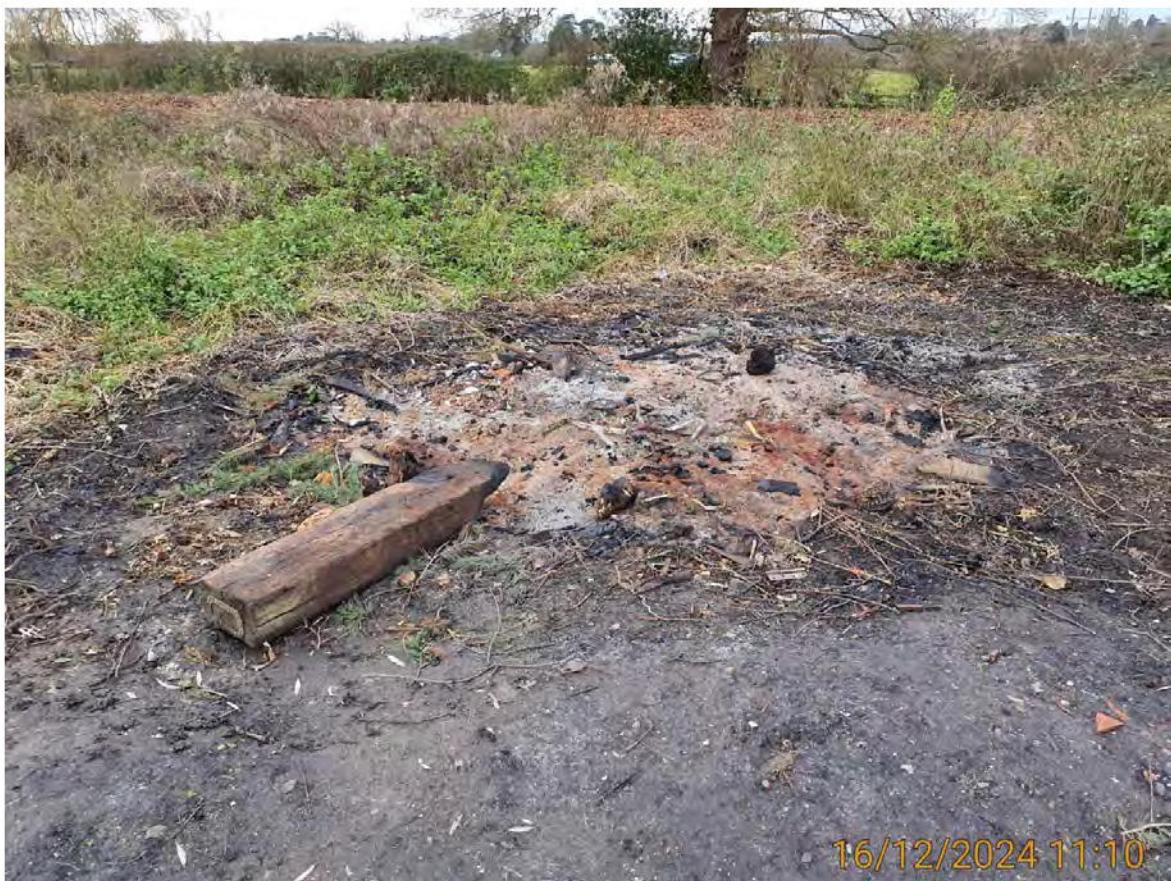
Plate No.: 16

Title.: Ref 16 Bonfire remains including treated sleeper

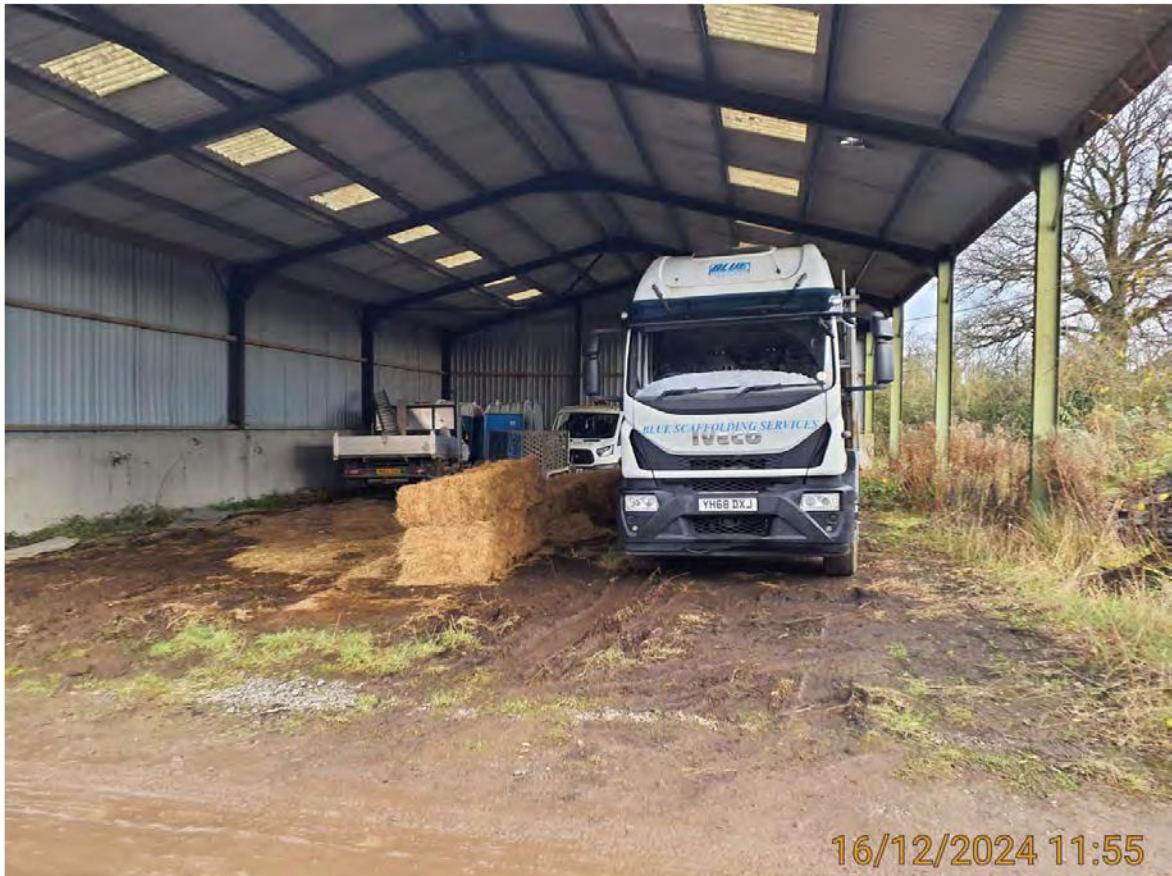
Plate No.: 17

Title.: Ref 17 Open barn with possible asbestos roof

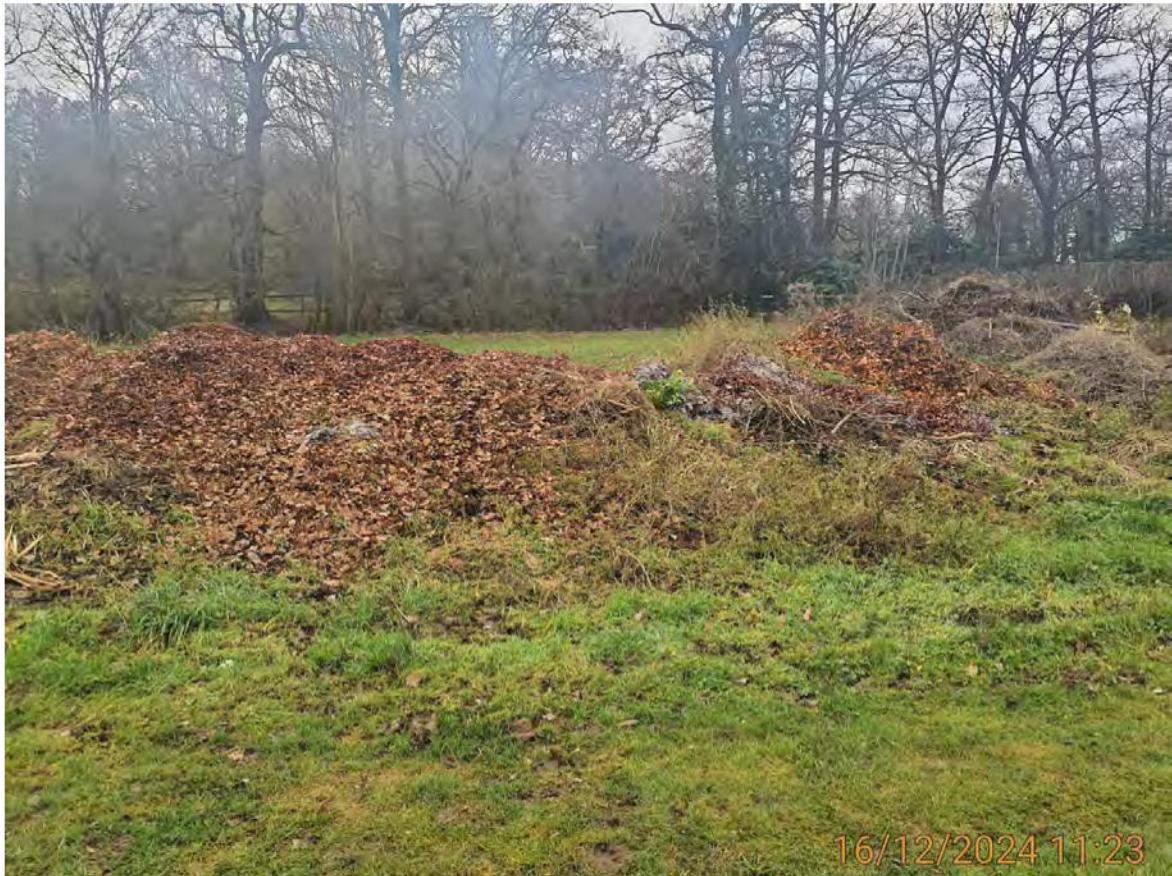
Plate No.: 18

Title.: Ref 18 Heaps of leaves and brash

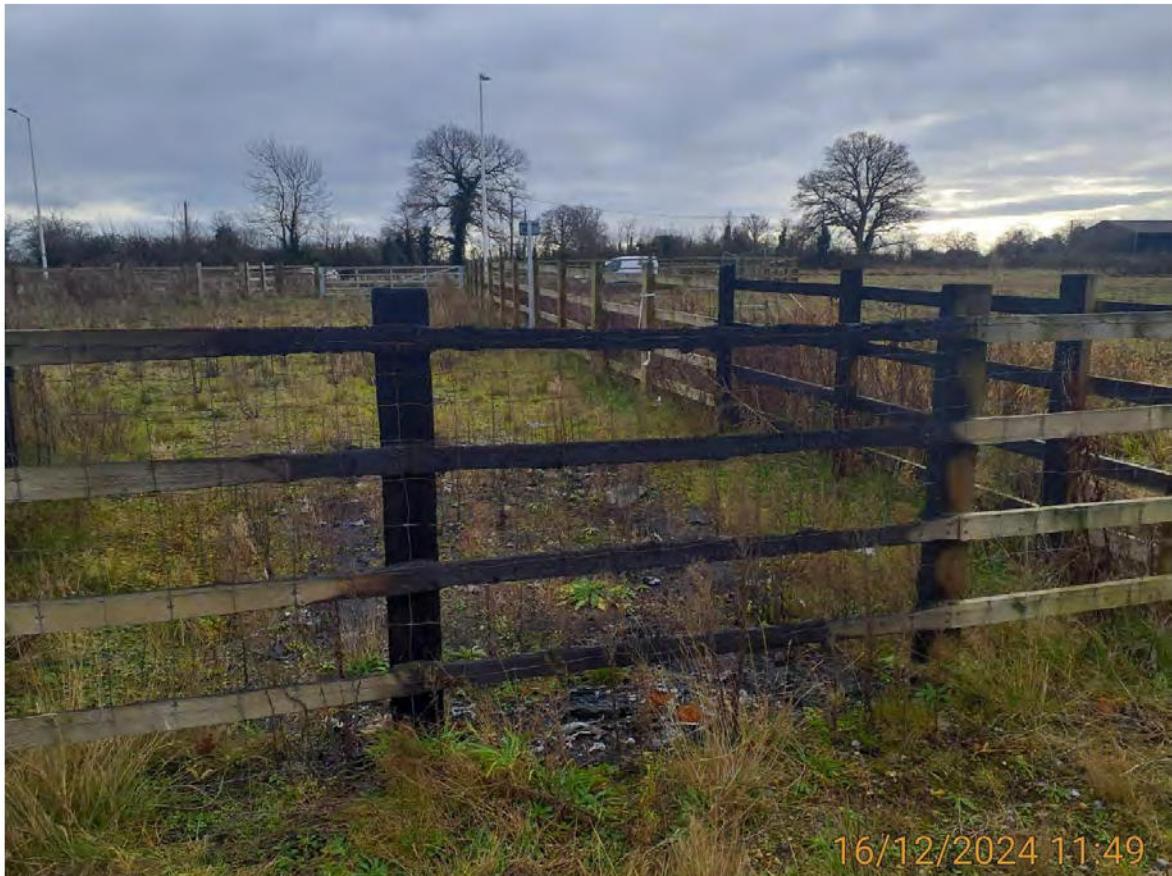
Plate No.: 19

Title.: Ref 19 Area of burnt-out vehicle

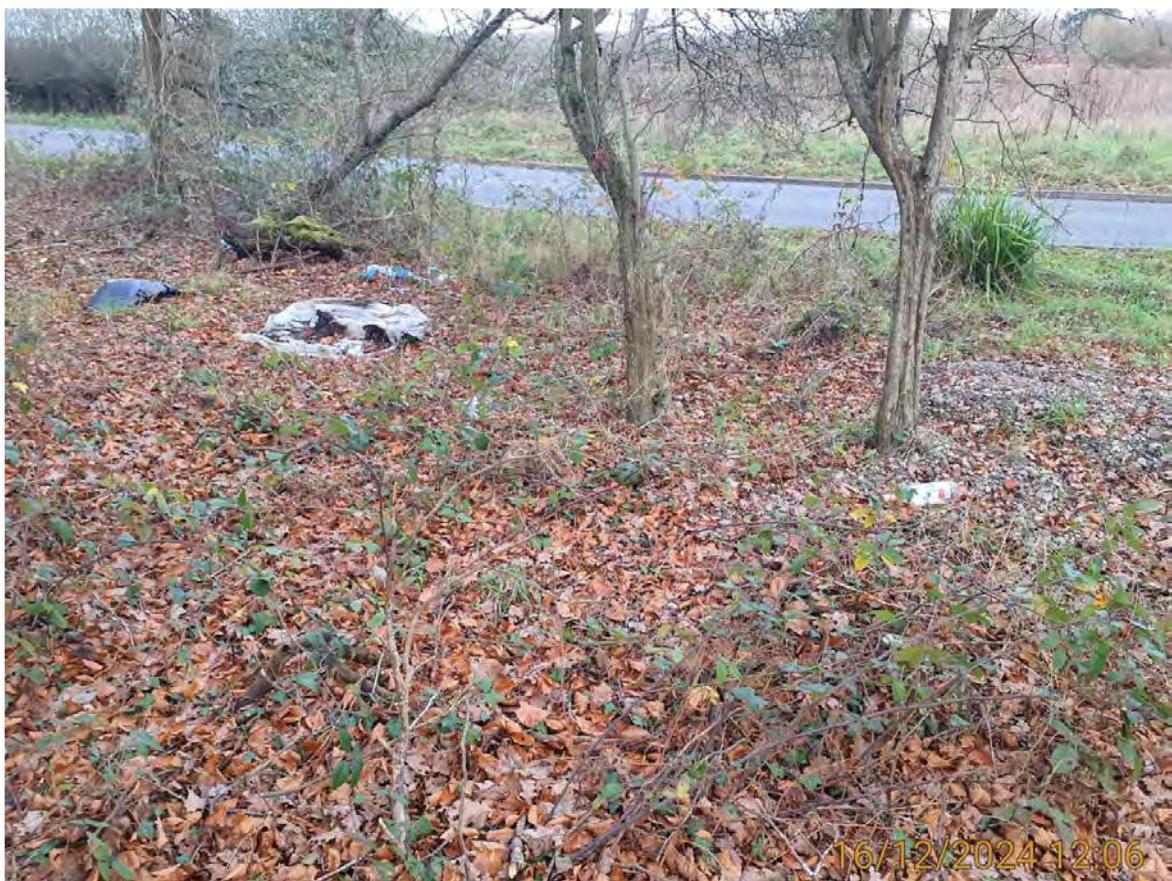
Plate No.: 20

Title.: Ref 20 Fly tipping (soils, plastic, stone and timber shed)

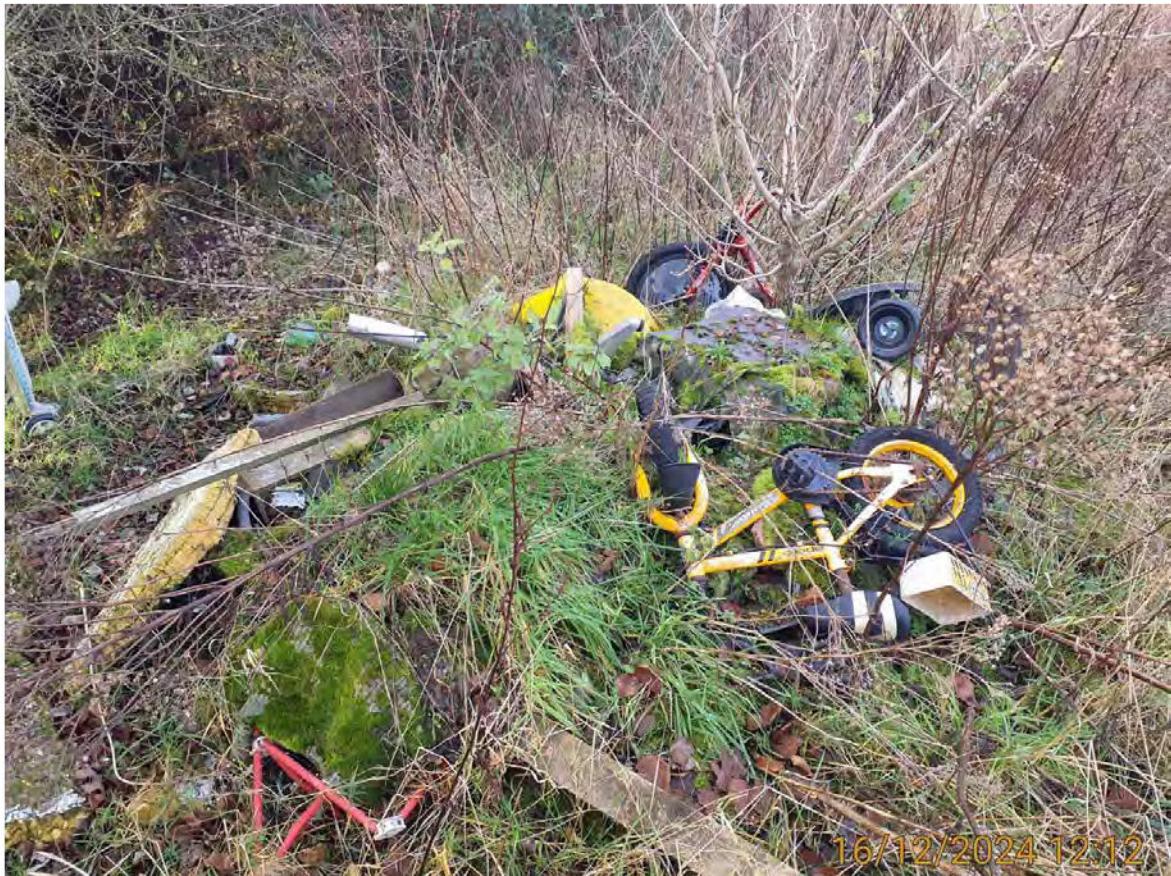
Plate No.: 21

Title.: Ref 21 Fly tipping (children's bikes, insulation, timber and carpet)

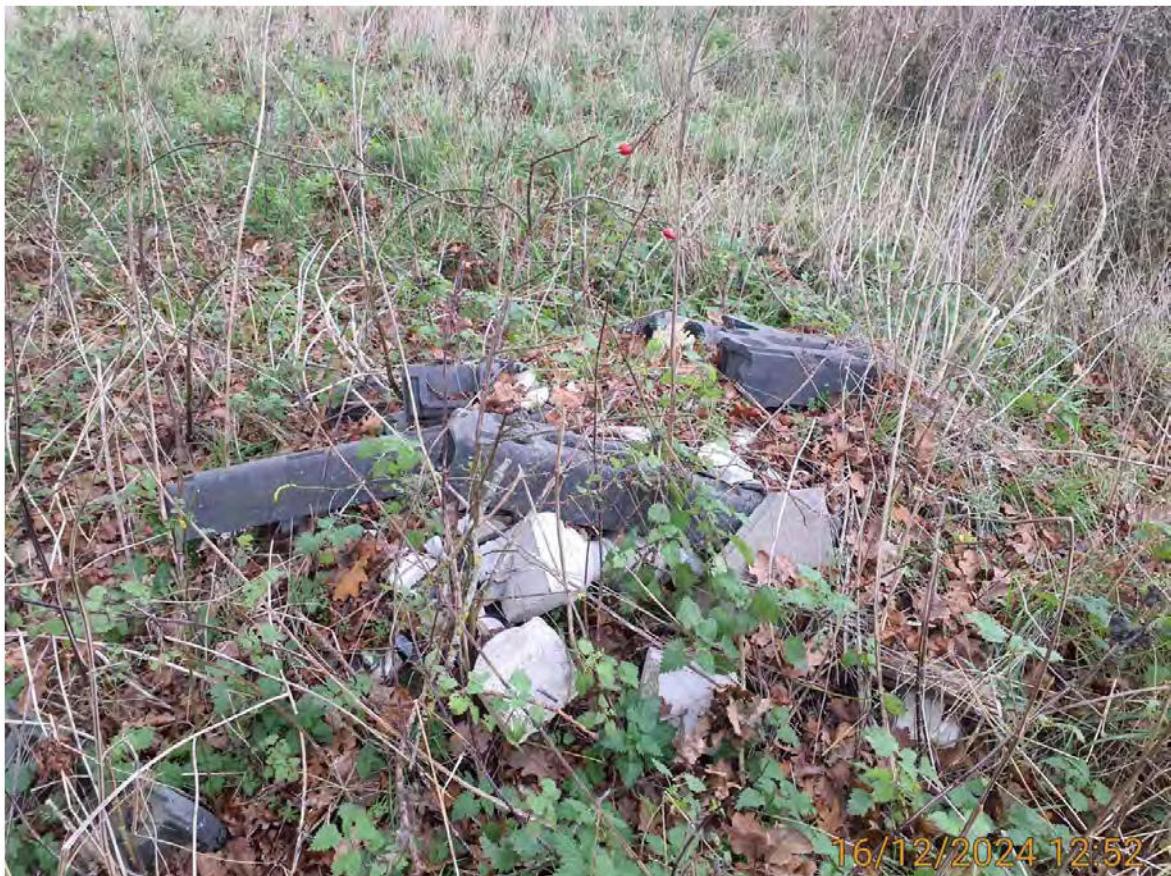
Plate No.: 22

Title.: Ref 22 Fly tipping (Heras fence bases and marble and concrete garden ornaments)
