Meadow Cottage  
18, Primrose Lane  
Winnersh  
Wokingham  
RG41 5UR

Structural Inspection  
of the rear chimney stack

Clive Hudson Associates  
Consulting Structural & Civil Engineers

April 2026  
Project Ref: 267040

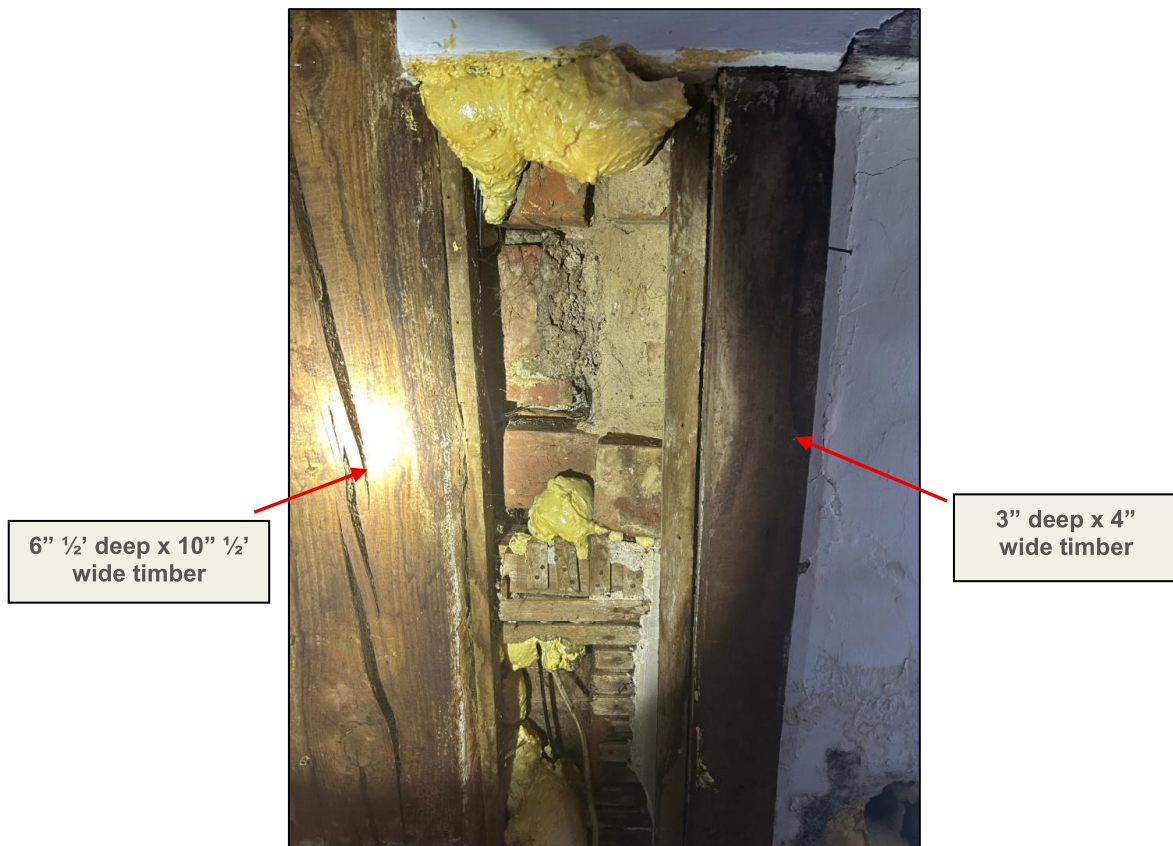
And a 3" deep x 4" wide timber that spans parallel to the main timber beam, which supports the east face of the stack (Fig. 6).

Figure 6. Obscured view of the soffit of the stack with the two supports indicated.

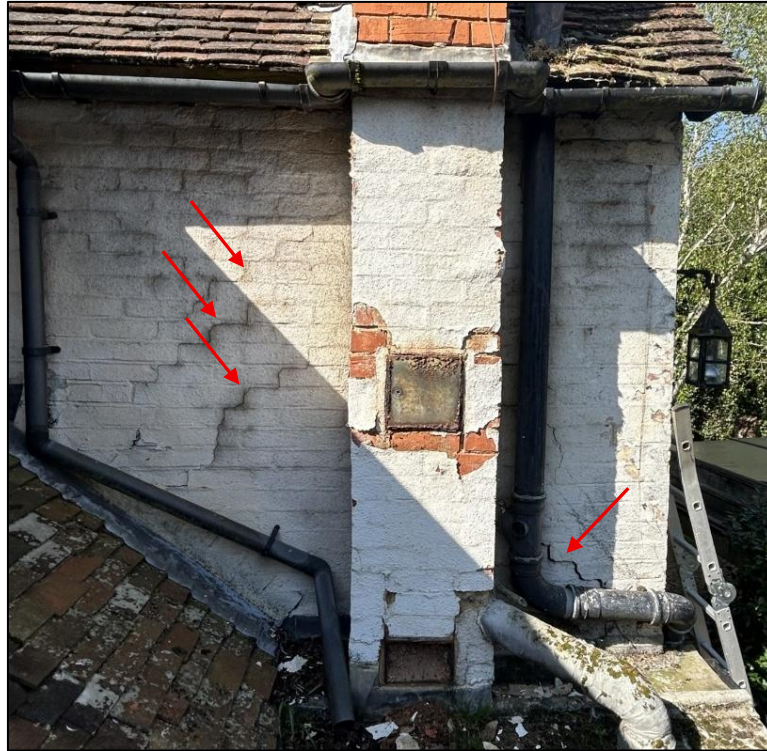
Figure 9. Cracks in the east wall .

- i. Although not directly related to the chimney stack, slight-to-moderate diagonal cracks were noted in the external brickwork and the internal plaster on the first floor, with cracks of up to 10mm in width recorded externally to the north of the stack (Figs. 9-12).

- ii. From the inspection undertaken, this movement is consistent with the deflection of the timber beam in this location. Although the chimney stack represents a relatively small proportion of the overall load, it is nevertheless contributing to the beam's deflection. While outside our scope, we would recommend that either the stiffness of the beam is improved, the load on the beam is reduced, or that supplementary supports are introduced as part of the proposed package of work.

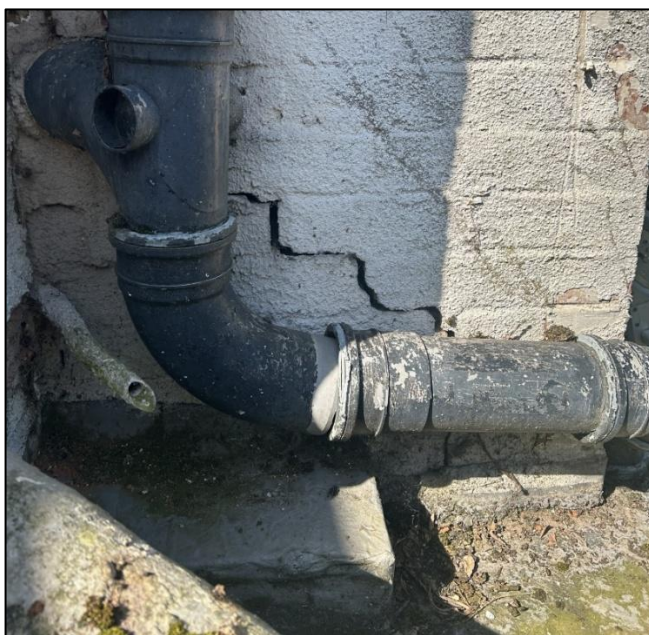
Figure 10.  
View of the crack to the  
north of the stack.

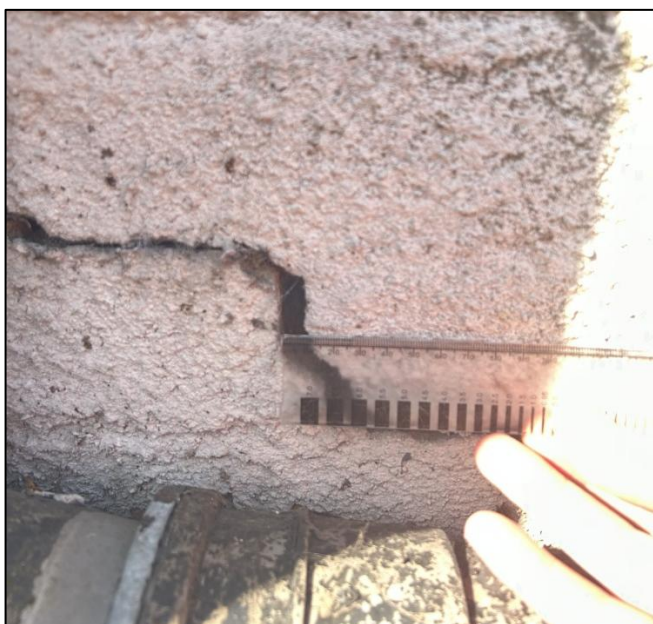
Figure 11.  
Close-up view of the crack  
to the north of the stack,  
with a crack gauge rule  
measuring the width of the  
crack.

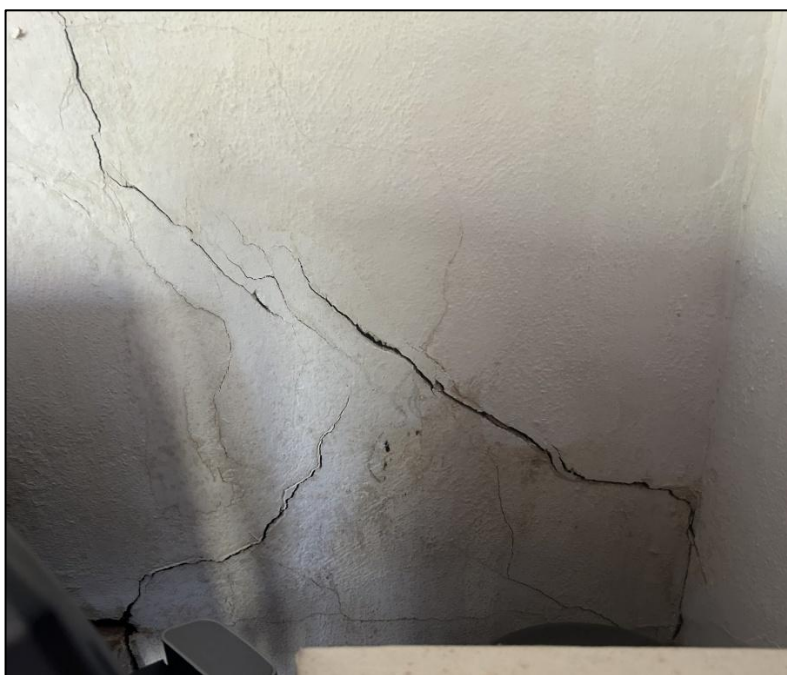
Figure 12.  
View of the cracks in the  
plaster in the 1<sup>st</sup>-floor  
study.

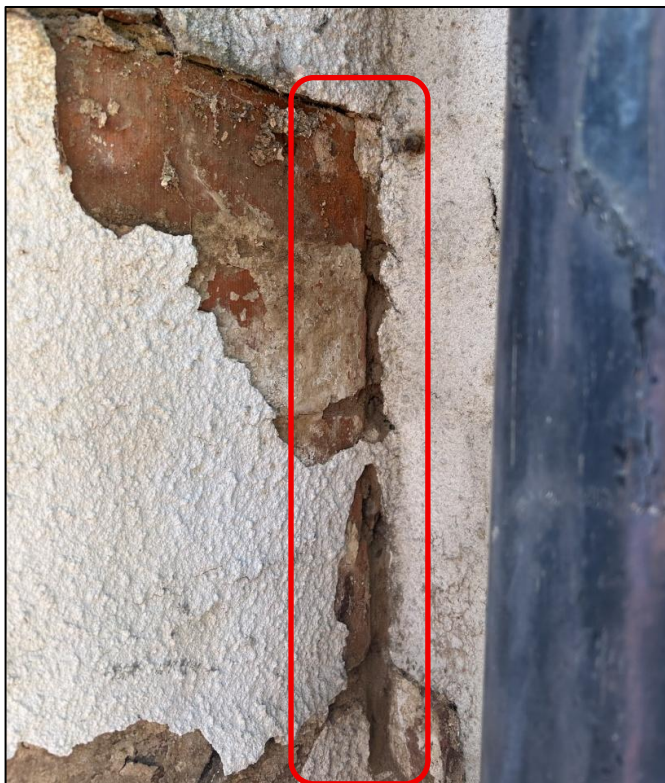
The situation is exacerbated, as the localised removal of detached sections of modern masonry paint revealed that at least 4 continuous courses on the north face of the stack are not bonded or coursed into the east wall (Fig. 13). This absence of interlocking masonry significantly reduces the lateral restraint normally provided at this junction, diminishing the effectiveness of the first-floor brickwork as a reliable point of support.

Figure 13.  
Straight joints within the  
brickwork at the junction of the  
north face of the stack and the  
east wall.

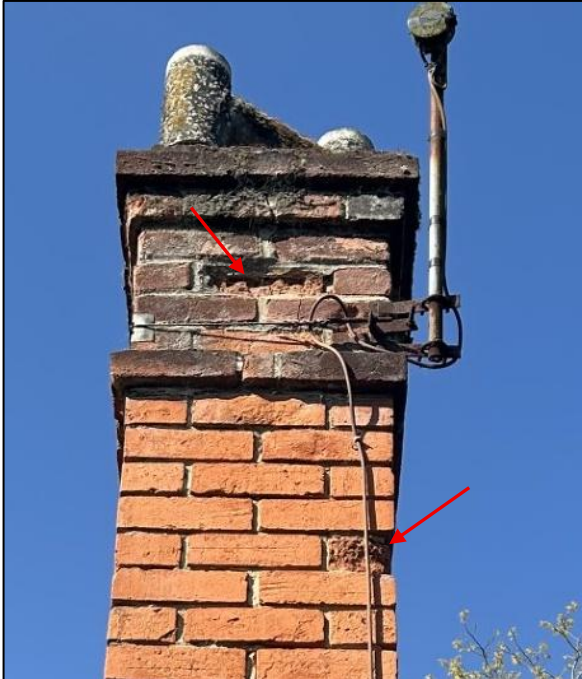
- iv. Although it does not warrant immediate structural concern, the top of the stack does lean in a northerly direction.
- v. Localised degradation, spalling and cracked bricks were noted (Fig. 14-16). If the stack were to be retained, then we would recommend that localised repairs are undertaken.

Figure 14.  
Spalling/degradation of the  
brickwork towards the top  
of the stack.

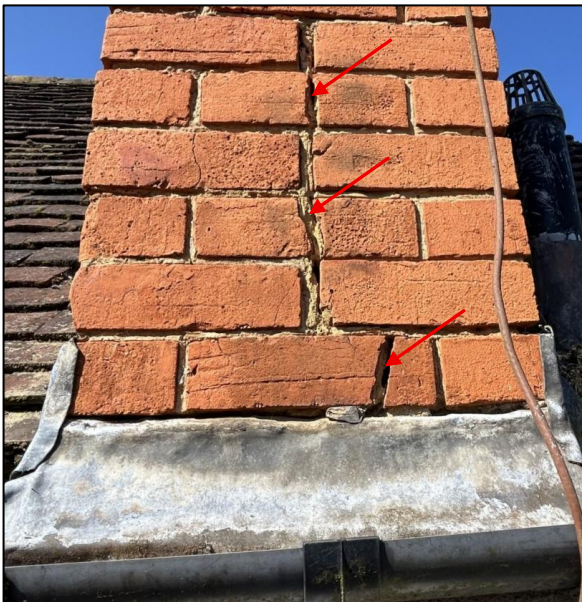
Figure 15.  
Cracked bricks just above  
the lead flashing/eaves.

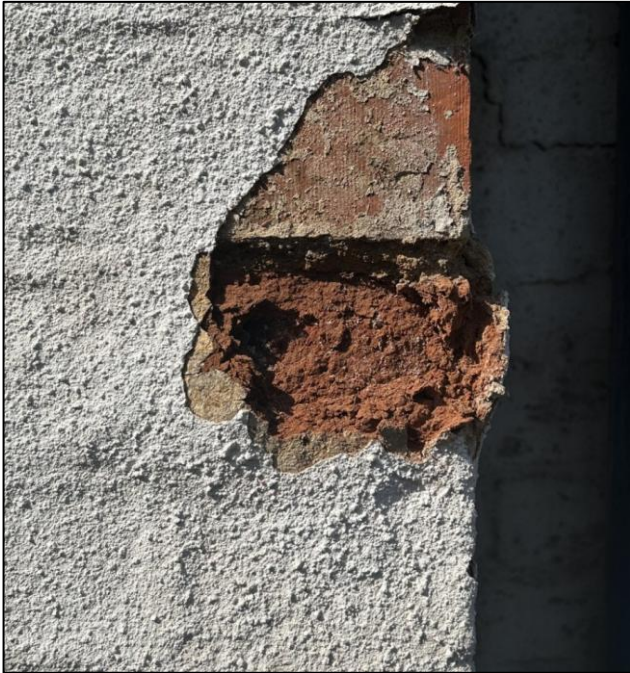
Figure 16.  
Spalling/degradation of a  
brick on the north-east  
corner.

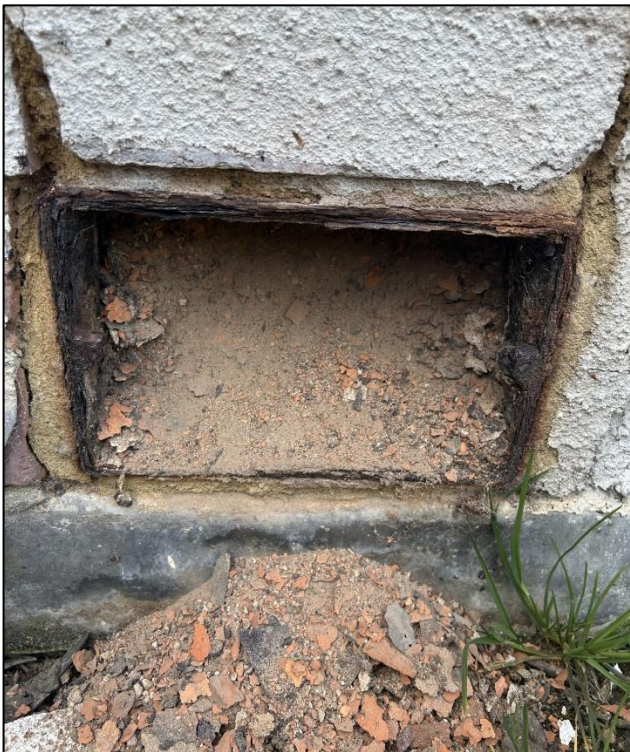
Figure 17.  
View of the low-level  
inspection hatch filled with  
mortar dust and brick  
fragments.

- vi. Above the eaves, the mortar is set back (recessed) from the face of the brickwork which, while it is not a structural defect in itself, is a poor detail as it exposes the brick arises and the mortar to rain, frost, and wind-driven moisture. Although a detailed inspection of the masonry above the eaves was not possible, limited access from the flat roof indicated sections of the mortar were very friable, and the low-level inspection hatch was found to contain loose mortar dust and brick

fragments (Fig.17). This indicates ongoing weathering and deterioration of the stack, consistent with the vulnerability created by the recessed joints and the inappropriate use of modern masonry paints below the eaves. If the stack were to be retained, then we would recommend that repairs are undertaken. Subject to a more detailed inspection of the bed joints above the eaves, it is likely that it would be necessary to dismantle the stack first before rebuilding it if it were to be retained.

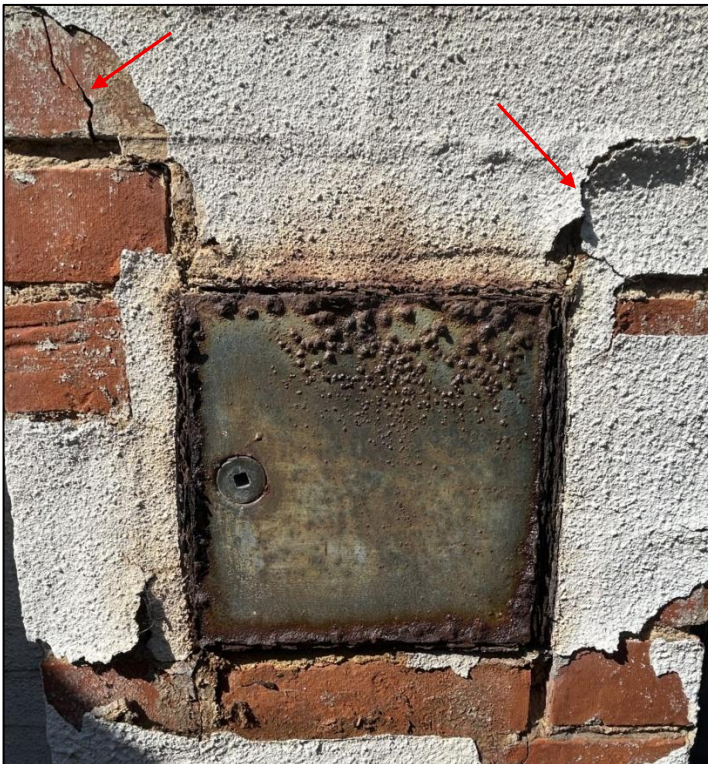
- vii. Corrosion and expansion of the metal work were noted in both inspection hatches. The deterioration of the upper hatch has caused cracks to develop in the adjacent brickwork (Fig. 18). If the stack were to be retained, then we would recommend that localised repairs are undertaken.

Figure 18.  
Corrosion and expansion of  
the metal inspection hatch,  
with localised cracks  
developing in the brickwork.

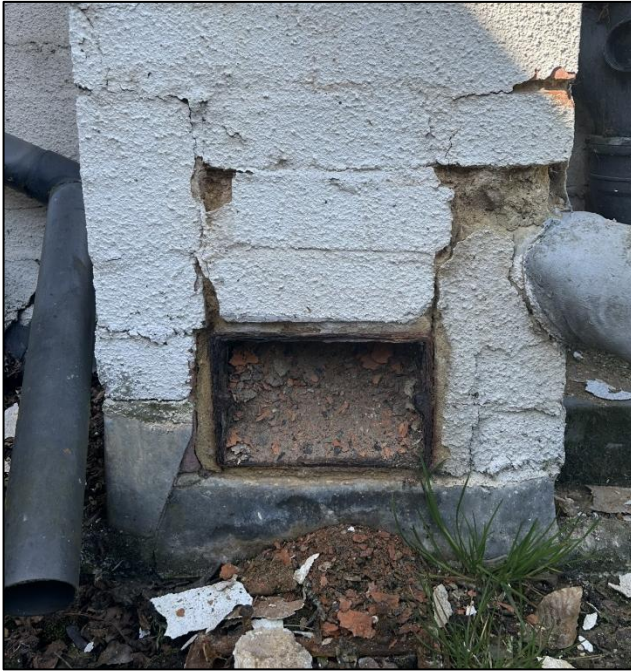
- viii. The aga flue penetrates the north-east corner of the stack just above the flat roof, with cementitious mortar observed between the top of the pipe and the underside of the brickwork (Fig. 19). Given the proximity of the pipe to the low-level inspection hatch, we would question whether the pipe is, in fact, supporting the brickwork above, which in opinion is a poor detail.

Figure 19.  
View of the flue penetrating  
the north-east corner of the  
stack.

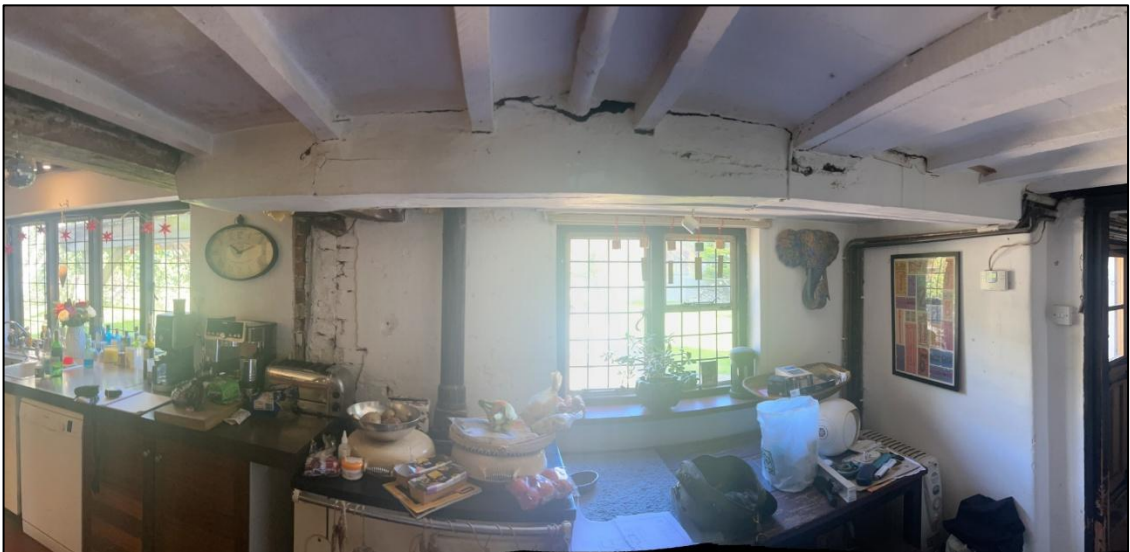
Figure 20. Panoramic view of the south face of the east-west beam with noticeable gaps between the ceiling and the beam, and signs of cracking/fractures within the beam.

- ix. While outside of our scope, potential fractures and signs of movement were noted in the (painted) timber beam supporting the flat roof and the east face of the stack (Fig. 20). Assuming this beam will be retained as part of the application, we would recommend that a provisional sum is set aside for repairs/strengthening work. Subject to discussions with our clients to establish whether the gaps between the ceiling and the beam are recent or long-standing, it may be prudent to install some temporary props to support both the painted beam and the main north-south timber beam in the intermediate term.
