**St Catherine's Parish Church,  
Bearwood Road, Sindlesham, RG41 5BN**

**Arboricultural report**

**Inspection carried out on 3<sup>rd</sup> August 2024  
by David White**

### **Tree reference: T1**

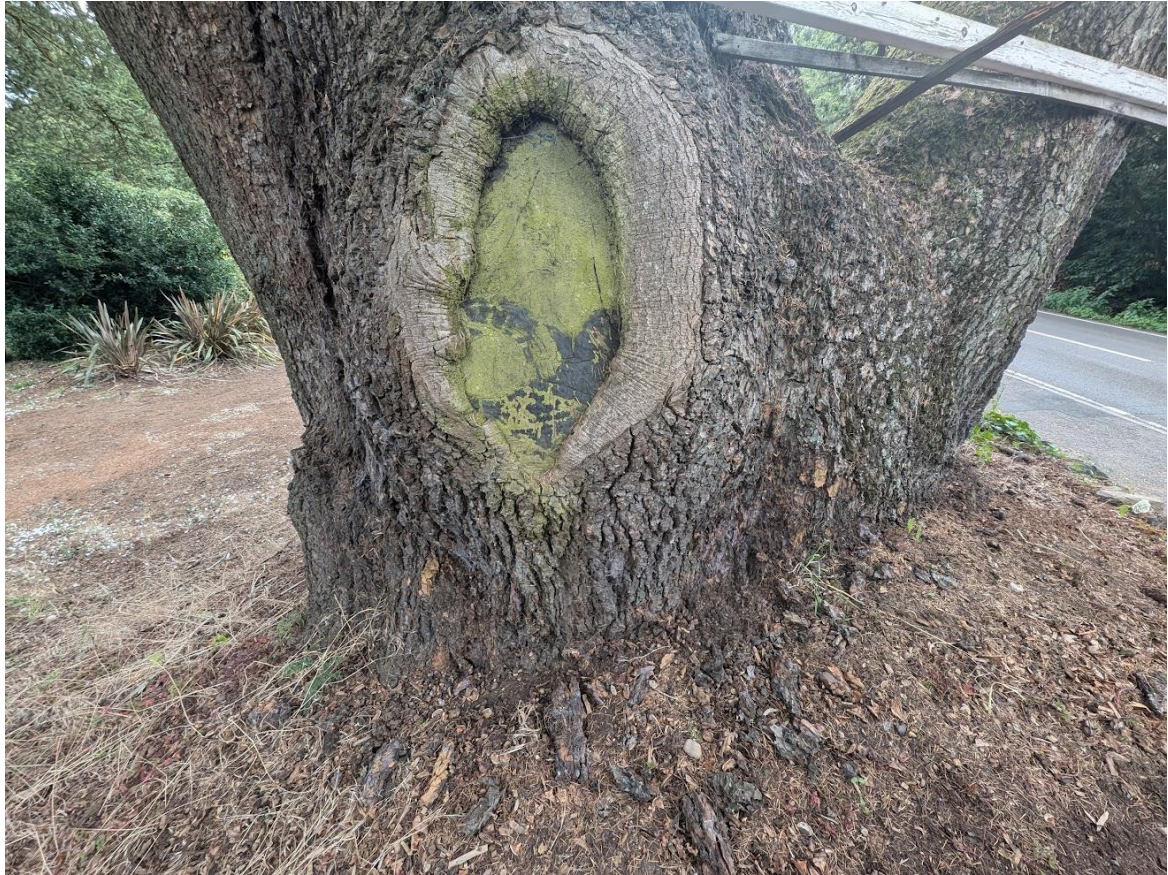
1. Potential audible defect at ground level on North side, 300mm wide, tapering to 400mm above ground level, no penetration with probe, slightly crumbling bark (see Figure 4).
2. Similar on North -North West side, 300x400mm. Both either side of very large historic wound (see Figure 4).
3. South-South West side, crumbling bark at ground level, no penetration.
4. Vertical rub of expansion growth on North side (larger stem) of union (see Figure 9).
5. No significant audible defects at base.

8. North-North West side, starting 600mm above ground level, enormous historic wound approximately 600mm wide by 900mm tall, exposed wood solid/sound, partially occluded, exposed area 350mm x 700mm (see Figure 4).

*Figure 4: photo relating point 1, 2 & 8 in Findings*

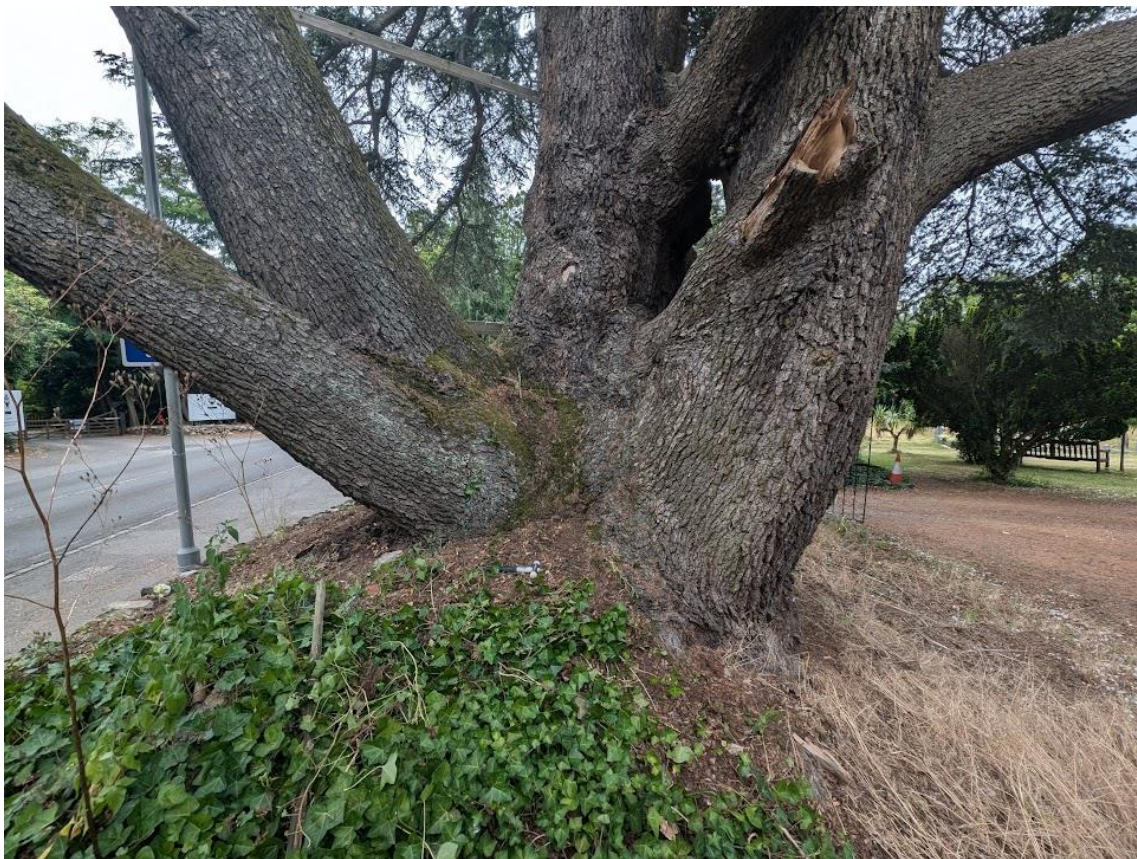
9. Relatively tight union on South West side rib mentioned in point 4, not significant
10. Main unions from South side around head height are tension forks (see Figure 5).

*Figure 5: South side of base, point 10 in findings*

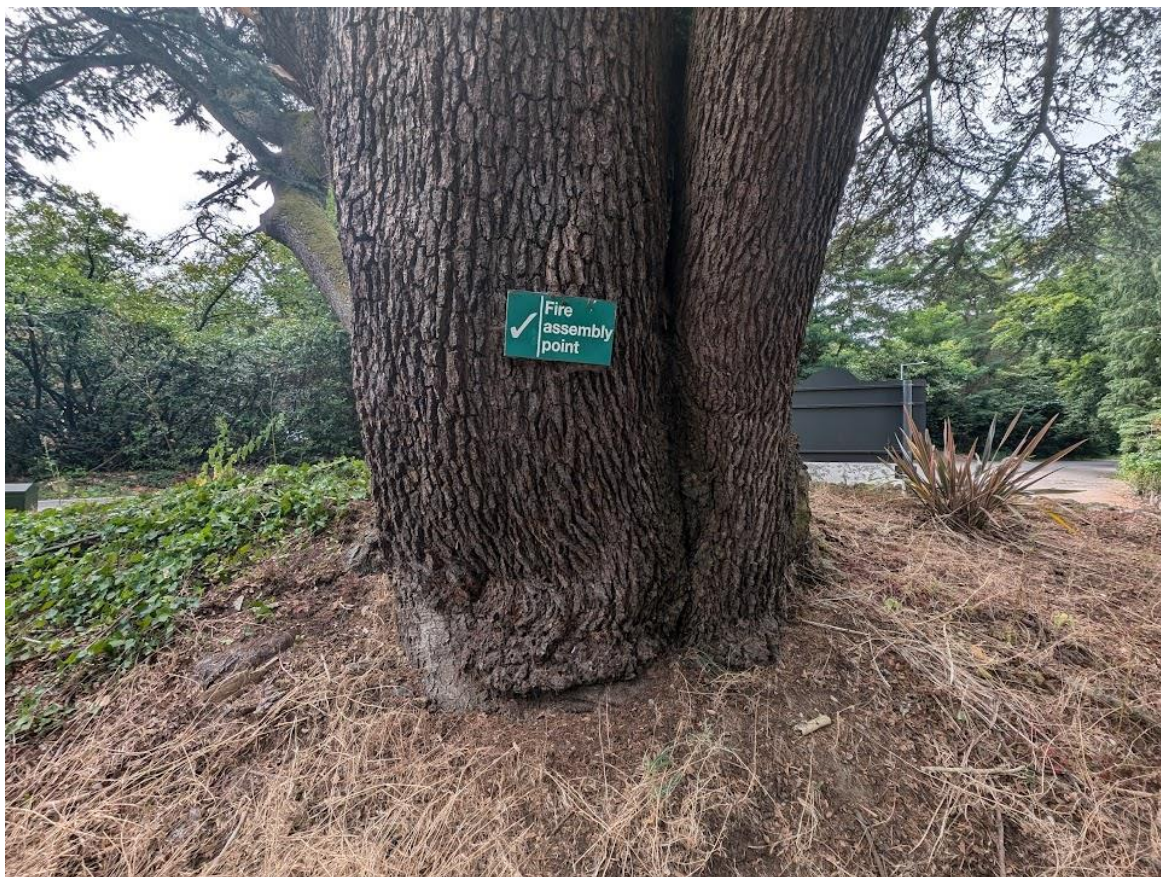
11. East side: Tight union between 2 main stems, not significant (see Figure 7).
12. Main stem on East-North East side extends over carpark.
  - 12.1 Fibre buckling at base (see Figure 11).

*Figure 7: East side of base, point 11 in findings*

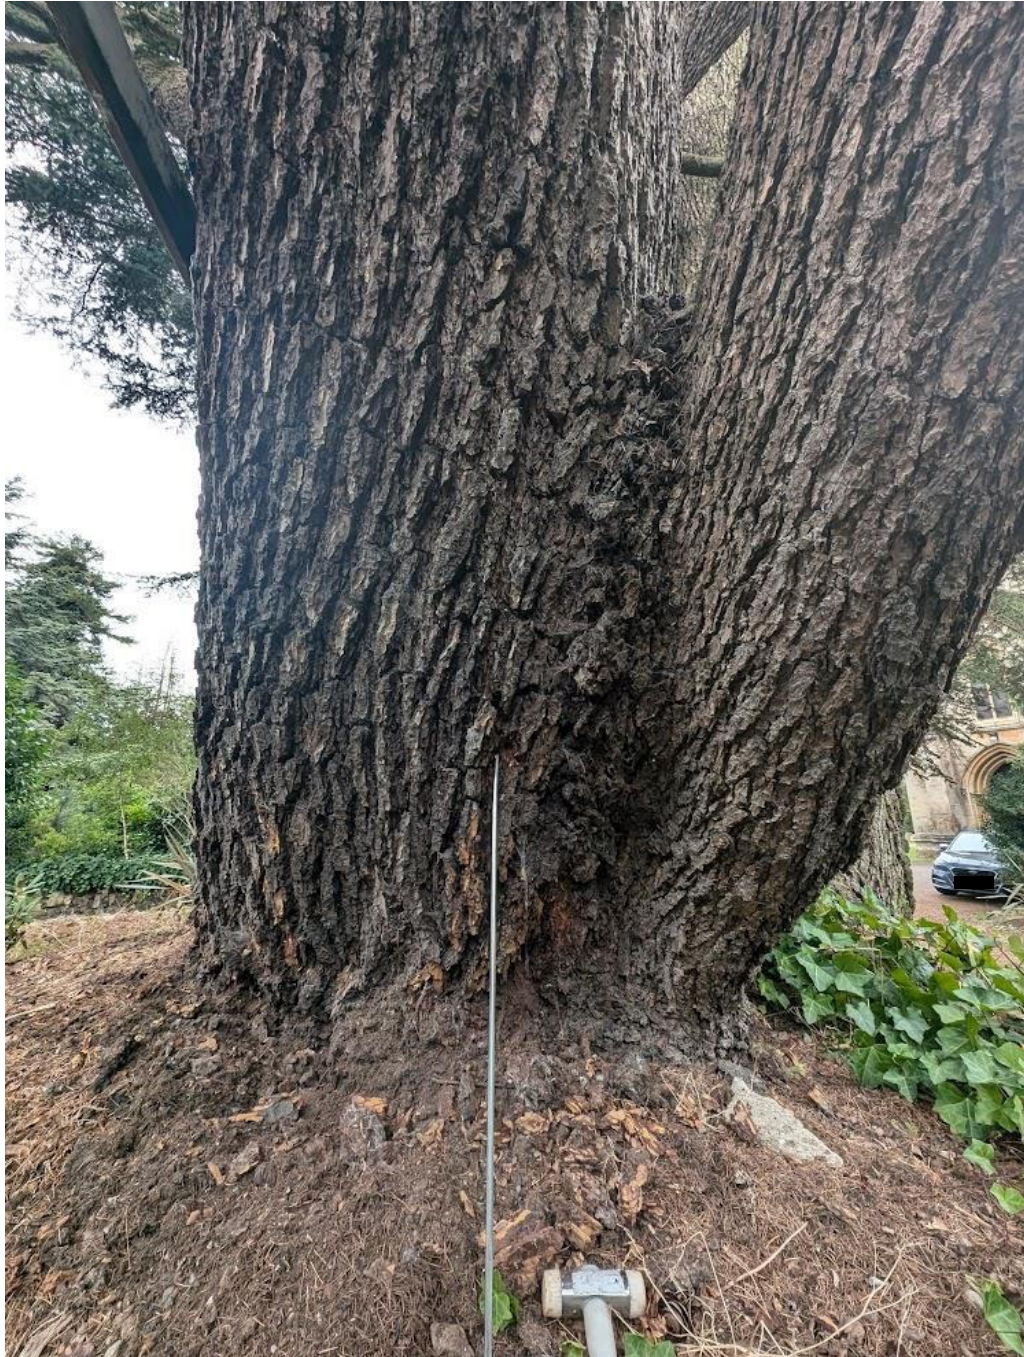
*Figure 9: rib mentioned in point 4 of Findings*

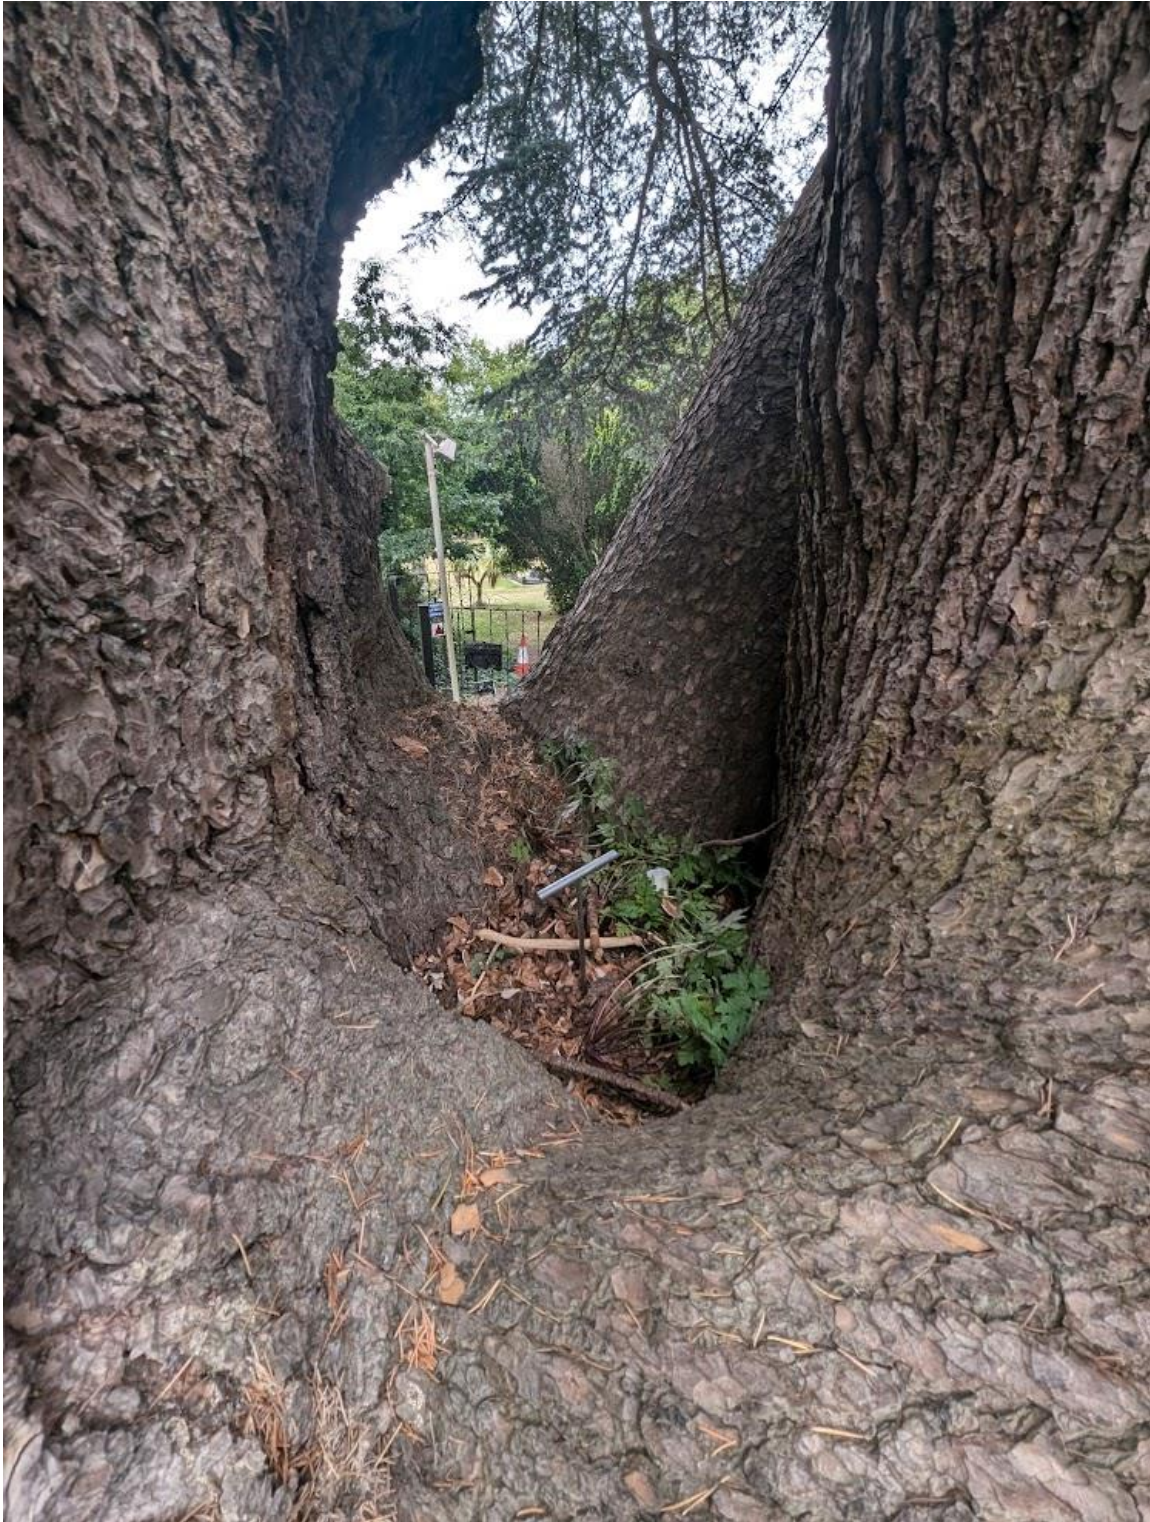
6. 'Cup' Union between main stems on North East side filled with soil approximately 400mm deep, well-defined boundary (see Figure 10).
7. Fully occluded wound North-North East side 300mm wide x 400mm tall, 200mm above ground level

*Figure 10: 'Cup' union, point 6 in Findings*

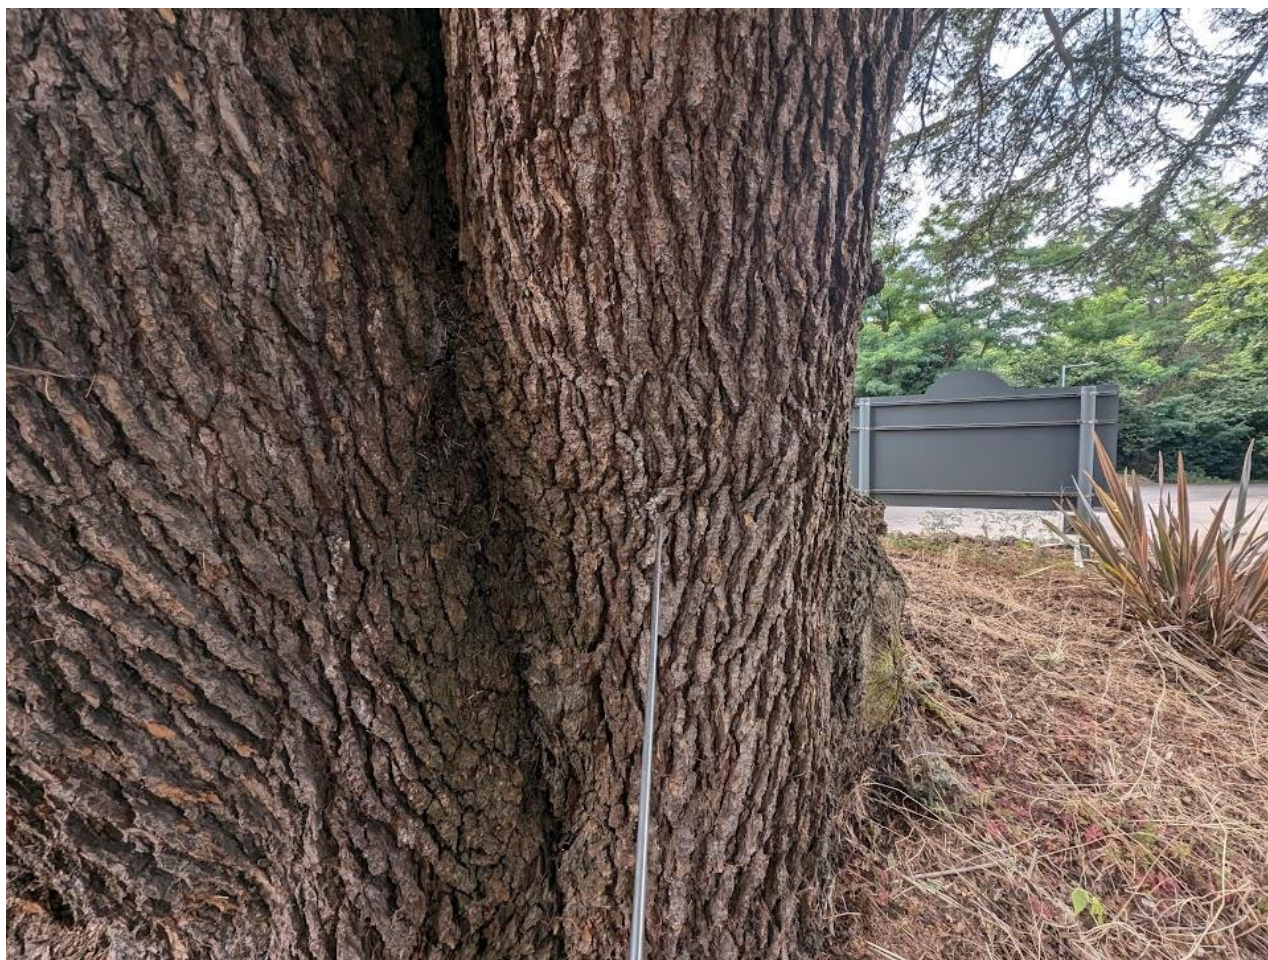
*Figure 11: Fibre buckling, 12.1 in findings*

- Crown reduction, removing approx. 2m in branch length, to lessen end weight and shorten lever arm to prevent premature failure of buckling limbs as well as reducing the sail area
- Remove/shorten major deadwood to retain veteran features and valuable habitat
- Remove snapped/hanging limbs
- Clear majority of minor deadwood to lessen literal dead weight acting on limbs

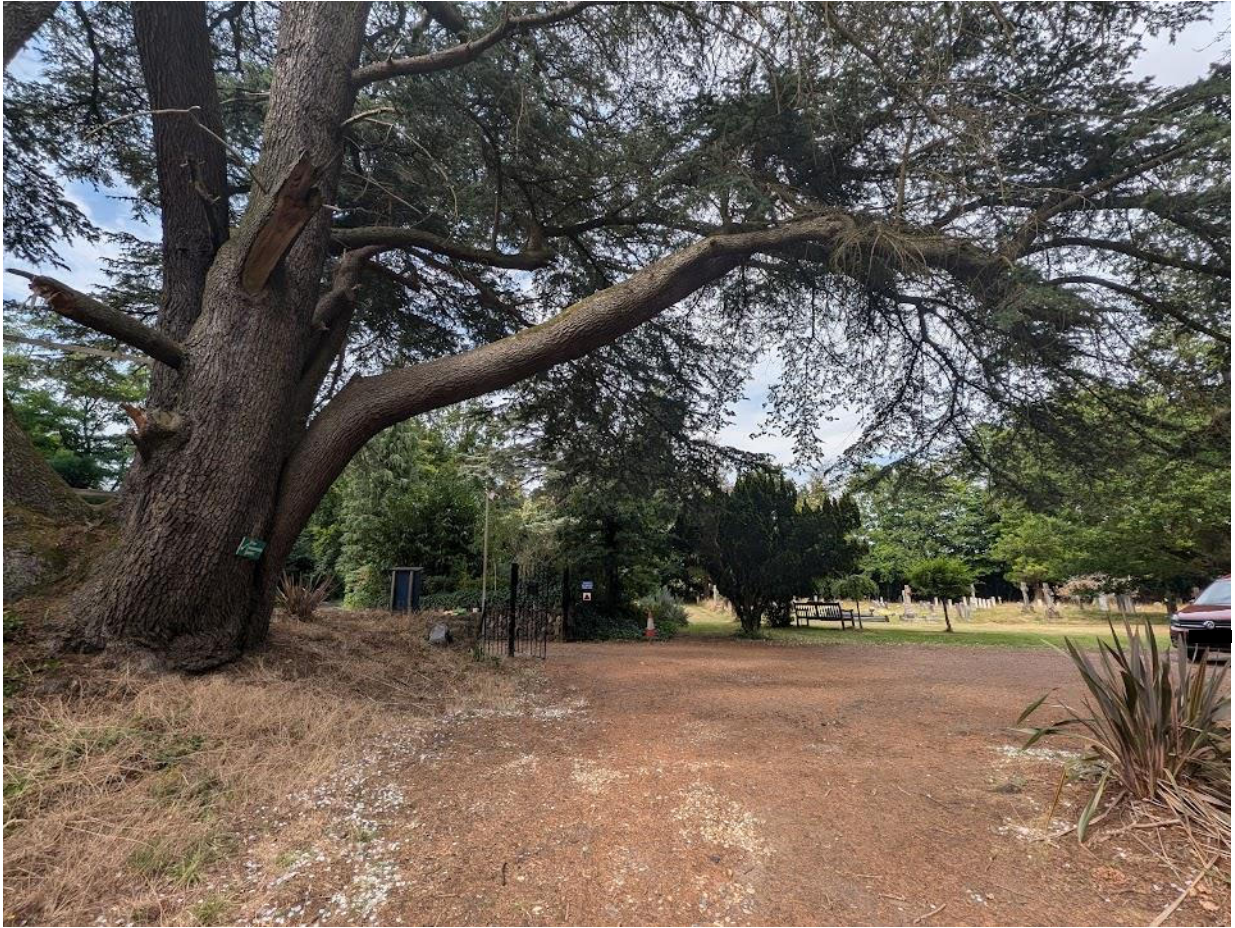
- 12.2 Possibly fibre buckling at bend approximately 3.5m above ground level (see Figure 12).
  - 12.3 Approximately 16m long lever arm (see Figure 12).

- 12.4 Good vitality, therefore significant amount of weight acting on stem (see Figure 12).
  - 12.5 Stem sweeps upwards towards North East (see Figure 13).

*Figure 12: points 12.2-12.4 in Findings*

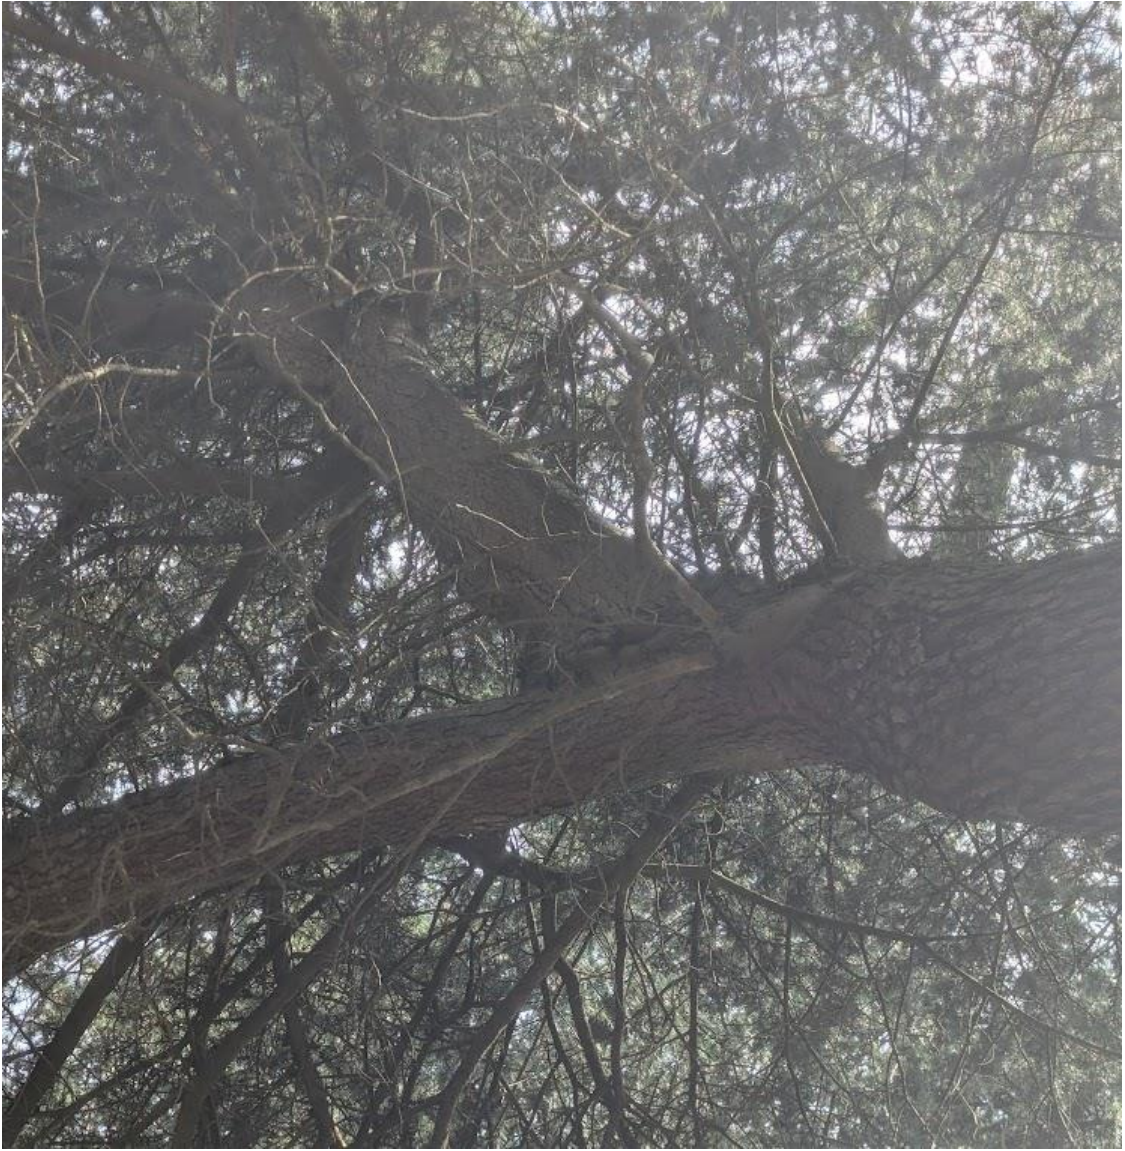
- 12.6 Upswept stem, odd-looking branch union, with horizontal fissure (similar to branch bark ridge) very evident (see Figure 13).
  - 12.7 Large historic wound on South side of limb, approximately 6m from the base of tree, looks solid, partially occluded.

*Figure 13: point 12.5 & 12.6 in Findings*

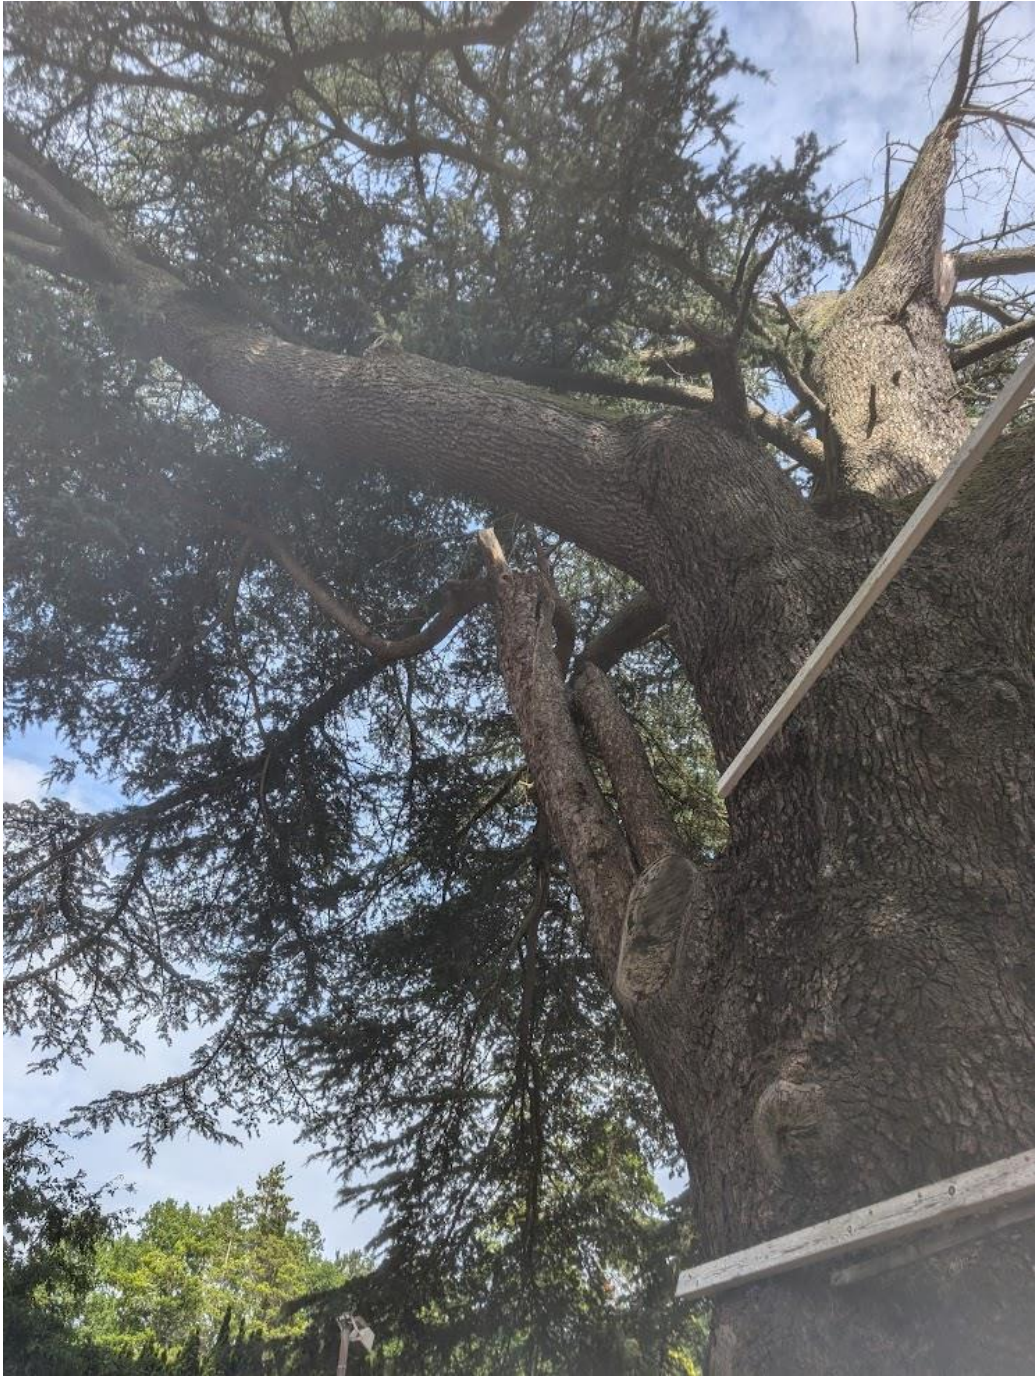
13. Relatively minor stem on North side (see Figure 14)
  - 13.1 Historic snap out to top of stem approximately 6m above ground level
  - 13.2 Two long limbs extend North with relatively little holding wood

- 13.3 Potential bird nest in wound, partially occluded.
14. Very large, major stem extends North at approximately 45° from very wide tension fork
  - 14.1 Fibre buckling on underside of union (see Figure 15).

*Figure 14: snapped stem, point 13 in Findings*

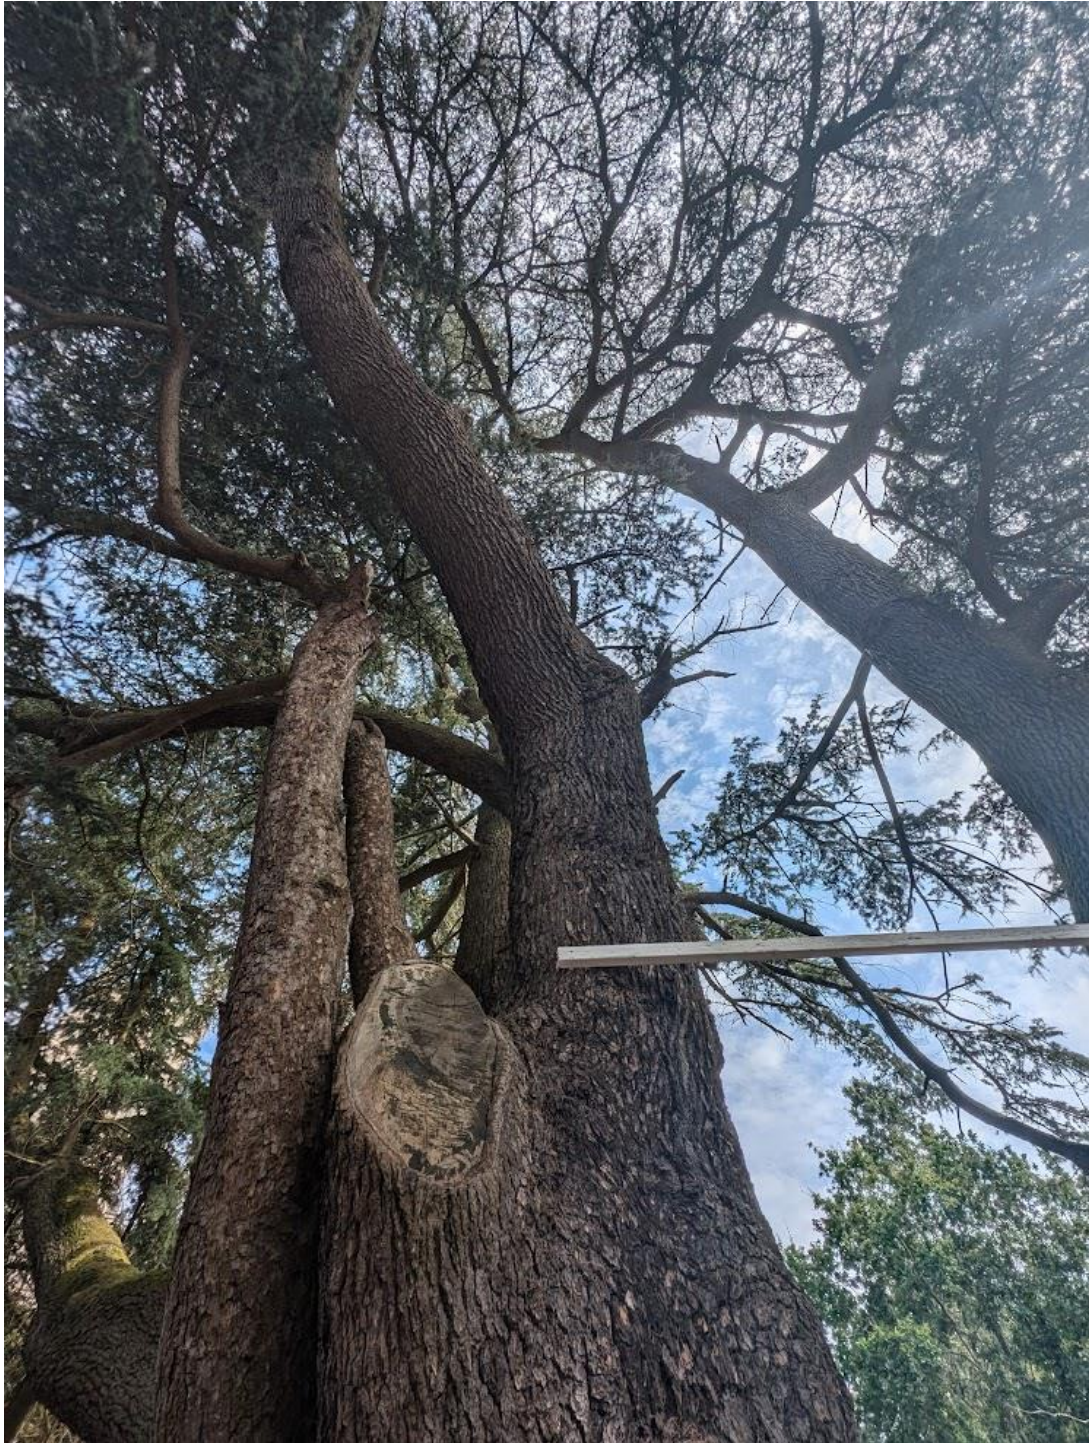
*Figure 15: Fibre buckling, point 14.1 in findings*

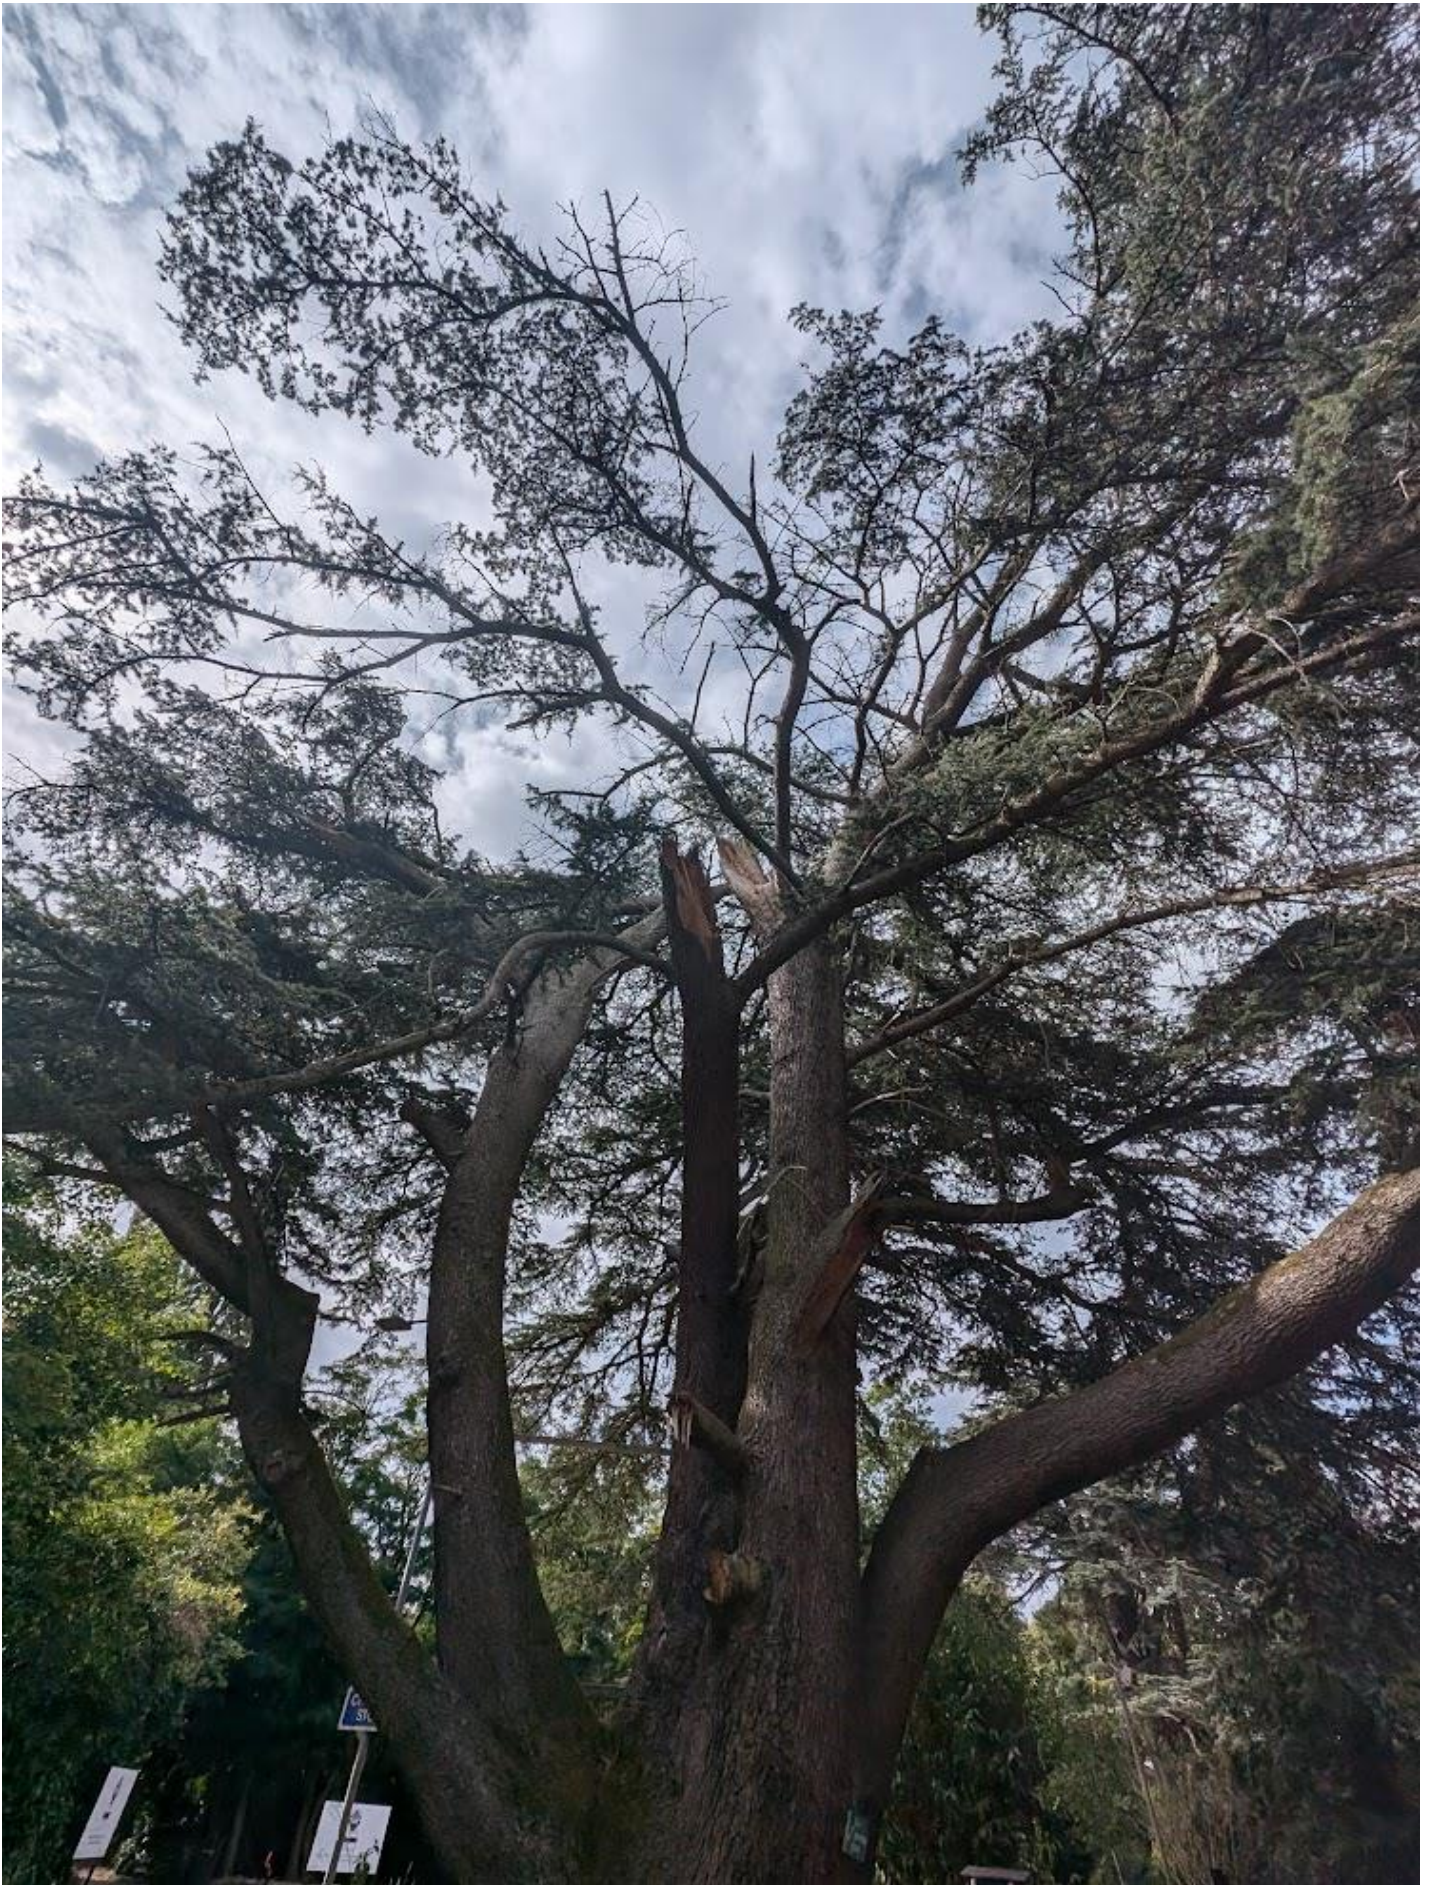
- 15.2 3rd major limb, end of limb snapped off relatively recently, still some photosynthetic material (see Figure 16)
  - 15.3 4th major limb extending over road, historically heavily pruned back to primary limb, no leaf present.

17.1 Recent major stem failure (see Figure 16)

18.2 Historic snap outs on lower limbs (see Figure 16)

18.3 Major historic head/stem failure South West side of main union (tension fork), approximately 1/2 of the main stem (see Figure 16)

A wonderful example of a veteran tree with a very striking form & character. Despite numerous, very large historic pruning wounds, no evidence of significant decay was found. The tree appears to have been a victim of its own success, in that it has such exceptional vitality for a tree of this age/size/life stage that it appears that one of the main stems failed under its own weight, snapping multiple other large limbs on the way down on the South side. The snapped ends of the limbs should be retained for habitat purposes.

*Figure 16: Multiple major limb failures, points 15.2, 17.1, 18.2 & 18.3 in Findings*

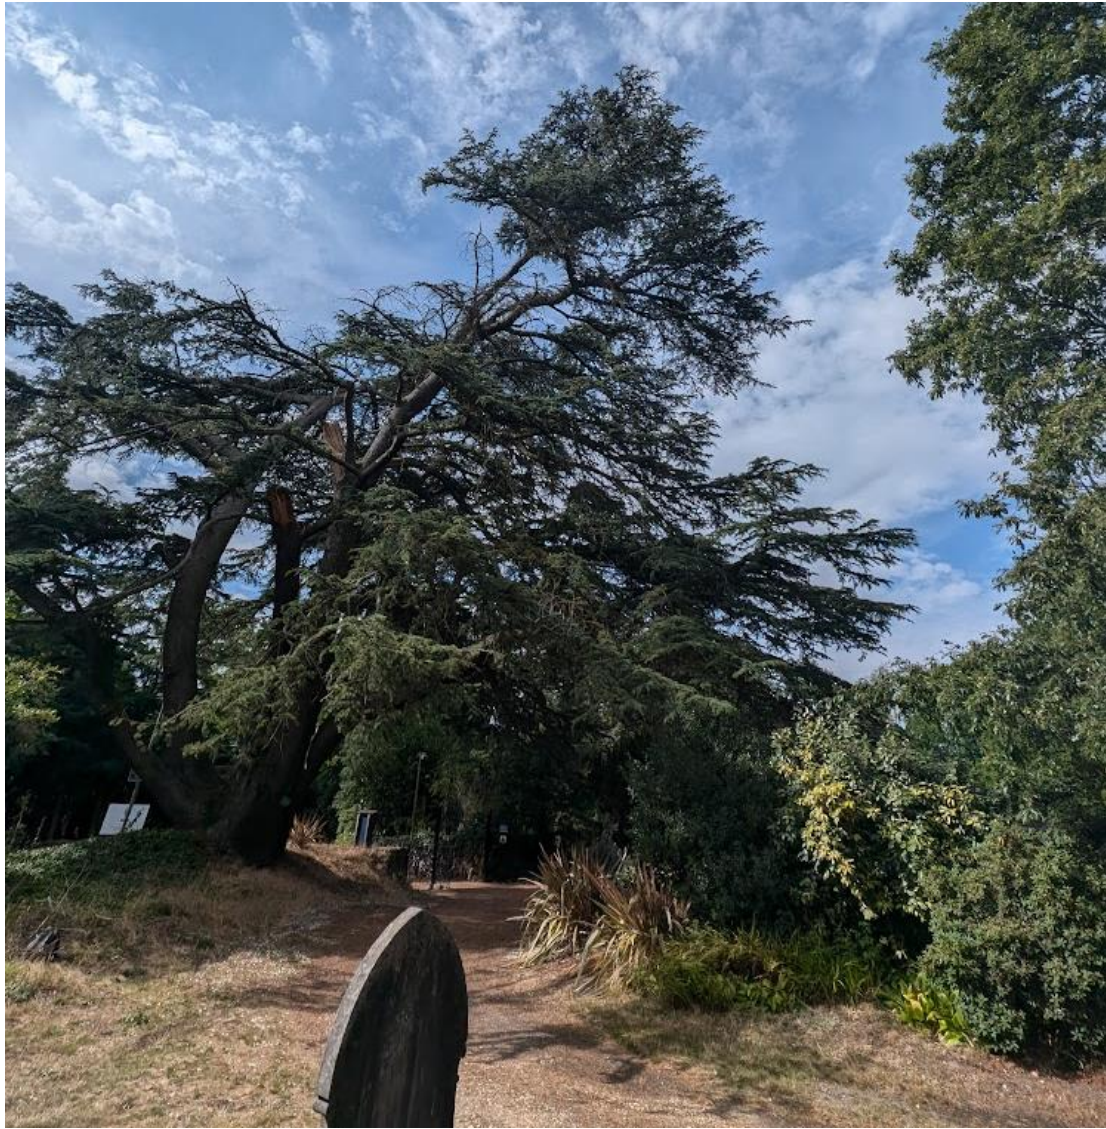
18.3.3 Extensive major deadwood (see Figure 17)

18.3.4 Long lever arm extending East (see Figure 17)

*Figure 17: points 18.3.3 & 18.3.4 in Findings*
