# ARBORICULTURAL REPORT

## TREE CONDITION SURVEY

HONEYSUCKLE DAY NURSERY  
CHURCH LANE  
SHINFIELD  
BERKSHIRE  
RG2 9BY

NOVEMBER 2024

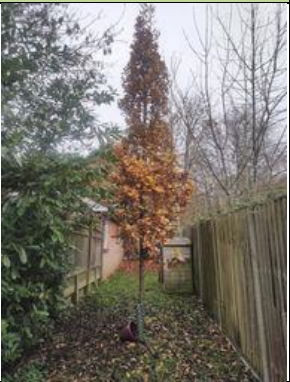
| Ref: | Species | Measurements | Survey Notes | Condition | Recommendations | Photo |
|---|---|---|---|---|---|---|
| T001 | Fastigate oak<br>( <i>Quercus robur</i><br>'Fastigiata') | Height (m): 6<br>Crown Radius (m): 1N, 0.5E, 0.5S, 0.5W<br>DBH (cm): 5<br>Life Stage: Early Mature<br>Life Exp.: 40+ Years | Recent planting. Well-formed canopy. Foliage dense and even. Good vitality. | Good | No works identified. | |

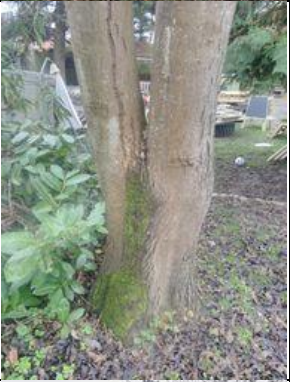
| Ref: | Species | Measurements | Survey Notes | Condition | Recommendations | Photo |
|---|---|---|---|---|---|---|
| T002 | Common ash<br>( <i>Fraxinus excelsior</i> ) | Height (m): 11<br>Crown Radius (m): 4N, 5.5E, 5S, 4.5W<br>DBH (cm): 30<br>Stems: 2<br>Life Stage: Early Mature<br>Life Exp.: 40+ Years | Twin stem from 0.6m. Fork well formed and satisfactory. Bracing not justified.<br><br>Rapid growth bark cracks on trunk.<br><br>Epicormic shoots on lower crown indicative of early Ash dieback disease.<br><br>Bud density good. Asymmetrical crown due to proximity of T003.<br><br>Pests and Diseases:<br>Ash Dieback Infection Level 1: 0% to 25% | Good | No works identified. | |

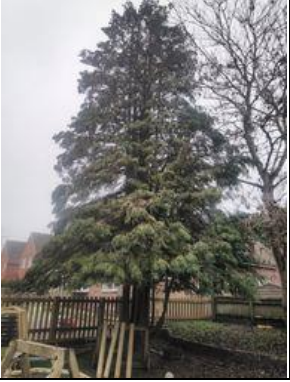
| Ref: | Species | Measurements | Survey Notes | Condition | Recommendations | Photo |
|---|---|---|---|---|---|---|
| T003 | Lawson cypress<br>( <i>Chamaecyparis lawsoniana</i> ) | Height (m): 11<br>Crown Radius (m): 3.5<br>DBH (cm): 50<br>Stems: 6<br>Life Stage: Mature<br>Life Exp.: 20+ Years | Multi-stem small tree. Compaction at base. Mechanical damage to exposed surface roots (not significant).<br>Canopy previously noted as being asymmetrical. Canopy is now broad and reasonably symmetrical crown. Reduction was previously recommended, however I consider this would cause harm to the tree and increase the risk of branch breakage therefore this recommendation is not carried forward.<br>Fair form and vitality. | Fair | No works identified. | |

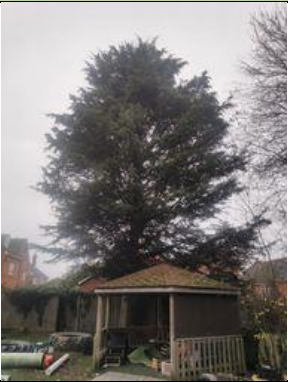
| Ref: | Species | Measurements | Survey Notes | Condition | Recommendations | Photo |
|---|---|---|---|---|---|---|
| T004 | Lawson cypress<br>( <i>Chamaecyparis lawsoniana</i> ) | Height (m): 13<br>Crown Radius (m): 3N, 3.5E, 5S, 7W<br>DBH (cm): 69<br>Stems: 6<br>Life Stage: Mature<br>Life Exp.: 20+ Years | Small girdling root. Swept stem West.<br><br>Base clear, bark intact. Hammer test even and satisfactory. No audible decay.<br><br>No evidence of any root plate movement.<br><br>Asymmetrical crown likely due to proximity of off-site trees which have since been removed.<br><br>New development close to tree and probably within rooting area, approximately 3.5m east of tree. Foliage density normal. | Fair | Crown lift to create 1.5m canopy clearance over pergola roof.<br><br><b>Timescale:</b><br>21-Nov-2025<br>(1 Year) | |

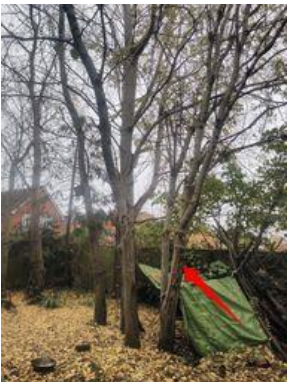
| Ref: | Species | Measurements | Survey Notes | Condition | Recommendations | Photo |
|---|---|---|---|---|---|---|
| G005 | Common ash x3<br>( <i>Fraxinus excelsior</i> )<br>Aspen x4<br>( <i>Populus tremula</i> ) | Height (m): 14<br>Crown Radius (m): 4<br>DBH (cm): 35<br>Trees: 7<br>Life Stage: Mature<br>Life Exp.: 20+ Years | Small trees, slender form. Swept stems and asymmetrical crowns where grown as a group.<br><br>Historic wounding possible fire damage and stripped bark on trunks. Some wounds fully occluded.<br><br>Various straps tied around trunks. Ash trees showing advanced symptoms of Ash dieback. Small trees, lower risk.<br><br>Pests and Diseases:<br>Ash Dieback Infection Level 2: 25% to 50% | Fair | Fell end Ash on Western end of group.<br><br><b>Timescale:</b><br>21-Nov-2025<br>(1 Year)<br><br>Long term Recommendations:<br>Monitor remaining Ash for progress of Ash Dieback.<br><br><b>Timescale:</b><br>Ongoing | |

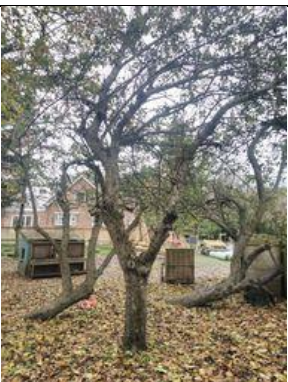
| Ref: | Species | Measurements | Survey Notes | Condition | Recommendations | Photo |
|---|---|---|---|---|---|---|
| G006 | Cultivar apple x3<br>( <i>Malus domestica</i> ) | Height (m): 7<br>Crown Radius (m): 4.5N, 2E, 2S, 2W<br>DBH (cm): 30<br>Trees: 3<br>Life Stage: Mature<br>Life Exp.: 40+ Years | Small trees, two of which have swept low stems close to crown level. Decay pockets in old pruning cuts. Asymmetrical crowns very heavily suppressed by adjacent trees.<br>Previous survey recommended pruning for fruit production, however, given nature of the site I have assumed fruit is not a priority. There is limited light available to the trees and removal of branches as previously recommended would further reduce the photosynthetic area. This work recommendation has not therefore been carried forward. | Fair | No works identified. | |

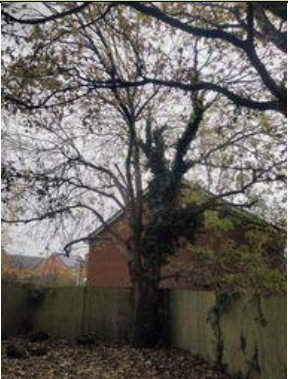
| Ref: | Species | Measurements | Survey Notes | Condition | Recommendations | Photo |
|---|---|---|---|---|---|---|
| T007 | Common ash<br>(Fraxinus excelsior) | Height (m): 16<br>Crown Radius (m): 6N, 6.5E, 4S, 5W<br>DBH (cm): 53<br>Life Stage: Mature<br>Life Exp.: 10+ Years | Ivy clad tree. Twin stem from 2m. Ivy clad. Epicormic shoots from base and throughout canopy. Deadwood in crown. Jelly ear fungus in fork at 2m. Elongated branch on North side over nursery play area. Tree has a short safe useful life expectancy due to Ash Dieback Disease.<br><br>Pests and Diseases:<br>Ash Dieback Infection Level 3: 50% to 75% | Poor | Fell and replace.<br><br><b>Timescale:</b><br>21-Nov-2027<br>(3 Years) | |

| Ref: | Species | Location / Target | Recommendations | Work Timescale |
|---|---|---|---|---|
| T007 | Common ash | Play areas and off-site neighbouring property | Fell and replace. | 21-Nov-2027<br>(3 Years) |

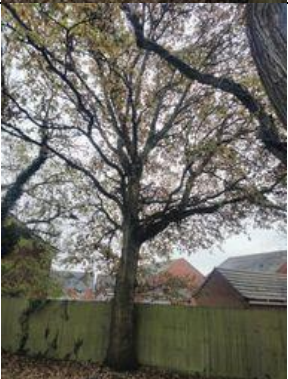
| Ref: | Species | Measurements | Survey Notes | Condition | Recommendations | Photo |
|---|---|---|---|---|---|---|
| T008 | Pedunculate oak<br>(Quercus robur) | Height (m): 16<br>Crown Radius (m): 5N, 6.5E, 4S, 6.5W<br>DBH (cm): 60<br>Life Stage: Mature<br>Life Exp.: 40+ Years | Base clear, bark intact. Broad, asymmetrical canopy. Foliage dense. Fair form and vitality. | Good | No works identified. | |

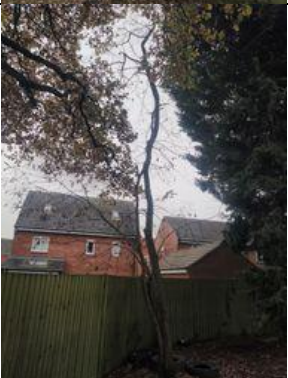
| Ref: | Species | Measurements | Survey Notes | Condition | Recommendations | Photo |
|---|---|---|---|---|---|---|
| T009 | False acacia<br>(Robinia pseudoacacia) | Height (m): 9<br>Crown Radius (m): 2N, 1E, 2S, 3W<br>DBH (cm): 20<br>Stems: 3<br>Life Stage: Mature<br>Life Exp.: 20+ Years | Small suppressed multi-stem tree. Canopy lacks vitality. No major defects. | Fair | No works identified. | |

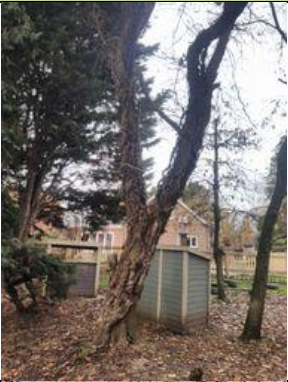
| Ref: | Species | Measurements | Survey Notes | Condition | Recommendations | Photo |
|---|---|---|---|---|---|---|
| T010 | False acacia<br>(Robinia pseudoacacia) | Height (m): 14<br>Crown Radius (m): 2N, 4E, 4S, 3W<br>DBH (cm): 42<br>Life Stage: Mature<br>Life Exp.: 20+ Years | Ivy cut on trunk. Sulphur tuft fungus on old ivy stems. Where accessible base clear, bark intact. Twin stem from 2m. Fork satisfactory. No audible decay. Small suppressed multi-stem tree. Deadwood in crown. Bud density normal. | Fair | Remove deadwood and dead ivy stems where possible.<br><br><b>Timescale:</b><br>21-Feb-2025<br>(3 Months) | |

| Ref: | Species | Location / Target | Recommendations | Work Timescale |
|---|---|---|---|---|
| T010 | False acacia | Play area | Remove deadwood and dead ivy stems where possible. | 21-Feb-2025<br>(3 Months) |

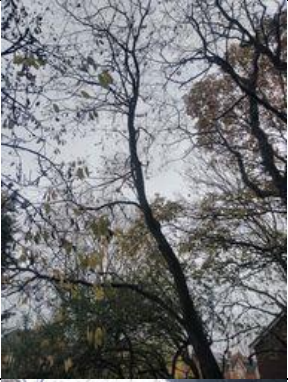
| Ref: | Species | Measurements | Survey Notes | Condition | Recommendations | Photo |
|---|---|---|---|---|---|---|
| T011 | False acacia<br>(Robinia pseudoacacia) | Height (m): 12<br>Crown Radius (m): 3<br>DBH (cm): 20<br>Life Stage: Mature<br>Life Exp.: 20+ Years | Slender swept stem. Small suppressed tree. Bud density normal. Good vitality. | Fair | No works identified. | |

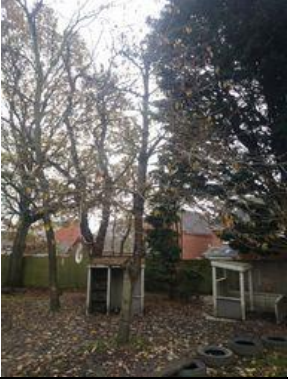
| Ref: | Species | Measurements | Survey Notes | Condition | Recommendations | Photo |
|---|---|---|---|---|---|---|
| T012 | Flowering cherry<br>(Prunus Serrulata) | Height (m): 6.5<br>Crown Radius (m): 3N, 2.5E, 2S, 3W<br>DBH (cm): 30<br>Life Stage: Mature<br>Life Exp.: 20+ Years | Base clear, bark intact. Twin stem from 1.5m. Second stem removed and wound remains. Small suppressed multi-stem tree. Remaining stem has been topped at 6.5m. small, symmetrical crown. Bud density normal. | Fair | No works identified. | |

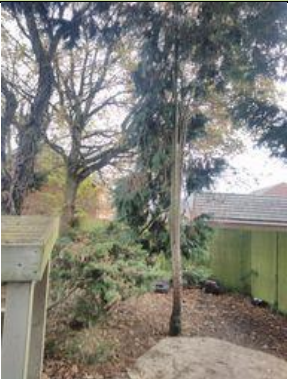
| Ref: | Species | Measurements | Survey Notes | Condition | Recommendations | Photo |
|---|---|---|---|---|---|---|
| T013 | Lawson cypress<br>( <i>Chamaecyparis lawsoniana</i> ) | Height (m): 6<br>Crown Radius (m): 1.5<br>DBH (cm): 10<br>Stems: 2<br>Life Stage: Mature<br>Life Exp.: 20+ Years | Two stems, small trees lacking vitality. | Fair | No works identified. | |

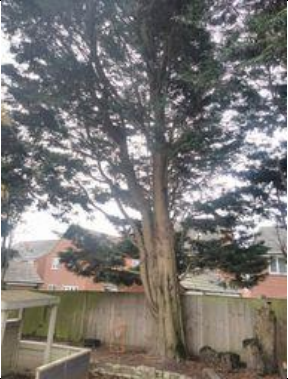
| Ref: | Species | Measurements | Survey Notes | Condition | Recommendations | Photo |
|---|---|---|---|---|---|---|
| T014 | Leyland cypress<br>( <i>X Cuprocyparis leylandii</i> ) | Height (m): 17<br>Crown Radius (m): 2.5N, 6.5E, 6.5S, 6.5W<br>DBH (cm): 74<br>Life Stage: Mature<br>Life Exp.: 20+ Years | Base clear, bark intact. No fungal fruiting bodies evident or audible decay. New development within rooting area. Swept stem to the south. Deeply fluted trunk. Multi stem from 3m. Occluded bark on forks. Asymmetrical crown. Foliage density normal. | Fair | Reduce height by 3-4m and lateral spread on West southern and eastern sides by 1-2m to create a more compact canopy and reduce exposure of branches in high winds.<br><br><b>Timescale:</b><br>21-May-2025<br>(6 Months) | |

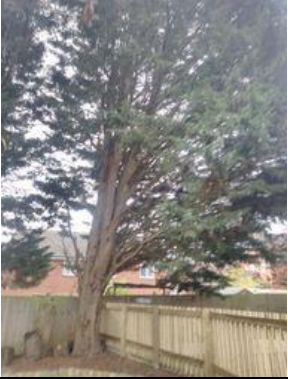
| Ref: | Species | Measurements | Survey Notes | Condition | Recommendations | Photo |
|---|---|---|---|---|---|---|
| T015 | Leyland cypress<br>( <i>X Cuprocyparis leylandii</i> ) | Height (m): 17<br>Crown Radius (m): 5N, 5.5E, 3S, 4W<br>DBH (cm): 68<br>Life Stage: Mature<br>Life Exp.: 20+ Years | Base clear, bark intact. No fungal fruiting bodies evident or audible decay. New development within rooting area. Swept stem to the south. Deeply fluted trunk. Multi stem from 2m. Occluded bark on forks. Asymmetrical crown. Foliage density normal. | Fair | Reduce height by 3-4m and lateral spread on West Northern and eastern sides by 1-2m to create a more compact canopy and reduce exposure of branches in high winds.<br><br><b>Timescale:</b><br>21-May-2025<br>(6 Months) | |

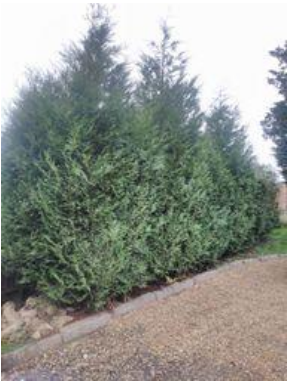
| Ref: | Species | Measurements | Survey Notes | Condition | Recommendations | Photo |
|---|---|---|---|---|---|---|
| G020 | Western red cedar<br>x6<br>(Thuja plicata) | Height (m): 4<br>Crown Radius (m): 0.5<br>DBH (cm): 15<br>Trees: 6<br>Life Stage: Early Mature<br>Life Exp.: 20+ Years | Recent planting of hedge. Sides clipped but good tips of trees not pruned and of irregular heights. | Good | Top trees at 4m to maintain formal hedge.<br><br><b>Timescale:</b><br>21-Nov-2025<br>(1 Year) | |

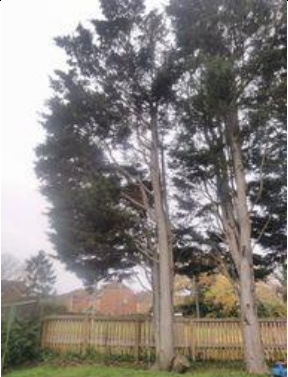
| Ref: | Species | Measurements | Survey Notes | Condition | Recommendations | Photo |
|---|---|---|---|---|---|---|
| T021a | Leyland cypress<br>(X Cuprocyparis leylandii) | Height (m): 12<br>Crown Radius (m): 2N, 1E, 1.5S, 4W<br>DBH (cm): 30<br>Stems: 4<br>Life Stage: Mature<br>Life Exp.: 20+ Years | Multi-stem tree. Low stem removed at ground level. Split limb in asymmetrical crown 4m above ground level. Upper canopy lacks vitality with minor dead / declining branches. Branch failure possible but over low occupancy areas. | Poor | Fell to ground level.<br><br><b>Timescale:</b><br>21-May-2025<br>(6 Months) | |

| Ref: | Species | Location / Target | Recommendations | Work Timescale |
|---|---|---|---|---|
| T021a | Leyland cypress | Front garden & public highway. | Fell to ground level. | 21-May-2025<br>(6 Months) |

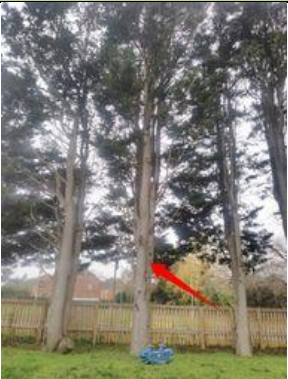
| Ref: | Species | Measurements | Survey Notes | Condition | Recommendations | Photo |
|---|---|---|---|---|---|---|
| T021b | Leyland cypress<br>(X Cuprocyparis leylandii) | Height (m): 13<br>Crown Radius (m): 3N, 1E, 3S, 2W<br>DBH (cm): 30<br>Life Stage: Mature<br>Life Exp.: 20+ Years | Base clear, bark intact. Single stem to 2m.<br>Excurrent multi-stem form in canopy.<br>Suppressed crown. Foliage slightly sparse. | Fair | No works identified. | |

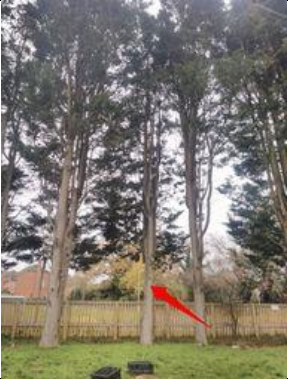
| Ref: | Species | Measurements | Survey Notes | Condition | Recommendations | Photo |
|---|---|---|---|---|---|---|
| T021c | Leyland cypress<br>(X Cuprocyparis leylandii) | Height (m): 13<br>Crown Radius (m): 2.5N, 1E, 2S, 1W<br>DBH (cm): 30<br>Stems: 2<br>Life Stage: Mature<br>Life Exp.: 20+ Years | Twin stem from 0.6m. included bark in fork.<br>Slender, suppressed crown. Foliage slightly sparse. | Fair | No works identified. | |

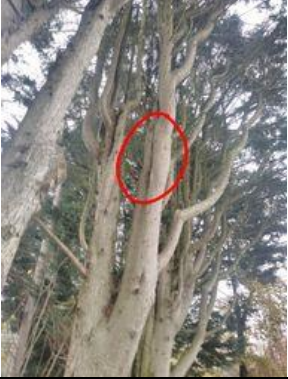
| Ref: | Species | Measurements | Survey Notes | Condition | Recommendations | Photo |
|---|---|---|---|---|---|---|
| T021d | Leyland cypress<br>(X Cuprocyparis leylandii) | Height (m): 13<br>Crown Radius (m): 3N, 1E, 3.5S, 1.5W<br>DBH (cm): 40<br>Life Stage: Mature<br>Life Exp.: 20+ Years | Twin stem from 2m. Included bark in fork between two smaller branches 100mm on south side of crown. Slender, suppressed crown. Foliage slightly sparse. | Fair | No works identified. | |

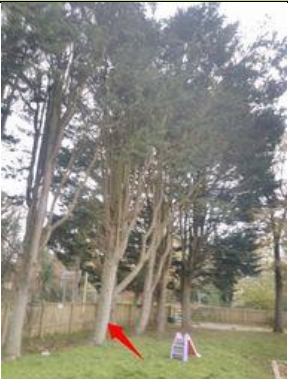
| Ref: | Species | Measurements | Survey Notes | Condition | Recommendations | Photo |
|---|---|---|---|---|---|---|
| T021e | Leyland cypress<br>(X Cuprocyparis leylandii) | Height (m): 13<br>Crown Radius (m): 2.5N, 2E, 5S, 2W<br>DBH (cm): 50<br>Life Stage: Mature<br>Life Exp.: 20+ Years | Base clear, bark intact. No audible decay. Multi-stem from 3m. Asymmetrical crown over highway. Slender, suppressed crown. Foliage slightly sparse. Split branch on south side of crown. Dead branch in upper crown on roadside. | Fair | Reduce lateral spread on south side of canopy - towards carpark by 1-2m.<br>Remove dead branches from upper crown.<br><br><b>Timescale:</b><br>21-Feb-2025<br>(3 Months) | |

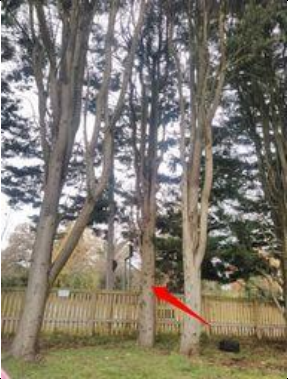
| Ref: | Species | Measurements | Survey Notes | Condition | Recommendations | Photo |
|---|---|---|---|---|---|---|
| T021f | Leyland cypress<br>(X Cuprocyparis leylandii) | Height (m): 13<br>Crown Radius (m): 3N, 3E, 1.5S, 1W<br>DBH (cm): 40<br>Life Stage: Mature<br>Life Exp.: 20+ Years | Base clear, bark intact. Multi-stem from 4m. Low, asymmetrical canopy. Foliage density normal. Canopy obscured Street light. | Fair | Cut back to clear streetlight.<br><br><b>Timescale:</b><br>21-Nov-2025<br>(1 Year) | |

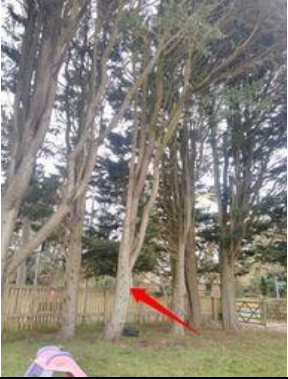
| Ref: | Species | Measurements | Survey Notes | Condition | Recommendations | Photo |
|---|---|---|---|---|---|---|
| T021g | Leyland cypress<br>(X Cuprocyparis leylandii) | Height (m): 13<br>Crown Radius (m): 1N, 1E, 4S, 1.5W<br>DBH (cm): 40<br>Life Stage: Mature<br>Life Exp.: 20+ Years | Swept, fluted lower trunk. Upper crown resumes vertical growth. Base clear, bark intact. Asymmetrical, suppressed canopy. Foliage slightly sparse. | Fair | No works identified. | |

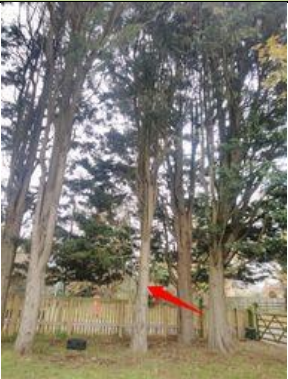
| Ref: | Species | Measurements | Survey Notes | Condition | Recommendations | Photo |
|---|---|---|---|---|---|---|
| T021h | Leyland cypress<br>(X Cuprocyparis leylandii) | Height (m): 13<br>Crown Radius (m): 2.5N, 1E, 3.5S, 2W<br>DBH (cm): 46<br>Life Stage: Mature<br>Life Exp.: 20+ Years | Base clear, bark intact. Multi-stem crown.<br>Suppressed, oval canopy. Foliage slightly sparse. | Fair | No works identified. | |

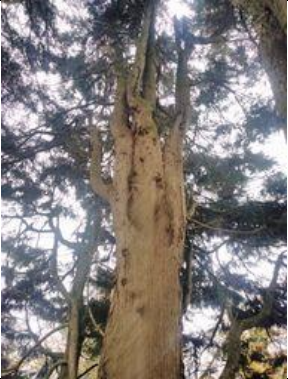
| Ref: | Species | Measurements | Survey Notes | Condition | Recommendations | Photo |
|---|---|---|---|---|---|---|
| T021i | Leyland cypress<br>(X Cuprocyparis leylandii) | Height (m): 13<br>Crown Radius (m): 4N, 4E, 1S, 2W<br>DBH (cm): 55<br>Life Stage: Mature<br>Life Exp.: 20+ Years | Base clear, bark intact. Deeply fluted trunk.<br>Multi-stem from 3m with long area of included bark between stems. Low, asymmetrical canopy. Foliage density normal. | Fair | No works identified. | |

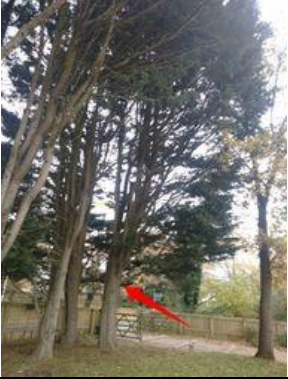
| Ref: | Species | Measurements | Survey Notes | Condition | Recommendations | Photo |
|---|---|---|---|---|---|---|
| T021j | Leyland cypress<br>(X Cuprocyparis leylandii) | Height (m): 13<br>Crown Radius (m): 1N, 4E, 4S, 2W<br>DBH (cm): 49<br>Life Stage: Mature<br>Life Exp.: 20+ Years | Base clear, bark intact. Multi-stem from 2m.<br>Asymmetrical canopy. Foliage density normal. | Fair | No works identified. | |

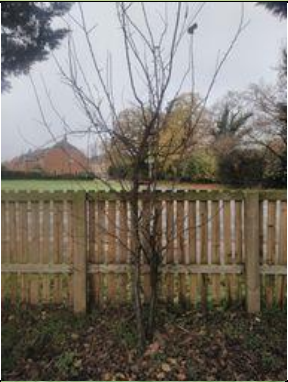
| Ref: | Species | Measurements | Survey Notes | Condition | Recommendations | Photo |
|---|---|---|---|---|---|---|
| T022 | English elm<br>(Ulmus procera) | Height (m): 3<br>Crown Radius (m): 1<br>DBH (cm): 3<br>Stems: 2<br>Life Stage: Young<br>Life Exp.: 10+ Years | Young tree, small. Suppressed form lacks vitality. Regeneration from felled stump? | Fair | No works identified. | |

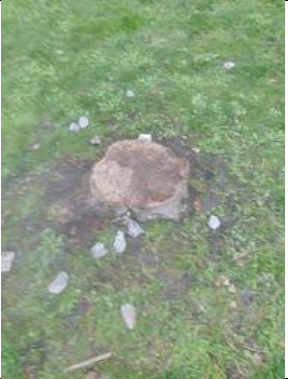
| Ref: | Species | Measurements | Survey Notes | Condition | Recommendations | Photo |
|---|---|---|---|---|---|---|
| T023 | Norway maple<br>(Acer platanoides) | Height (m): 0<br>Crown Radius (m): 0<br>DBH (cm): 32<br>Life Stage: Dead | Stump from felled tree. | | No works identified. | |

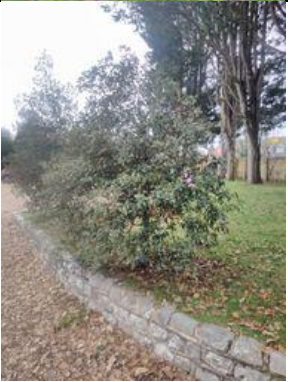
| Ref: | Species | Measurements | Survey Notes | Condition | Recommendations | Photo |
|---|---|---|---|---|---|---|
| T024 | Holm oak<br>(Quercus ilex) | Height (m): 2.5<br>Crown Radius (m): 1<br>DBH (cm): 7<br>Life Stage: Young<br>Life Exp.: 40+ Years | Small tree, feathered form. Reasonable vitality. No significant defects. | Good | No works identified. | |

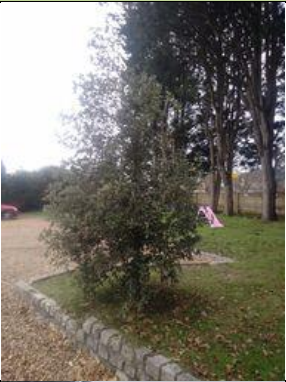
| Ref: | Species | Measurements | Survey Notes | Condition | Recommendations | Photo |
|---|---|---|---|---|---|---|
| T025 | Holm oak<br>(Quercus ilex) | Height (m): 3<br>Crown Radius (m): 1<br>DBH (cm): 7<br>Life Stage: Young<br>Life Exp.: 40+ Years | Small tree, feathered form. Reasonable vitality.<br>No significant defects. | Good | No works identified. | |

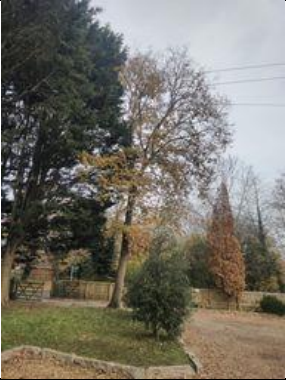
| Ref: | Species | Measurements | Survey Notes | Condition | Recommendations | Photo |
|---|---|---|---|---|---|---|
| T026 | Pedunculate oak<br>(Quercus robur) | Height (m): 15<br>Crown Radius (m): 4.5N, 5E, 5S, 1W<br>DBH (cm): 43<br>Life Stage: Early Mature<br>Life Exp.: 40+ Years | Behind low level retaining wall. Base clear, bark intact. No fungal fruiting bodies evident or audible decay. Single stem forks at 6m. Asymmetrical crown. Foliage dense and even. Good vitality. | Good | No works identified. | |

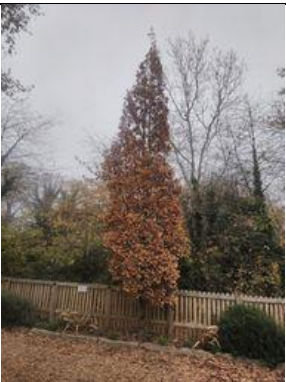
| Ref: | Species | Measurements | Survey Notes | Condition | Recommendations | Photo |
|---|---|---|---|---|---|---|
| T028 | Fastigate oak<br>(Quercus robur 'Fastigiata') | Height (m): 9<br>Crown Radius (m): 1<br>DBH (cm): 11<br>Life Stage: Early Mature<br>Life Exp.: 40+ Years | Recent planting. Trunk forks at 4m above ground level. Well-formed canopy. Foliage dense and even. Good vitality. | Good | No works identified. | |

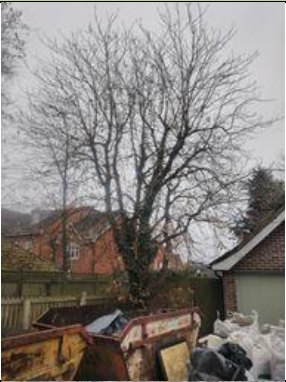
| Ref: | Species | Measurements | Survey Notes | Condition | Recommendations | Photo |
|---|---|---|---|---|---|---|
| T029 | Horse chestnut<br>(Aesculus<br>hippocastanum) | Height (m): 9<br>Crown Radius (m): 4N, 4E, 4.5S, 4W<br>DBH (cm): 65<br>Life Stage: Mature<br>Life Exp.: 40+ Years | Ivy clad tree. Base and trunk partially obscured by ivy and epicormic shoots. Where accessible no fungal fruiting bodies evident or audible decay. Previously reduced crown. 2-3m on previous reduction points. Good bud density and vitality.<br><br>Pests and Diseases:<br>Horse Chestnut Leaf Blotch ( <i>Guignardia aesculi</i> )<br>Horse Chestnut Leaf Miner ( <i>Cameraria ohridella</i> ) | Fair | Remove epicormic shoots at base.<br>Reduced lateral branches south side to create 1-1.5m canopy clearance to garage roof.<br><br><b>Timescale:</b><br>21-Nov-2025<br>(1 Year) | |

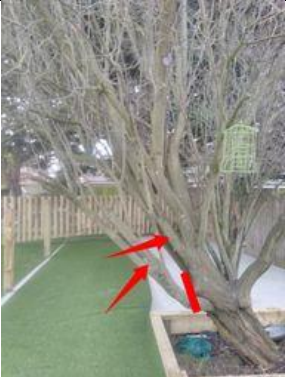
| Ref: | Species | Measurements | Survey Notes | Condition | Recommendations | Photo |
|---|---|---|---|---|---|---|
| T030 | Cherry plum<br>'Nigra'<br>(Prunus cerasifera) | Height (m): 8<br>Crown Radius (m): 4N, 4E, 2.5S, 2.5W<br>DBH (cm): 30<br>Life Stage: Mature<br>Life Exp.: 10+ Years | Swept stem. Base clear. Bark intact. Hammer test even and satisfactory. No audible decay. Dead / decaying branches in crown. Dog legged limbs in crown. Bud density good. Reasonable vitality. | Poor | Prune out dead / decaying branches and reduce two dog-legged limbs in crown back to previous reduction points.<br><br><b>Timescale:</b><br>21-Feb-2025<br>(3 Months) | |

| Ref: | Species | Location / Target | Recommendations | Work Timescale |
|---|---|---|---|---|
| T030 | Cherry plum 'Nigra' | Play area with AstroTurf. | Prune out dead / decaying branches and reduce two dog legged limbs in crown back to previous reduction points. | 21-Feb-2025<br>(3 Months) |
