# **ADDENDUM TPO REPORT**

## **SUBSIDENCE CLAIM**

**Crawford Reference: 1784404**

**2 Greenside, Crowthorne, Berkshire, RG45 6EX**

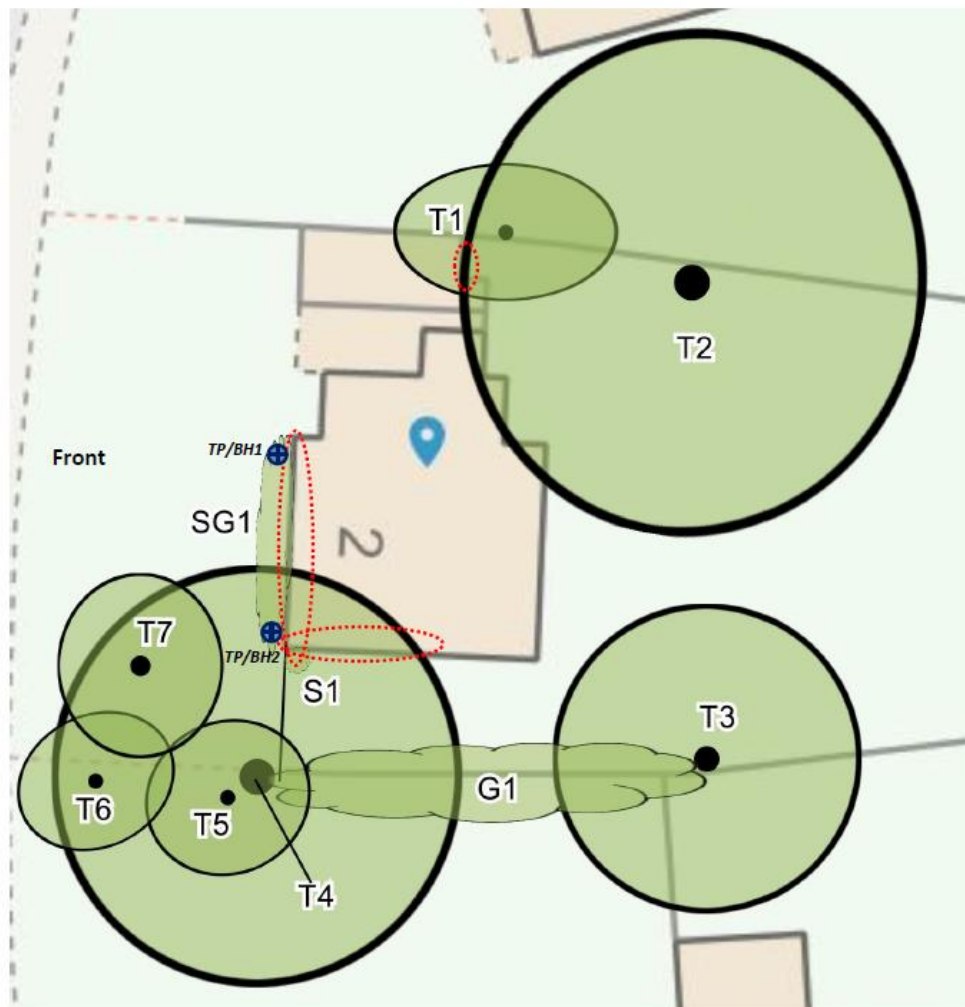
## Site Plan

Approximate areas of damage

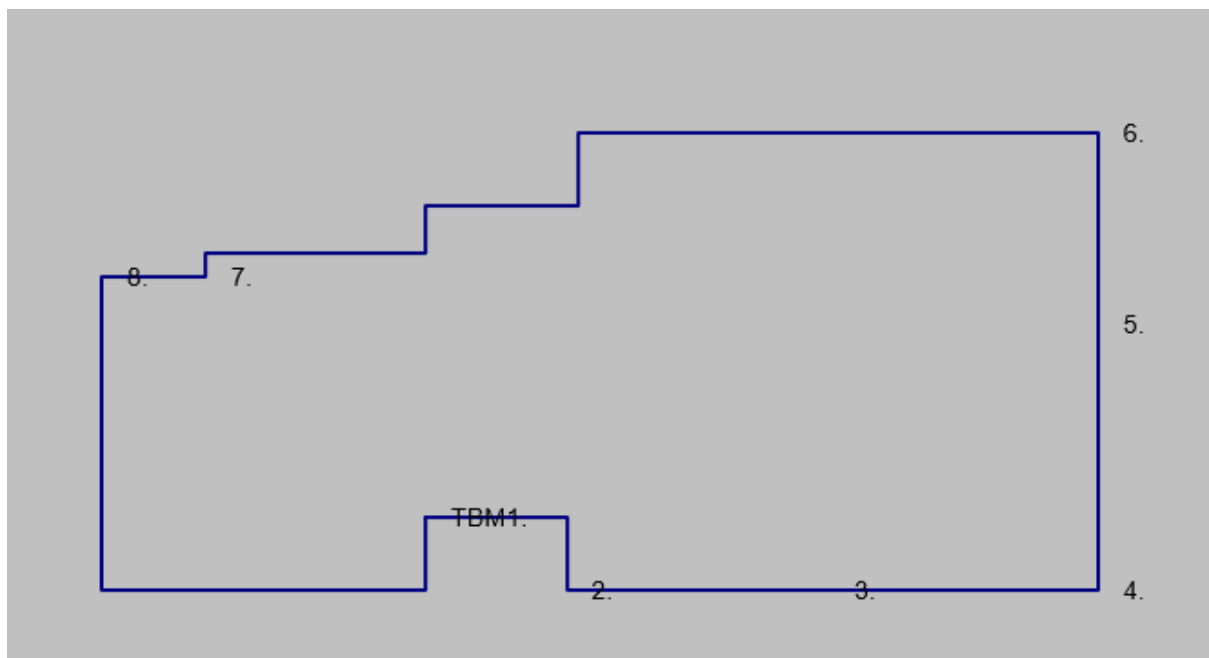
LEVEL MONITORING - RELATIVE MOVEMENT SKETCH

Level monitoring was undertaken between 14/10/2022 and 24/09/2024 which clearly shows evidence of cyclical seasonal movement consistent with root induced clay shrinkage, with downward movement during the summer and corresponding upward movement over the subsequent winter. The movement which is focused at points to the front and front right and shows movement of up to 4mm, is located in the area of subsidence damage affecting the property. This is characteristic of the seasonal pattern of foundation movement where vegetation is involved. No other cause produces a similar pattern.

The pattern of movement is not uniform around the property so 'nominal clay shrinkage' can be discounted as a cause; nearby vegetation is seen to be the source of the ongoing localised movement to the area of damage.

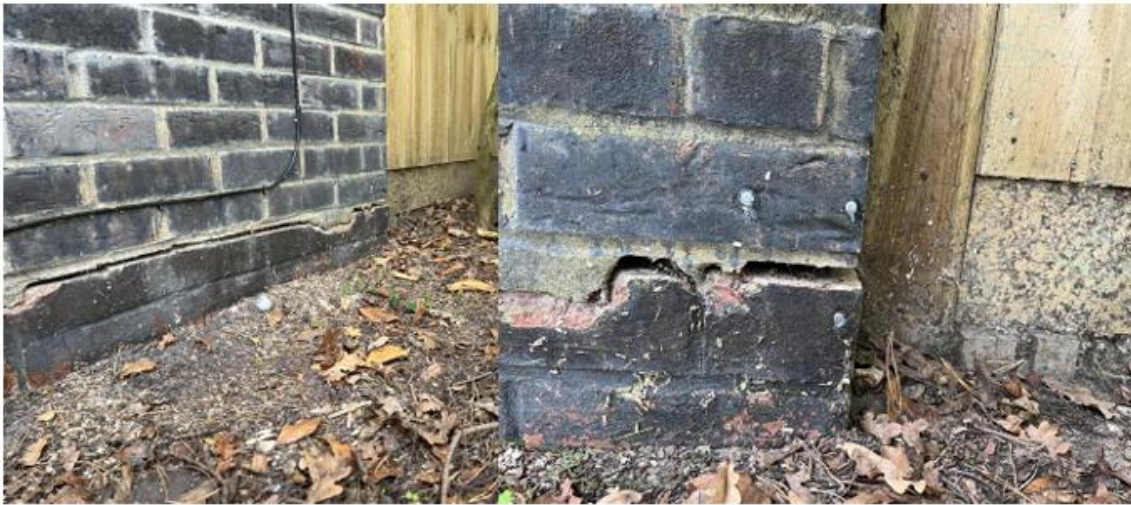
Horizontal crack 7 brick courses below DPC, extending from left corner of gable elevation tapering open to front right corner, max opening c.14mm. One vertical crack below this main horizontal crack about 2m from corner.

The horizontal crack noted above continues down the flank elevation, tapering to closure towards the rear but still open where the crack disappears below ground level (due to the sloping ground). The crack also shows there has been lateral movement to the right of c.5mm at the corner, tapering less to rear.

Front right

Front right corner

Localised superstructure repairs shall proceed once all required tree management works have been completed and monitoring confirms stability of the property at a cost of circa £12,000. Should consent not be granted or third parties refuse to allow the required tree reduction works to be carried out, underpinning to the property will be required to arrest the movement, and we have been quoted costs up to £350,000 for these works.

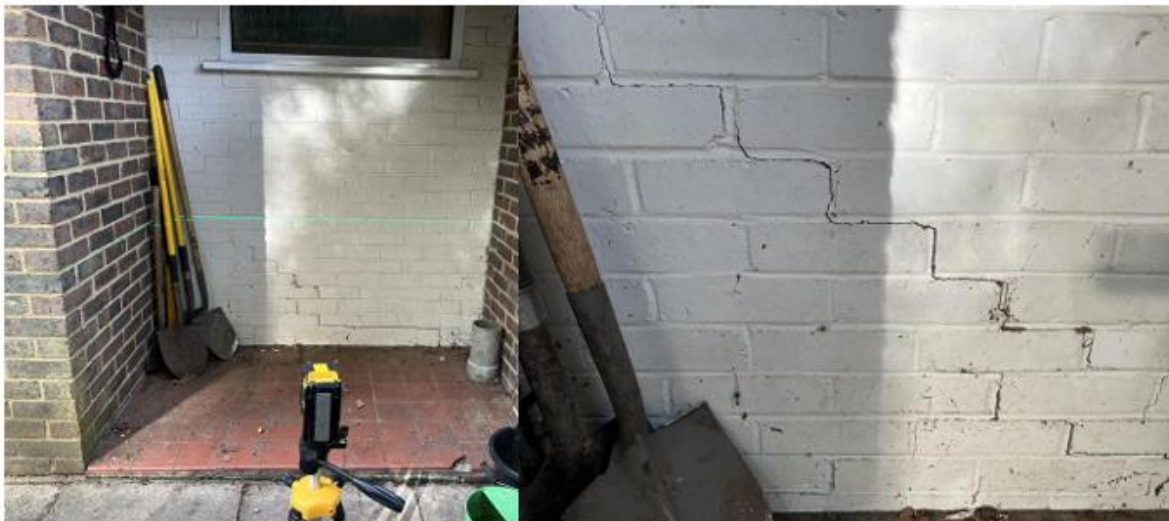
Stepped crack on rear wall at low level. Laser level indicates brick bed joints are level.

Garage rear wall – level brickwork

Garage rear wall crack

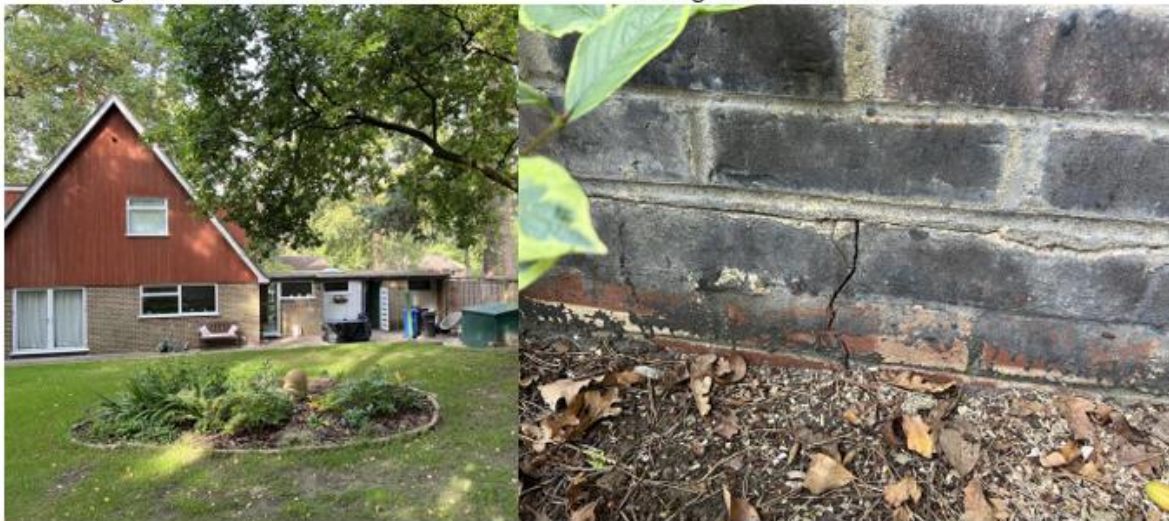
Rear elevation

Vertical crack on front elevation

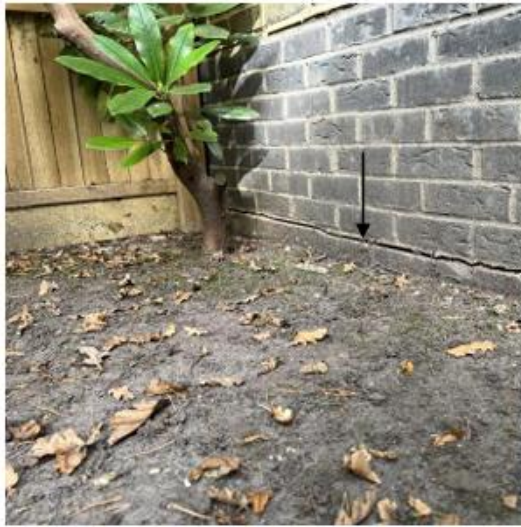
Right flank looking towards front

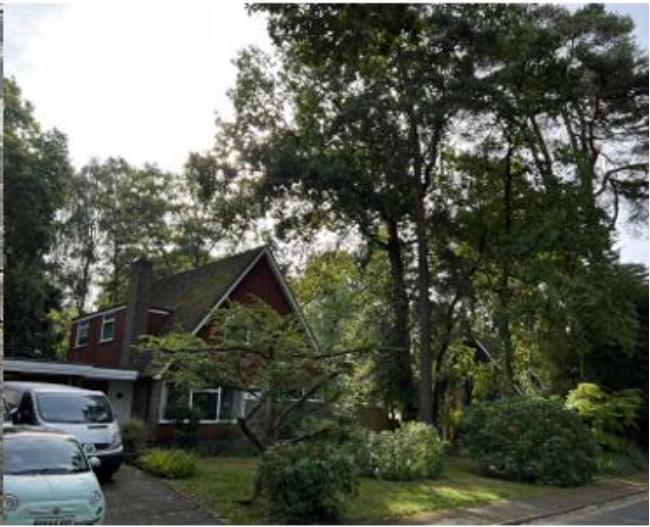
Based on the above, the roots identified will have emanated from Oak T4 and from Pine T1, Oak T2, Oak T5, Oak T6 and Pine T7 noted in the Arboricultural report. The location of Oak T4 in relation to the damage indicates that this tree is the most likely dominant cause.

Oak and pine trees

**Tree Oak T4** – Fell to ground level (subject to TPO consent being granted)
