## ARBORICULTURAL REPORT

TREE CONDITION SURVEY & MITIGATION STRATEGY

WATERLOO COTTAGE  
BATH ROAD  
KNOWL HILL  
WOKINGHAM  
BERKSHIRE  
RG10 9UP

Ref: 06408/2024 0.3

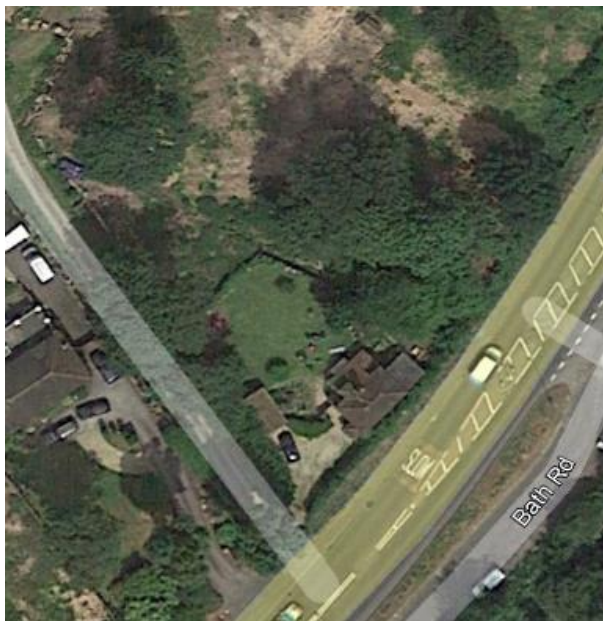
A comparison of aerial photographs taken in June 2018 and June 2024 confirms the same trees as being present. During my recent visit I did not find any visible evidence of recent tree pruning work having been undertaken. I am therefore satisfied that no trees have been removed or pruned since the Tree Preservation Order was served.

Fig. 2 – Aerial Photos (Google Earth Pro) from 06/2018

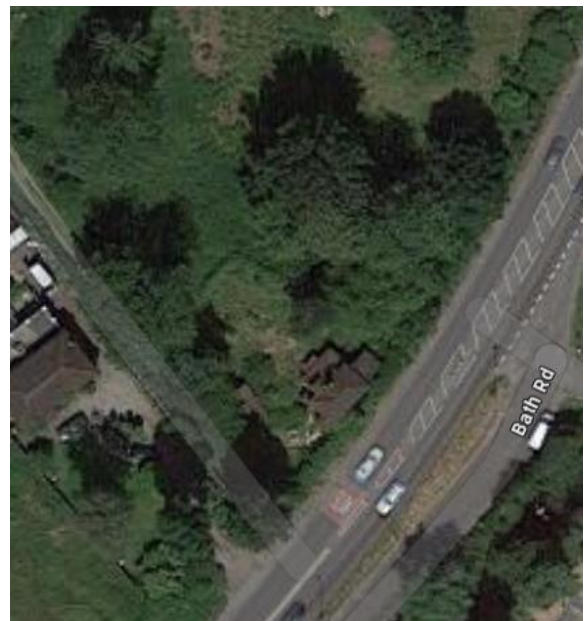
Fig. 3 – Aerial Photos (Google) from 2024

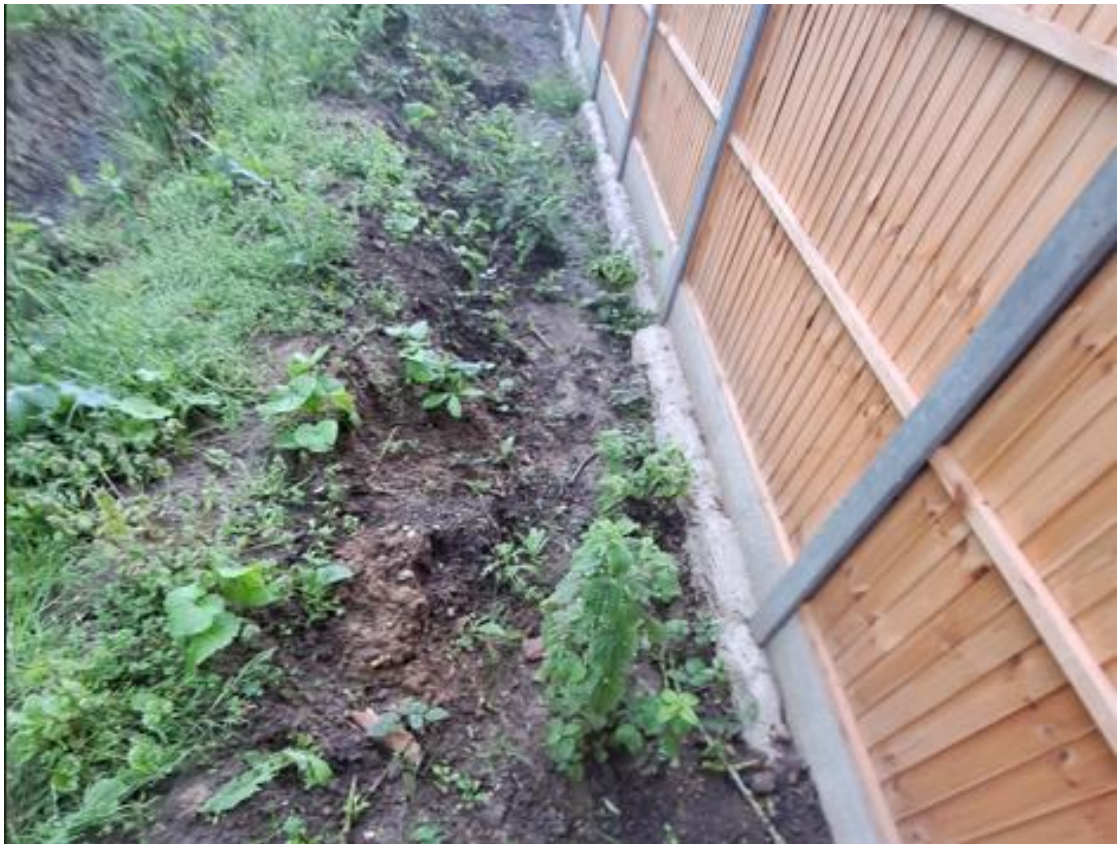
A bed of concrete has been laid under the base board of the new boundary fence. I have been advised that this concrete was laid directly onto the soil without any excavation. The concrete is intended to prevent water running under the fence towards Waterloo Cottage and to direct it back into the new ditch.

The leachate from poured wet concrete is toxic to plants. However, the concrete under the fence was trowelled in place in a semi-set state and this will have reduced leachate from the mix. The concrete, being placed in a narrow line along the fence covers a very small area of the tree's overall rooting area. The impact on the adjacent trees is negligible.

Fig. 4 – Concrete laid on existing soil level directly under fence kickboard

Concrete laid under the new fencing panels has been placed directly onto the existing surface and will not have damaged trees or tree roots.

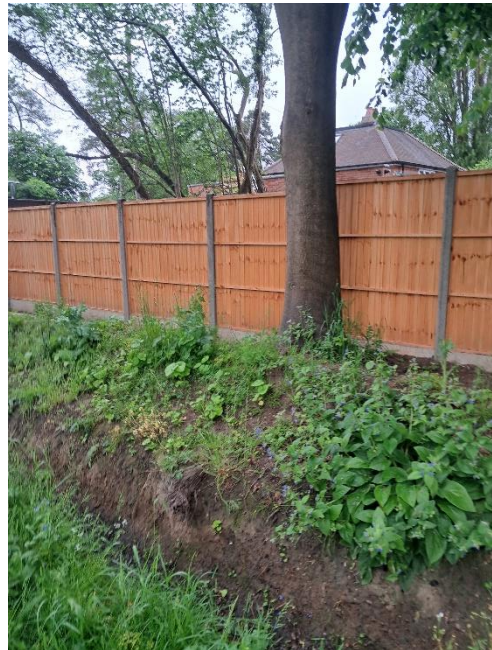
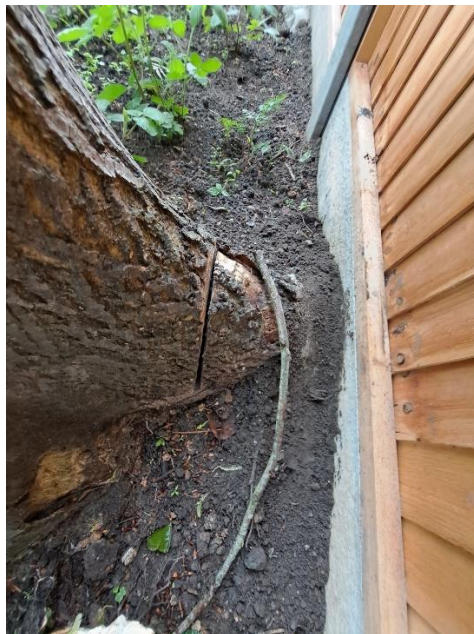
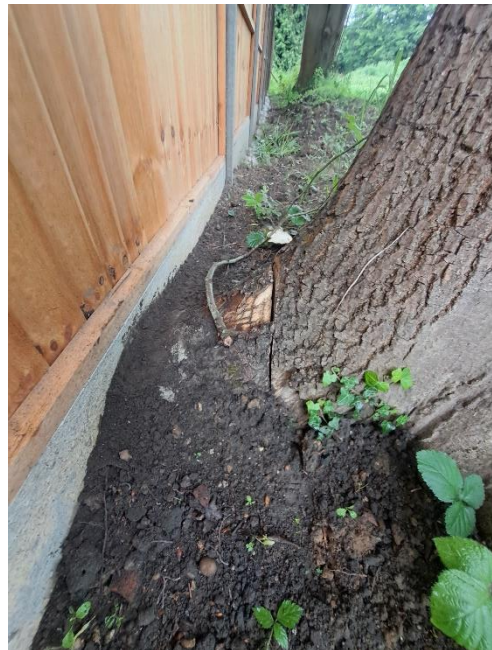
##### T003 – Ash

Cut marks at the base of T003 (Ash), show one buttress root has been cut through to accommodate the fence.

Large root over 100mm diameter cut 1.5m from base with recent ditch works. Plunger roots from main root visible but intact. Twin stem from 4m. Union satisfactory. 35% defoliated. Buttress root cut on southwest side at base mechanically cut through for installation of fence.

Major dead branches throughout asymmetrical crown. Tree in decline and undermined by root severance.

Ash Dieback Infection Level 2: 25% to 50%

T003 & T005 are two Ash which were in decline because of Ash Dieback Disease even before the recent ground works. In my opinion, the decline of the trees is terminal and their stability undermined therefore, my recommendation is that an application be submitted to Wokingham Borough Council to fell both trees.

**Recommended works: Fell and replace**

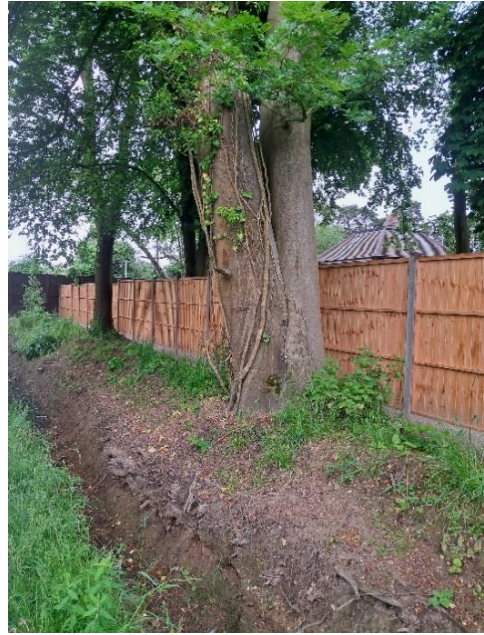
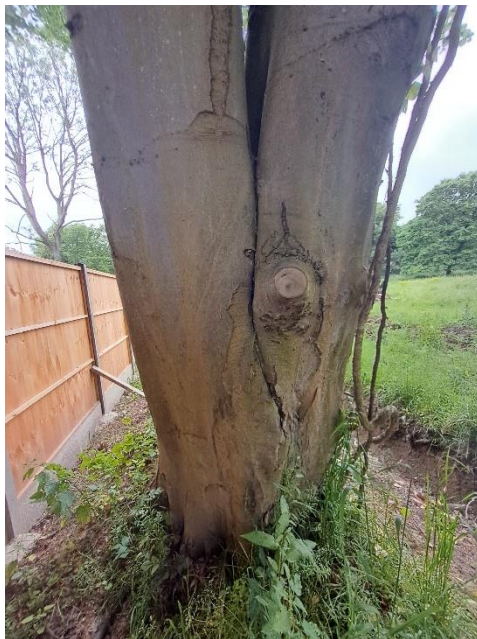
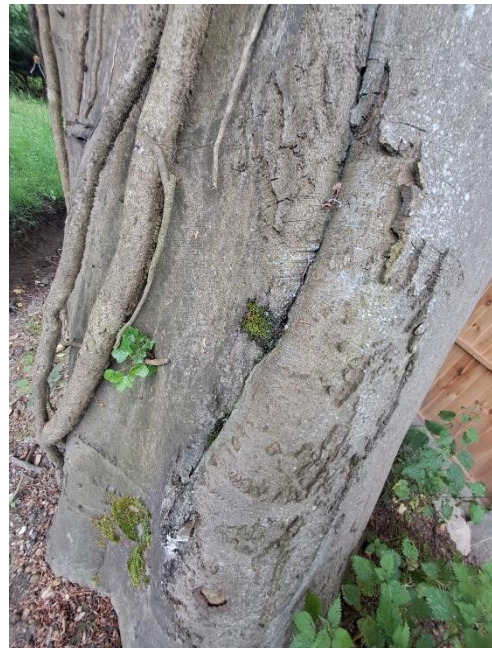
## T004 – Beech

Woody and fibrous roots cut 1m from base with recent ditch works. 30% of roots lost. Twin stem from 0.5m. Long area of included bark in fork to 2m. Ruptured bark on east side at 1m. Rapid bark growth scars suggest major defect /decay. Stability of tree cannot be guaranteed. Light ivy growth. Foliage dense and even. Good vitality.

T004 is a large Beech which is undermined by a weak fork on the lower trunk. The tree has an inherently weak structural form but has also been further undermined by root severance with the adjacent ground works. My recommendation is that T004 (Beech) also be felled and replaced.

| Ref. | Species | Measurements | Canopy Spread | General Observations | Condition | General Assessment | Recommended tree work |
|---|---|---|---|---|---|---|---|
| T004 | Common beech<br>( <i>Fagus sylvatica</i> ) | Height (m): 19<br>2 stems, avg.(mm): 600<br>Crown Clearance (m): 3<br>Life Stage: Mature<br>Rem. Contrib.: 10+ Years | N:7<br>E:5<br>S:6.5<br>W:7 | Large number of woody and fibrous roots cut 1m from base with recent ditch works. 30%of roots lost. Twin stem from 0.5m. Long area of included bark in fork to 2m. Ruptured bark on east side at 1m. Rapid bark growth scars suggest major defect /decay.<br>Due to root severance and poor form the stability of tree cannot be guaranteed. Light ivy growth. Foliage dense and even. Good vitality. | Physiological Condition: Poor<br>Structural Condition: Physical Defect<br>Public Amenity Value: Moderate | Tree structure undermined by weak fork on lower stem. Stability of tree undermined by root severance for ditch and post hole. Tree canopy healthy. | Fell to ground level and replace |

**Recommended works: Fell and replace**

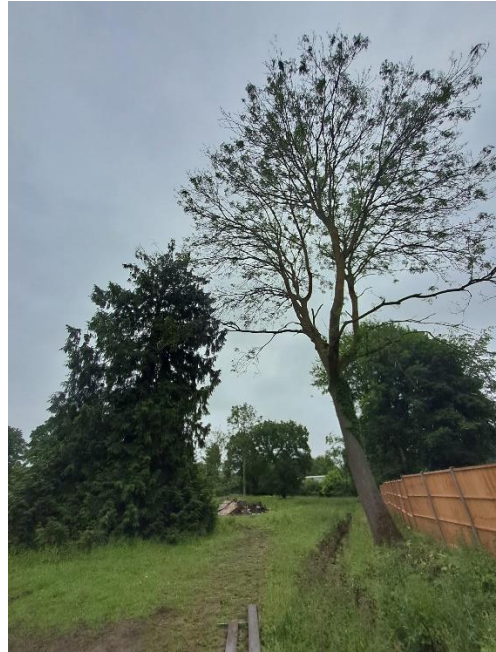
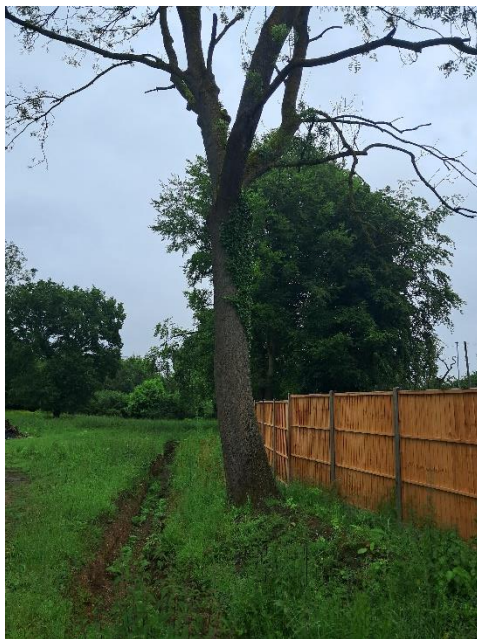
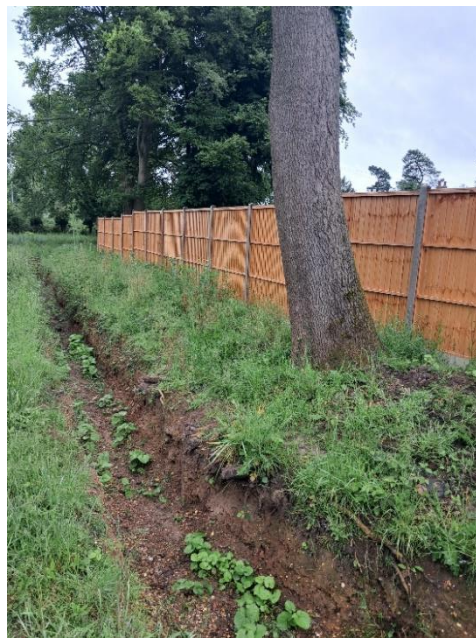
## T005 – Ash

Large roots x4 over 100mm diameter and other smaller woody roots cut 1m from base with recent ditch works. Deadwood throughout asymmetrical crown. 30% defoliated. Major deadwood in crown. Foliage sparse. Stability of tree cannot be guaranteed.

Ash Dieback Infection Level 2: 25% to 50%

| Ref. | Species | Measurements | Canopy Spread | General Observations | Condition | General Assessment | Recommended tree work |
|---|---|---|---|---|---|---|---|
| T005 | Common ash<br>( <i>Fraxinus excelsior</i> ) | Height (m): 17<br>Stem Diam(mm): 760<br>Crown Clearance (m): 5<br>Life Stage: Mature<br>Rem. Contrib.: 10+ Years | N:8.5<br>E:7<br>S:5.5<br>W:7 | Large roots x4 over 100mm diameter and other smaller woody roots cut 1m from base with recent ditch works. Deadwood throughout asymmetrical crown. 30% defoliated. Major deadwood in crown. Foliage sparse. Stability of tree cannot be guaranteed.<br>Ash Dieback Infection Level 2: 25% to 50% | Physiological Condition: Poor<br>Structural Condition: Physical Defect<br>Public Amenity Value: Moderate | Stability of tree greatly undermined by root severance. Tree canopy is in decline | Fell to ground level and replace |

**Recommended works: Fell and replace**

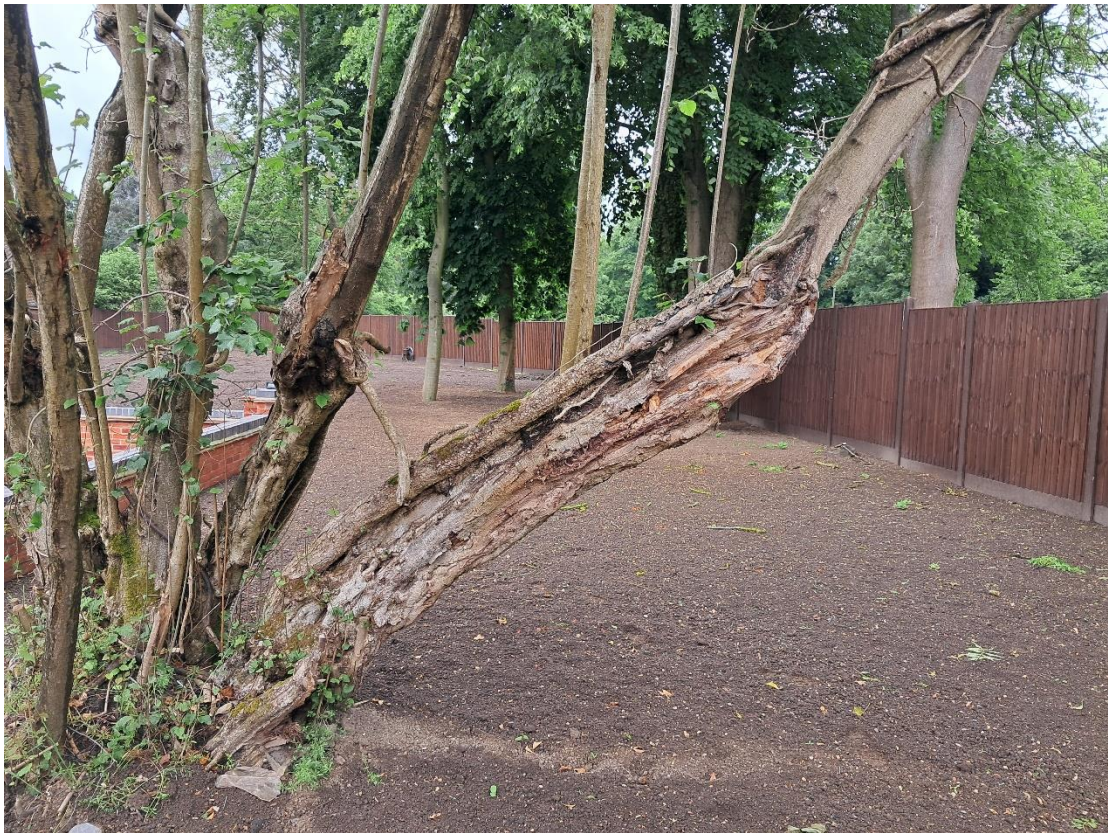
T008 (Hazel) is an over-mature coppice stool with extensive decay and dieback in the tree's canopy. The poor condition of the tree is due to its age and the decay and dieback predates the recent ground works. T008 is in terminal decline and is not expected to recover. There is a foreseeable risk of branch breakages, and the tree causes an unacceptable risk to future occupants of Waterloo Cottage.

Fig. 5 – Extensive decay on stems of T008 (Hazel)

| Ref. | Species | Measurements | Canopy Spread | General Observations | Condition | General Assessment | Recommended tree work |
|---|---|---|---|---|---|---|---|
| T008 | Hazel<br>( <i>Corylus avellana</i> ) | Height (m): 7<br>4 stems, avg.(mm): 300<br>Crown Clearance (m): 3<br>Life Stage: Mature<br>Rem. Contrib.: <10 years | N:6.5<br>E:4.5<br>S:3<br>W:2.5 | Over mature coppiced stool. Asymmetrical canopy. Extensive decay on stems and major deadwood in crown. Future stem failure likely. | Physiological Condition: Poor<br>Structural Condition: Physical Defect<br>Public Amenity Value: Moderate | Old coppice. Decay in trunk is historic and predates ground works. Branch failure foreseeable. | Fell to ground level and replace |

In view of this my recommendation is that an application be submitted to fell the tree, and a replacement planted.

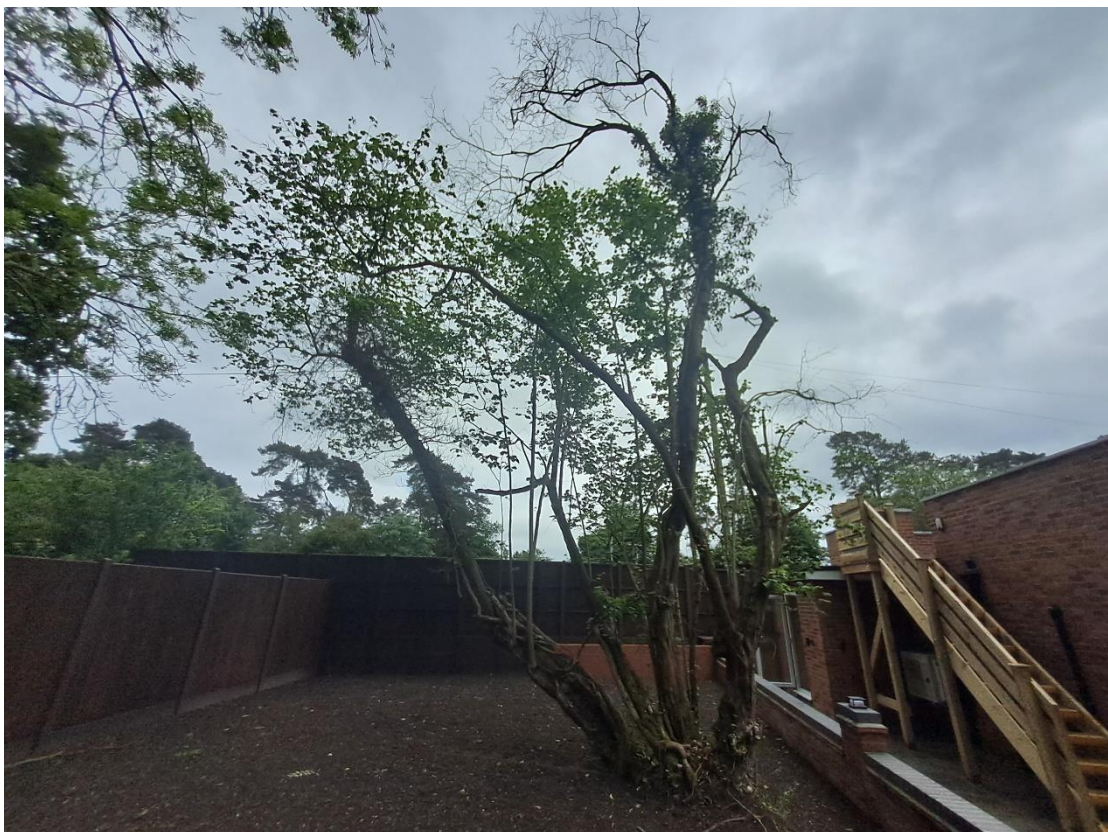
Fig. 6 – Dieback in crown of T008 (Hazel)
