## ARBORICULTURAL REPORT

### TREE CONDITION SURVEY

12 WALLACE CLOSE  
WOODLEY  
BERKSHIRE  
RG5 3HW

Ref: 07153 / 2026

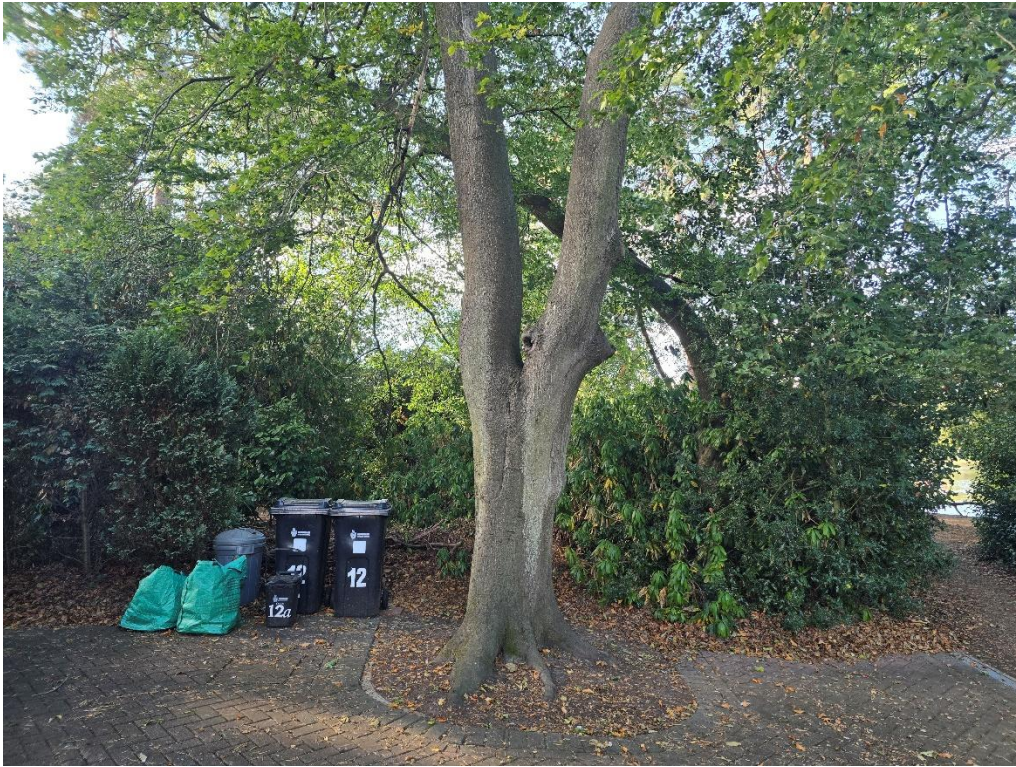
**STEM & UNIONS:** Beech bark aphids on trunk – not significant. Small wound east side 1.2m above ground level 50x25mm. Good wound wood formation. Trunk bifurcates 2m above ground level. Fork open - small area of included bark in fork – not significant.

Photo 1 – T1 (Beech), lower trunk and fork

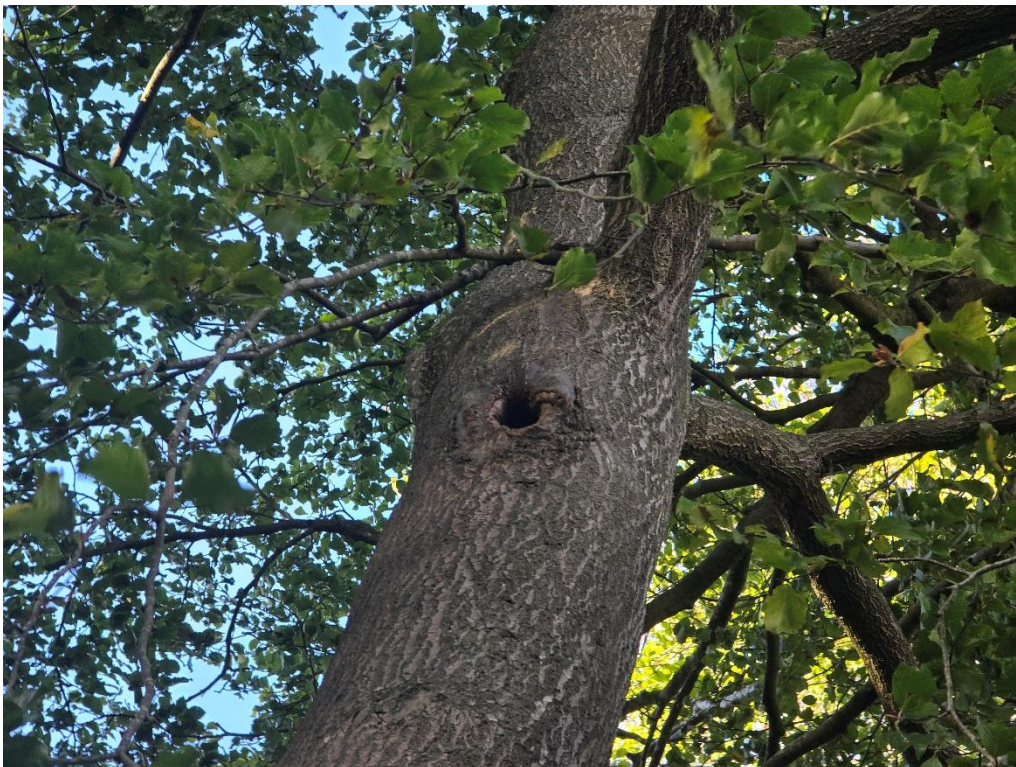
Northwest trunk has several cavities associated with previous pruning cuts:

- 1) On northeast side of stem. Small cavity – where reachable can be probed up to 100mm deep - sides firm. Good wound wood formation.
- 2) On southwest side 0.3m above fork, inaccessible. Good wound wood formation. Small cavity may be present in protruding branch stump
- 3) 3.5m above fork. Open cavity - some damage to wound wood - depth unknown

Photo 2 – T1 (Beech), cavity in old pruning cut

| <p><b>Recommended Tree Works:</b></p> <ul style="list-style-type: none"> <li>• Reduce heavily weighted branch on northeast side of crown over front of property by approximately 4m in length &amp; up to 2m lateral spread, removing/thinning out kinked regrowth from previous reduction points to reduce weight/overbearing nature of elongated branch back in line with surrounding canopy to provide a better structure for future growth.</li> <li>• Crown lift tertiary / secondary branch tips around canopy to create 4-5m crown clearance above ground level.</li> <li>• Selectively prune/reduce slender low branch on northwest side by 2-3m to create minimum 1m canopy clearance to streetlight / lamp column.</li> <li>• Remove 1x slender crossing branch in central lower crown which is resting / rubbing on the base of the elongated northwest branch</li> <li>• Inspect cavities on north/west stem when climbing tree.</li> <li>• Remove deadwood</li> </ul> <p><b>Cuts will be made back to suitable growth points in accordance with BS 3998:2010 'Tree Work Recommendations'.</b></p> <p><b>Pruning cuts will be kept small &lt;60mm diameter.</b></p> | <b>Priority</b> | Within 6 months |

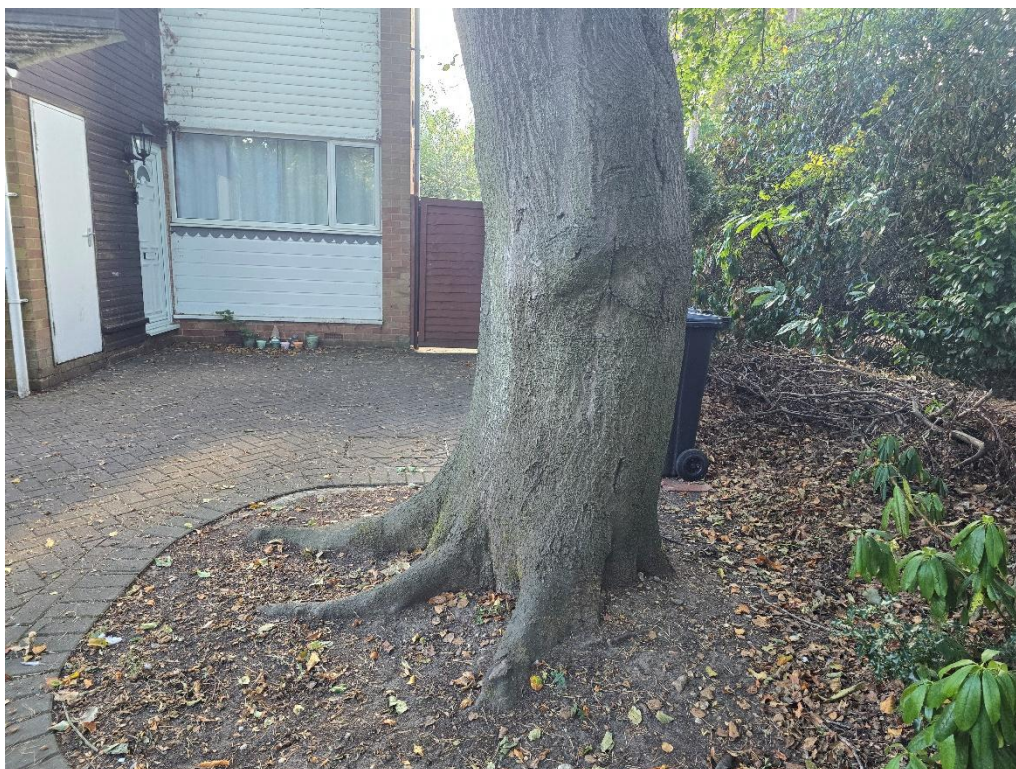
**BASE:** No major defects. Base clear, bark intact, one small superficial bark wound on slender buttress on northwest side of base. Enlarged prominent buttress on north-northwest side.

**Photo 3 – T1 (Beech), base and lower trunk**

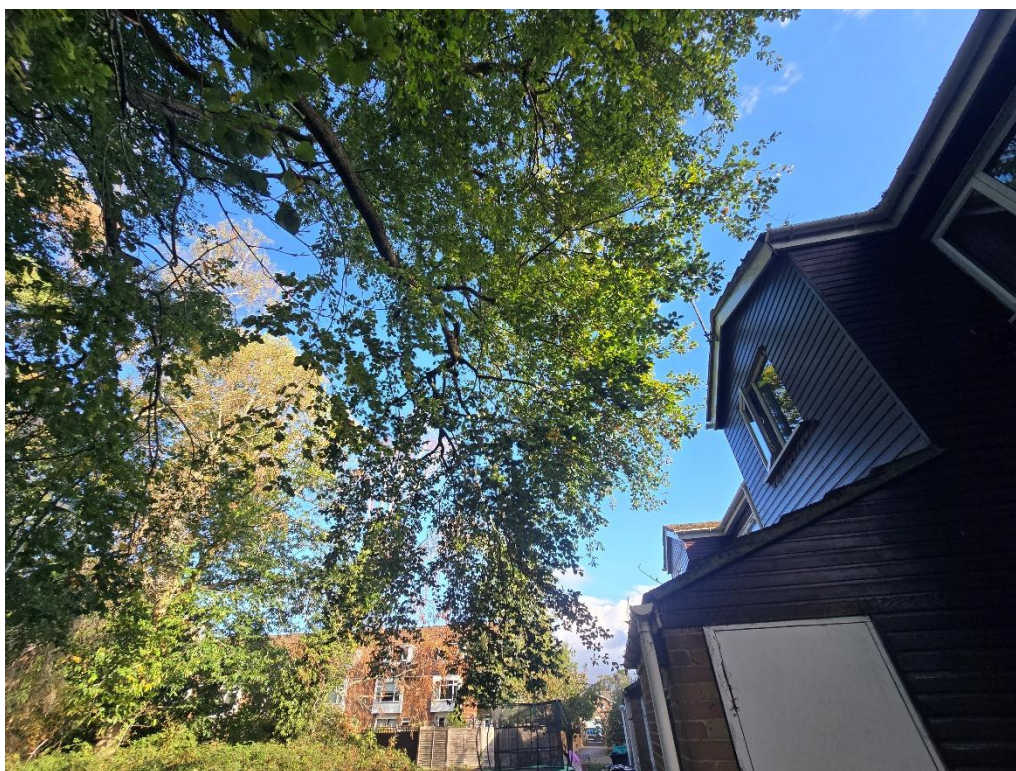
Low pendulous branch on northeast side of crown. Branch tips touching roof. Canopy excessively close and overbearing in relation to the adjacent property. Deadwood in crown over low occupancy woodland area. Low pendulous branch on northwest side touching lamp column.

**Photo 4 – T1 (Beech), broad low canopy close to residential property**

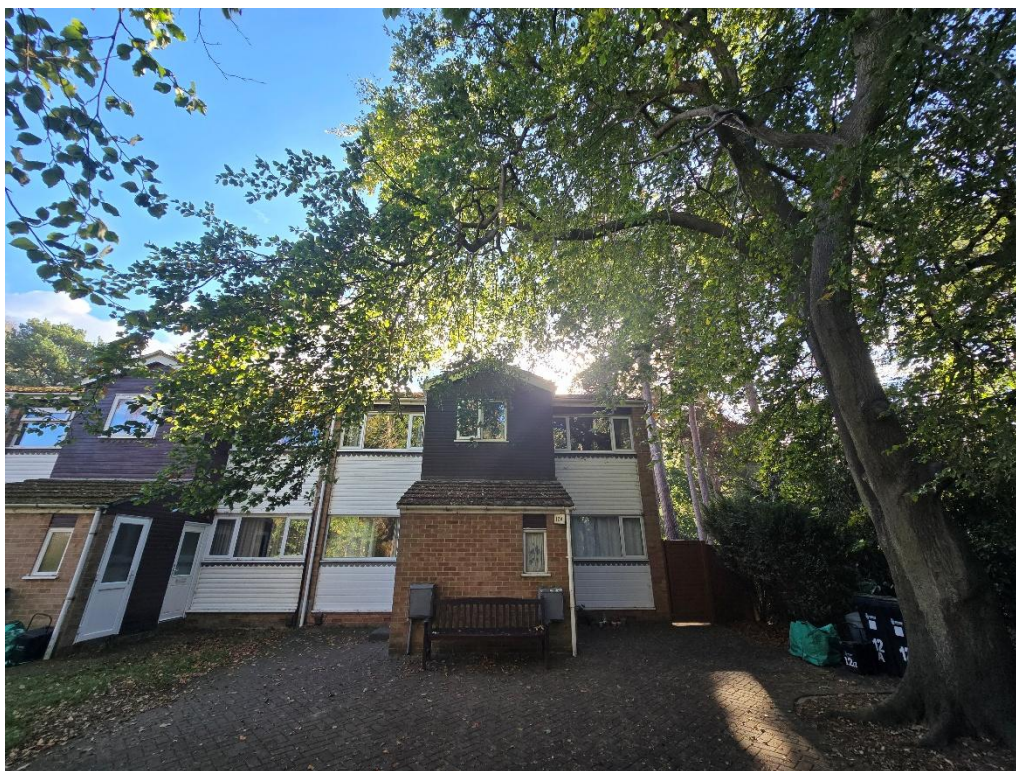
**CANOPY:** Broad crown. Foliage dense & even with good vitality. Several defects associated with northwest trunk. Historic wound and large stump remains 150mm diameter in upper crown from previous branch failure. Irregular, asymmetrical canopy previously reduced creating heavily weighted branch tips and numerous kinked 'dog-leg' branches.

**Photo 5 – T1 (Beech), elongated branches over front of dwelling**
