# ARBORICULTURAL REPORT

## TREE CONDITION SURVEY

11 CHIVE ROAD  
EARLEY  
READING  
RG6 5XP

Ref: 06852 / 2025

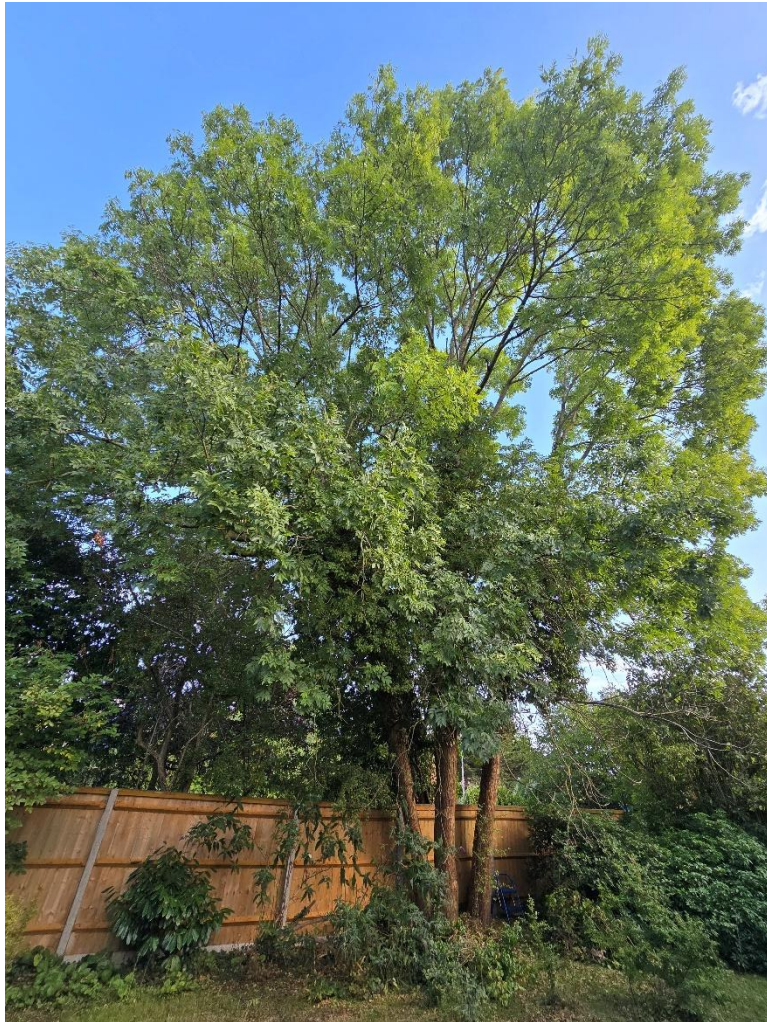
Photo 1 – G1 (Ash) as viewed from rear garden of 11 Chive Road

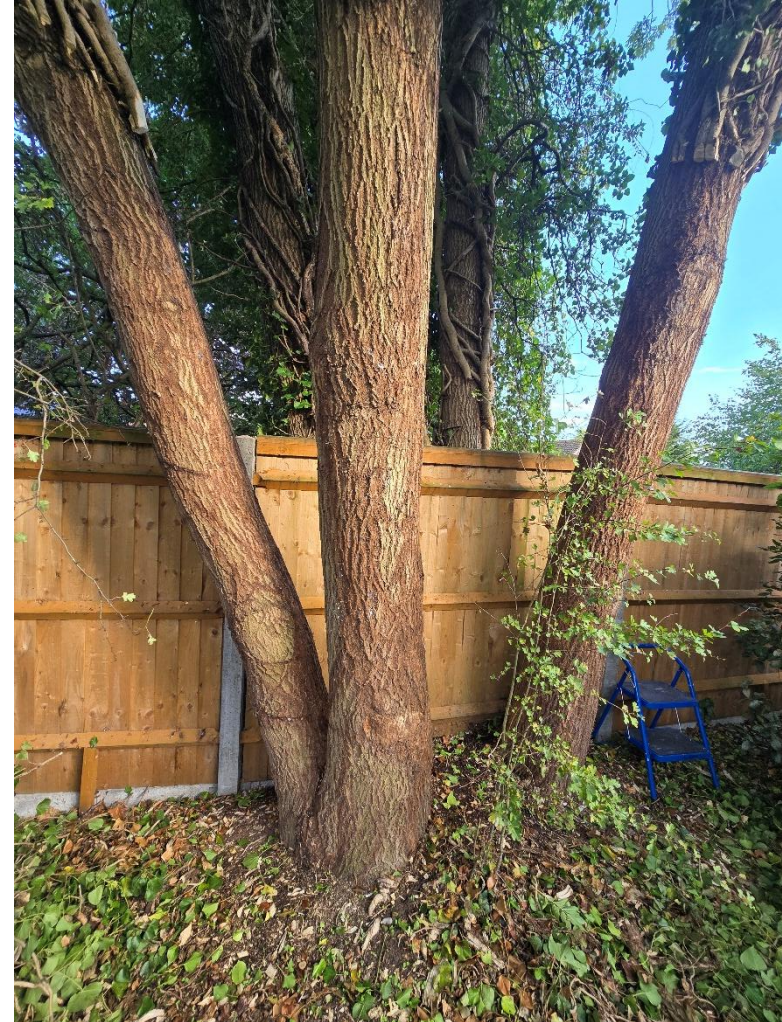
**BASE:** Rooting area of the tree(s) consists of lawn and dense vegetation within the highway verge. Mature ivy of trees within 11 Chive Road has been removed on the trunks prior to inspection. Bases clear, bark intact. No visible defects.

Photo 2 – Stems of Ash with Ivy cut within garden of 11 Chive close

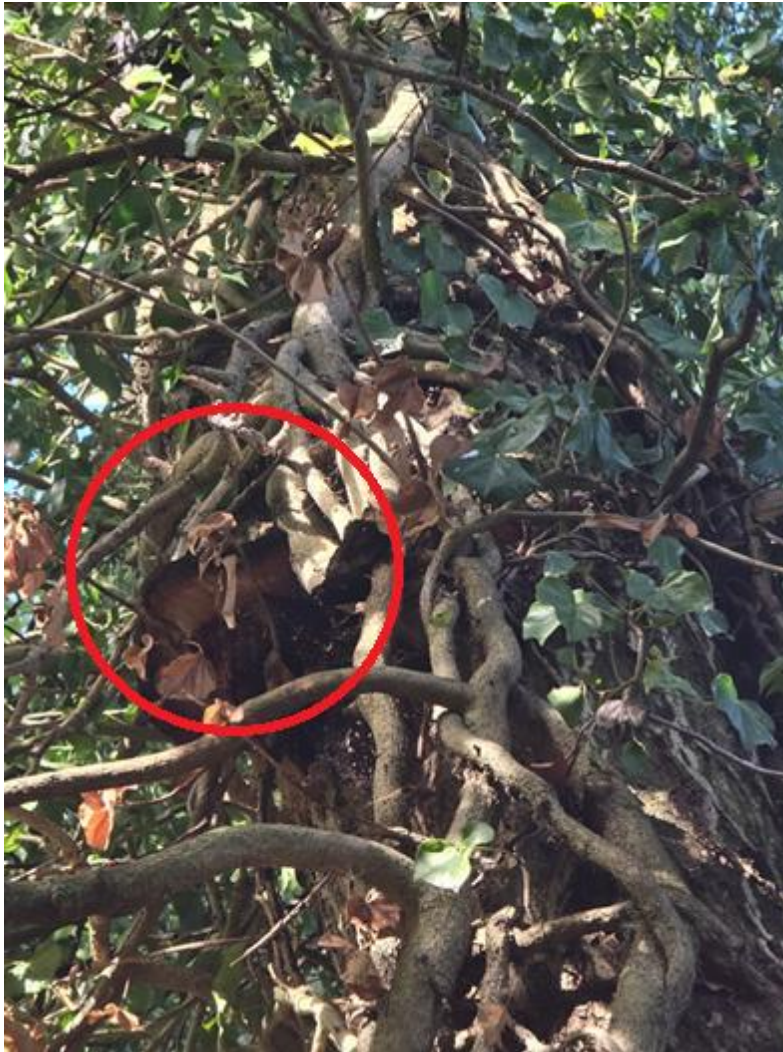
**STEM & UNIONS:** Within the garden of 11 Chive Road, the twin stem tree has fungal fruiting bodies on trunk 4.5m above ground level of the decay fungus *Inonotus hispidus*. This fungus causes a 'simultaneous white rot' on Ash trees and causes affected branches and areas of the trunk to snap. The breakage of this trunk at this point on the trunk would cause a large part of the tree crown over the garden of 11 Chive Road to fall towards the dwelling. There is no cure or treatment and the removal of the tree is appropriate to alleviate the risk to property and residents.

Photo 3 – Decay fungi – *Inonotus hispidus* on trunk

| <b>Recommended Tree Works:</b> <ul style="list-style-type: none"> <li>Fell two trees within the garden of 11 Chive Road to ground level due to presence of decay and potential instability of adjacent trees.</li> <li>Request Council to carry out appropriate works to manage the remaining trees within the group which are offsite within the highway verge.</li> </ul> | Priority | Within 2 months |

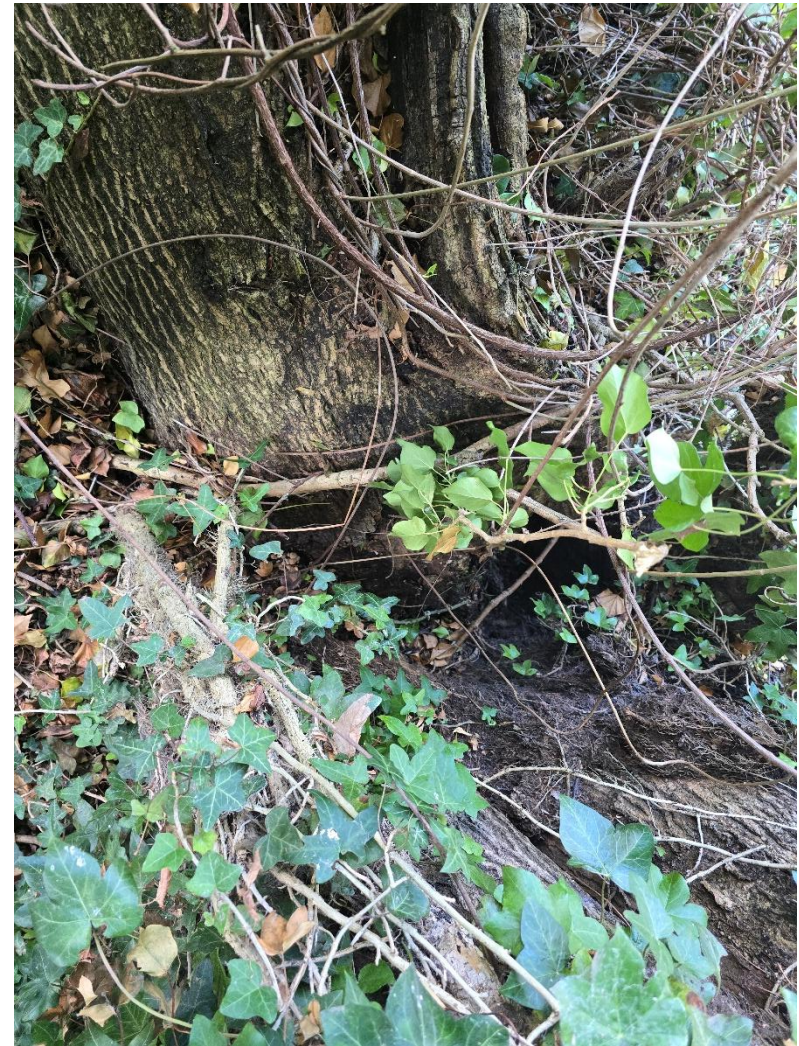
For trees offsite, tree bases and lower trunks are obscured by ivy and dense vegetation. One large stem fell out of the group approximately 18 months prior to this inspection, onto the highway verge and was cut and cleared by the Council. Dense vegetation & climbing plants may obscure defects.

Photo 4 – Point of previous stem failure – trees within highway verge

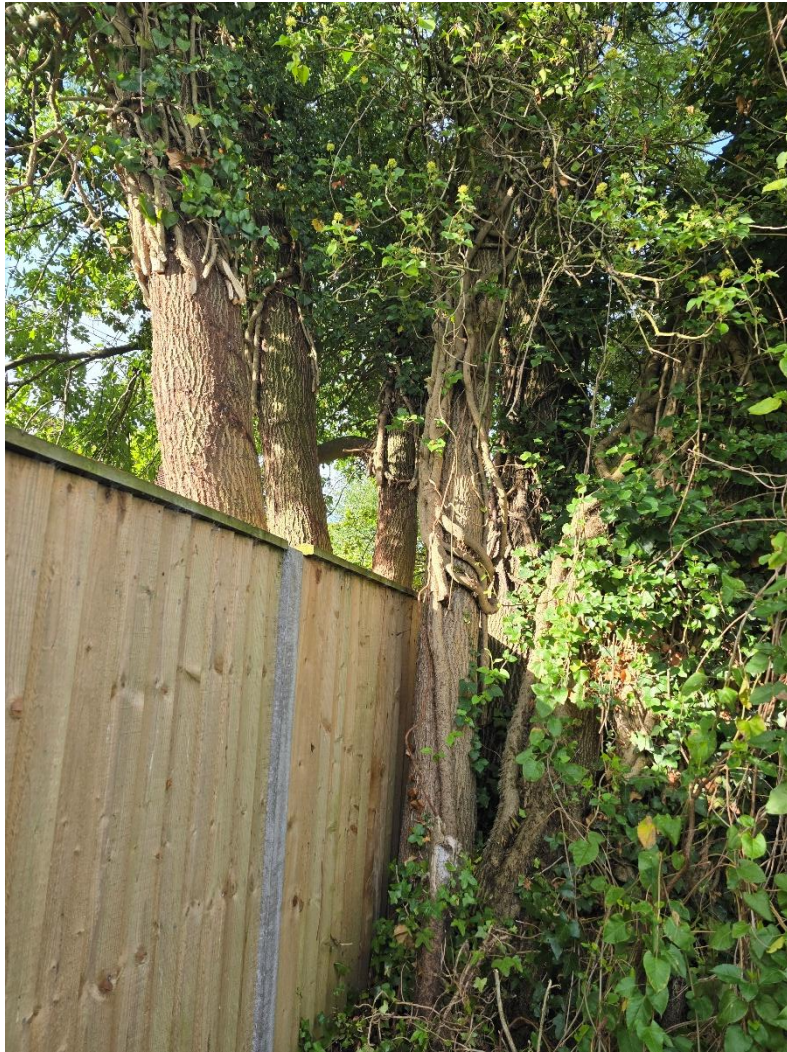
**SITUATION:** A mature tree group formed of approximately 6 individual Ash trees growing close together to form a single canopy unit. The trunks straddle the rear (northern) boundary of 11 Chive Road. The tree group is 9.5m from rear elevation of dwelling. This survey primarily relates to two trees within the curtilage of 11 Chive Road one of which is a twin stem from ground level – however due to their proximity, it is appropriate that the management of all the trees in the group be considered collectively as the individual trees in the group will be providing each other mutual support, shelter and stability.

Photo 5 – Stems of individual trees within G1 (Ash) straddle boundary

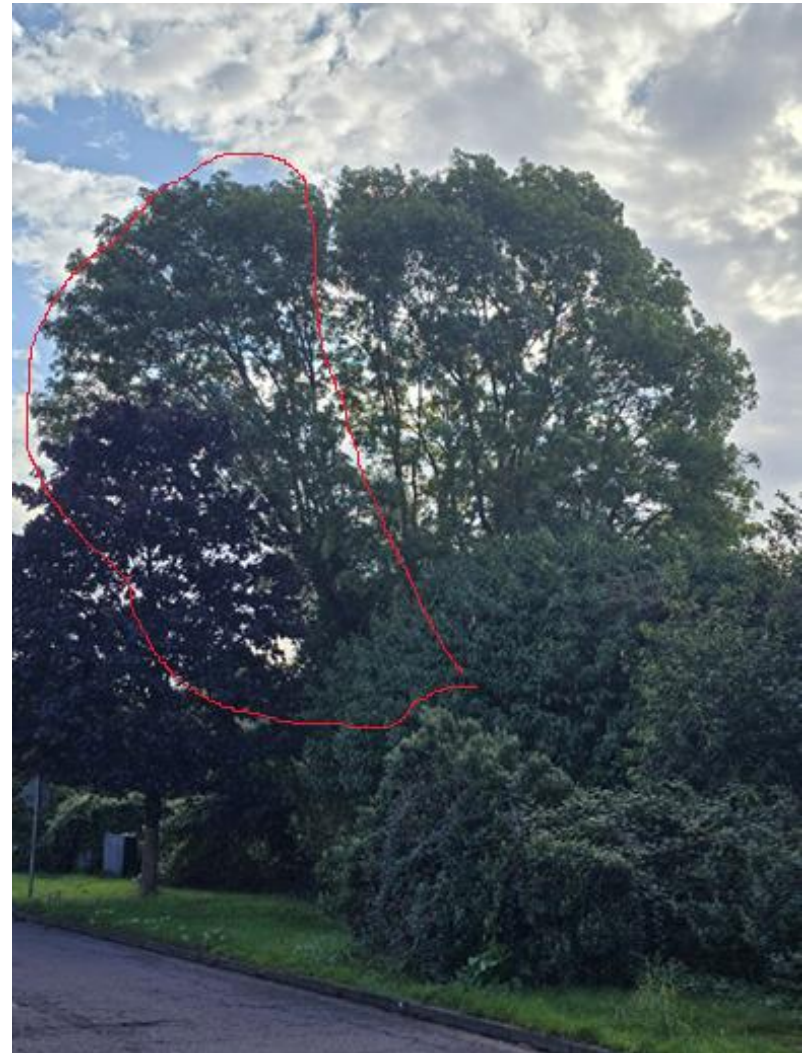
**CANOPY:** The individual trunk undermined by decay has a high, very asymmetrical crown towards dwelling. Smaller single stem grows east over the neighbouring property. All stems growing offsite have leaning asymmetrical crowns over the verge and towards Rushey Way. Foliage dense and even with good vitality. No symptoms of Ash Dieback Disease.

Photo 6 – Trees in verge lean towards the public highway at Rushey Way (note gap forming between two halves of the crown).

The Council is advised that essential works to the trees at 11 Chive Road will impact on the stability of offsite trees on the highway verge, and that a reduction of these trees is likely to be required. The management of these trees and responsibility for the health and safety of the offsite tree group rests with Wokingham Borough Council as the Highway Authority.
