Client: Georgina Kelly  
Site Address: 15 Dark Lane, Wargrave, RG10 8JU  
Date: 28/01/2026

## TREE REPORT

## To1

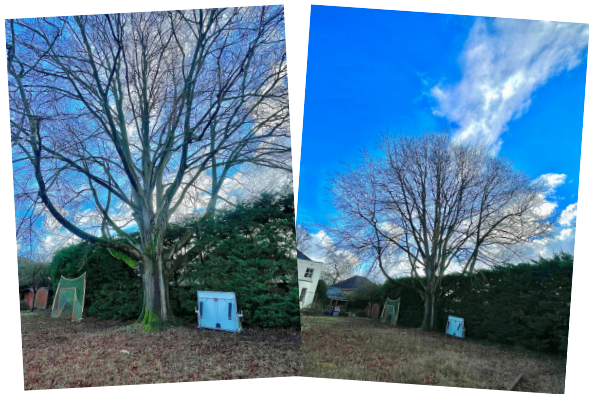
This mature Copper Beech stands in the rear garden of no. 15 Dark Lane, halfway down the south side of the garden approximately 2 metres from the boundary fence (A,B). The tree is approximately 25 metres tall, with a crown spread of 23 metres East - West. North to South measurements of the crown were not possible but are approximately 23 metres. The circumference of the trunk is 3.70 metres at 1.5 metre.

To1 from garden N/W. (A)

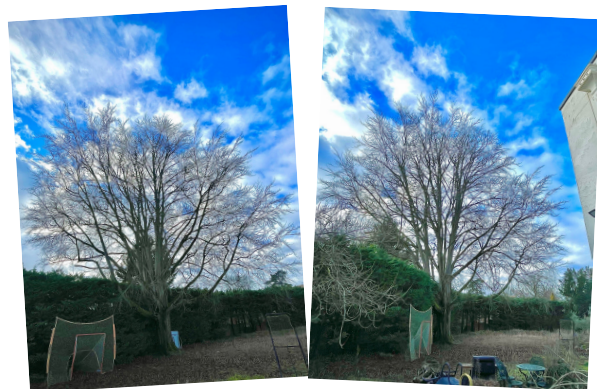
To1 from garden N/E. (B)

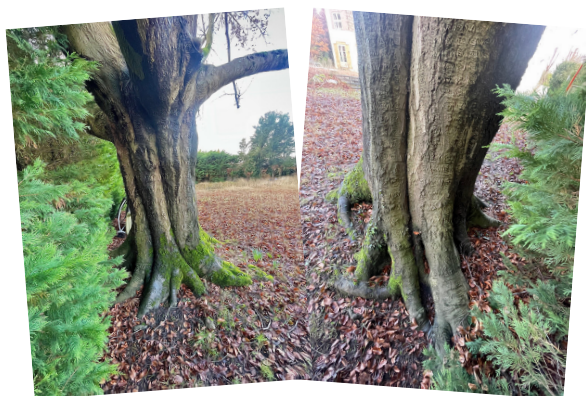
The root system showed no visible abnormalities at ground level. There were no signs of ground heave, soil cracking, or lifting around the base of the tree. A sounding hammer was used to assess the lower stem, buttresses, and root flare, and no indications of internal decay or hollowing were detected (C,D). No fungal fruiting bodies were present around the base of the tree or within the surrounding area at the time of inspection.

To1 Trunk and Buttresses (C)

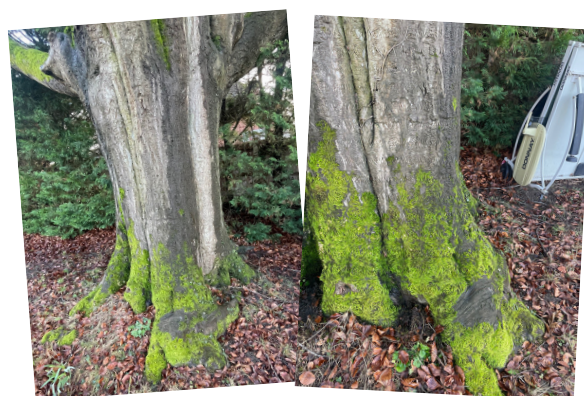
To1 Trunk and Buttresses (D)

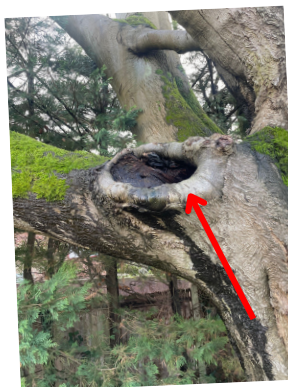
The main stem up to approximately 2.5 metres appeared normal and free from defects. At approximately 2.5 metres, the first major scaffold limbs branch from the main trunk (F). On the primary limb extending to the East, there is a large historic pruning wound located on the north side of the branch, approximately 0.5 metres from the main stem (E). This wound has developed into a cavity, it is unclear how deep this cavity extends down the limb. Occlusion is occurring; however, it is unlikely that the wound will fully occlude. Despite this, the limb union itself appears stable at present. All other major limb unions at this level were observed to be normal and in good condition (F).

To1 Cavity lowest eastern limb (E)

I would also recommend reducing the lowest eastward limb to lessen mechanical loading on the union where the cavity is present.

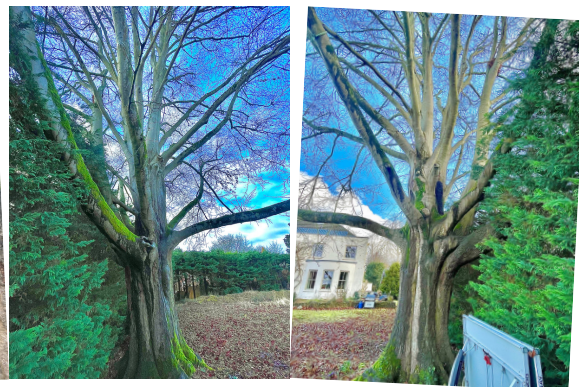
To1 Trunk and lower Scaffold limbs (F)

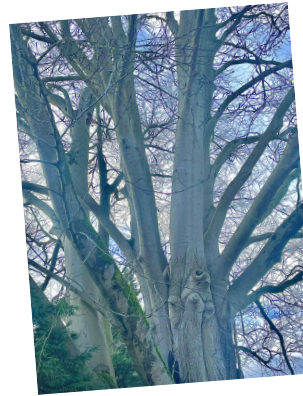
Further up the crown, there are several historic pruning wounds, most of which are successfully occluding (G). One pruning wound has not fully occluded but does not currently present obvious signs of associated decay (H). At approximately 6 metres above ground level, the tree transitions into a multi-stemmed structure (G).

To1 multi-stemmed trunk (G)

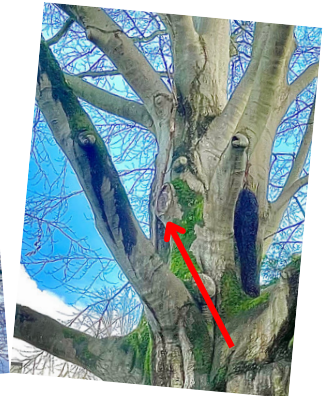
Historic wound (H)

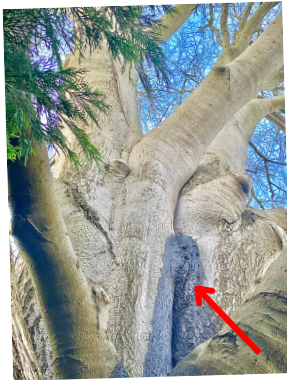
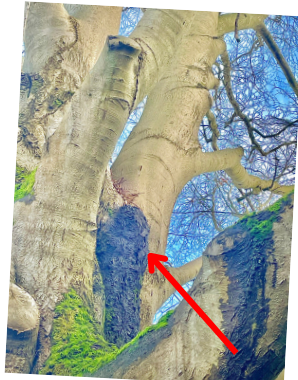
N-E elephant ear (I)

S-W elephant ear (J)

At the union between the south-eastern lead stem and the other stems, there is evidence of an “elephant ear” formation (I,J). This area appeared darker in colour, likely due to moisture retention, which may be indicative of underlying internal decay; however, this cannot be confirmed from ground-level inspection alone. The elephant ear formation on the south-west side (J) is notably larger than that on the opposing side. The remaining lead stems appeared normal, with no visible signs of decay or structural weakness.

It is recommended that attention is given to the lead stem unions where the elephant ear formation is present by selectively thinning and slightly reducing the stem by 1-2 metres. This would help to reduce sail effect, improve airflow through the canopy, and lessen mechanical loading on the potentially weakened union.

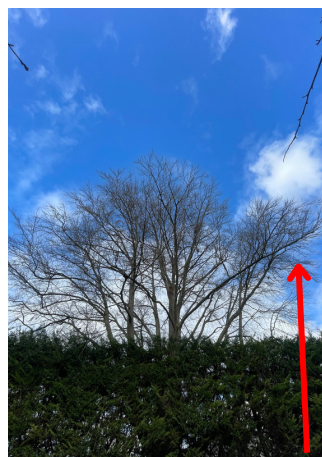
From a visual perspective, there is a slight asymmetry to the crown, particularly with several major limbs extending toward the dwelling and towards the swimming pool area (L). These limbs could be reduced to better balance the crown in line with the upper canopy. A similar condition exists on the south-eastern side of the tree, where limbs extend over adjacent conifer trees (K).

To1 Crown South side (K)

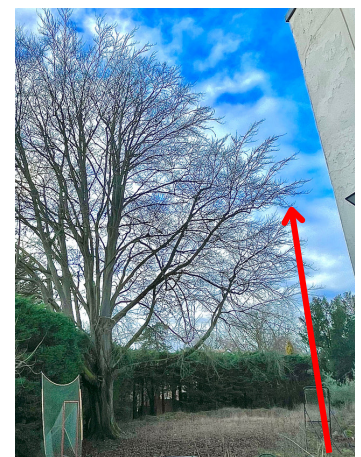
To1 Crown East side (L)
