# ARBORICULTURAL REPORT

## TREE CONDITION SURVEY

20 KERRIS WAY  
EARLEY  
READING  
BERKSHIRE  
RG6 5UW

DECEMBER 2025  
Ref: 06871 / 2025

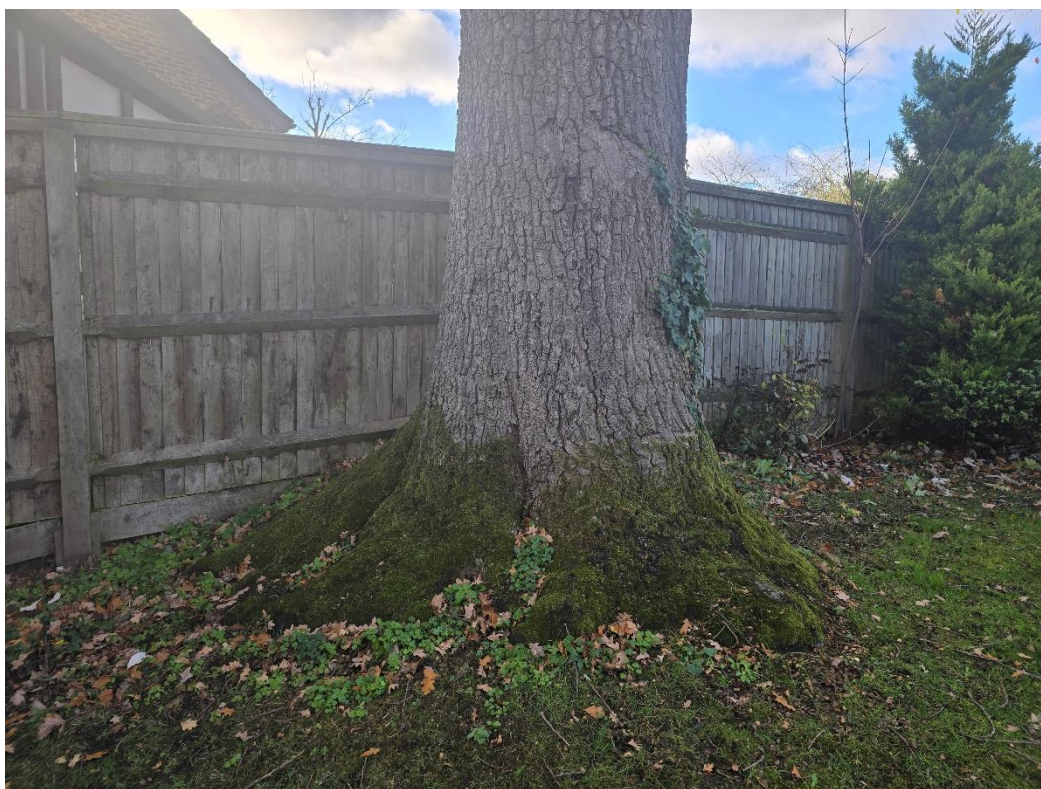
Photo 2 – Tree base

**BASE:** Light Ivy growth on south side of tree. The base of the tree has a very broad, pronounced buttress skirt around the trunk up 0.9m wide on the southern side of the tree. Mossy bole. No fungal fruiting bodies visible around tree base.

Slight audible hollowing / changes in sound intonation under the buttress flare, more noticeably on the south side of the trunk which is likely to be more evident due to the thinness of the flared root. Elsewhere around the base and lower trunk - sound intonation even and satisfactory.

Historic wounding and small cavity between roots on southwest and southeast sides of trunk. Good wound wood formation – small cavities cannot be probed to any great depth.

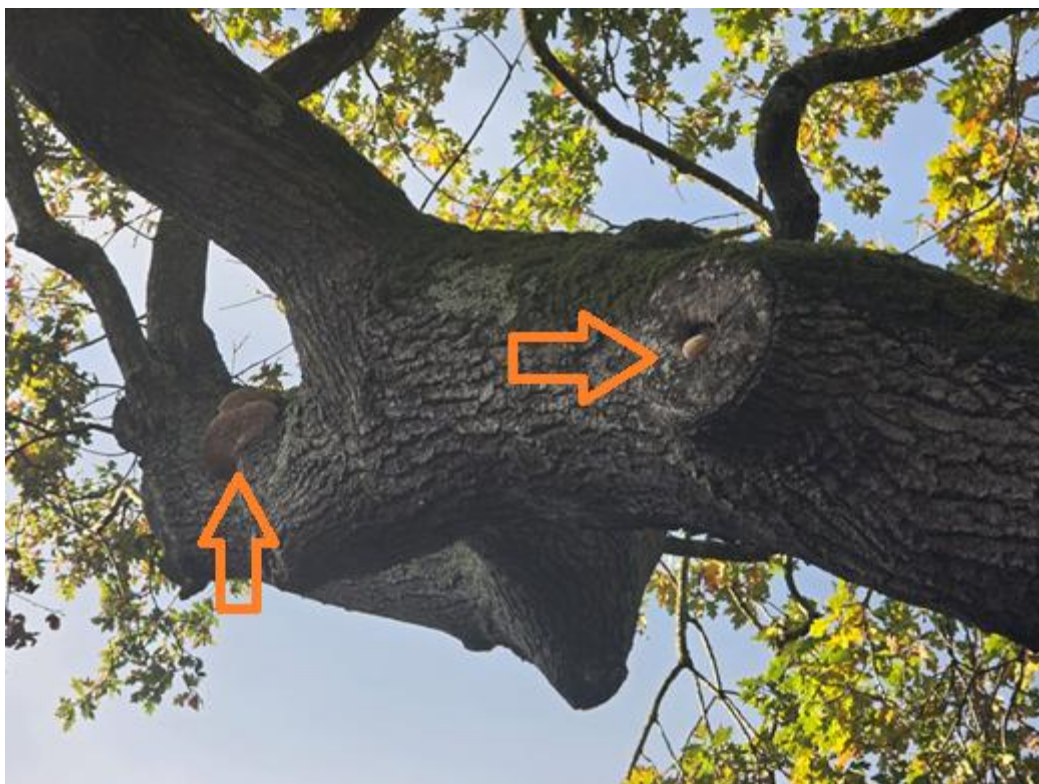
T1 (Oak) has been identified as having Oak Maze Gill Fungus colonising a low, lateral branch on the west side of the crown. This fungus is weakly pathogenic degrading wood which is already dead / dysfunctional.

Large side limb grows more or less horizontally over neighbouring garden and outbuilding. Fungal fruiting bodies of the Oak Mazegill fungus emerging from cuts along branch 1.5m and 2m from trunk (see photo 3).

Photo 3 – Decay fungi emerging from cavities on site limb towards neighbouring property

- 1) Remove deadwood over 1m long and 50mm diameter. Reduce one large dead branch on the south side of the crown back to live spur at source.
- 2) Reduce tips of low branch on west side of tree growing over neighbouring garden by 2.5m to reduce exposure and wind loading on decaying branch.
- 3) Reduce elongated branches on south side of crown towards highway by 2-3m to reduce weight & exposure, back in line with surrounding canopy.
- 4) Reduce low branch east side of canopy by 1-1.5m to create reasonable clearance to property.
- 6) Reduce elongated limb on the north side of the crown by 2m, back in line with surrounding canopy.
- 7) Consider soil amelioration. Avoid using Lawn Weed & Feed within 5m of tree base.

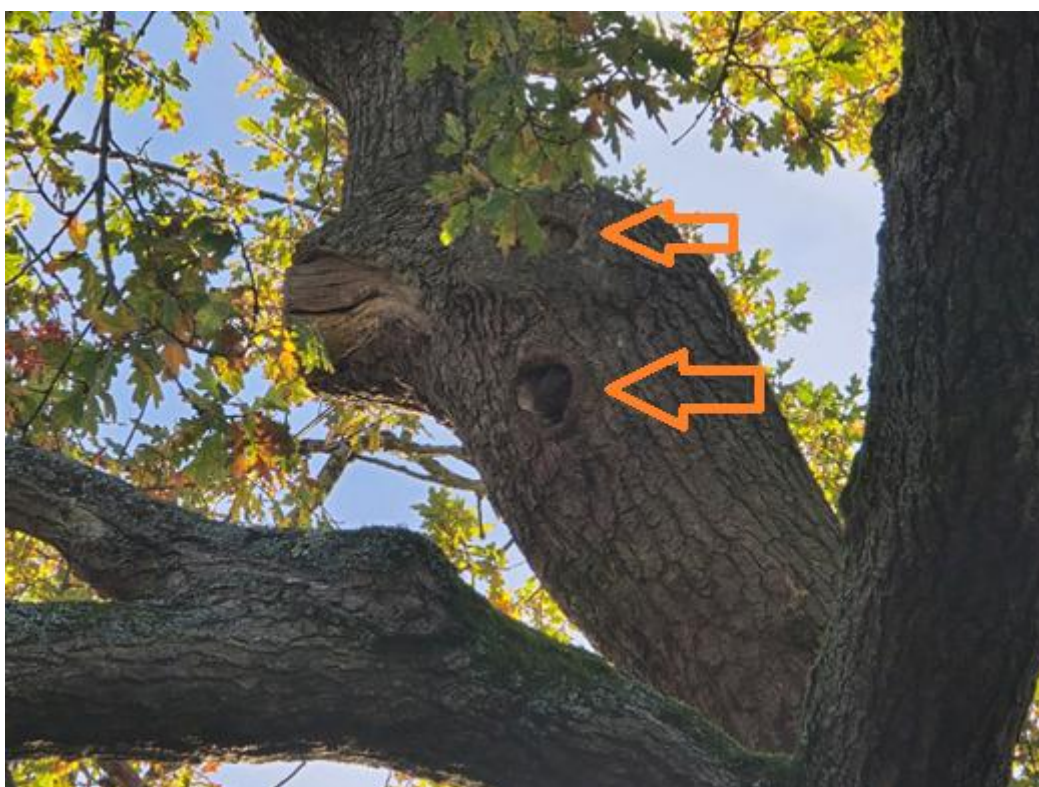
Dead branch on southeast side of crown extensively decayed. Habitat holes in dead stump at top of trunk (see photo 4).

Photo 4 – Habitat holes in trunk (central canopy)

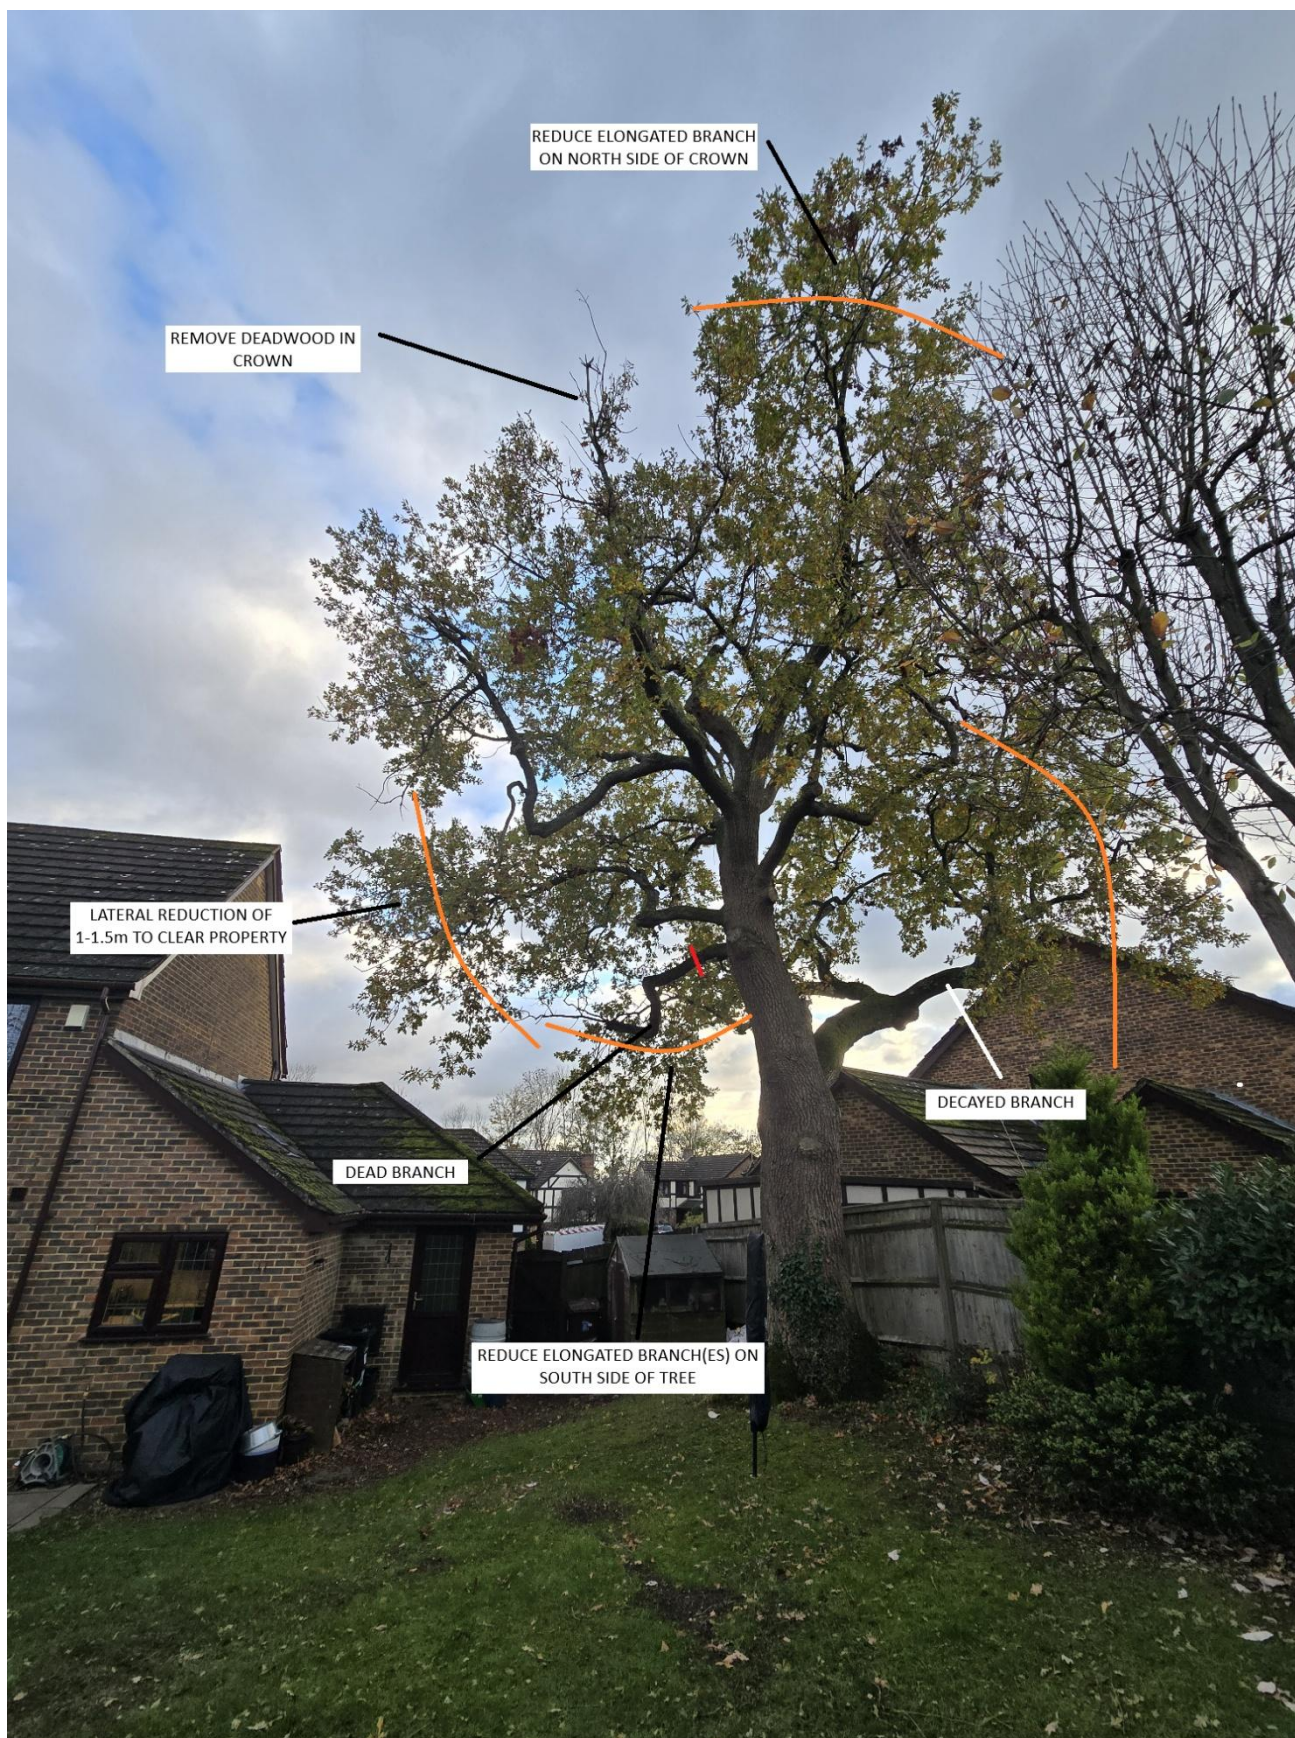
Photo 5 – Annotated photo of tree works
