# ARBORICULTURAL REPORT

## TREE CONDITION SURVEY

1 STARMEAD DRIVE  
WOKINGHAM  
BERKSHIRE  
RG40 2HX

Ref: 06507/2024

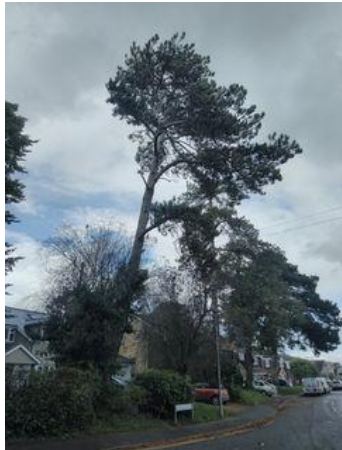
| Ref: | Species | Measurements | Survey Notes | Condition | Recommendations | Photo |
|---|---|---|---|---|---|---|
| T001 | Corsican pine<br>( <i>Pinus nigra</i><br><i>laricio</i> ) | Height (m): 18<br>Crown Radius (m): 3.5<br>DBH (cm): 61<br>Life Stage: Mature<br>Life Exp.: 40+ Years | <p>Tree growing within raised lawn area. Ground level, no sign of root plate movement or instability. Mycorrhizal fungi in lawn area around base.</p> <p>Base clear, bark intact. Hammer test satisfactory, no audible decay.</p> <p>Swept stem to southeast over Starmead Drive. Additional growth on tension side of trunk. Pronounced buttress roots on northeast, and southeast side of trunk. Remaining trunk has a smooth, gradual root flare.</p> <p>Single stem, excurrent form. Stem leans all the way to upper canopy. Asymmetrical crown with elongated branches over the public highway of Starmead Drive. Two dead branch stubs on trunk over low occupancy area.</p> <p>Needles dense, slightly browning. Reasonable vitality.</p> | Fair | <p>No tree works required.</p> <p>Monitor for fungal fruiting bodies - Ongoing</p> | |

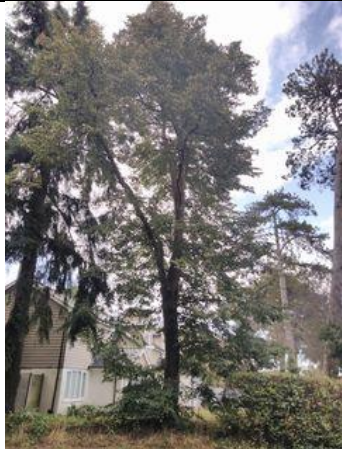
| Ref: | Species | Measurements | Survey Notes | Condition | Recommendations | Photo |
|---|---|---|---|---|---|---|
| T002 | Lime<br>( <i>Tilia</i> sp.) | Height (m): 16<br>Crown Radius (m): 4<br>DBH (cm): 54<br>Life Stage: Mature<br>Life Exp.: 40+ Years | <p>Prominent tree on grass bank, 1.5m from public highway.</p> <p>Base and lower trunk partially obscured by epicormic shoots.</p> <p>Historic damage to exposed surface roots. (Insignificant) girdling root. Slightly swept lower trunk to northeast.</p> <p>Where accessible hammer intonation even and satisfactory. No fungal fruiting bodies evident. Single stem.</p> <p>Cavity at 4m on southeast side of trunk, 4m above ground level.</p> <p>Low pendulous crown. Foliage dense and even. Good vitality.</p> <p>Low branches to ground level over grass verge.</p> <p>Wildlife Value: Good</p> <p>Inspection Limitations: Epicormic shoots.</p> | Good | <p>Crown lift to create 2.5m canopy clearance above ground level for mower access and 3m over pavement.</p> <p><b>Timescale:</b><br/>07-Apr-2025<br/>(6 Months)</p> | |

| Ref: | Species | What 3 Words | Recommendations | Work Timescale |
|---|---|---|---|---|
| T002 | Lime<br>( <i>Tilia sp.</i> ) | ///goat.music.these | Crown lift to create 2.5m canopy clearance above ground level for mower access and 3m over pavement. | 07-Apr-2025<br>(6 Months) |

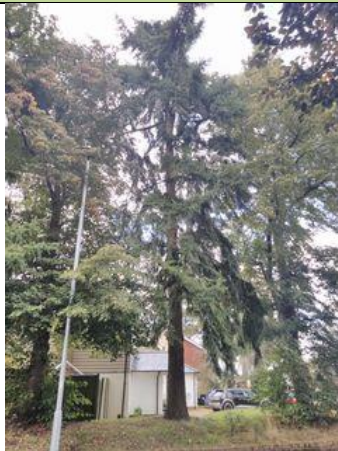
| Ref: | Species | Measurements | Survey Notes | Condition | Recommendations | Photo |
|---|---|---|---|---|---|---|
| T003 | Douglas fir<br>( <i>Pseudotsuga menziesii</i> ) | Height (m): 18<br>Crown Radius (m): 4.5<br>DBH (cm): 60<br>Life Stage: Mature<br>Life Exp.: 40+ Years | Slender tree on raised lawn area 2.1m from public highway. Base clear, bark intact. Mycorrhizal fungi within rooting area. No decay fungi observed. Sound intonation even and consistent around base and lower trunk but sounds tinny. This can indicate basal decay – however, usually the sound intonation would be irregular and localised in certain areas. That the sound around the base is consistent suggests it may not be caused by decay but could also be as a result of faster growth (therefore less dense wood) or thicker bark. T003 has a broader trunk than T005 although they are likely to be of a similar age. Smooth even root flare very slightly bulbous on West side at base. Single stem. Kinked trunk in very upper crown. Needle density good. Good vitality. Wildlife Value: Good | Good | Monitor for fungal fruiting bodies - Ongoing<br><br>Crown lift to create 3m canopy clearance over pavement<br><br><b>Timescale:</b><br>07-Apr-2025<br>(6 Months) | |

| Ref: | Species | What 3 Words | Recommendations | Work Timescale |
|---|---|---|---|---|
| T003 | Douglas fir<br>( <i>Pseudotsuga menziesii</i> ) | ///chill.cheat.helps | Crown lift to create 3m canopy clearance over pavement | 07-Apr-2025<br>(6 Months) |

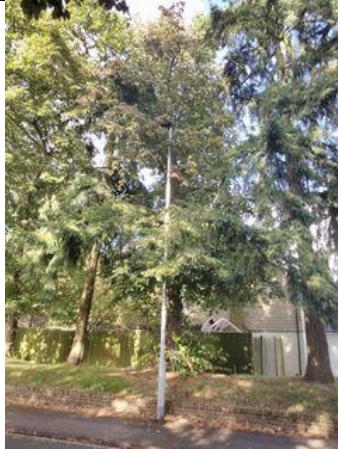
| Ref: | Species | Measurements | Survey Notes | Condition | Recommendations | Photo |
|---|---|---|---|---|---|---|
| T004 | Lime<br>( <i>Tilia</i> sp.) | Height (m): 14<br>Crown Radius (m): 4.5<br>DBH (cm): 56<br>Life Stage: Mature<br>Life Exp.: 20+ Years | Prominent tree on grass bank, 2m from public highway and lamp column. Base and lower trunk partially obscured by dense epicormic shoots.<br>Historic damage to exposed surface roots. Where accessible hammer intonation even and satisfactory. No fungal fruiting bodies evident.<br>Single stem. Short stub cuts and wounds on trunk where branches removed. Foliage dense and even. Good vitality.<br>Low branches to 1m over grass verge and obscuring lamp column.<br>Wildlife Value: Good<br>Inspection Limitations: Epicormic growth | Fair | Crown lift to 2.5m over verge and remove epicormic shoots at base. Selective prune back side branches to create 1m clearance to streetlight and column.<br><br><b>Timescale:</b><br>07-Apr-2025<br>(6 Months) | |

| Ref: | Species | What 3 Words | Recommendations | Work Timescale |
|---|---|---|---|---|
| T004 | Lime<br>( <i>Tilia sp.</i> ) | ///income.behind.hidden | Crown lift to 2.5m over verge and remove epicormic shoots at base.<br>Selective prune back side branches to create 1m clearance to streetlight and column. | 07-Apr-2025<br>(6 Months) |

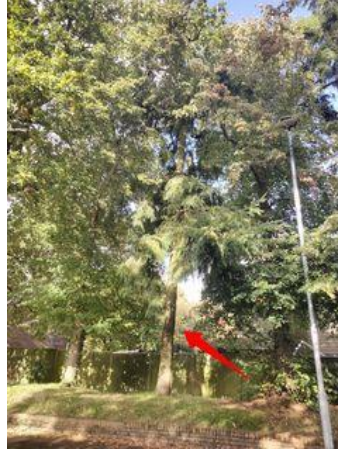
| Ref: | Species | Measurements | Survey Notes | Condition | Recommendations | Photo |
|---|---|---|---|---|---|---|
| T005 | Douglas fir<br>( <i>Pseudotsuga menziesii</i> ) | Height (m): 14<br>Crown Radius (m): 6<br>DBH (cm): 46<br>Life Stage: Mature<br>Life Exp.: 40+ Years | Slender tree on raised lawn area 2m from public highway. Base clear, bark intact.<br>No fungal fruiting bodies evident.<br>Hammer test satisfactory, no audible decay. Smooth even root flare.<br>Single stem. Suppressed crown with elongated branches over garden of 1 Starmead Drive. Needle density for. Good health and vitality.<br><br>Wildlife Value: Moderate | Fair | No works required. | |

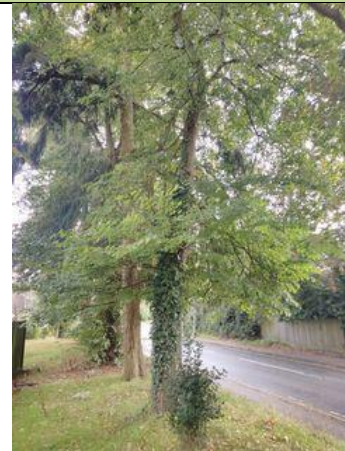
| Ref: | Species | Measurements | Survey Notes | Condition | Recommendations | Photo |
|---|---|---|---|---|---|---|
| T006 | Lime<br>(Tilia sp.) | Height (m): 13<br>Crown Radius (m): 3.5<br>DBH (cm): 40<br>Life Stage: Mature<br>Life Exp.: 40+ Years | <p>On raised lawn area, 2.3m from public highway. Light ivy growth on trunk. Where accessible base clear, bark intact. Girdling root. Short epicormic shoots at base.</p> <p>No fungal fruiting bodies evident.</p> <p>Hammer test satisfactory, no audible decay.</p> <p>Single stem straight to 2m above which the stem kinks. Pendulous crown suppressed by adjacent trees. Collage density normal. Low pendulous crown to 1.5m.</p> <p>Wildlife Value: Good<br/>Inspection Limitations: Ivy</p> | Good | <p>Sever ivy. Crown lift to create 2.5m canopy clearance for grass cutting.</p> <p><b>Timescale:</b><br/>07-Oct-2025<br/>(1 Year)</p> | |

| Ref: | Species | What 3 Words | Recommendations | Work Timescale |
|---|---|---|---|---|
| T006 | Lime<br>( <i>Tilia sp.</i> ) | ///zebra.hedge.snows | Sever ivy. Crown lift to create 2.5m canopy clearance for grass cutting. | 07-Oct-2025<br>(1 Year) |

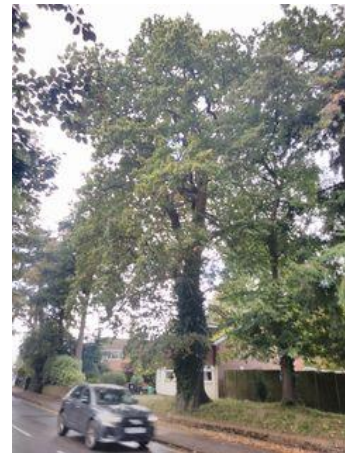
| Ref: | Species | Measurements | Survey Notes | Condition | Recommendations | Photo |
|---|---|---|---|---|---|---|
| T007 | Pedunculate oak<br>(Quercus robur) | Height (m): 18<br>Crown Radius (m): 6<br>DBH (cm): 114<br>Life Stage: Mature<br>Life Exp.: 40+ Years | <p>Large bankside oak. Directly adjacent to brick retaining wall and the public highway.</p> <p>Light ivy growth around base and on trunk.</p> <p>Pronounced buttress roots on retaining wall side. Small indent between roots where metal probe can be pushed 100mm between roots with some resistance. Small cavity 300mm deep – it is not clear whether this is a cavity into the trunk or a gap between roots.</p> <p>No fungal fruiting bodies evident. Hammer test satisfactory, no audible decay.</p> <p>Epicormic shoots on trunk. Trunk obscured by ivy. Large printing cuts at 6m where side branches have been removed. Flush cuts. Partial wound wood formation.</p> <p>Broad canopy. Foliage density normal. Minor deadwood - not significant in canopy. Low branches to 2m above ground level.</p> <p>Wildlife Value: High<br/>Inspection Limitations: Ivy</p> | Good | <p>Crown lift to 3.5m above ground level, removing short epicormic shoots directly off trunk and shortening pendulous side branches over neighbouring driveway for access.</p> <p>Sever ivy</p> <p><b>Timescale:</b><br/>07-Apr-2025<br/>(6 Months)</p> | |

| Ref: | Species | What 3 Words | Recommendations | Work Timescale |
|---|---|---|---|---|
| T007 | Pedunculate oak<br>( <i>Quercus robur</i> ) | ///mixed.tries.shift | Crown lift to 3.5m above ground level, removing short epicormic shoots directly off trunk and shortening pendulous side branches over neighbouring driveway for access.<br>Sever ivy | 07-Apr-2025<br>(6 Months) |
