# Subsidence Tree Report

## For William Hunt Consulting

**Property:** South Lodge, Wellington Court, Spencers Wood, RG7 1BN

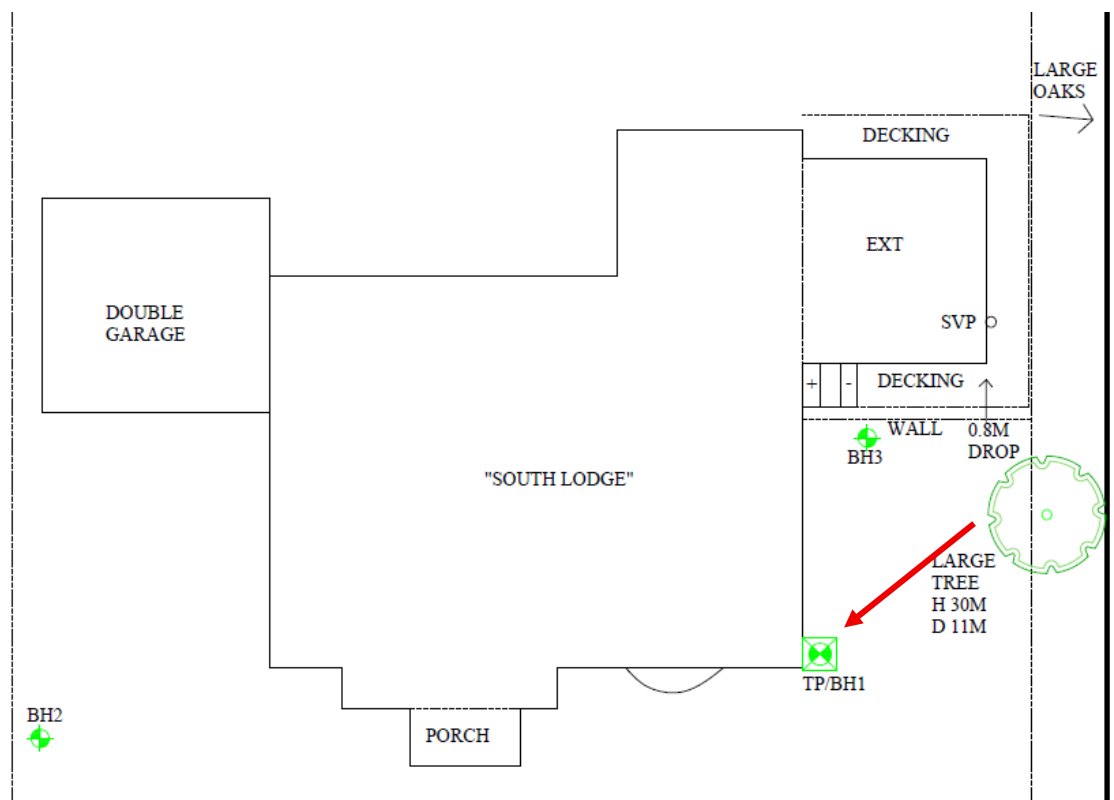
**Fig 2 – Site investigation location plan showing locations of TP/BH1 and remote boreholes BH2 and BH3.**

- 5.7 TP1/BH1 was extended to a depth of 5m but a noted collapse occurred at 3.4m. Roots were noted to 3m.
- 5.8 Soils samples were recovered and tested in the laboratory and shown to be of intermediate to high plasticity (BS5930). Driscolls formula details that a soil can be described as desiccated where the moisture content is <40% of the liquid limit. The results relative to these figures are tabulated as follows:

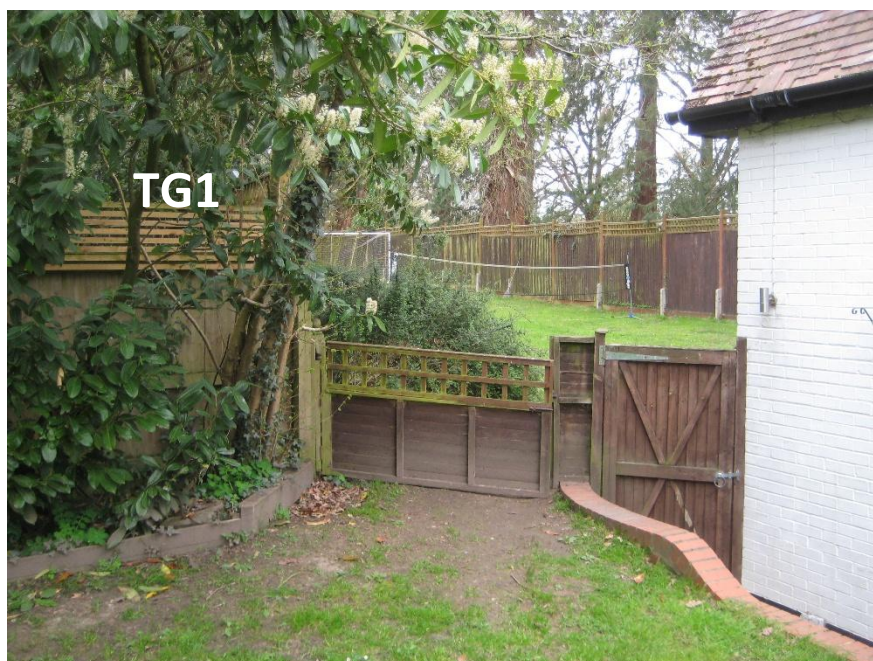
- 5.13 The localised area of TG1 close to the barrier installation is small Hazel and Laurel (as the noted Yew are on the southern boundary). These trees are not the subject of the TPO and at such small sizes we would not envisage issues associated with the proposal. If required some localised removal of vegetation (of TG1 only) proximate to the barrier installation can be completed.

**Fig 3 – TG1 relative to the rear corner of the property. This vegetation is both small and not the subject of the TPO.**

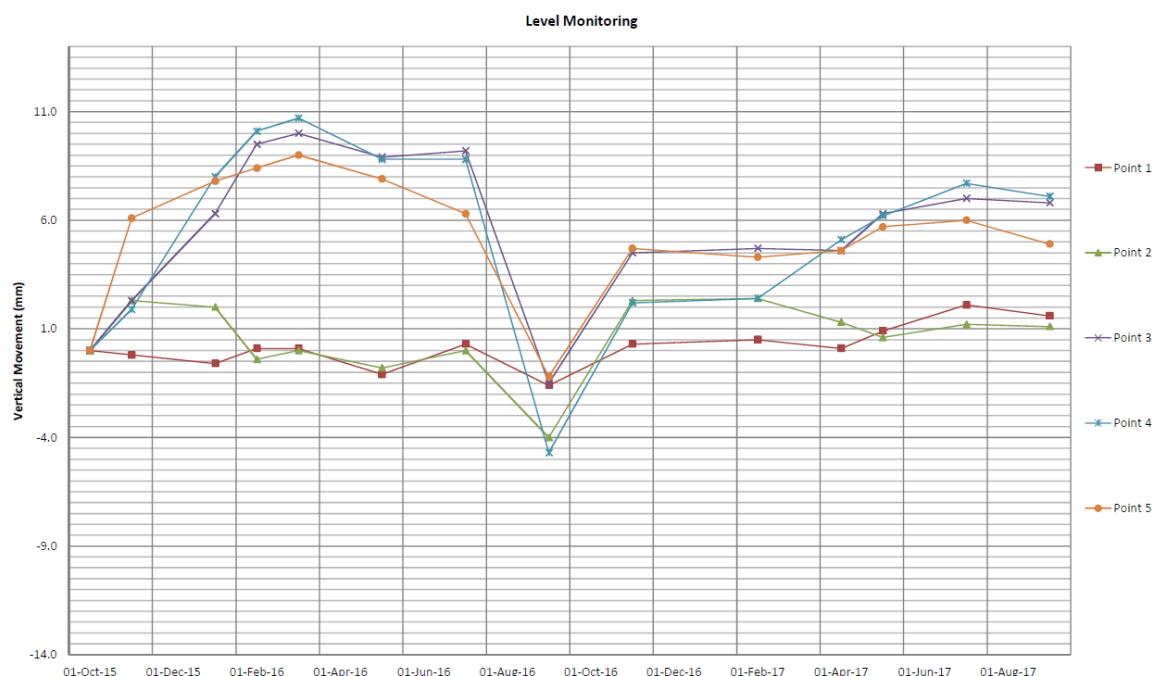
- 5.17 Monitoring records seasonal movement this is wholly consistent with the role of vegetation on an underlying clay soil. The widespread nature of seasonal movement at the property is supportive of a wide-ranging influence and informs opinion on why insurers are proposing a barrier around the complete property footprint to isolate it completely from the influence of trees located to the west, north and south.

**Fig 5 – Level monitoring confirms a pattern of movement consistent with the role of vegetation on the property.**

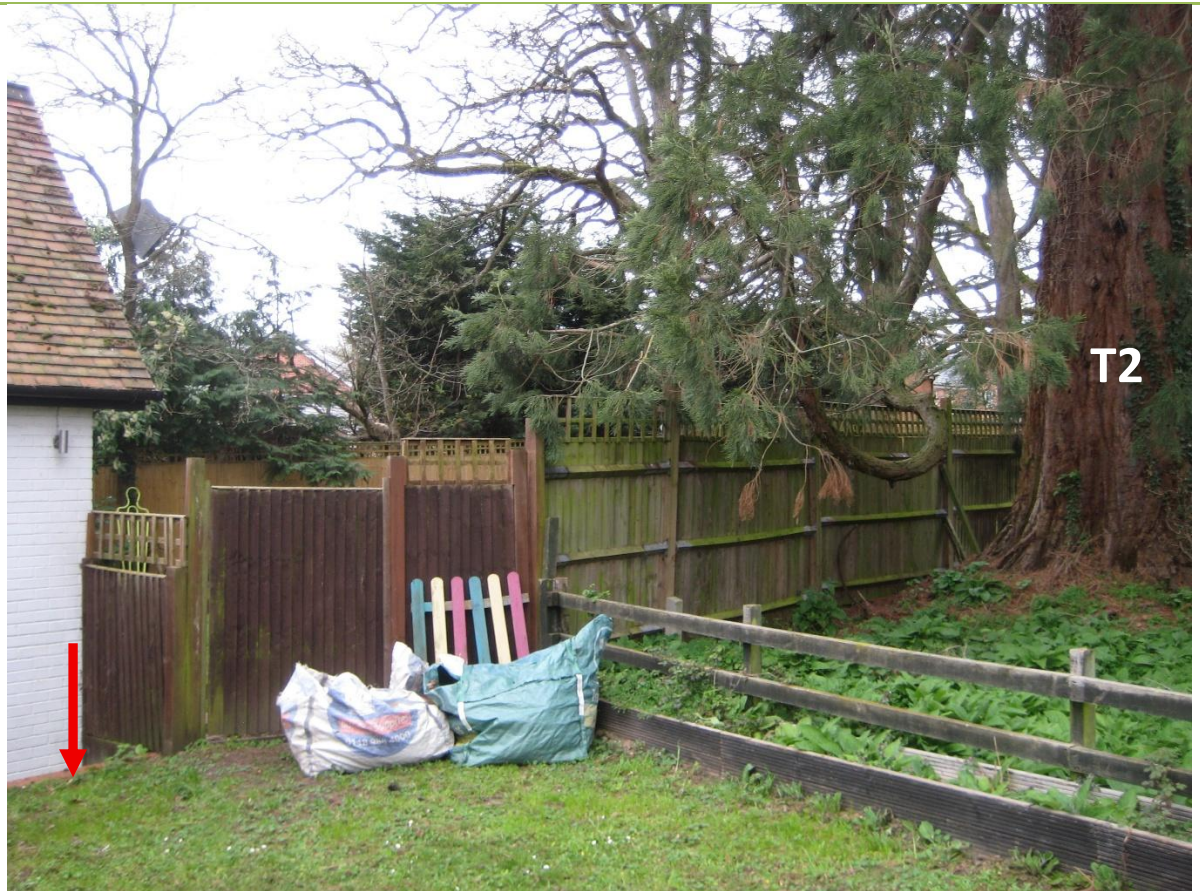
- 5.10 11 *Taxodiaceae* roots were recovered from TP/BH1 between depths of 0.75m – 3m. The location of the trial pit relative to the surveyed trees means these will likely originate from T2 (Wellingtonia). Further root testing in 2024 again recovered *Taxodiaceae* samples.

- 5.11 The largest root size recovered was 5mm. Whilst the barrier proposal is slightly offset from the building this root size is supportive of the opinion that the barrier installation will have little impact on the health and stability of T2, if at all.

**Image 1 –T2 relative to the property. The largest root size recovered from TP/BH1 (arrow) was 5mm**

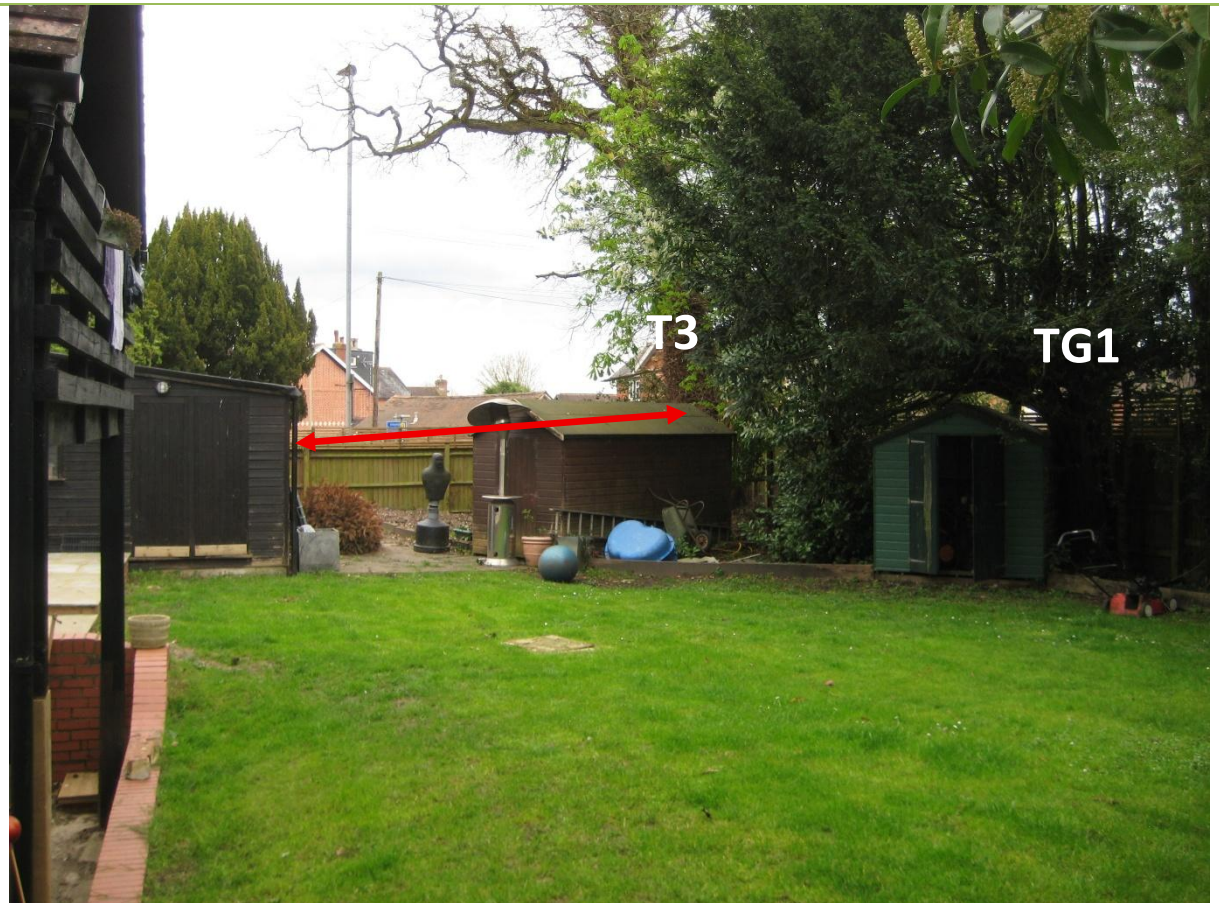
- 5.12 The location of the trial pits is such that roots from T3 (Oak) or TG1 have not been recovered. It is likely they extend to and below the property. In the case of T3 it is 10.1m from the property. Again, the barrier is offset slightly but at these distances and given the integrity of the remaining rooting area (and proposed tree protection measures detailed on a Tree Protection Plan included within the TPO application) is completely unaffected it is not considered there will be any adverse impact on the health and stability of T3 (Oak) from the proposed barrier.

**Image 2 – Rear garden showing spatial distribution of T3 and TG1 relative to the property. T3 is 10.1m from the property.**
