# ARBORICULTURAL REPORT

## TREE CONDITION SURVEY

3 LARCH DRIVE  
WOODLEY  
READING  
RG5 3LW

Ref: 06452 / 2024

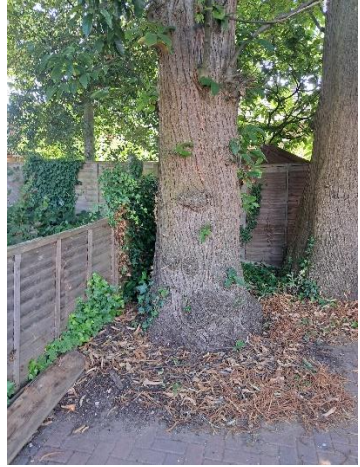
| Ref. | Species | Measurements | Survey Notes | Condition | Recommendations | Tree Base |
|---|---|---|---|---|---|---|
| T001 | Sweet Chestnut | <p><b>Measurements:</b><br/>Height (m): 19<br/>DBH (cm): 770</p> <p><b>Canopy Size/Spread:</b><br/>North: 5m<br/>East: 2m<br/>South: 4m<br/>West: 6.5m</p> <p><b>Life Stage:</b><br/>Over Mature</p> <p><b>Life Expectancy:</b><br/>20+ Years</p> | <p><b>Situation:</b> Over mature tree growing 11.5 metres from the Conservatory.</p> <p><b>Base:</b> Previous owner block paved garden. Block paving extends to within 0.6 metres of tree base. Base clear, bark intact, no fungal fruiting bodies evident, no audible decay at base. Tree impacted by block paving - age unknown. Sound intonation even.</p> <p><b>Trunk:</b> Bud proliferation and early epic shoots on trunk. Multiple pruning cuts on trunk 200mm diameter to 10m above ground level.<br/>Mixed rates of occlusion around wounds – 10% to no wound wood formation.</p> <p><b>Canopy:</b> Canopy has been heavily crown lifted with much of primary branch structure removed. Canopy 50% dead, 20% in decline, 30% foliage stunted. Chlorotic, low vitality.</p> | Poor | <p>Remove deadwood back to live growth.</p> <p>Reduce remaining side branches to 1-2m stumps.</p> <p>All healthy small branches and epic shoots growing on the lower trunk will be retained to support new growth from which point the tree can be retained in a reduced form as a pollard.</p> <p>Consider soil amelioration (see Section 3.3)</p> | |

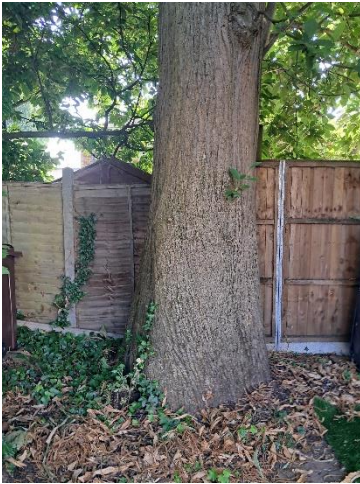
| Ref. | Species | Measurements | Survey Notes | Condition | Recommendations | Tree Base |
|---|---|---|---|---|---|---|
| T002 | Sweet Chestnut | <p><b>Measurements:</b><br/>Height (m): 20<br/>DBH (cm): 1200</p> <p><b>Canopy Size/Spread:</b><br/>North: 5m<br/>East: 5m<br/>South: 6m<br/>West: 6m</p> <p><b>Life Stage:</b><br/>Mature</p> <p><b>Life Expectancy:</b><br/>40+ Years</p> | <p><b>Situation:</b> Mature tree growing 13 metres from the dwelling on the rear boundary.</p> <p><b>Base:</b> Base partially obscured by fence. Broad gradual root flare. Small crust of white fungus (mycelium) at base 20mm high x 10mm – too small to identify, was under leaf litter. Elsewhere, where accessible, base clear, bark intact, sound intonation even and satisfactory, no audible decay.</p> <p><b>Trunk:</b> Large trunk with strong pronounced buttressing. Slight helical growth on trunk, feathered form with mature epic growth.</p> <p><b>Canopy:</b> Canopy from 2.5m. Large asymmetrical/elongated brunch on the southwest side 9m long. Epicormic shoots throughout canopy. Foliage dense and even, good vitality.</p> | Fair | <p>Reduce elongated limb on southwest side by approximately 2-3m to reduce exposure / weight following essential works to T001 and T003.</p> | |

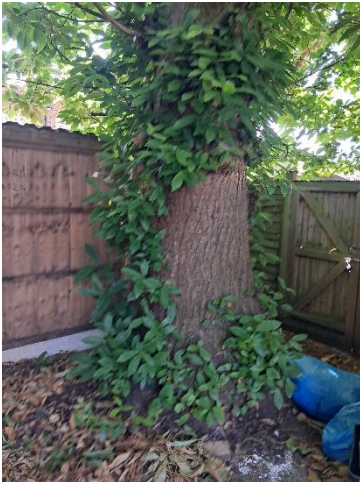
| Ref. | Species | Measurements | Survey Notes | Condition | Recommendations | Tree Base |
|---|---|---|---|---|---|---|
| T003 | Sweet Chestnut | <p><b>Measurements:</b><br/>Height (m): 19<br/>DBH (cm): 840</p> <p><b>Canopy Size/Spread:</b><br/>North: 3m<br/>East: 5m<br/>South: 3m<br/>West: 5m</p> <p><b>Life Stage:</b><br/>Over Mature</p> <p><b>Life Expectancy:</b><br/>20+ Years</p> | <p><b>Situation:</b> Block paving on all three sides. within 0.5m of tree base.</p> <p><b>Base:</b> Boletus fungus at base (not significant). Warty bole, bud proliferation. Base and trunk partially obscured by prolific epicormic growth. Where accessible, base clear, bark intact, no fungal fruiting bodies evident, no audible decay.</p> <p><b>Trunk:</b> Single stem, feathered, excurrent form to approximately 10m. Foliage on stem consists of dense green shoots.</p> <p><b>Canopy:</b> Cuts visible where branches have been cut in upper crown. Main upper canopy mostly dead. Live growth sparse, browning and stunted – past the point from which they might reasonably recover.</p> | Poor | <p>Remove deadwood back to live growth.</p> <p>Reduce remaining side branches to 1-2m stumps.</p> <p>All healthy small branches and epic shoots growing on the lower trunk will be retained to support new growth from which point the tree can be retained in a reduced form as a pollard.</p> <p>Consider soil amelioration (see Section 3.3)</p> | |

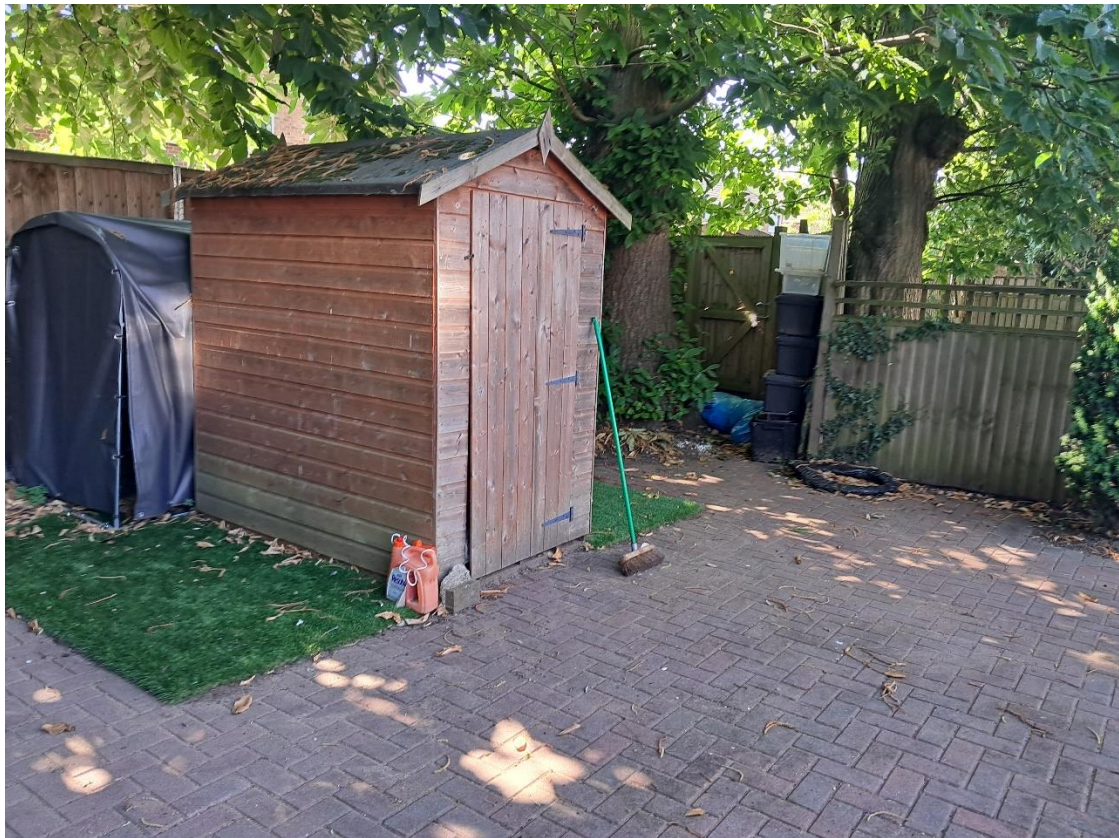
Trees at 3 Larch Drive may have been adversely affected by the installation of block paving over a significant percentage of their rooting areas. Removing an area of the block paving at the bases of trees will benefit the trees by improving the rooting environment. It may also improve tree health and physiological condition.

Photo 1 – Block paving over trees' rooting areas

To do this, block pavers and sub-base around the base of the tree should be removed by hand. The radius of the mulched area should be as large as possible – out to the edge of the canopy would be best but any mulched area, however small, will benefit the growing conditions for the tree.

Once the paving and subbase has been removed, the ground can be loosely tined using a garden fork to break up any surface crust and improve water and oxygen penetration. A mulch of good-quality topsoil topped with **well-rotted** bark chip or fully composted organic material should be raked over the area 60- 100mm deep taking care not to obscure the natural root flare around the base of the tree.

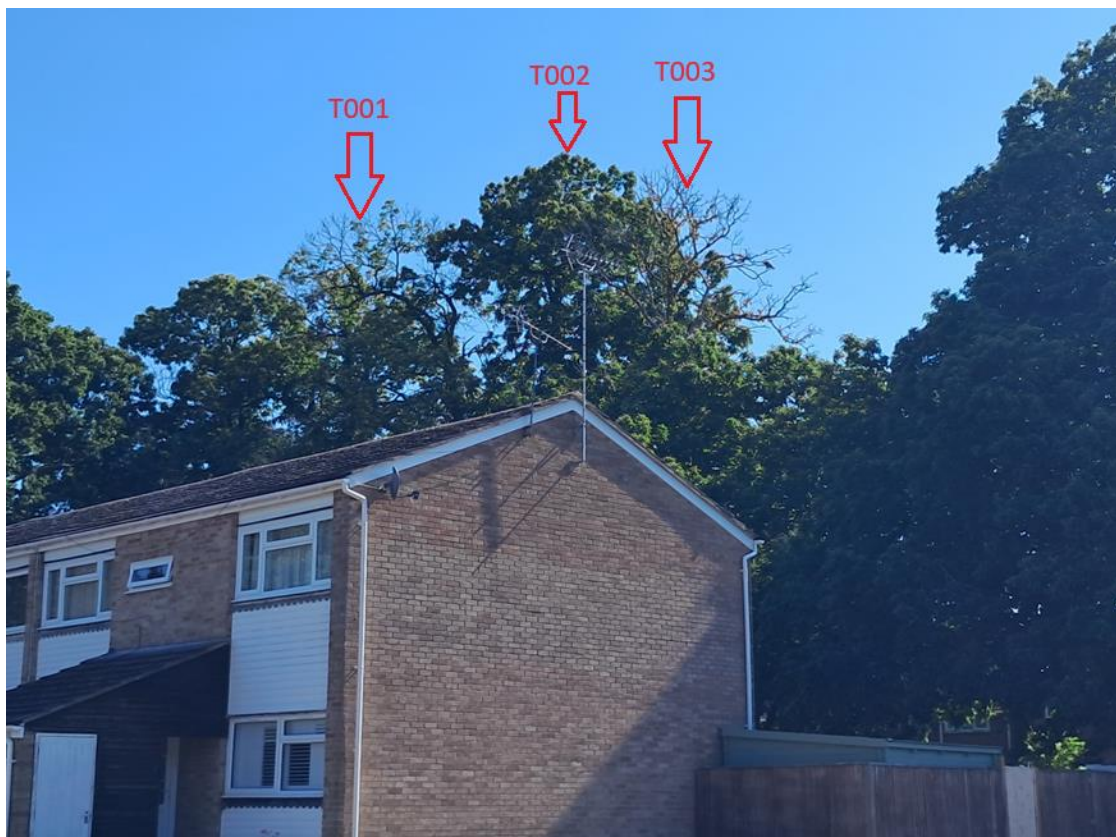
Photo 2 – Deadwood in upper canopies of T001 & T003

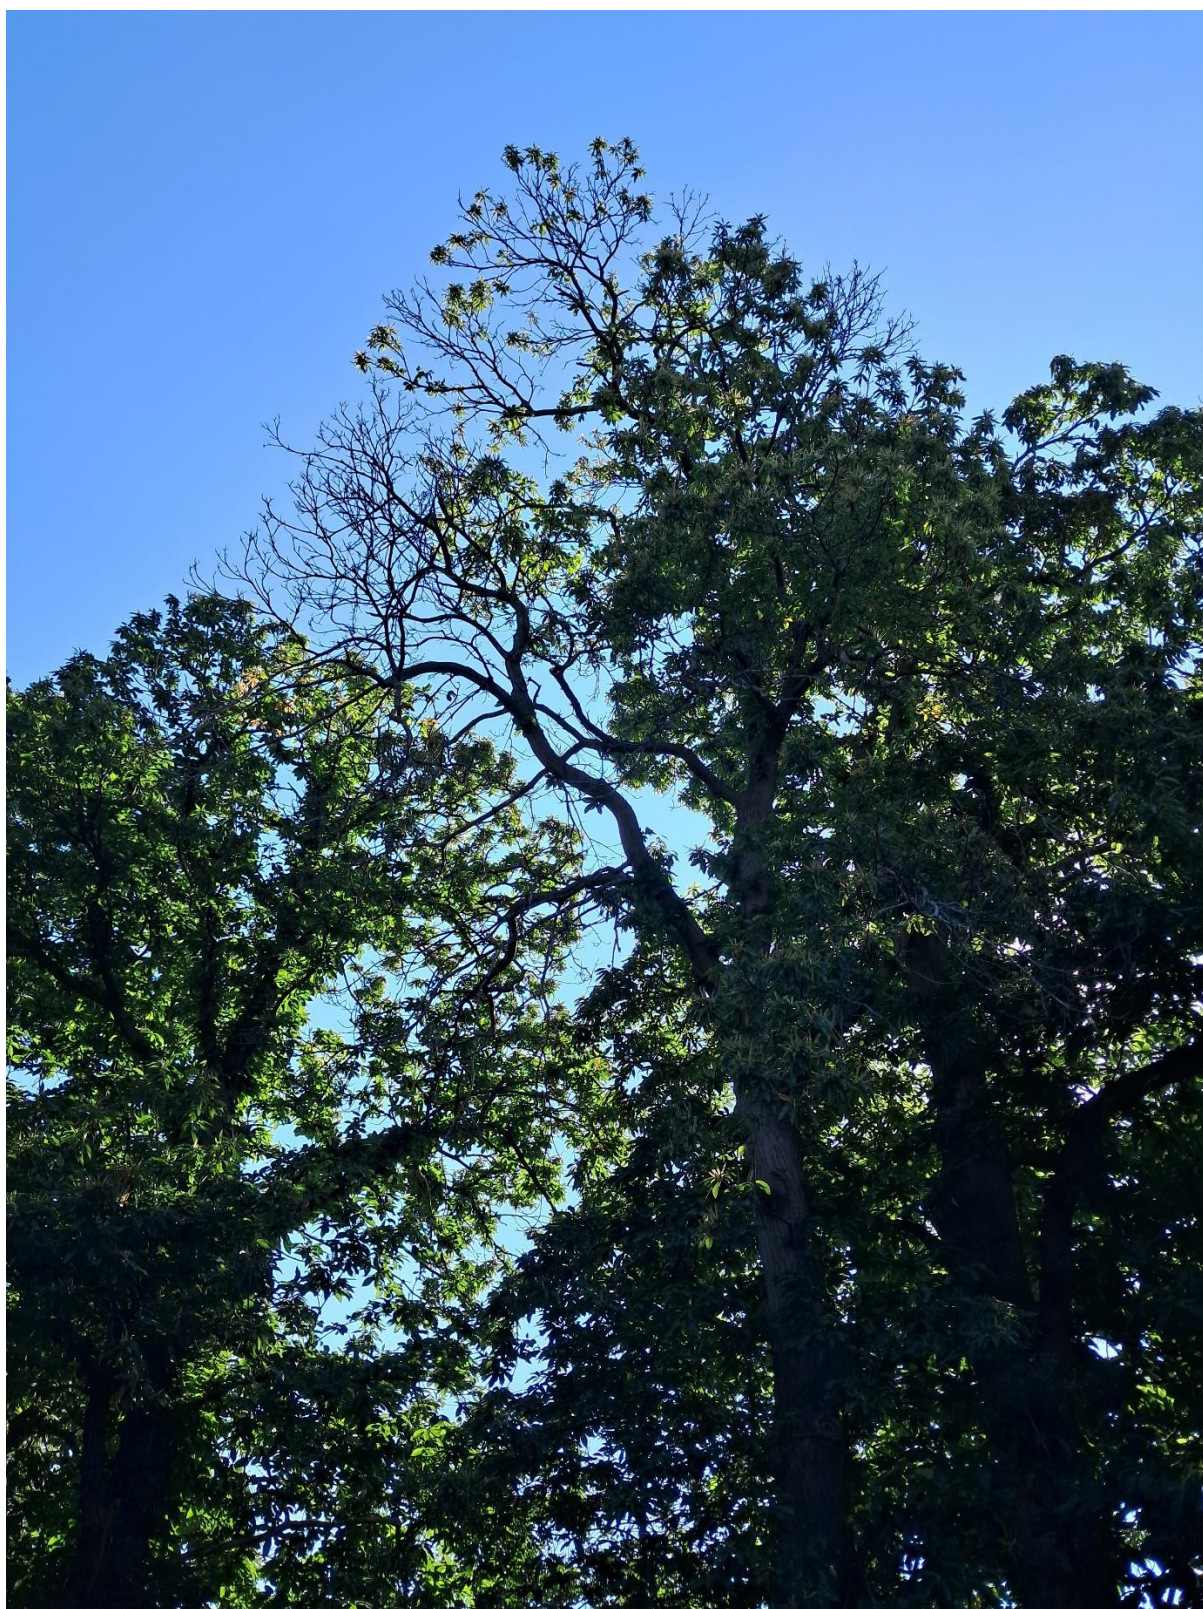
Photo 3 – Dead / declining upper canopy of T001 (Sweet Chestnut)

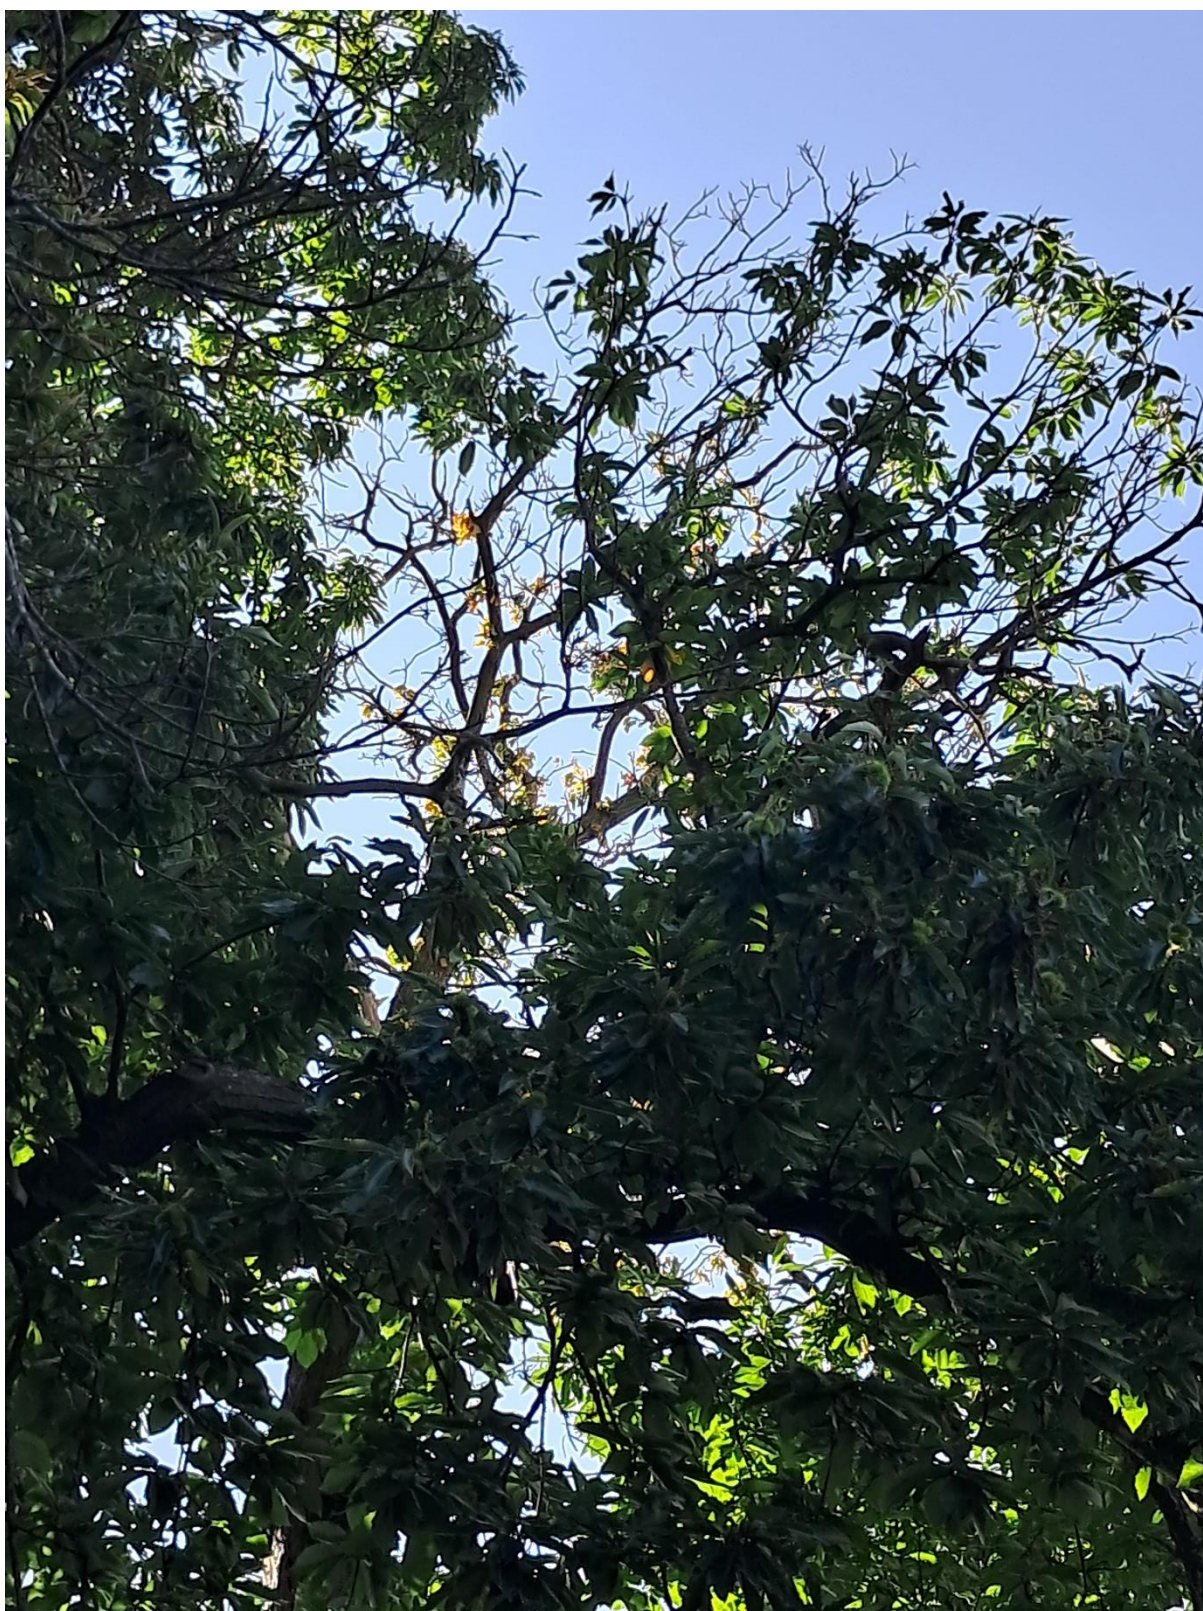
Photo 4 – Dead / declining upper canopy of T003 (Sweet Chestnut)
