**A Tree Condition Report carried out at:**

**St James Church  
Church Lane, Finchampstead  
RG40 4LU**

**10/06/2025**

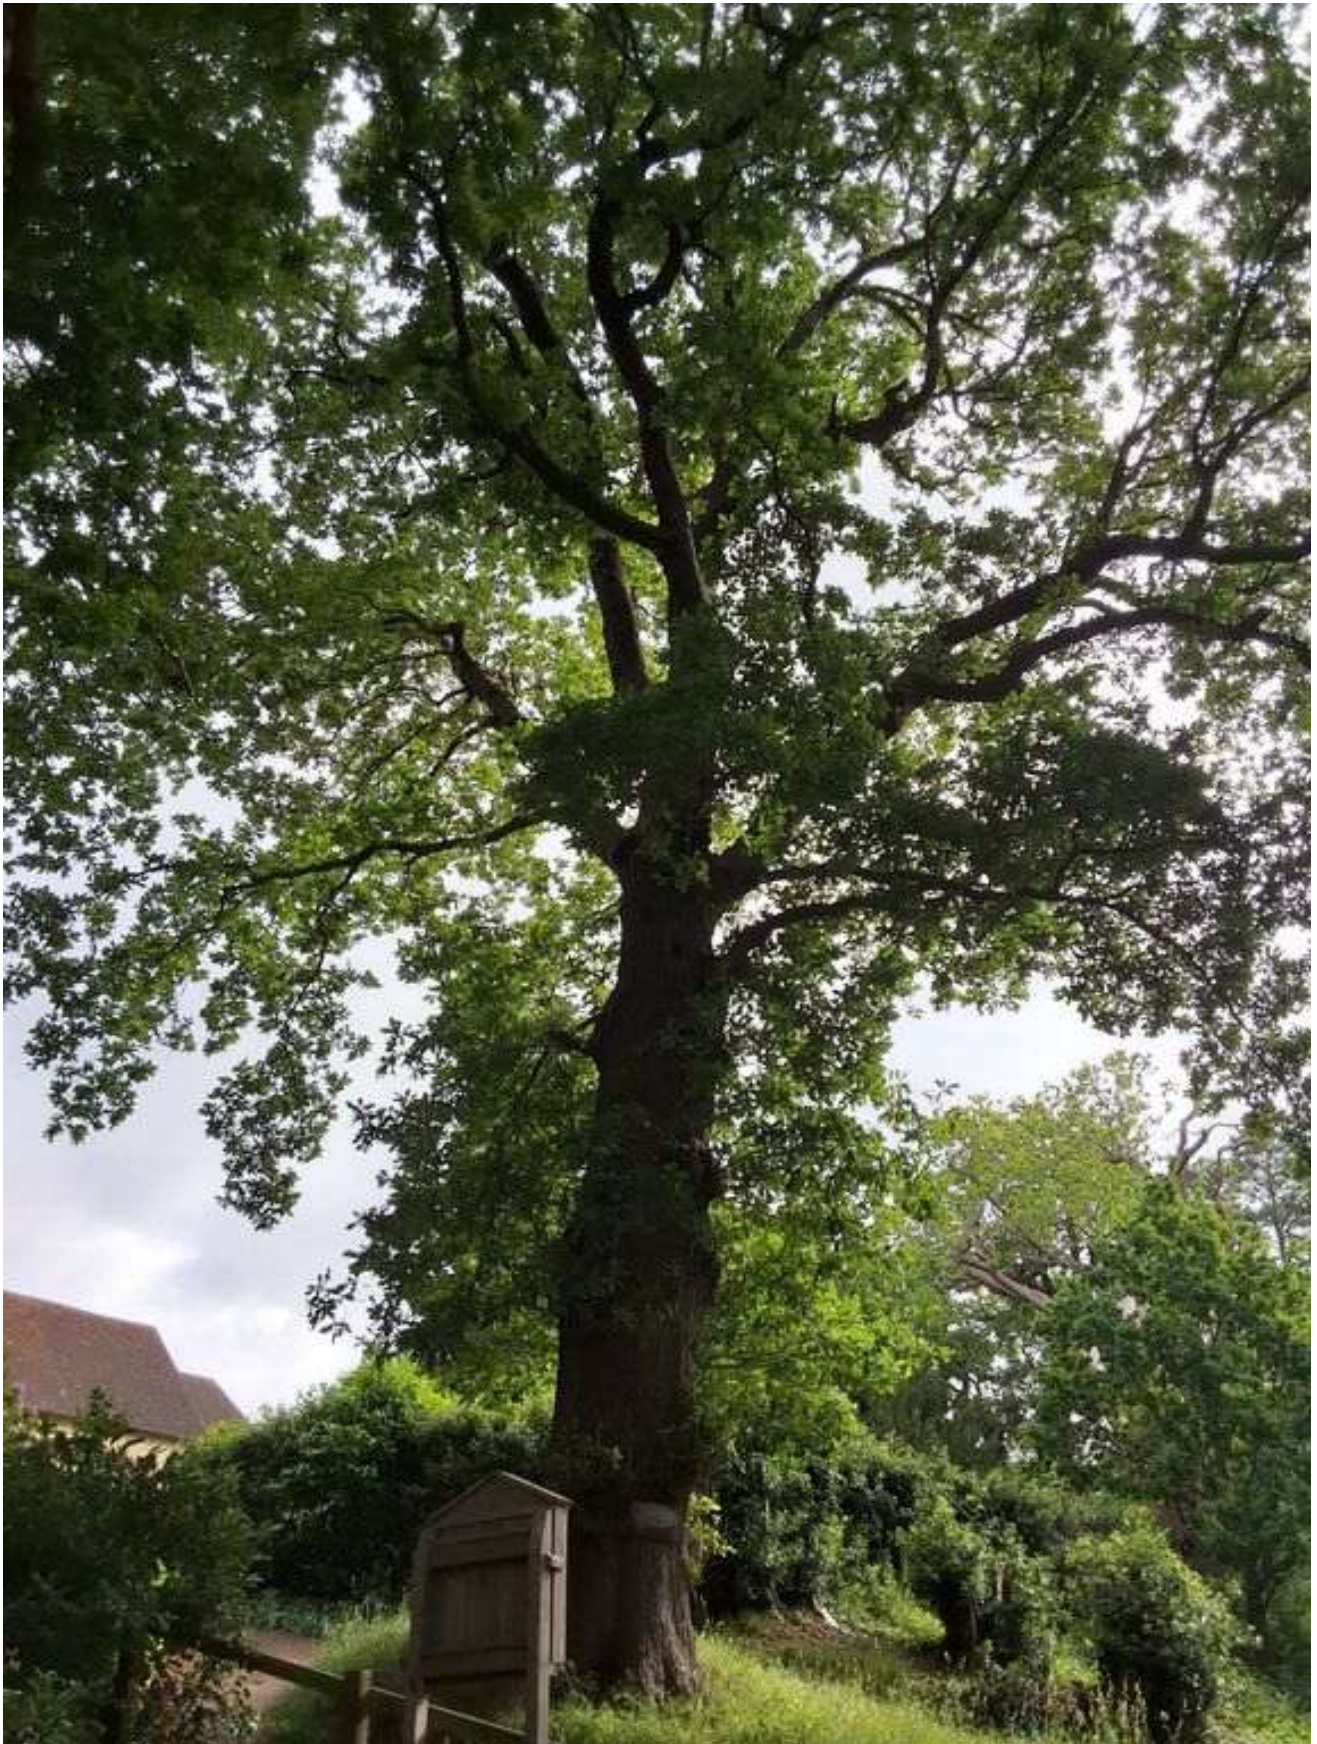
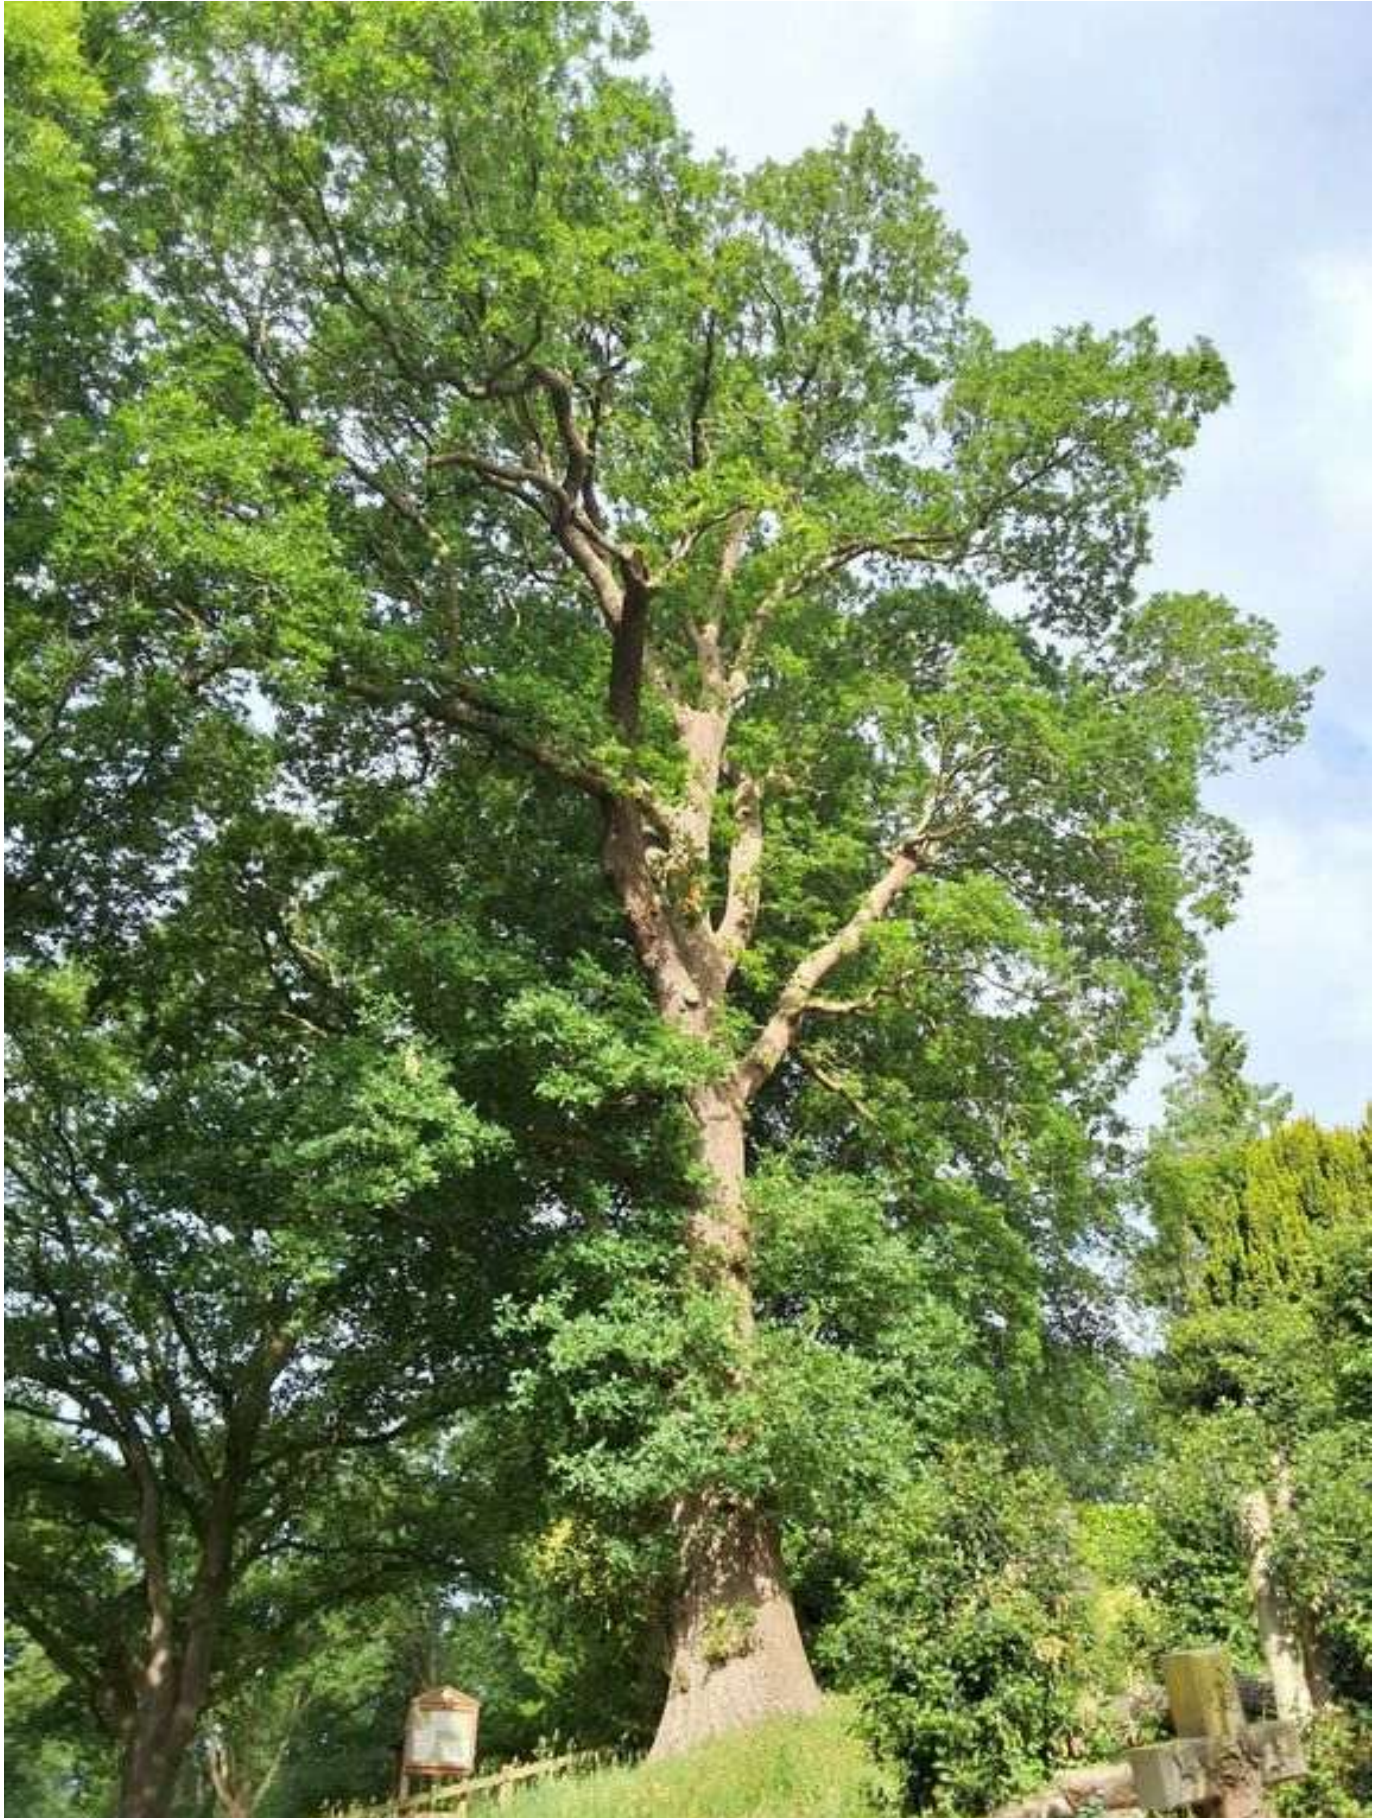
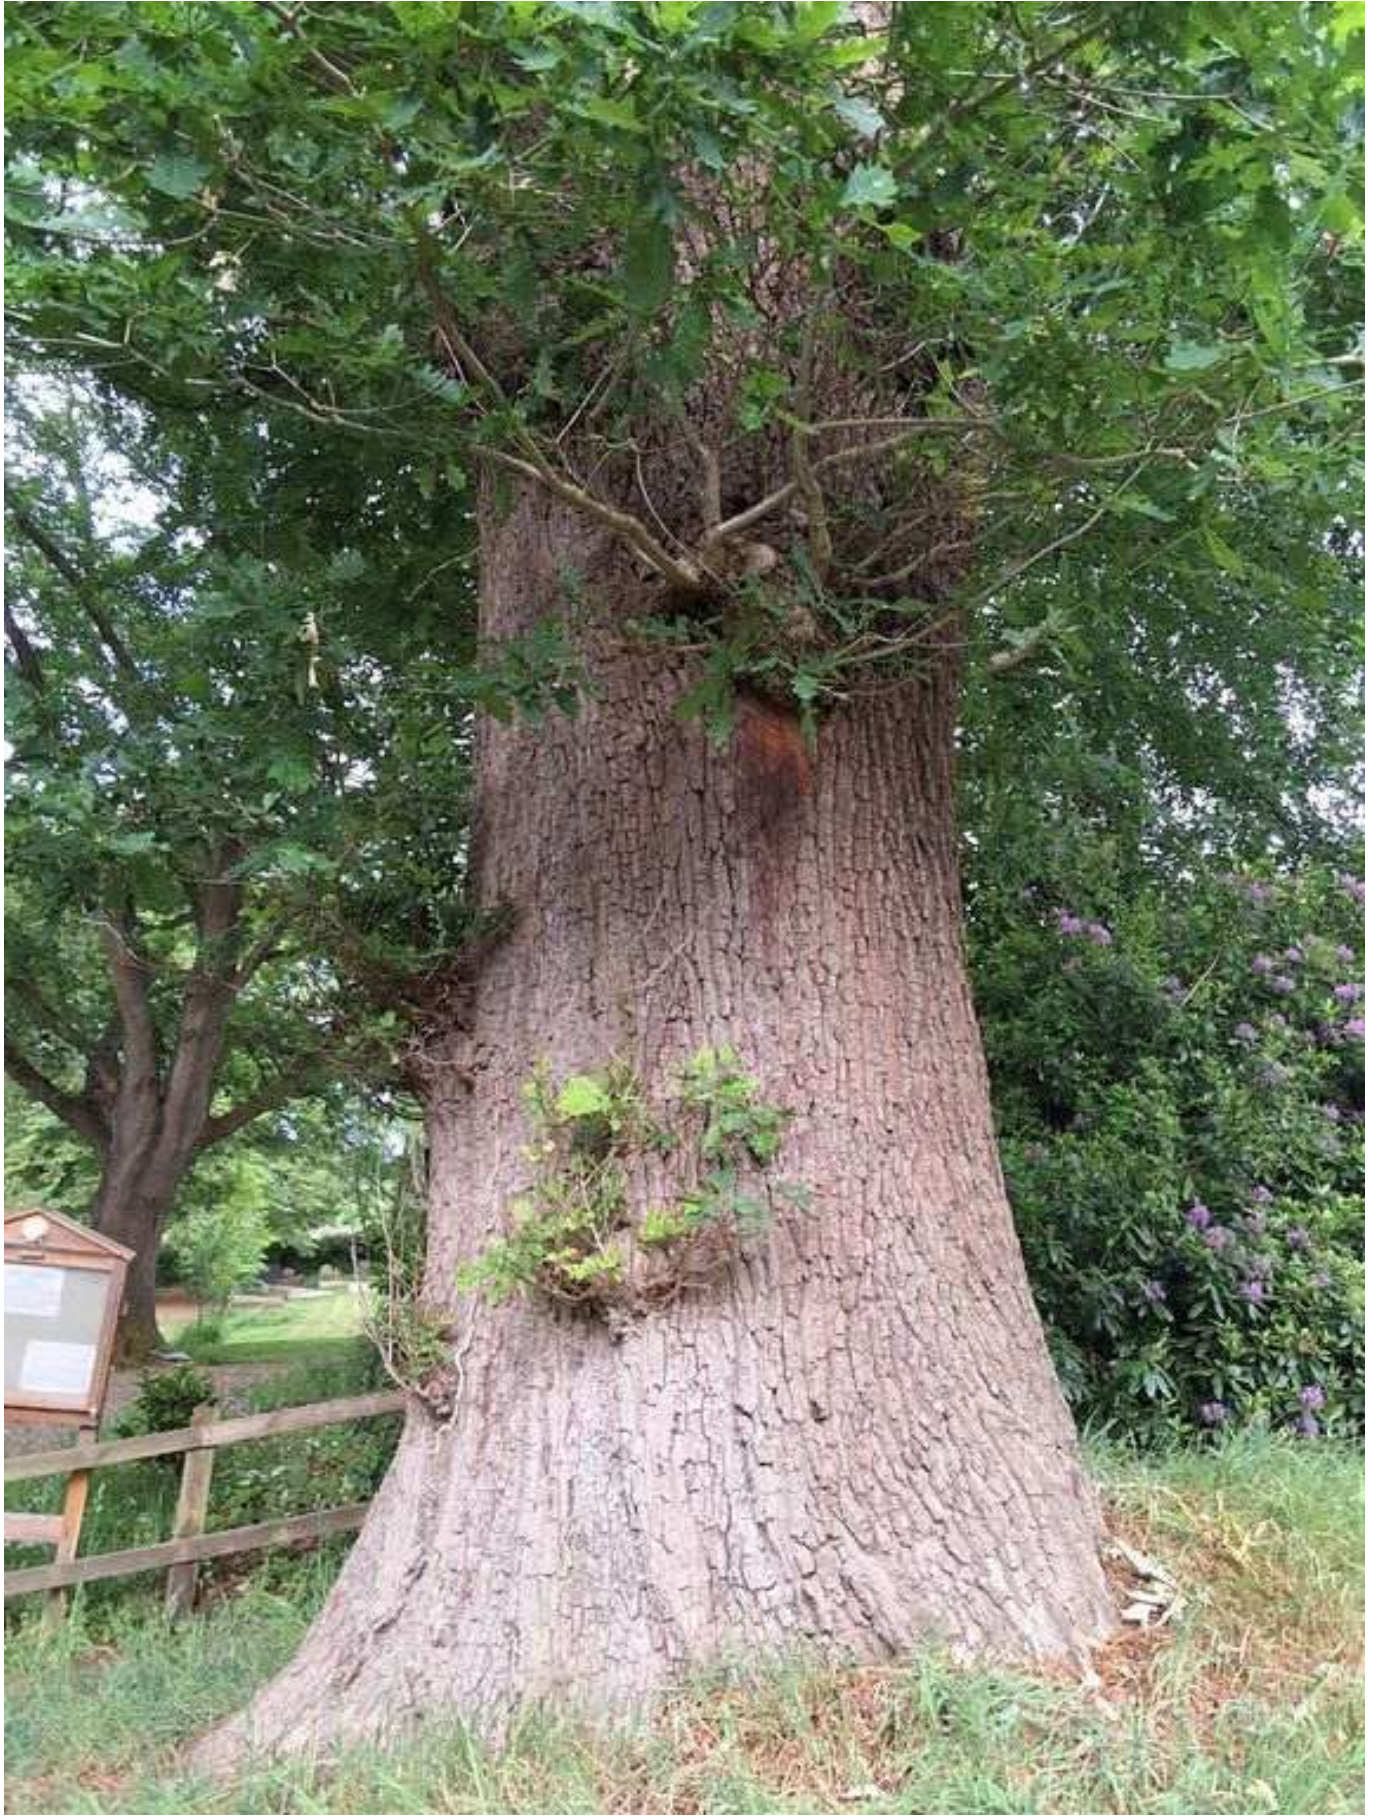
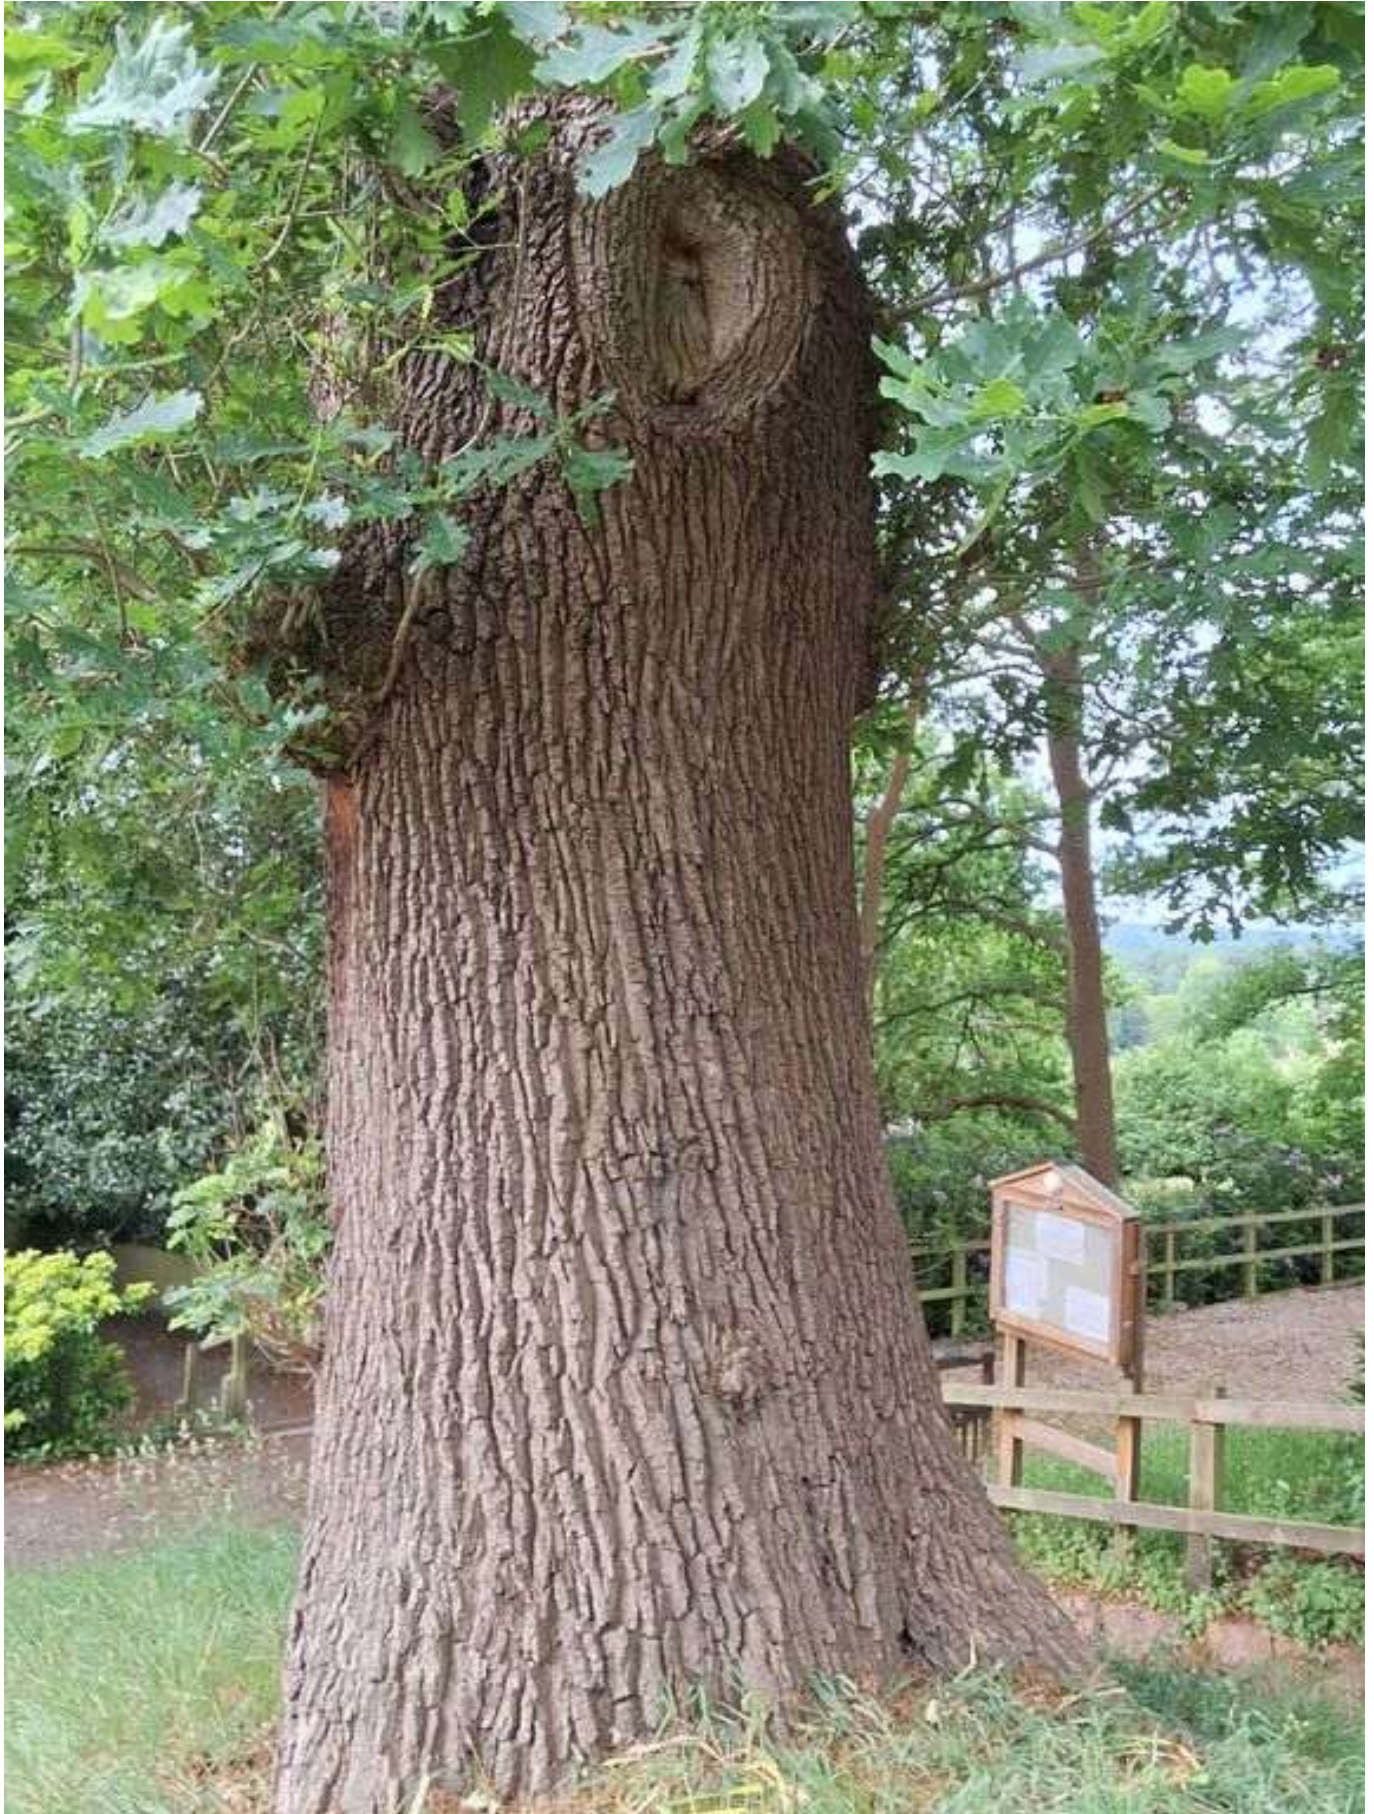
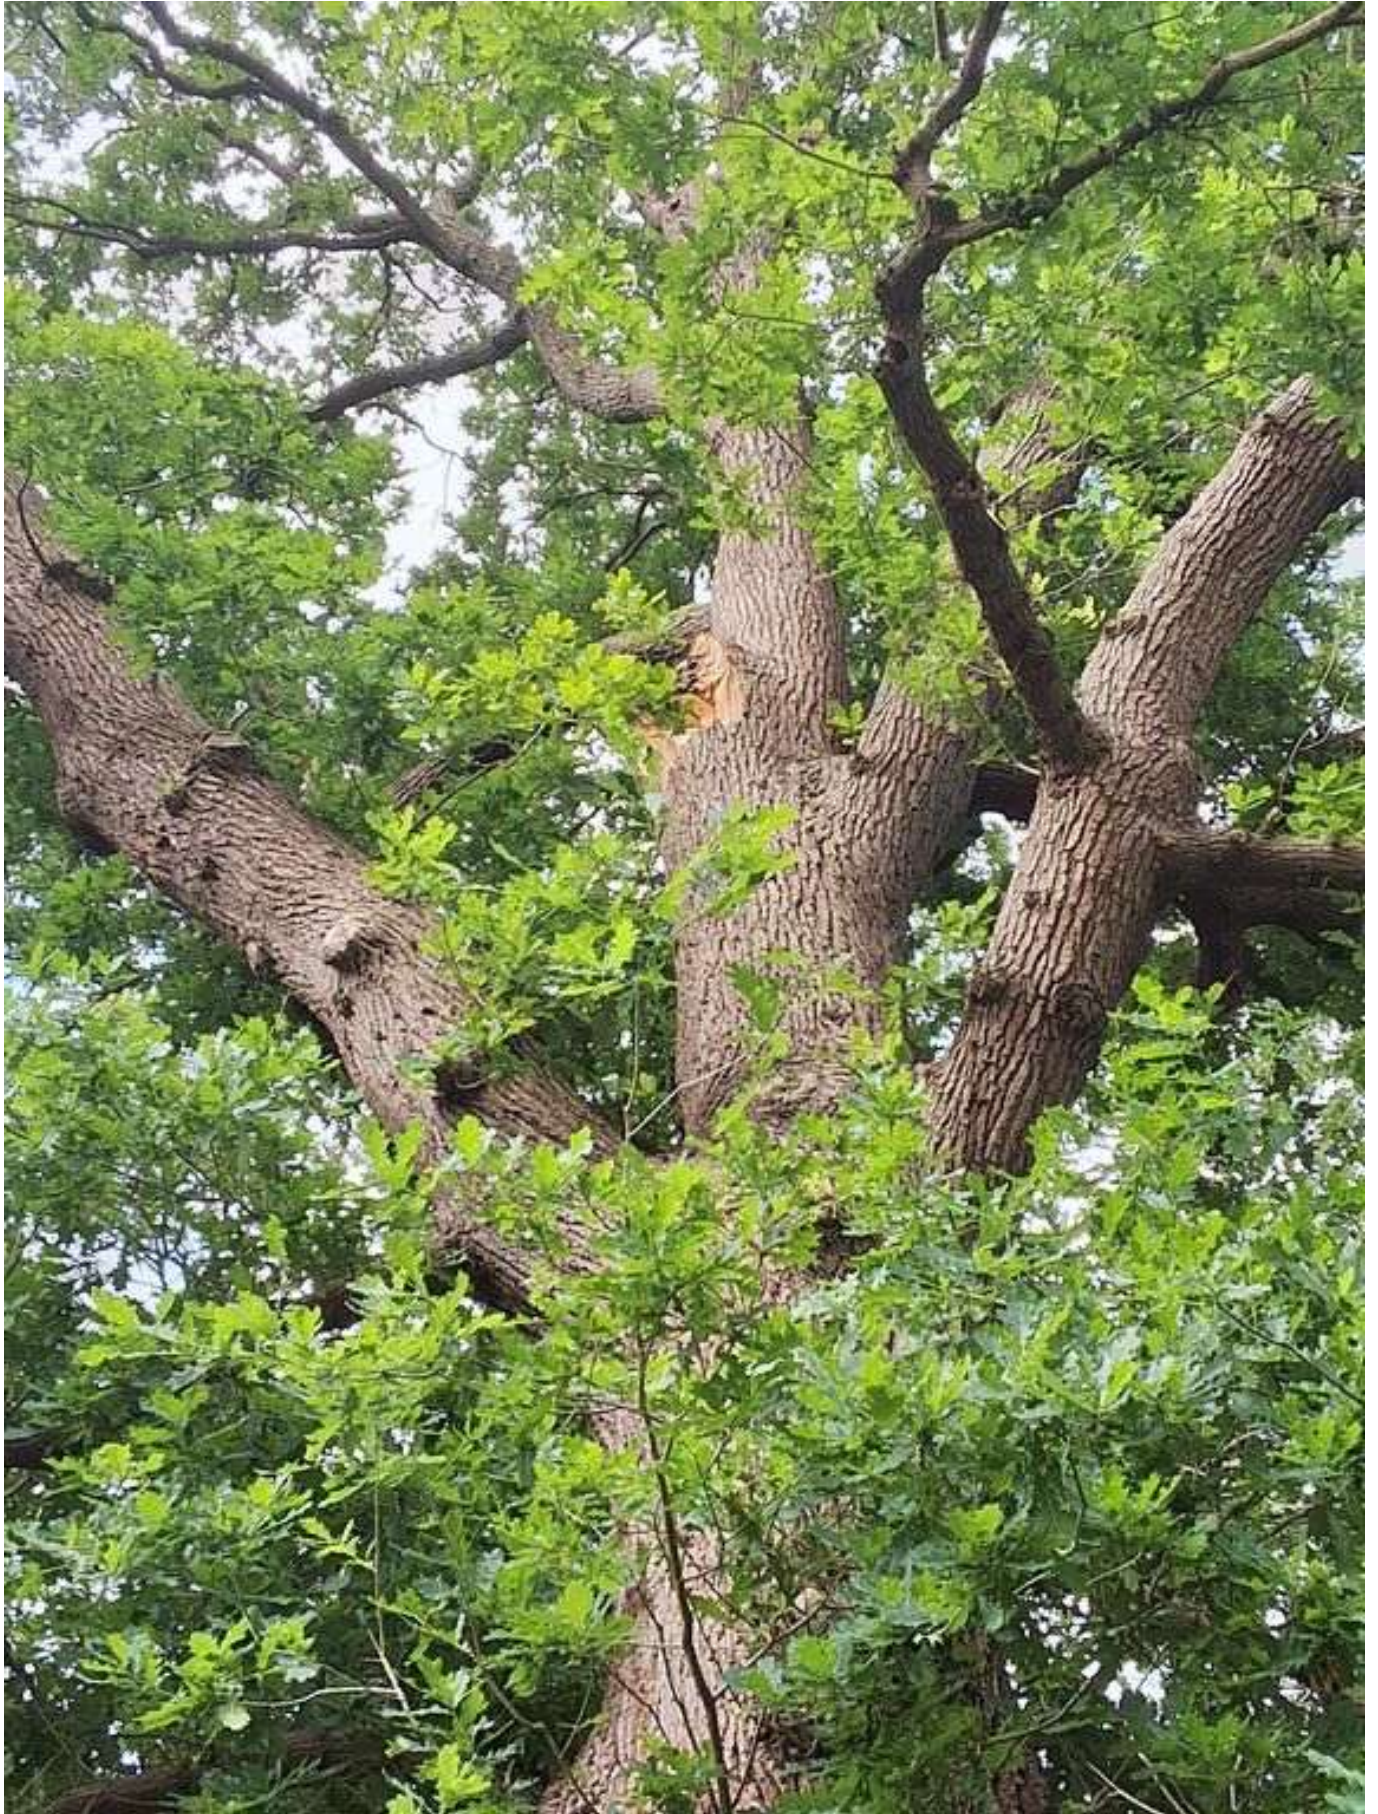
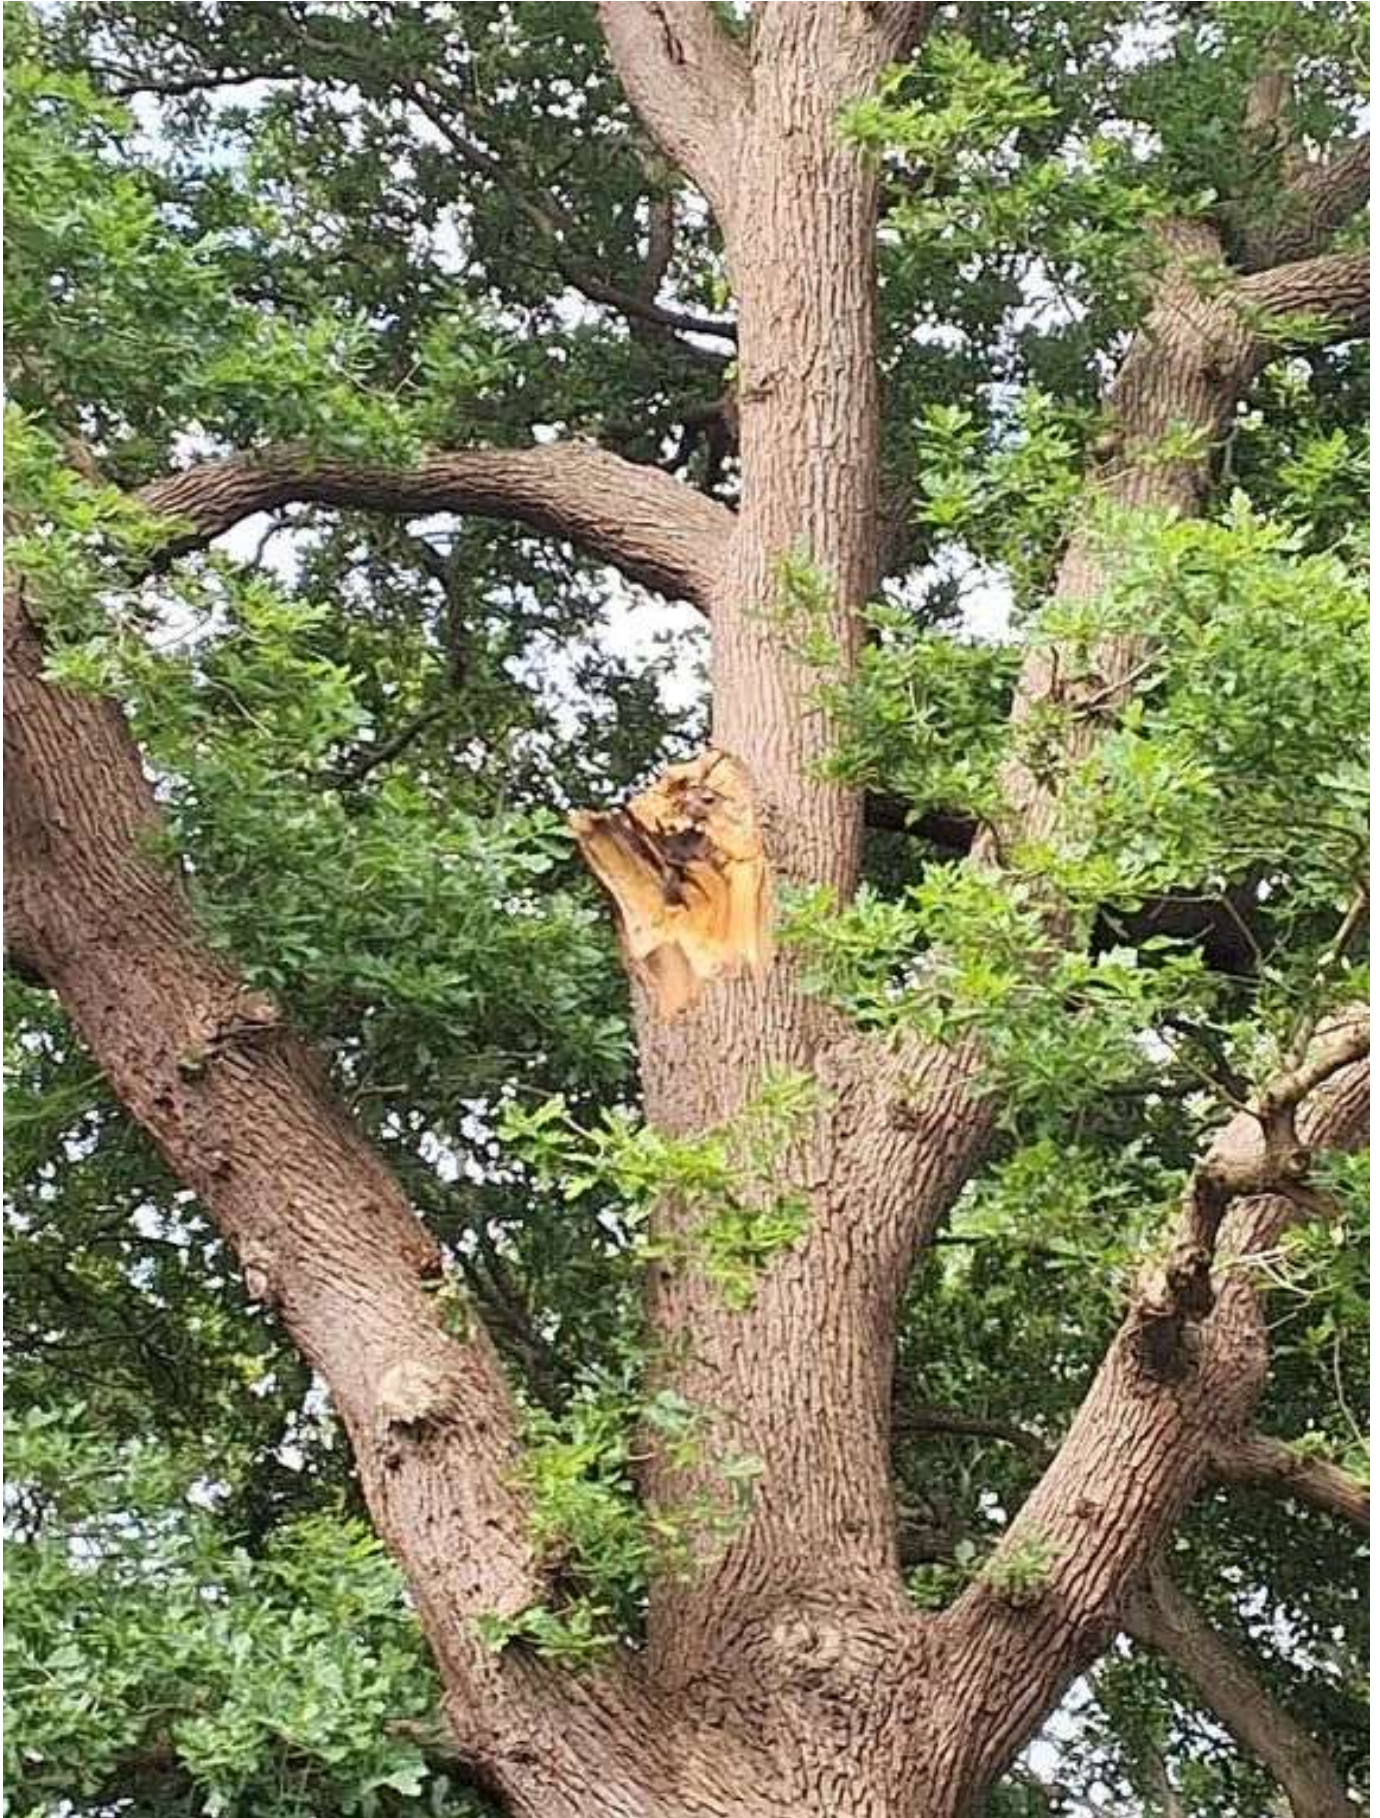
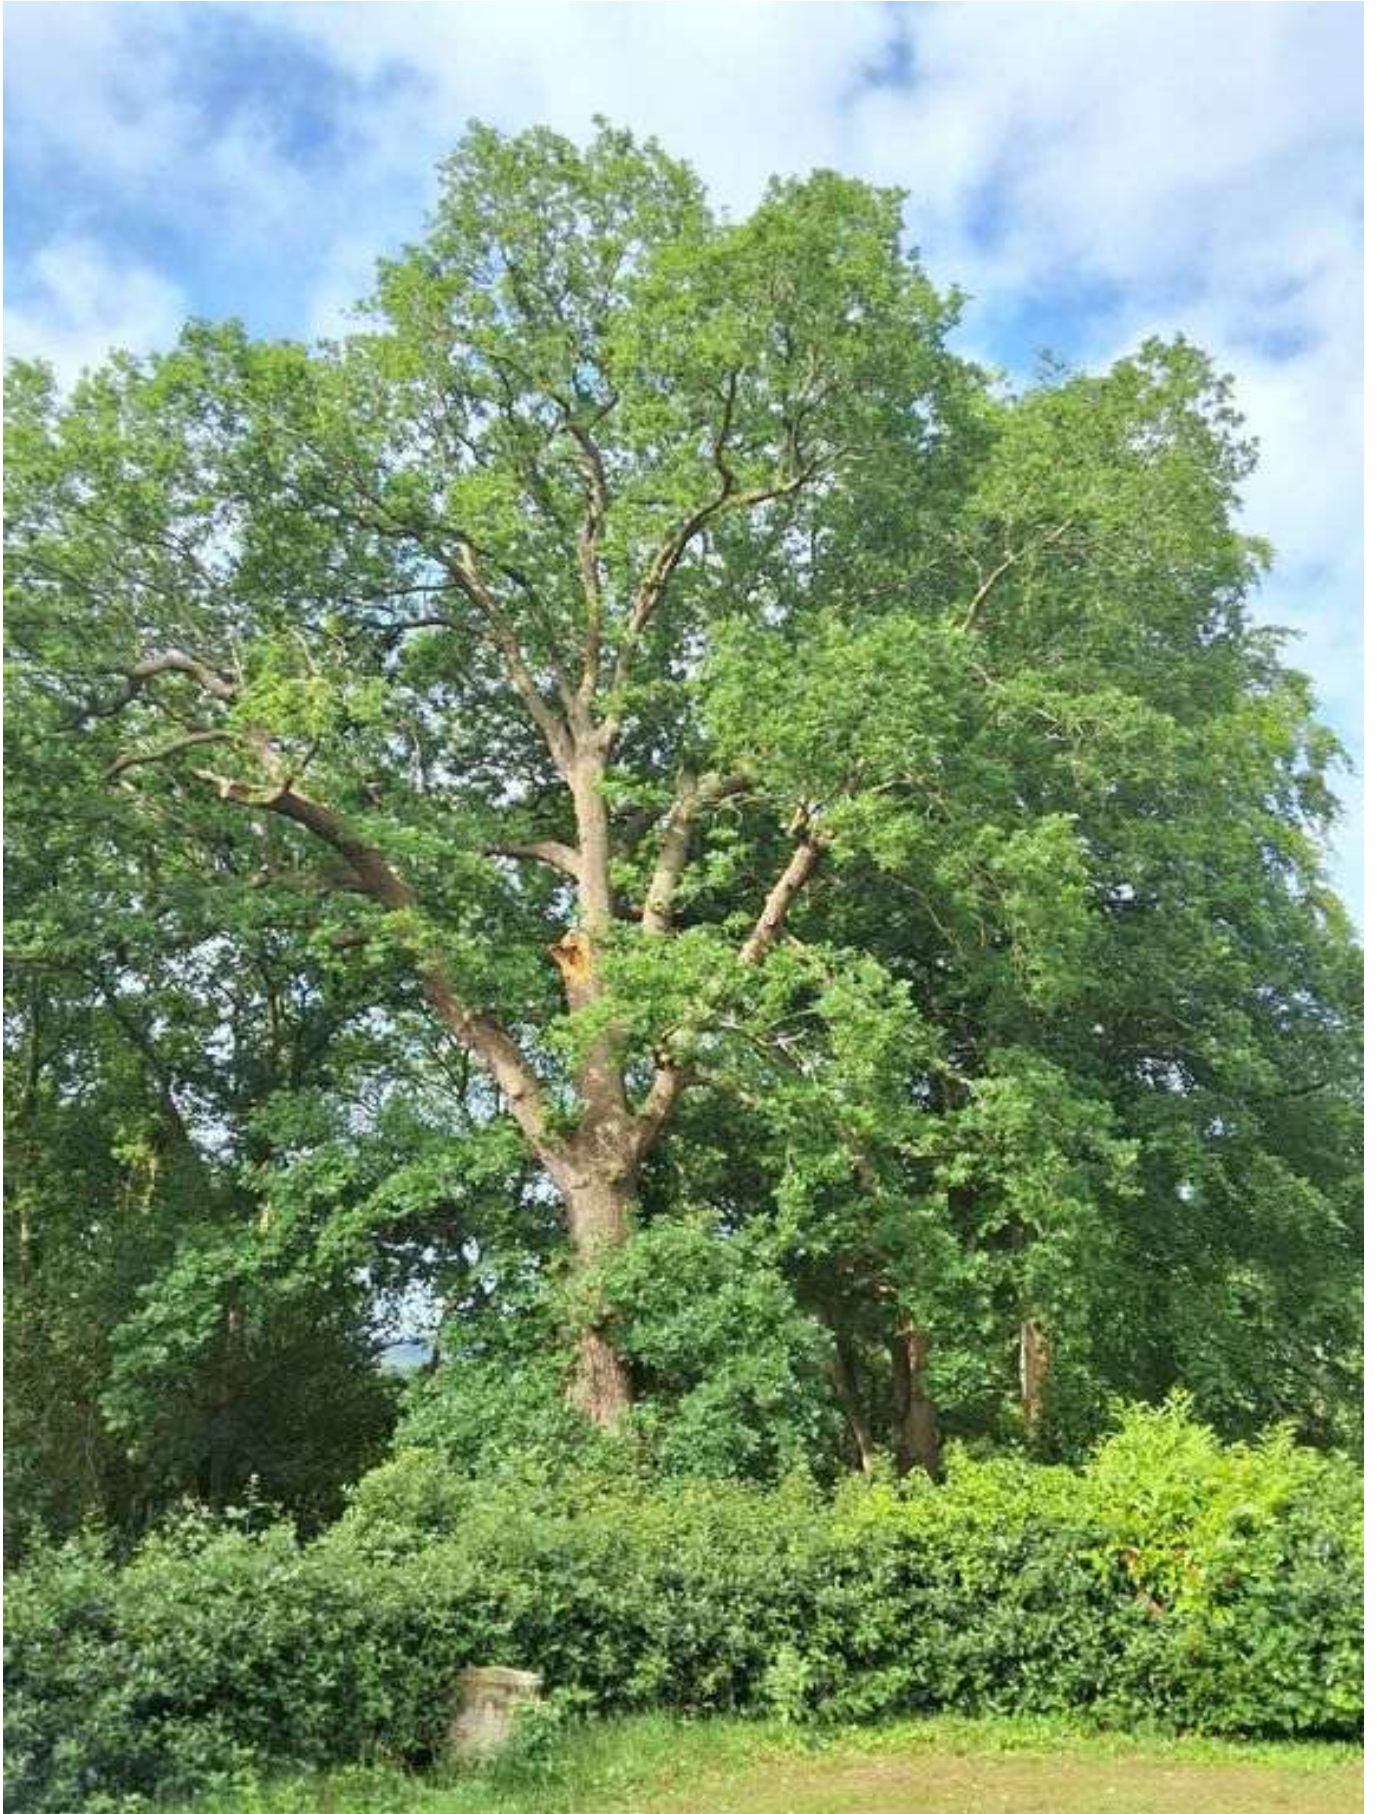
| Tree Survey Recommendations | | | | | | | |
|---|---|---|---|---|---|---|---|
| T001 | Pedunculate oak<br>( <i>Quercus robur</i> ) | Owned by the estate.<br>Target # - footpath.<br>Target # - graveyard | Height (m): 19<br>Crown Radius (m): 9<br>DBH (cm): 131<br>Life Stage: Mature<br>Life Exp.: 50+ Years | Aerial decay (good reactive growth) localised decay<br>Historical failure north 10m<br>Dead wood. | Fair | Crown reduce by 3m over east, 3m south, 1-2m west, 3m off the height | 31-May-2026 (1 Year) |

### T001

**Failure Score**

Potentially with tim ▼

**Target Score**

Low ▼

**Impact Score**

Severe ▼

**Risk Score**

120

**Threat Category**

2: Minimal

**T001-** Due to the vitality of the tree currently, pruning is a viable option as the tree is likely to respond well.
