**A Tree Condition Report carried out at:**

**St James Church  
Church Lane, Finchampstead  
RG40 4LU**

**10/06/2025**

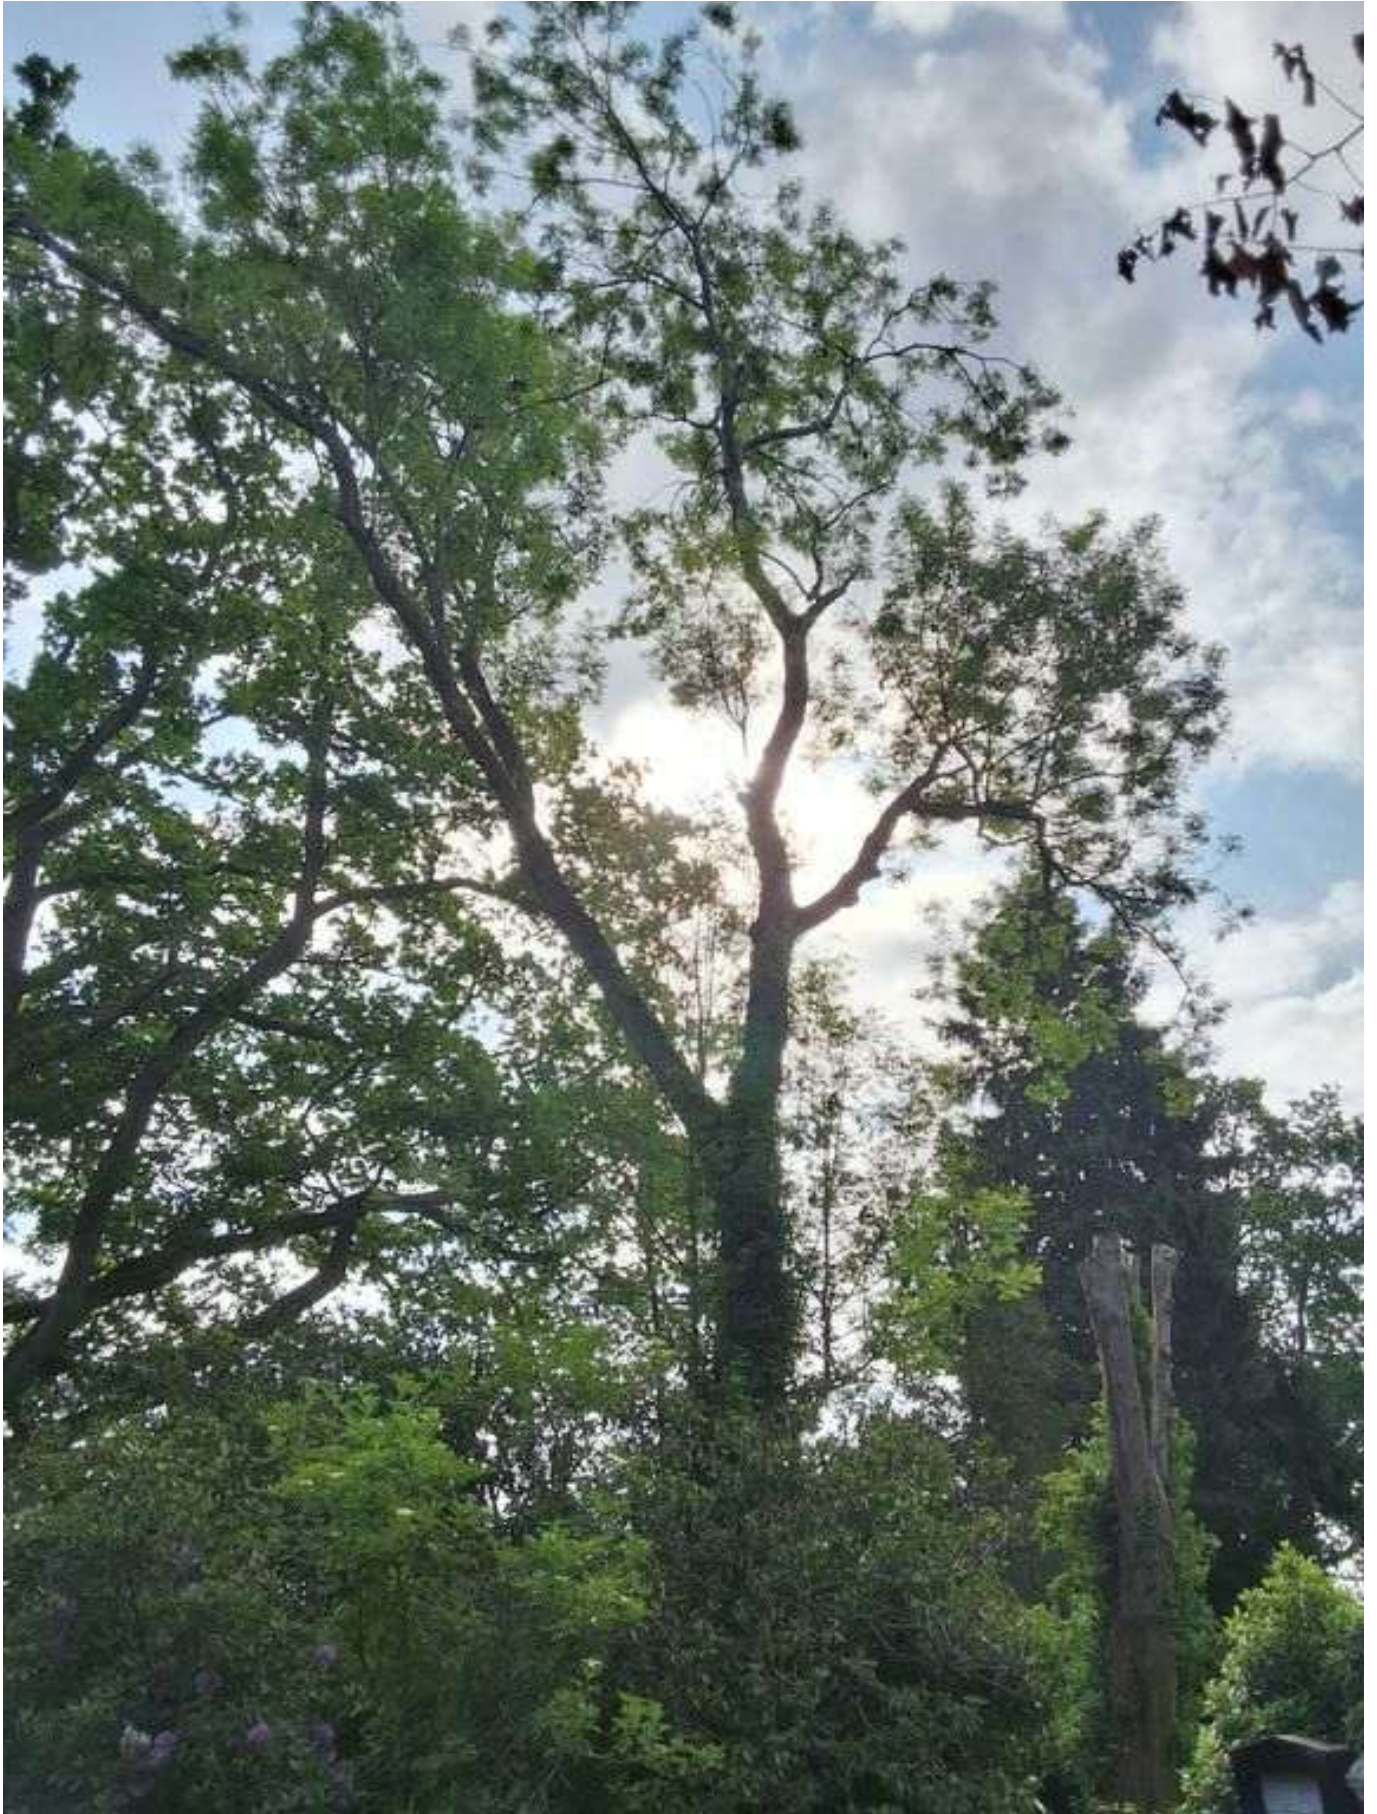
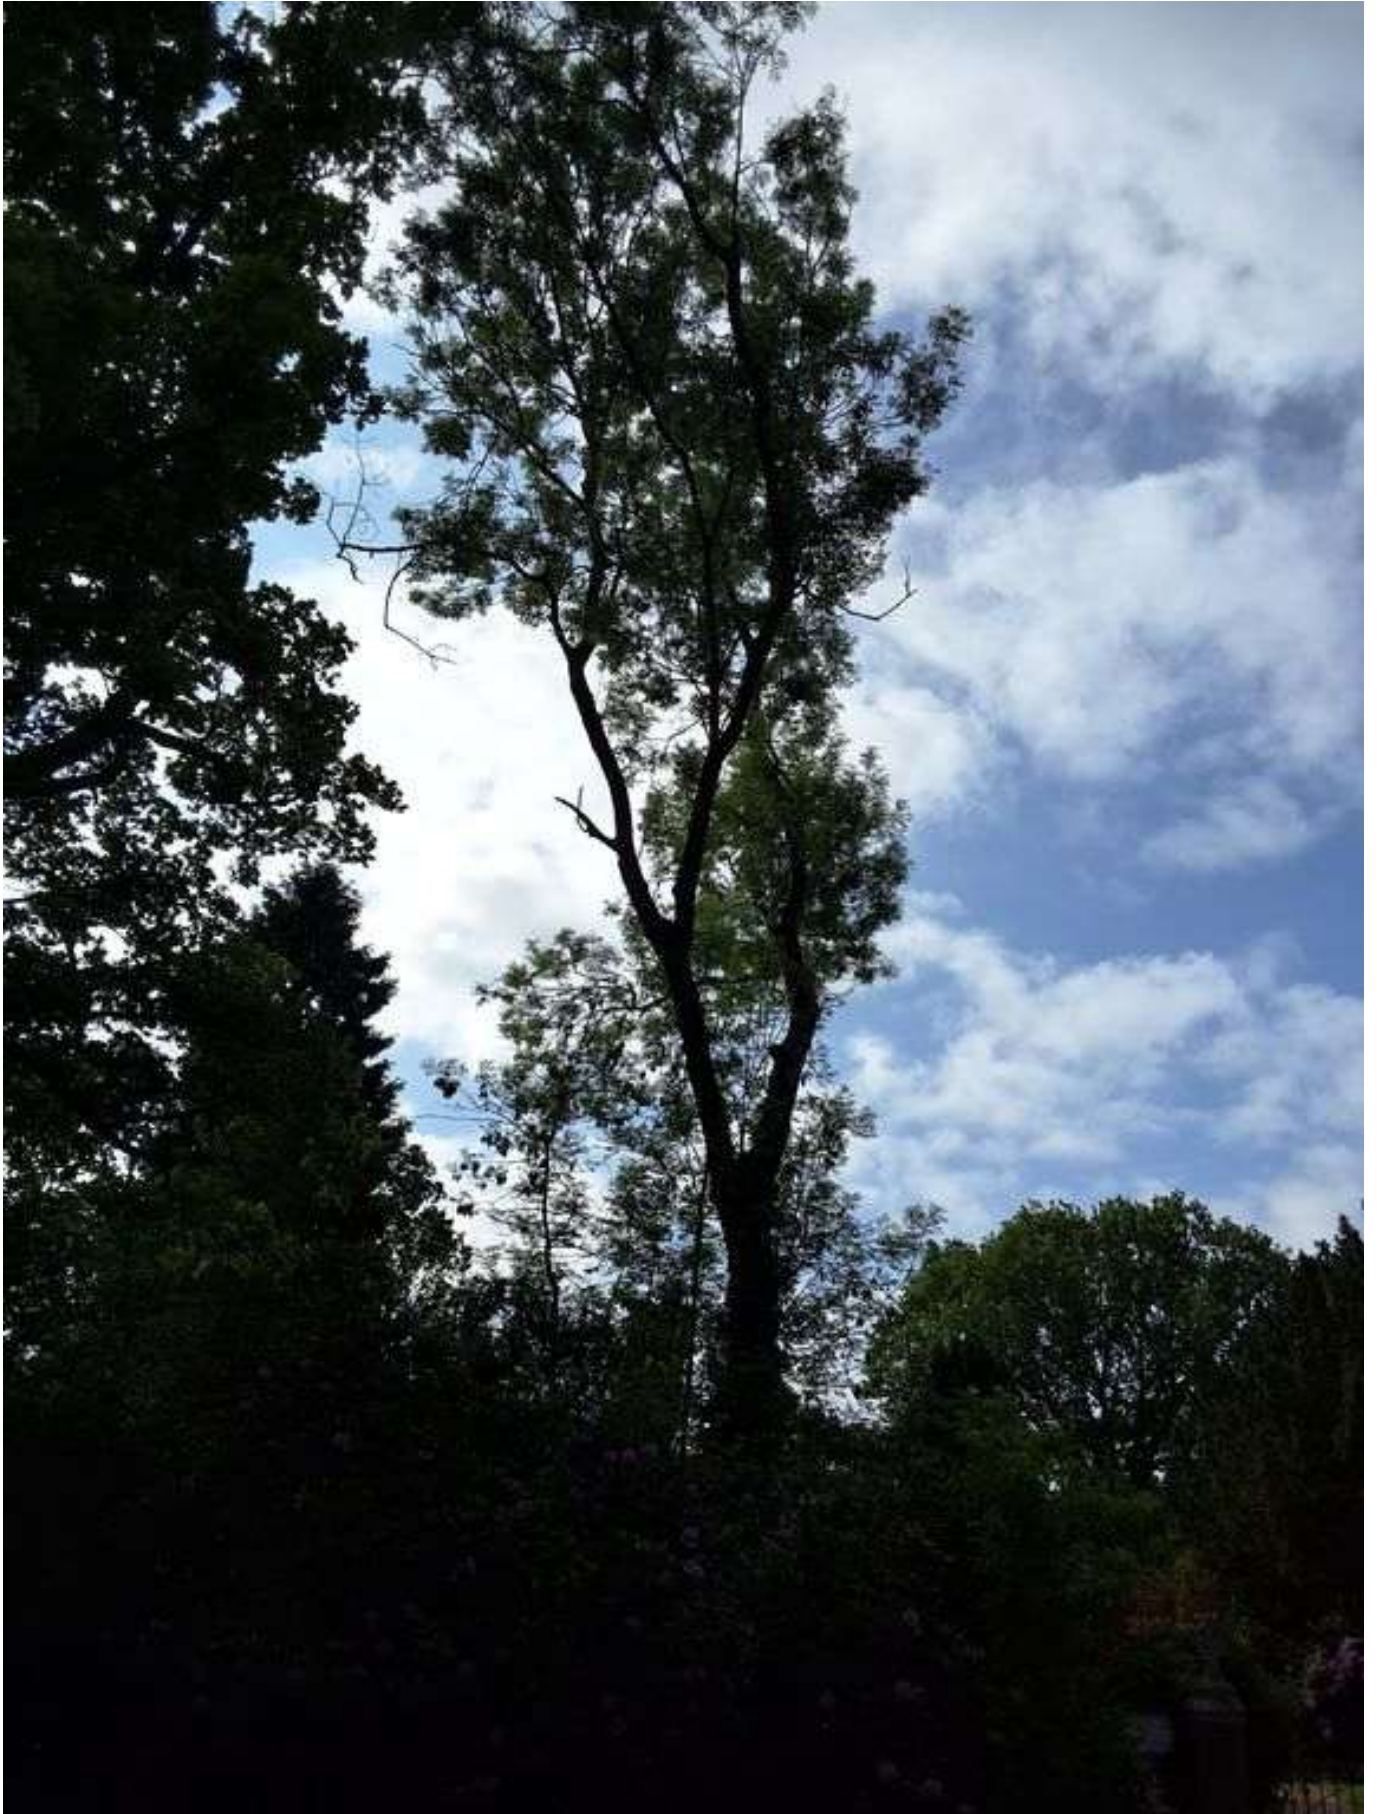
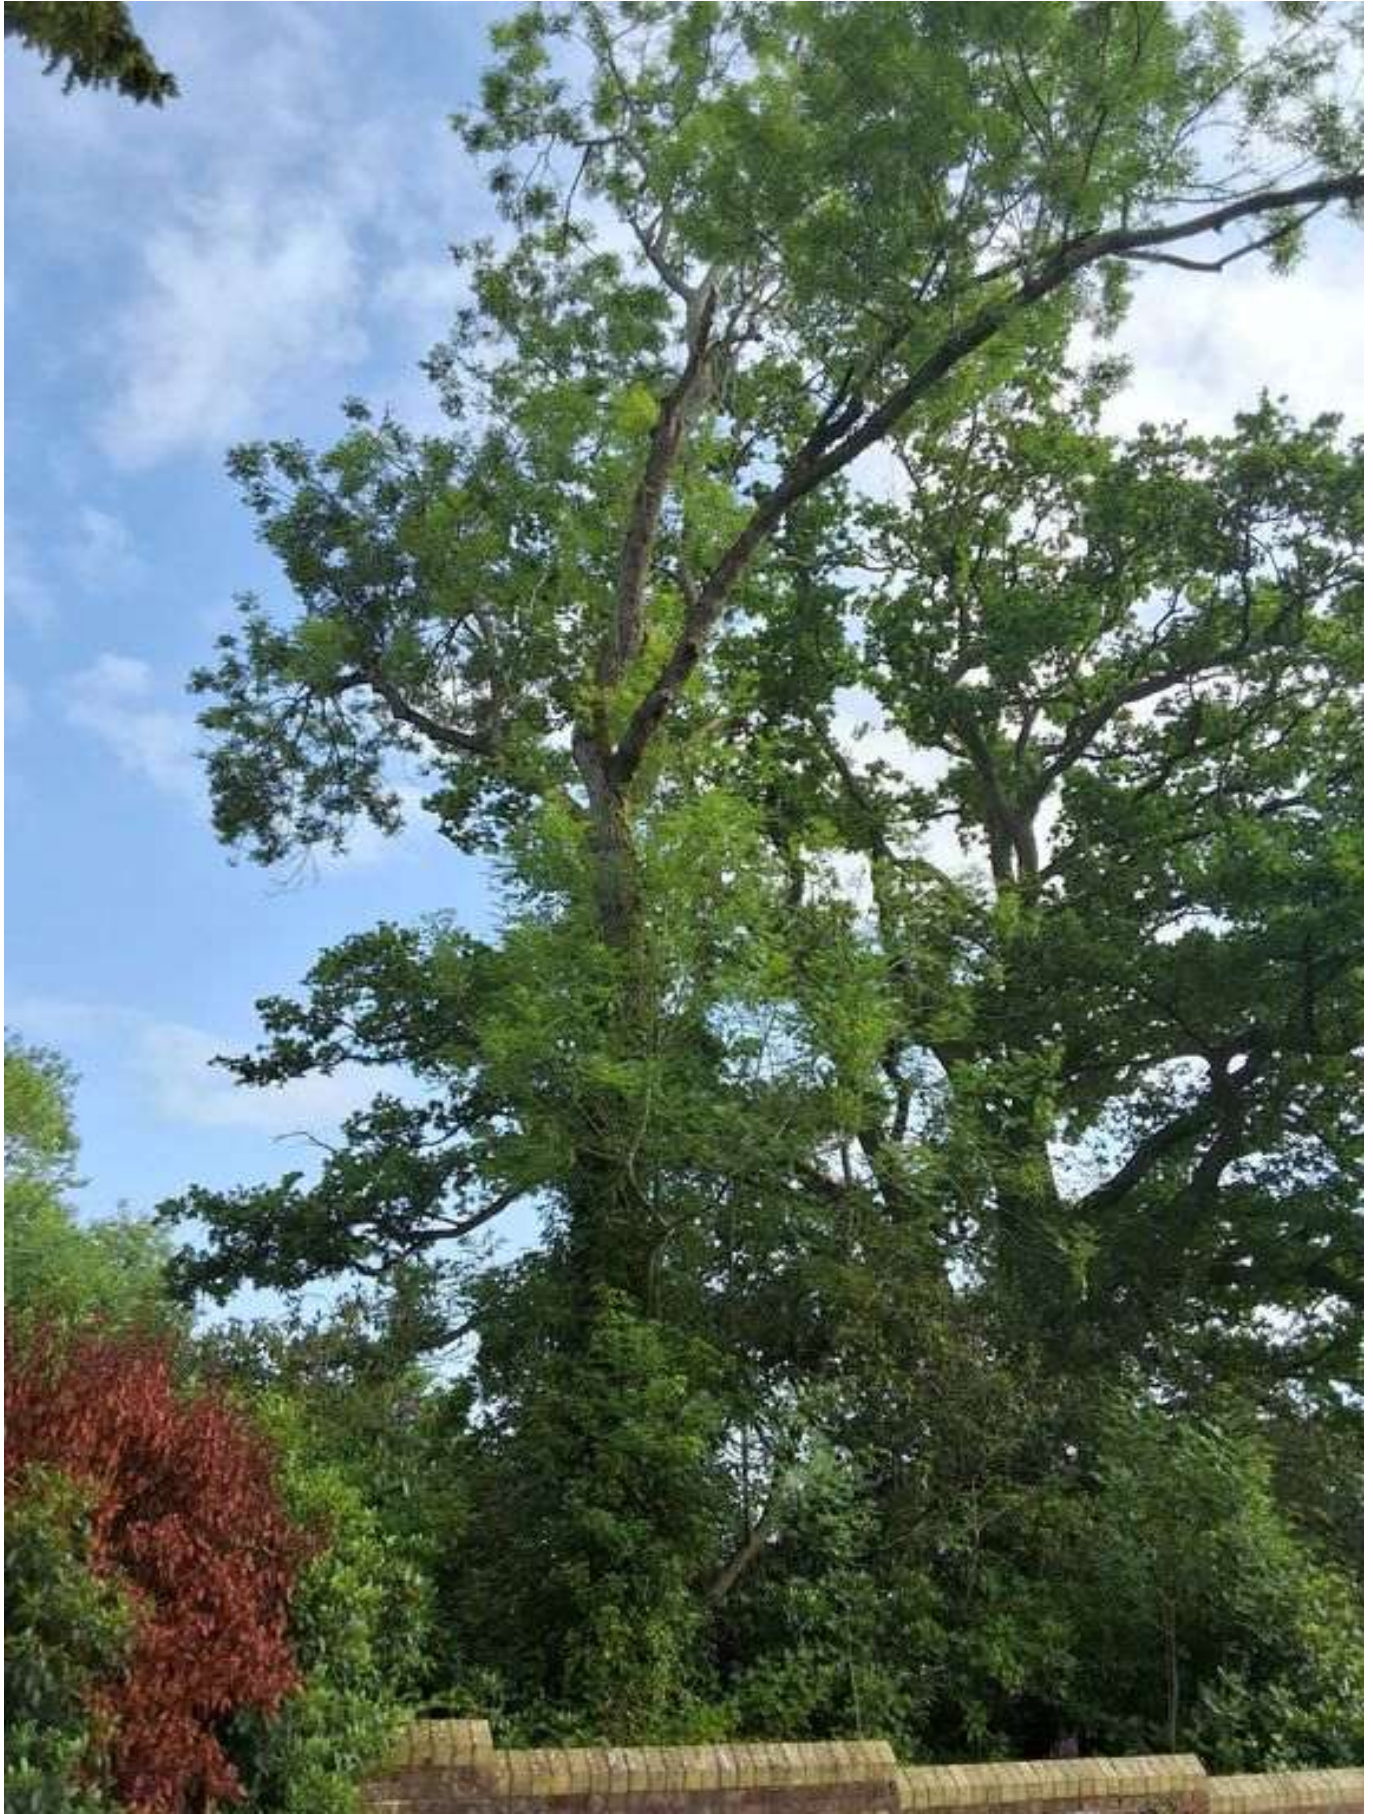
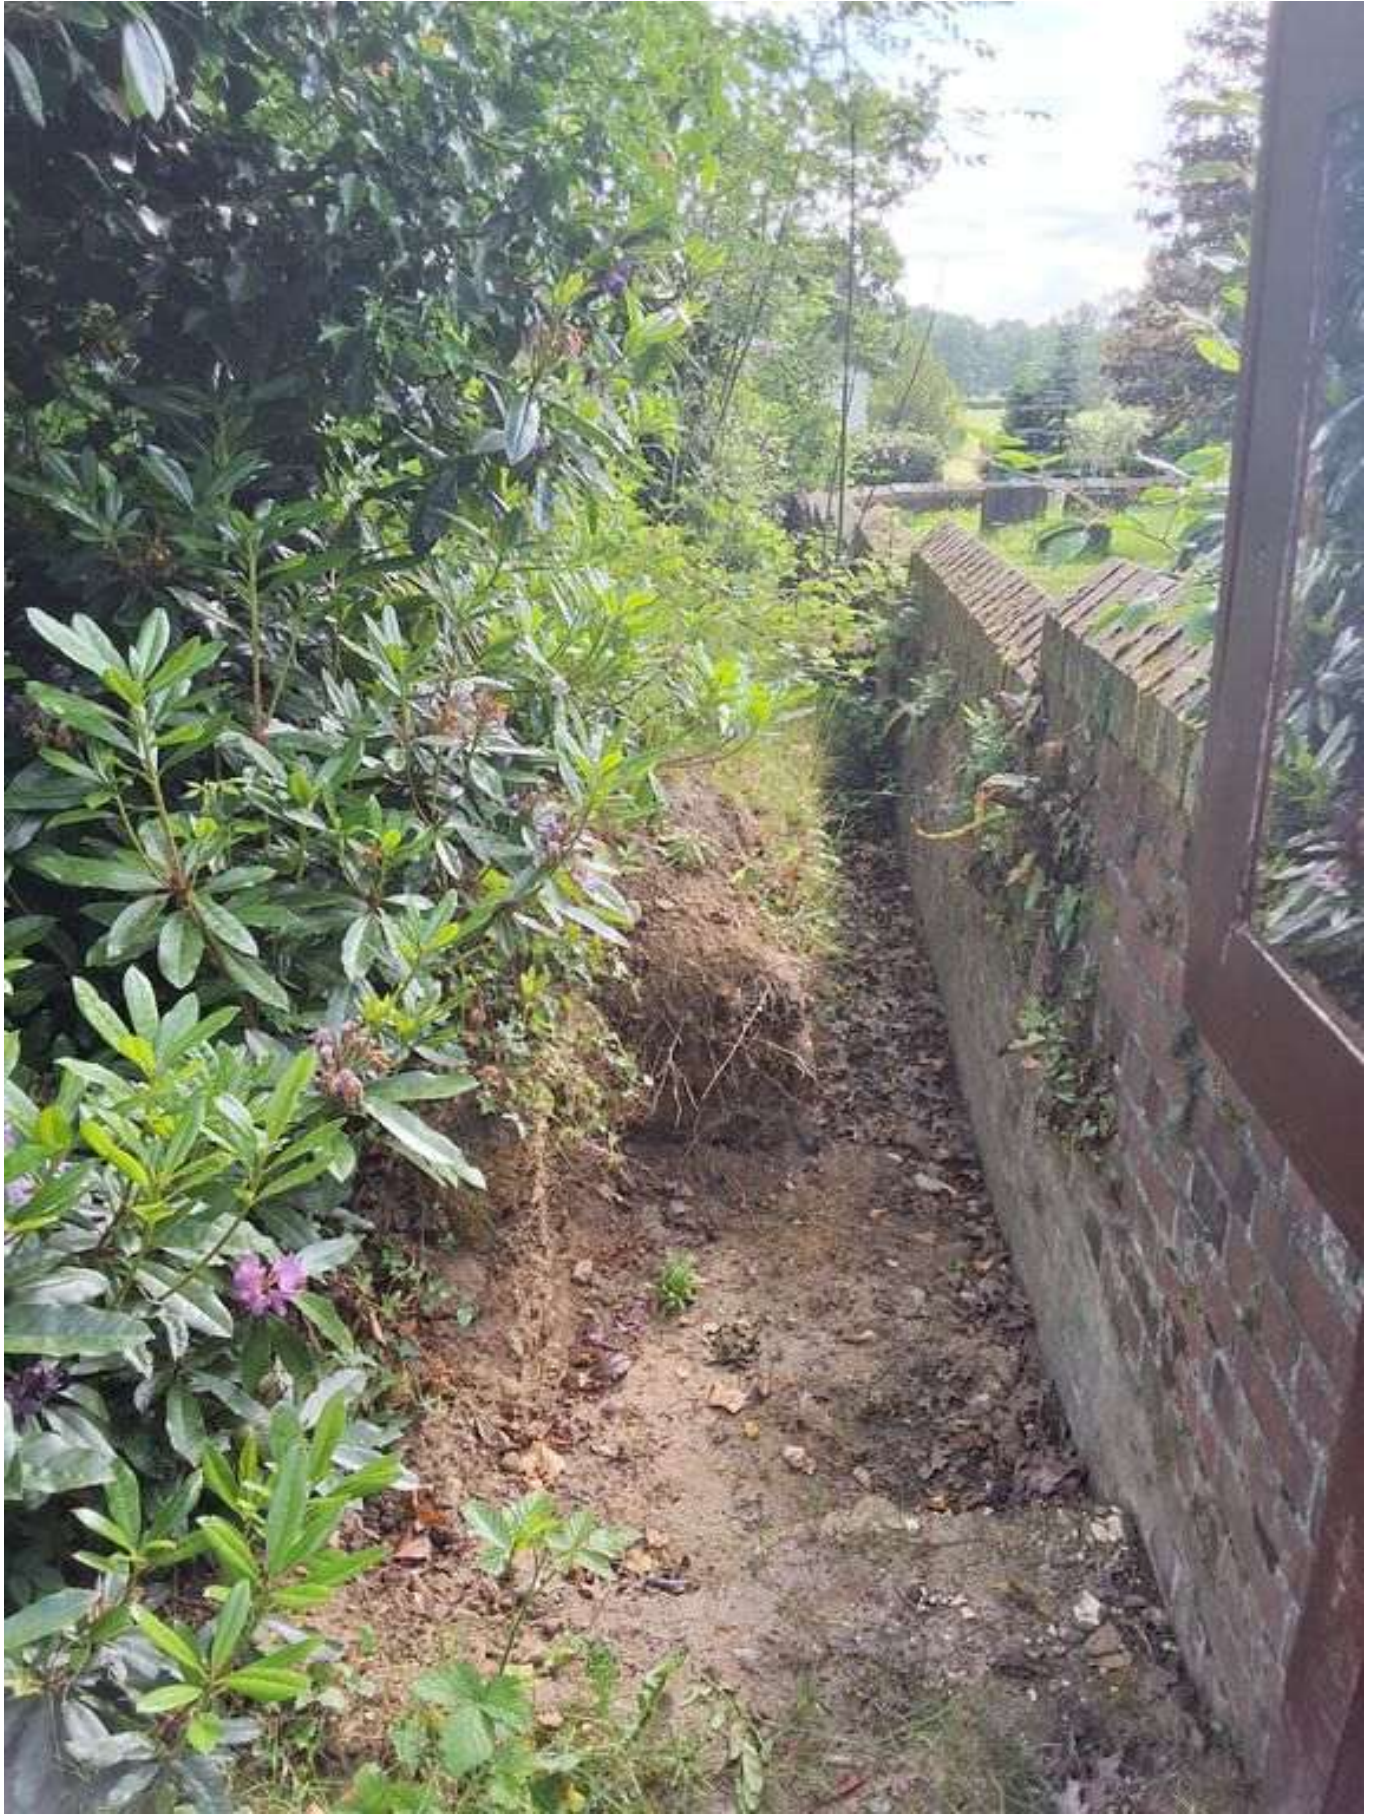
| Tree Survey Recommendations | | | | | | | |
|---|---|---|---|---|---|---|---|
| T002 | Common ash<br>( <i>Fraxinus excelsior</i> ) | Owned by the estate.<br>Target # - graveyard.<br>Target # - footpath.<br>Target # - road. | Height (m): 18<br>Crown Radius (m): 7<br>DBH (cm): 40<br>Life Stage: Early Mature<br>Life Exp.: <10 years | Overweight, subsiding or lion-tailed limbs.<br><br>Pests and Diseases:<br>Ash Dieback Infection Level 2: 25% to 50% | Fair | No action required. | No Action |

### T002

**Failure Score**

Likely, foreseeable ▼

**Target Score**

Low ▼

**Impact Score**

Moderate ▼

**Risk Score**

180

**Threat Category**

3: Slight

**T002-** No work currently recommended. Reinspect in 1 year.

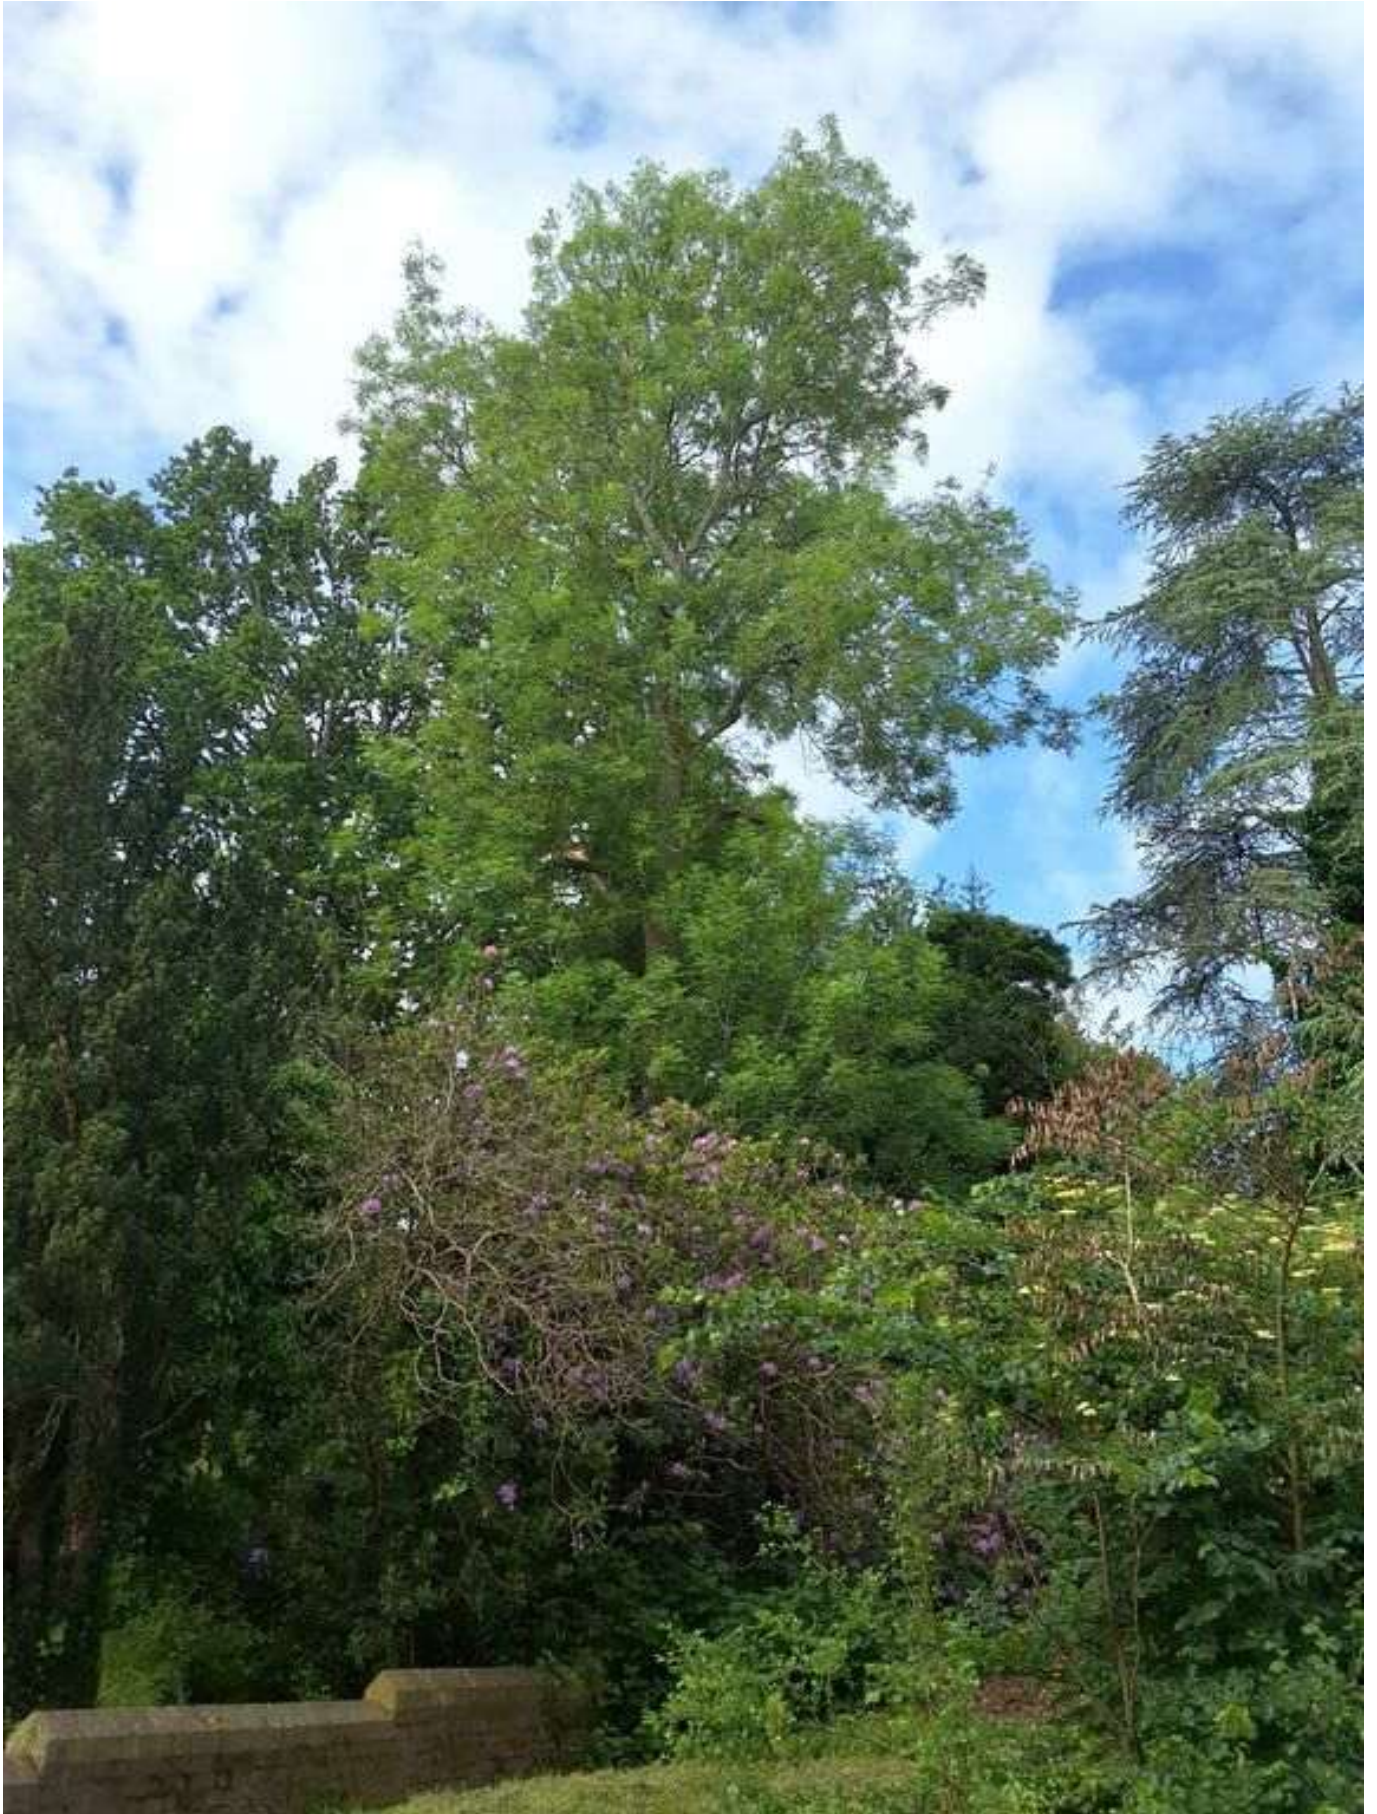
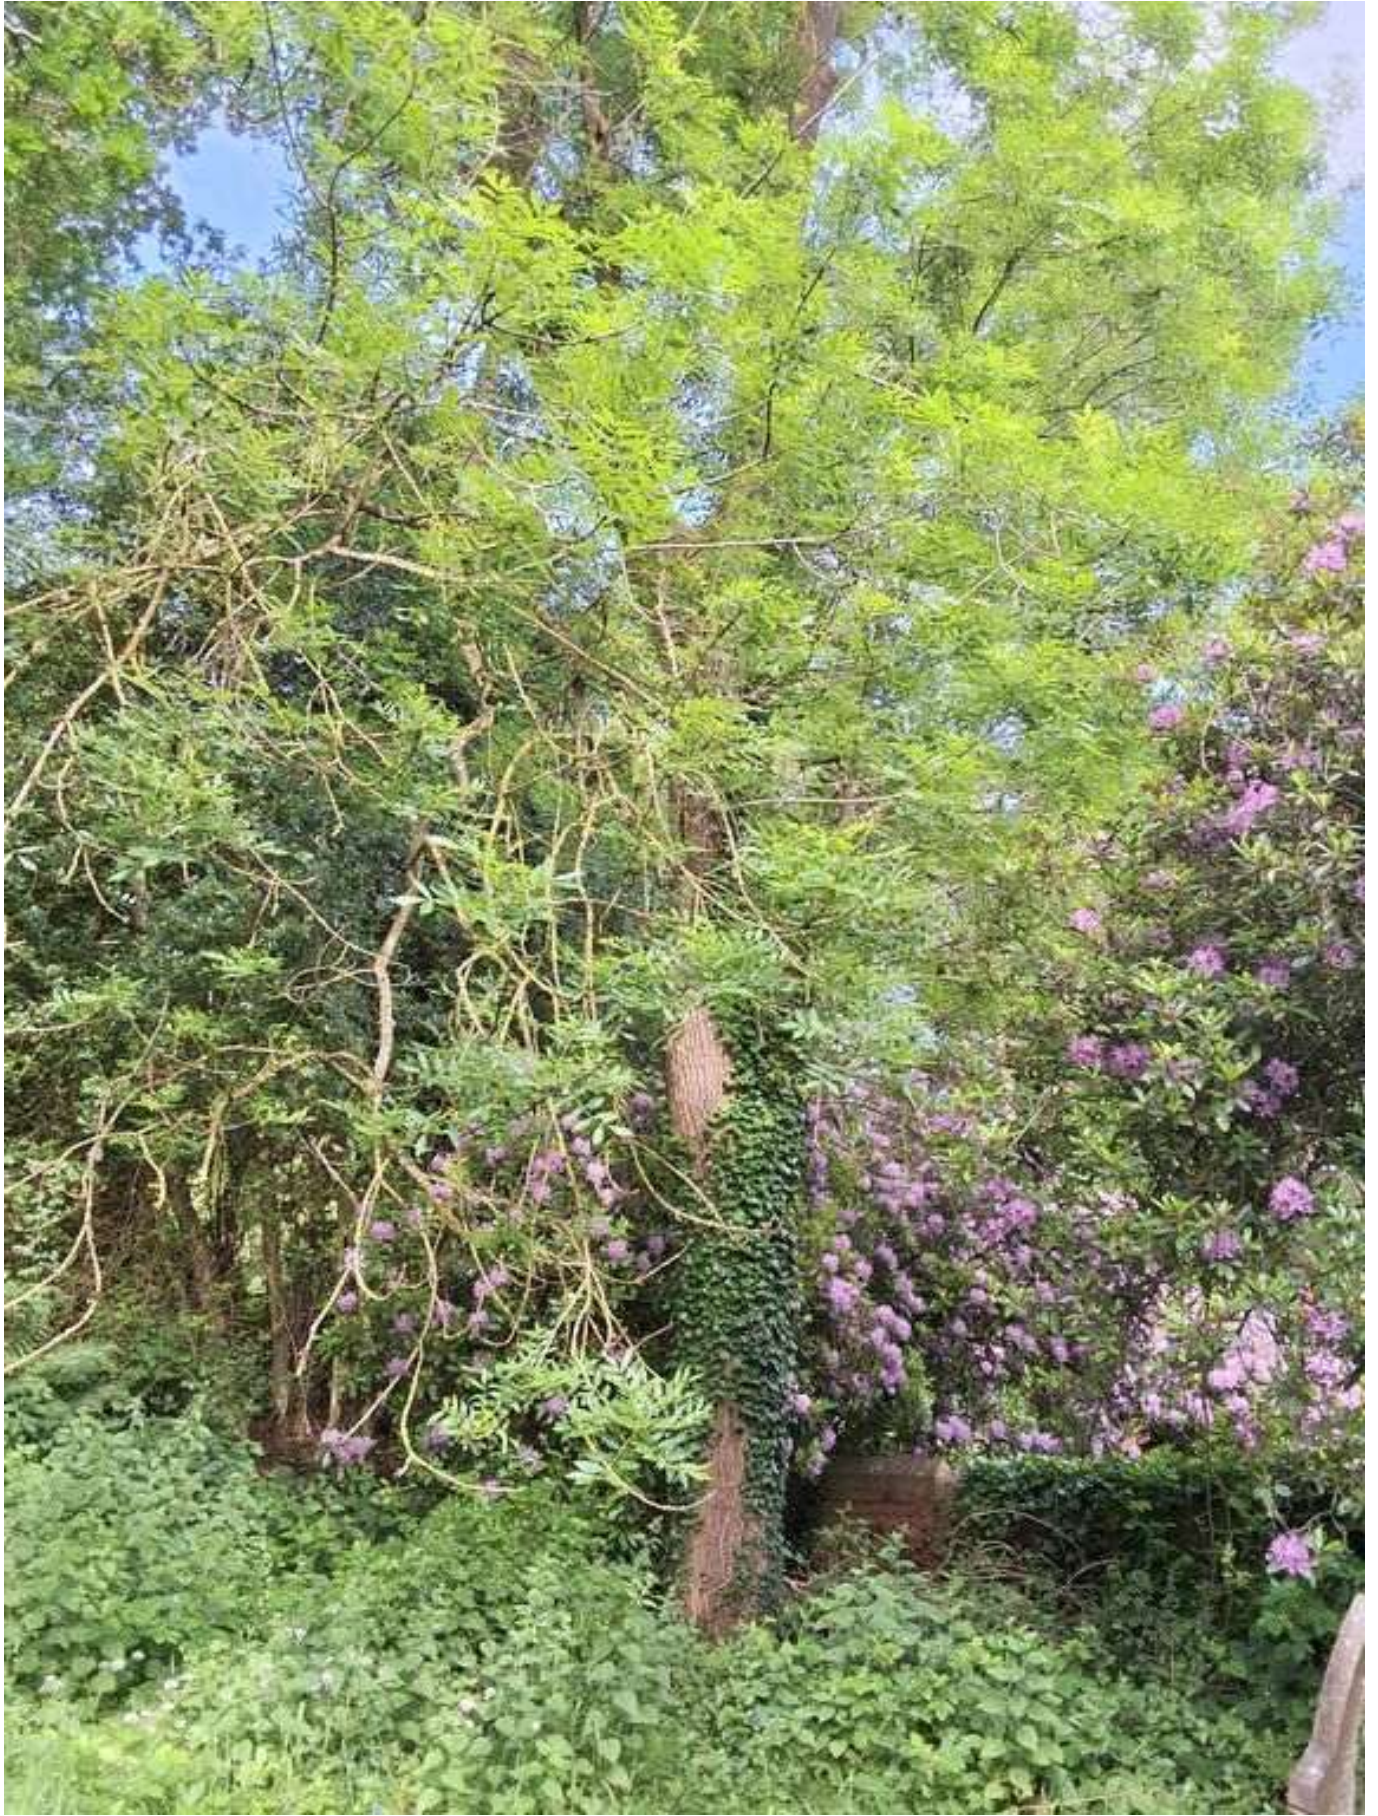
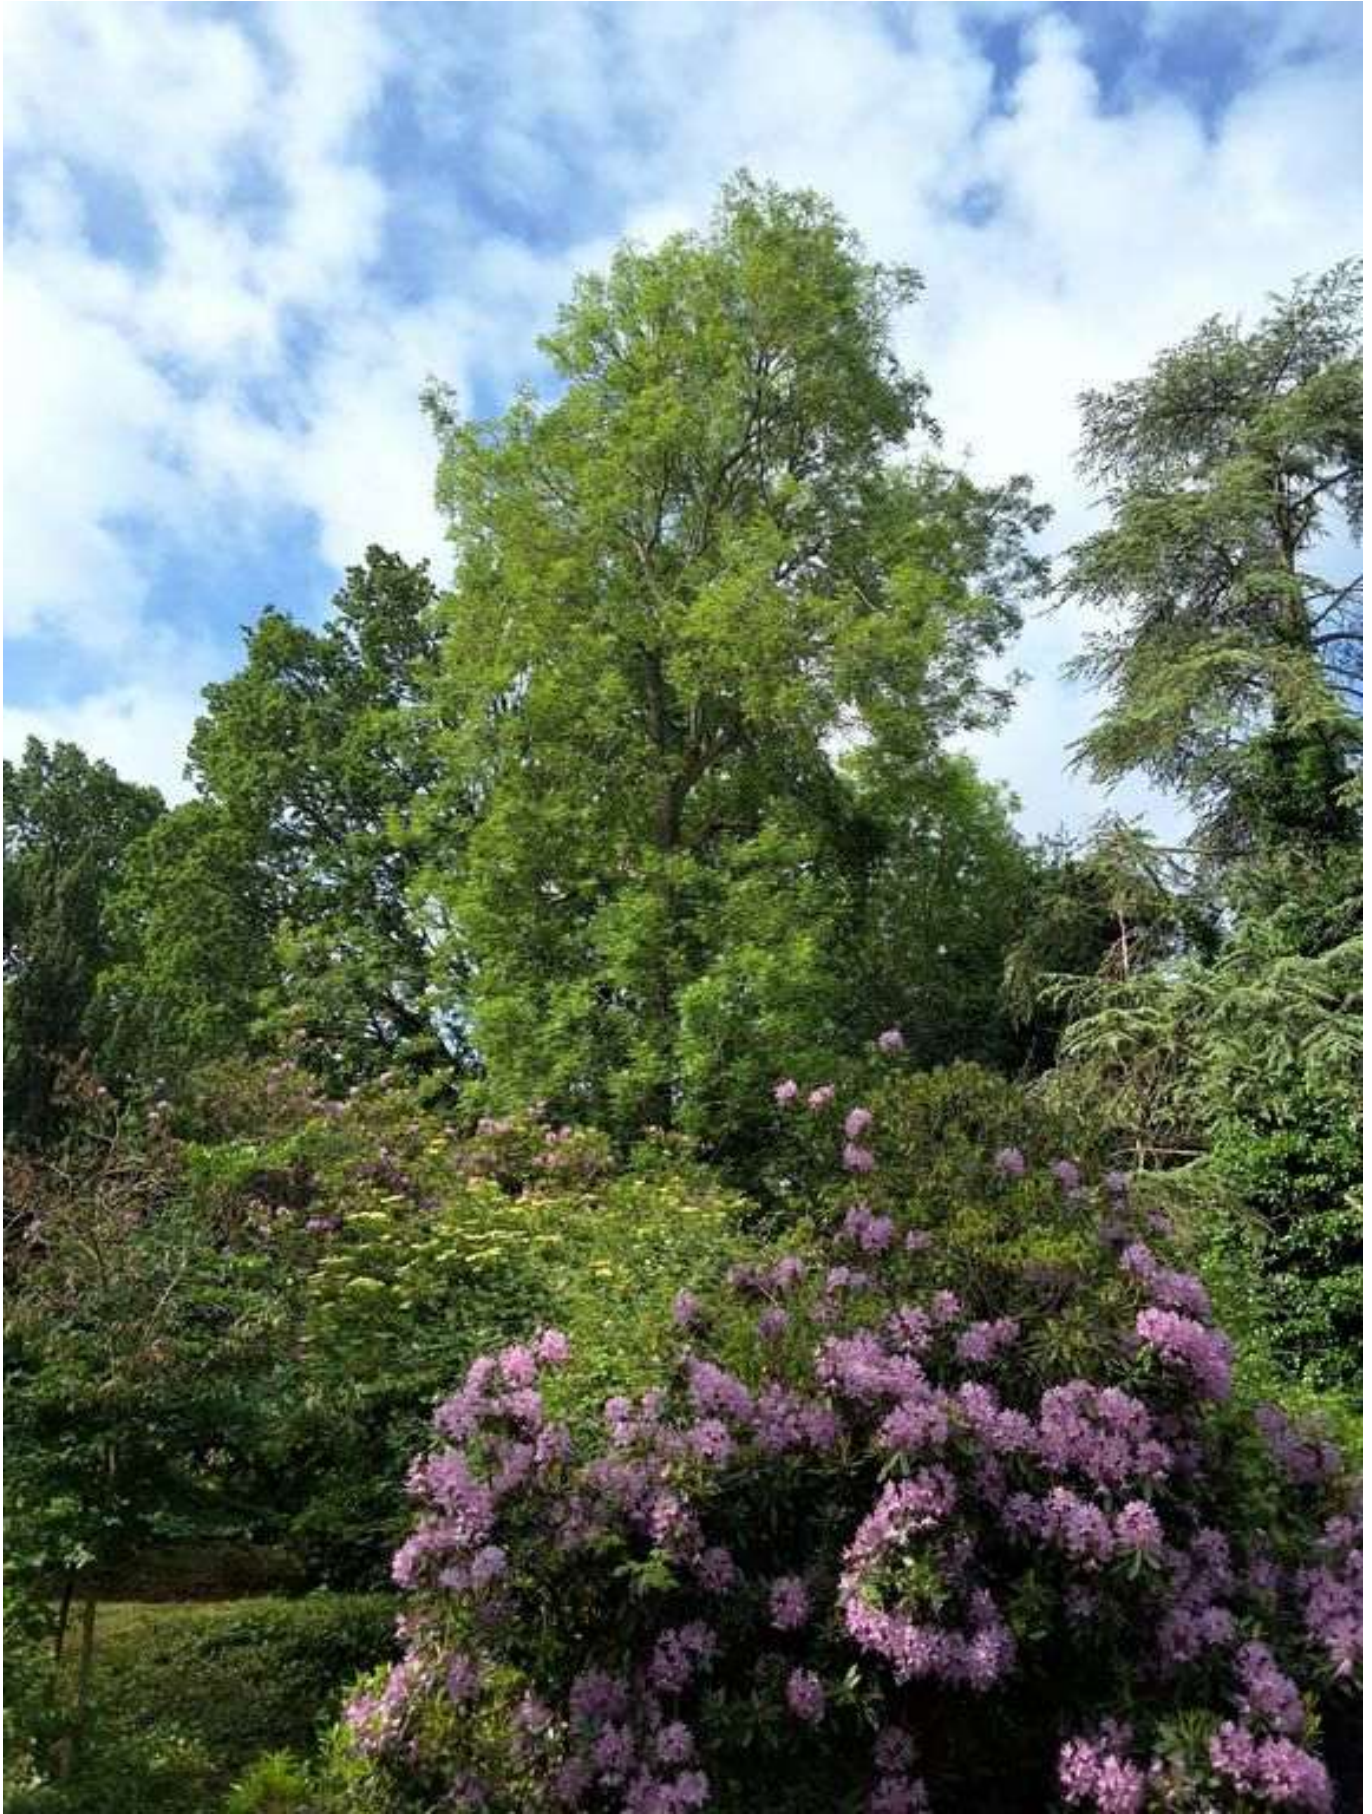
| Tree Survey Recommendations | | | | | | | |
|---|---|---|---|---|---|---|---|
| T003 | Common ash<br>( <i>Fraxinus excelsior</i> ) | Owned by the estate.<br>Target # - graveyard.<br>Target # - footpath.<br>Target # - road. | Height (m): 18<br>Crown Radius (m): 7<br>DBH (cm): 40<br>Life Stage: Early Mature<br>Life Exp.: <10 years | Overweight, subsiding or lion-tailed limbs.<br><br>Pests and Diseases:<br>Ash Dieback Infection Level 2: 25% to 50% | Fair | No action required. | No Action |

### T003

**Failure Score**

Likely, foreseeable ▼

**Target Score**

Low ▼

**Impact Score**

Moderate ▼

**Risk Score**

180

**Threat Category**

3: Slight

**T003-** No work currently recommended. Reinspect in 1 year

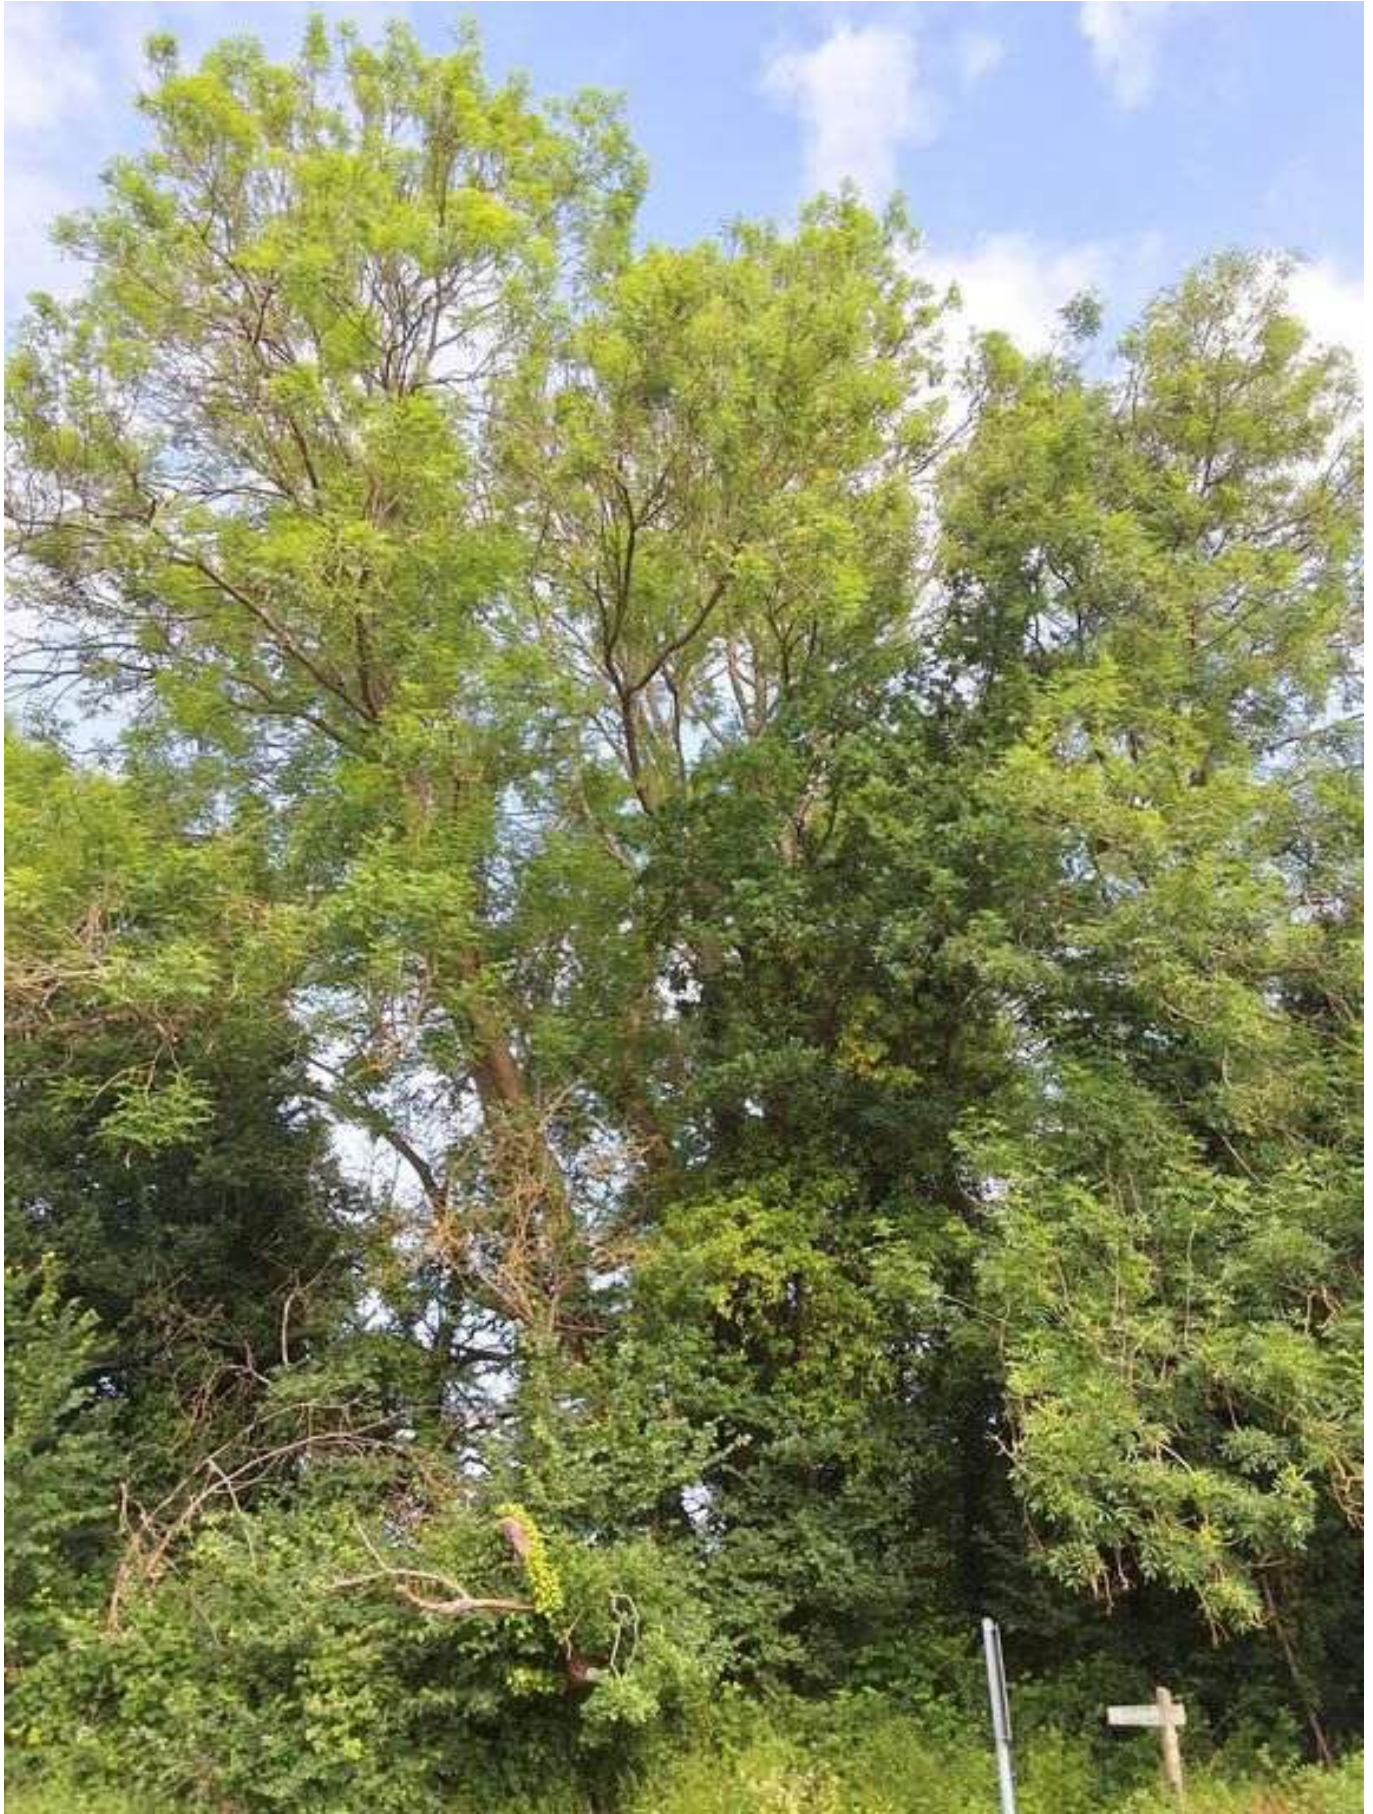
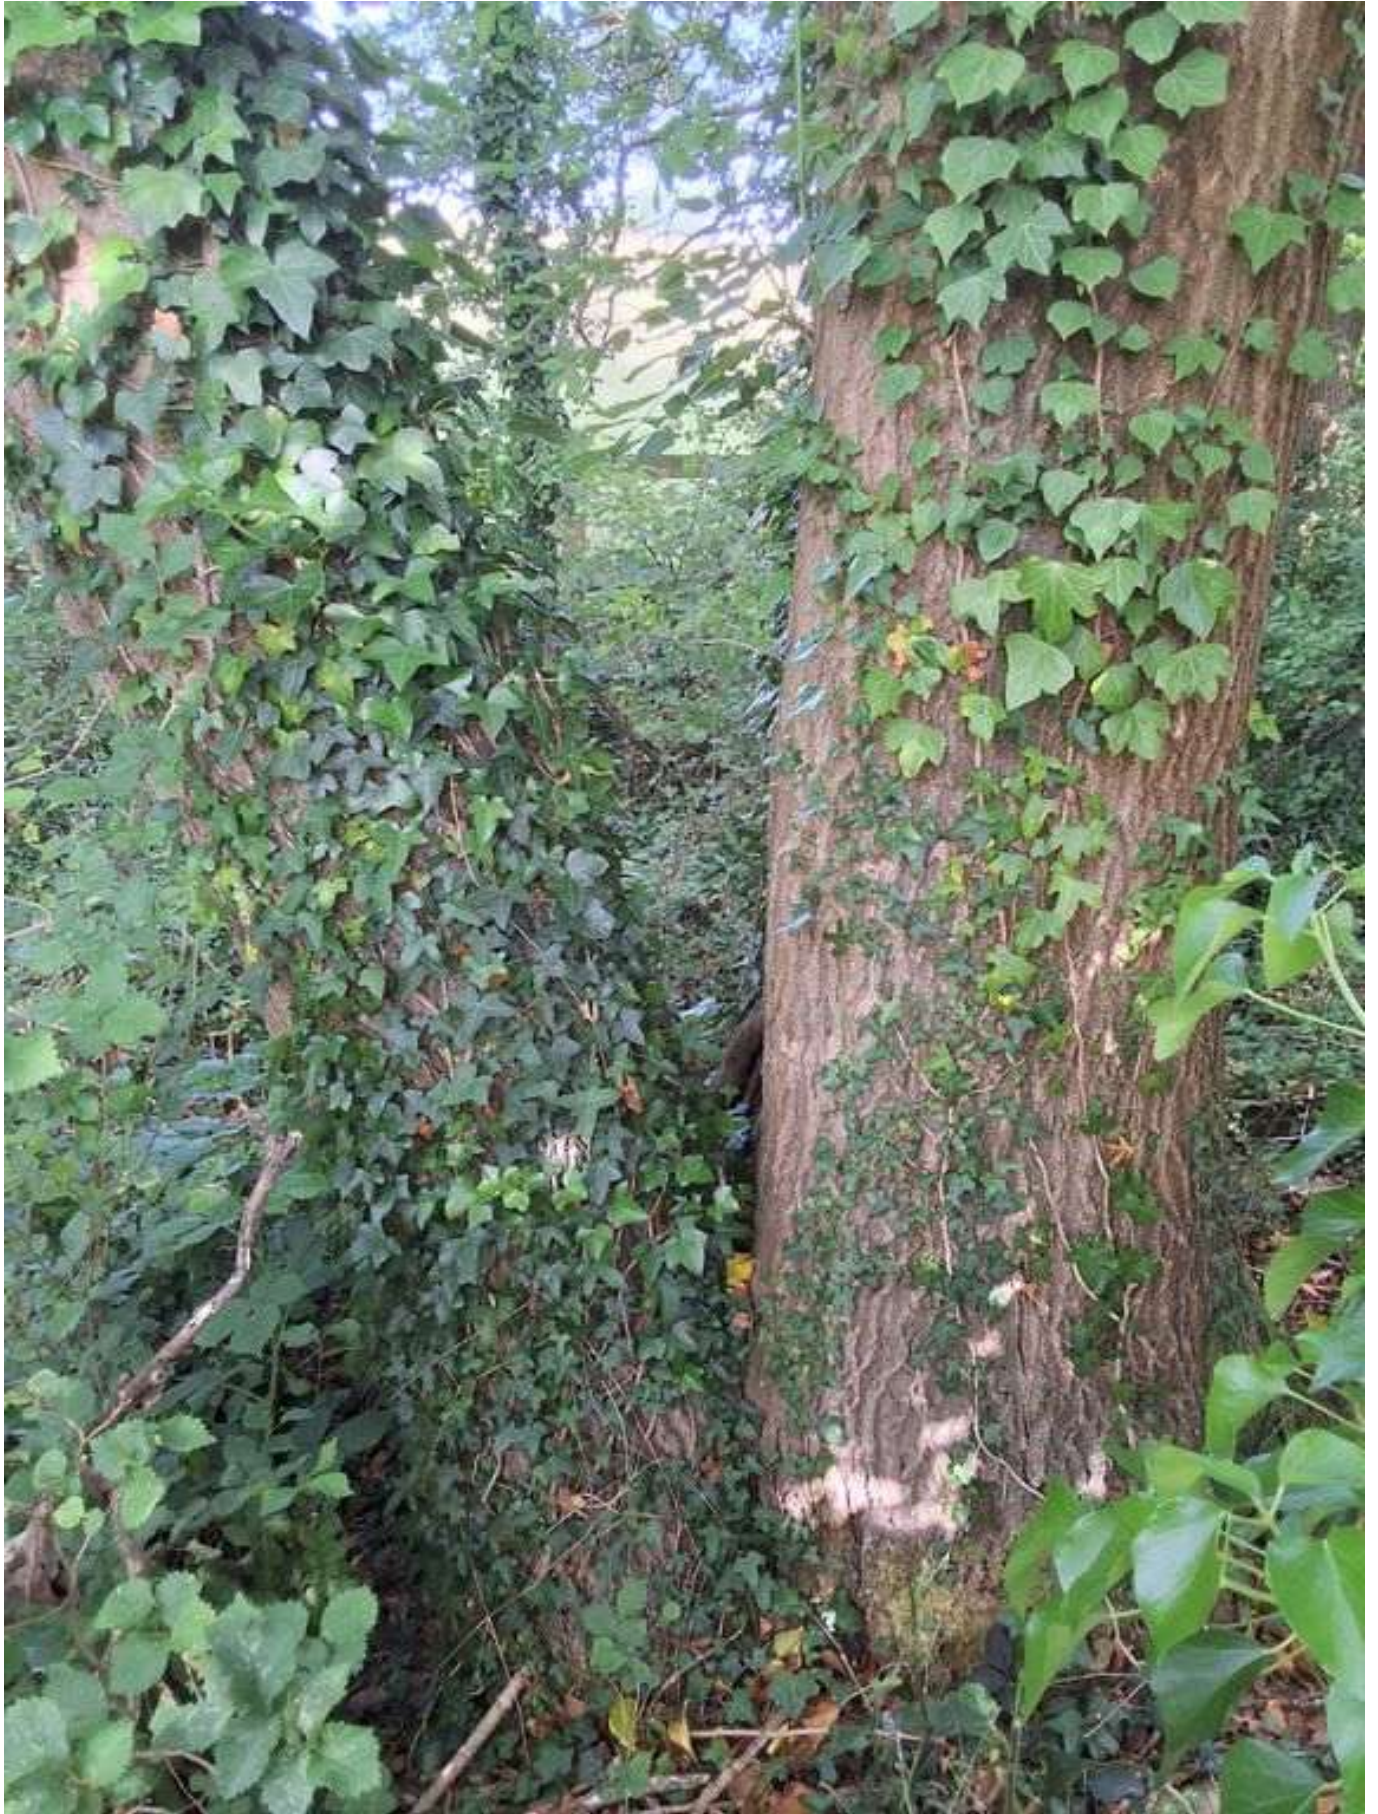
| Tree Survey Recommendations | | | | | | | |
|---|---|---|---|---|---|---|---|
| G001 | Common ash x4<br>( <i>Fraxinus excelsior</i> ) | Owned by the estate.<br>Target # - car park.<br>Target # - footpath.<br>Target # - road. | Height (m): 19<br>Crown Radius (m): 10<br>DBH (cm): 30<br>Trees: 4<br>Life Stage: Mature<br>Life Exp.: <10 years | Pests and Diseases:<br>Ash Dieback Infection Level 2: 25% to 50% | Poor | Fell triple stemmed ash within group.<br>Monitor remaining ash | 18-July-2025 (1 Month) for fell. 31-May-2025 (1 Year) for reinspection |

**G001-** 1x triple stemmed ash tree within G001 has been assessed via the THREATS risk matrix. All other trees were of no significance for risk analysis although in early stages of the ash die back disease. The progression of the disease within this group is to be monitored in line with the recommendations in this report.
