**A Tree Condition Report carried out at:**

**St James Church  
Church Lane, Finchampstead  
RG40 4LU**

**10/06/2025**

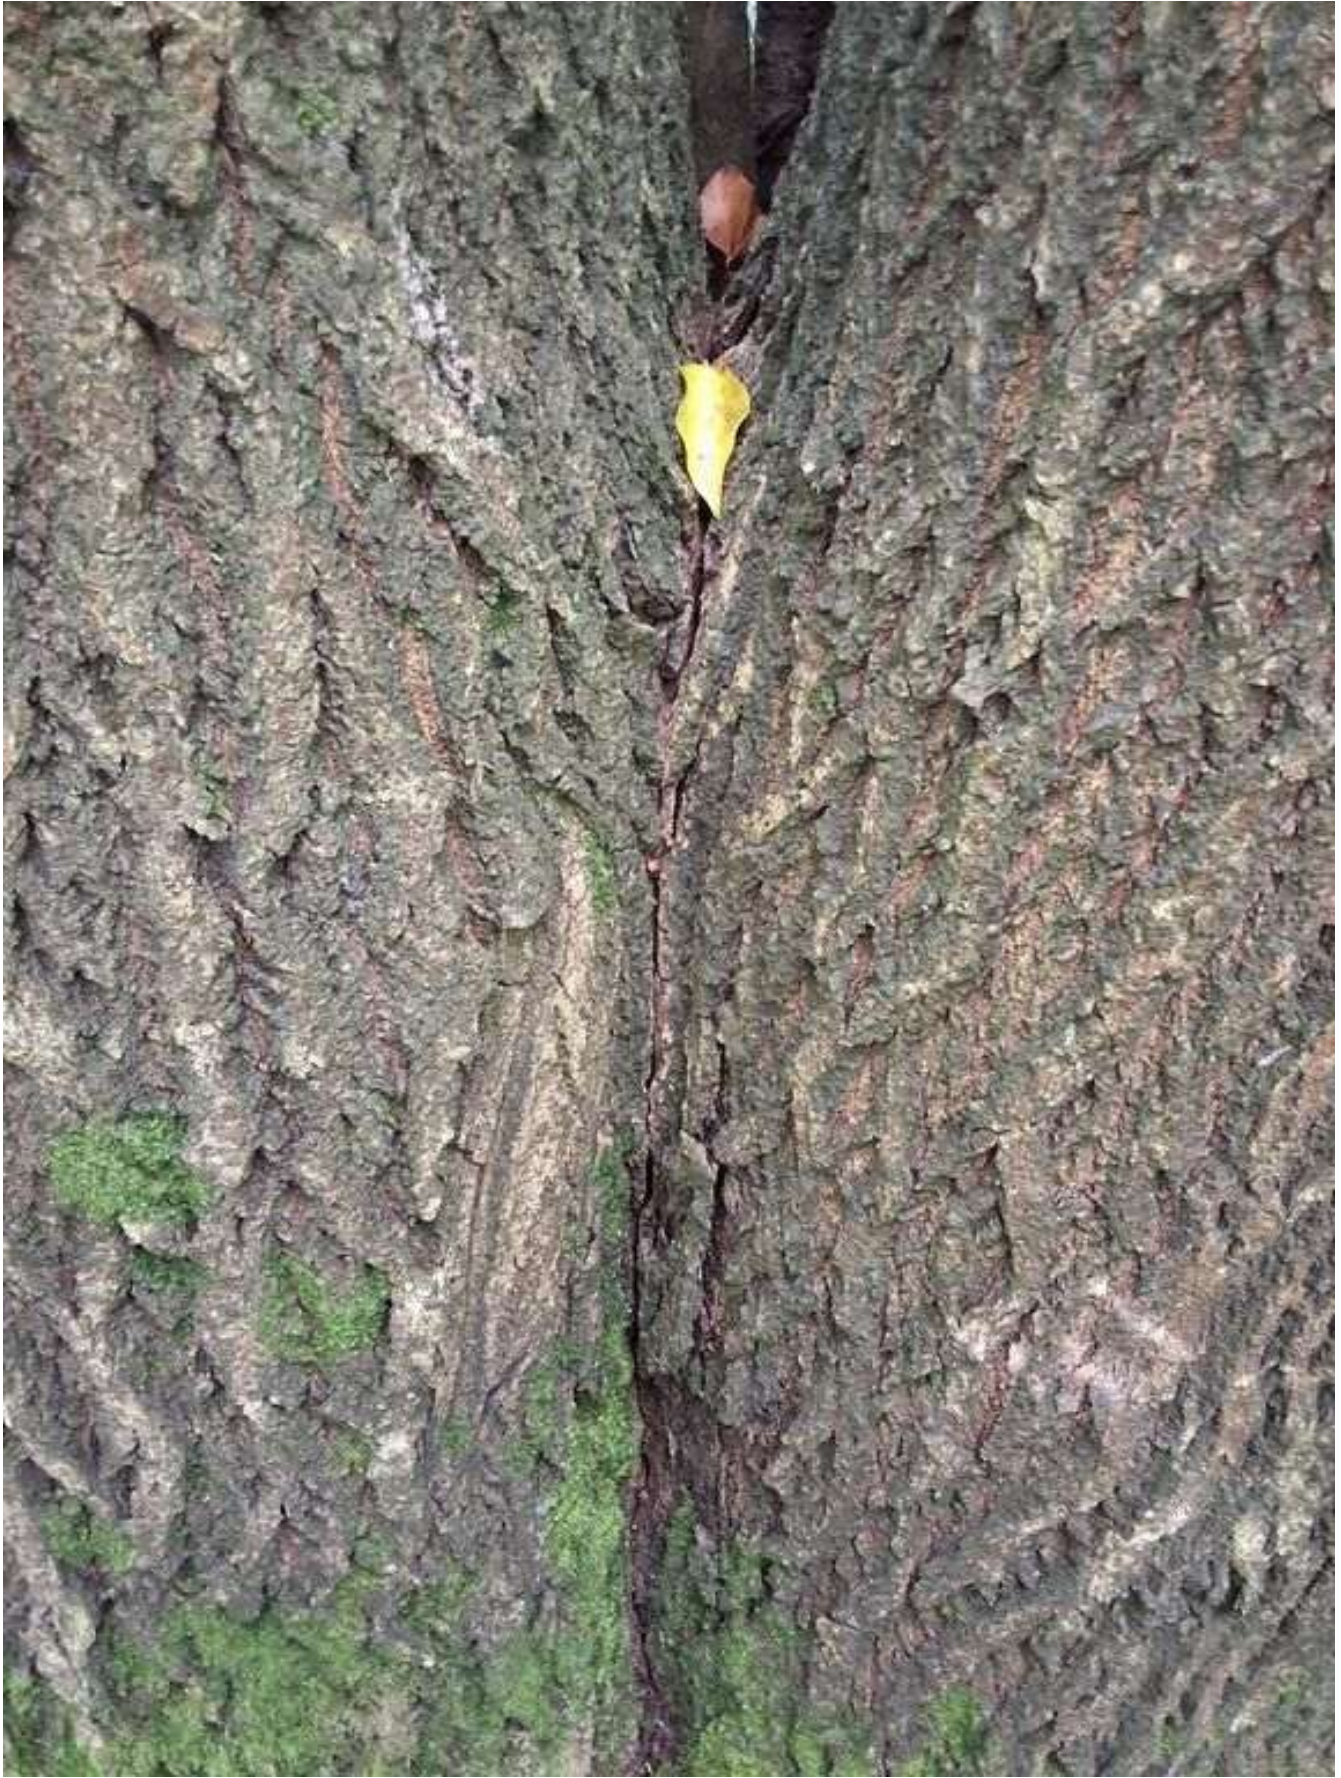
**Photo 17 (G001)**

| Tree Survey Recommendations | | | | | | | |
|---|---|---|---|---|---|---|---|
| G001 | Common ash x4<br>( <i>Fraxinus excelsior</i> ) | Owned by the estate.<br>Target # - car park.<br>Target # - footpath.<br>Target # - road. | Height (m): 19<br>Crown Radius (m): 10<br>DBH (cm): 30<br>Trees: 4<br>Life Stage: Mature<br>Life Exp.: <10 years | Pests and Diseases:<br>Ash Dieback Infection Level 2: 25% to 50% | Poor | Fell triple stemmed ash within group.<br>Monitor remaining ash | 18-July-2025 (1 Month) for fell. 31-May-2025 (1 Year) for reinspection |

### G001

**Failure Score**

Probable/Soon ▼

**Target Score**

Medium ▼

**Impact Score**

Severe ▼

**Risk Score**

1,600

**Threat Category**

5: Significant

**G001-** Due to the split stem separating at the fork junction from ground level to 1m and evidencing movement in photo 17 this tree should be removed.
