# Tree Management, Duty of Care Report©

Site: St Cecilia's C of E School, Howlett Grove, Wokingham, RG41 1BJ

Client: c/o Chloe Franklin    Date: 13/01/26    Surveyor: Danny Konstantinidis

## HERITAGE TREE SERVICES ABORICULTURAL DUTY OF CARE & MAINTINANCE SURVEY

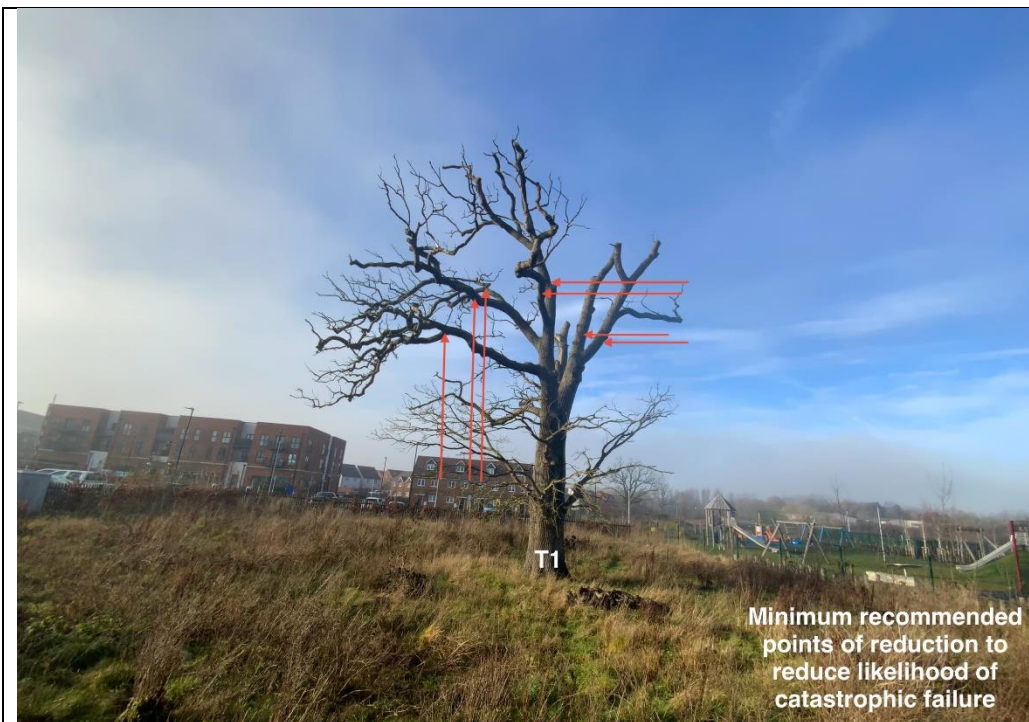
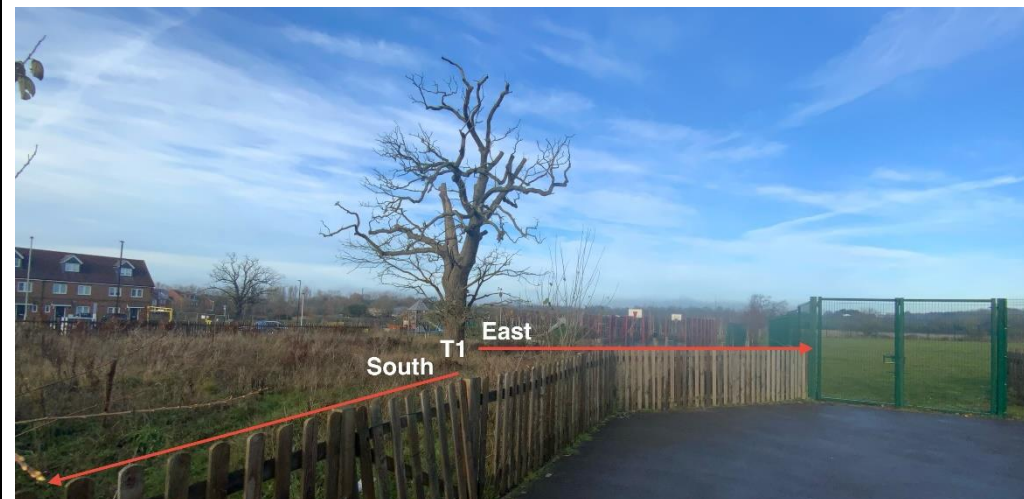
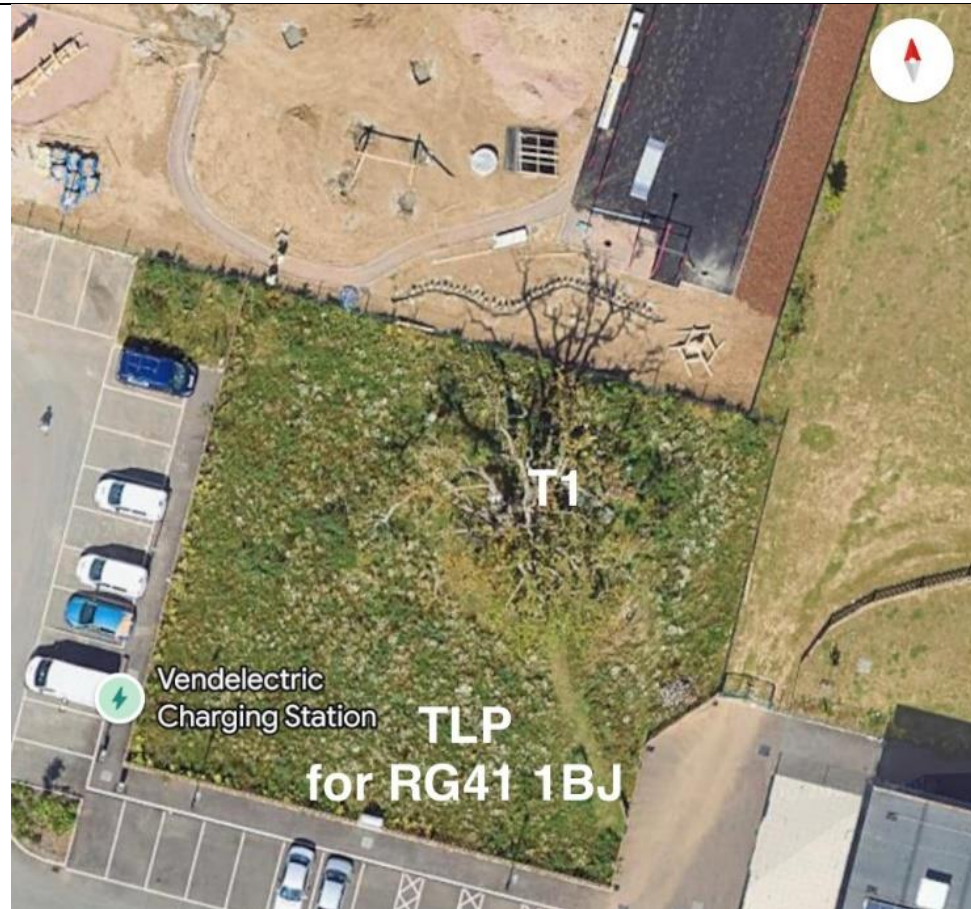
| Tree Group<br>Hedge<br>or<br>Shrub<br>N°<br><br>Tag N° | SPECIES | AGE | H<br>e<br>i<br>g<br>h<br>t<br><br>S-<br>VL | PHYSIO<br>LOGICAL<br>STATUS<br><br>Good<br>Fair<br>Poor<br>Dead | STRUCTUR<br>AL<br>STATUS<br><br>Good<br>Fair<br>Poor<br>Dead | ARBORICULTURISTS<br>OBSERVATIONS | RECOMMENDED<br>WORKS | S.O.P<br>+<br>L.O.F<br>+<br>T.A.O<br><br>1-3 | Action<br>Relative<br>To<br>Score<br><br>3-9 | Advised<br>Time<br>Scale<br>In months<br>from date<br>of survey<br><br>A-C |
|---|---|---|---|---|---|---|---|---|---|---|
| T1<br>No<br>tag | Oak | M | M | D | P | <p>Dead standing habitat snag.</p> <p>Previously weight bias pruned to the East.</p> <p>Buttress roots on the Northern aspect are the only remaining intact dead roots.<br/>Nylon sounding hammer returns the only semi positive tone from this area.</p> <p>Remaining cardinal points, all return low resonance, indicating, bark delamination &amp; hollowing where bark has fallen, exposing heartwood.<br/>Likely advanced decay leading to hollowing that may now lead to catastrophic failure at base.</p> <p>The tree is 9.4m from Northern boundary fence, 14.5m from Eastern boundary fence, 18m from Southern boundary, &amp; 18.3m from the Western boundary fence.</p> | <p>Further bias pruning to retain as many habitat features as possible.</p> <p>The minimum end height to aim for will be 9m on the Eastern stem &amp; 7m on the Northern stem.<br/>This will bring the tree well within the compound area should catastrophic failure occur.</p> <p>The lower intact lateral branches can be reduced to lessen lever arm weight that may prematurely cause failure if left untouched.</p> <p>Careful consideration to structural condition when</p> | 3<br>2<br>3 | 8 | B |

| | | | | | <p>The tree is measured as 14.3m in height on the upper most Eastern remaining crown &amp; 11.8m from the highest Northern stem point.</p> <p>This Veteran tree is a vital habitat feature within the surrounding landscape.</p> <p>Within UK planning policies, (NPPF para 193(c) the NPPF glossary defines 'ancient or veteran tree' and 'irreplaceable habitat' this tree is categorised as being an irreplaceable habitat.</p> <p>As such, efforts should be made to retain standing for as long as possible.</p> <p>This will be achieved via pruning works to a height that will not impact the play area to the North &amp; the School field entrance to the East.</p> <p>Distances from other targets beyond the fenced off area are well beyond the reach of the tree, should catastrophic failure occur.</p> | <p>works is carried out, will be made.</p> <p>A harder reduction scale may be considered favourable during the time of works, if it is thought that this will likely increase the useful working cycle of standing deadwood habitat beyond that of a lesser reduction in height &amp; lateral spread.</p> <p>Debris to be stacked &amp; laid within drip line.</p> <p><i>As an ongoing project, it may be an idea to bring interested classes of children into the compound to look for self set Oak seedlings. This will of course require risk assessment due to the nature of the area. If suitable seedlings are found, these can be carefully dug up to bring on in the school grounds with the view of planting out as succession trees.</i></p> | | | |
