# CASTLEMANS COTTAGE ROOF REPAIRS

**Planning Portal Reference: PP-13905061**

**BCS Reference: 25/0784/OTHBN**

This document forms part of an application for listed building consent sought for the repairs to the existing second storey tiled roof.

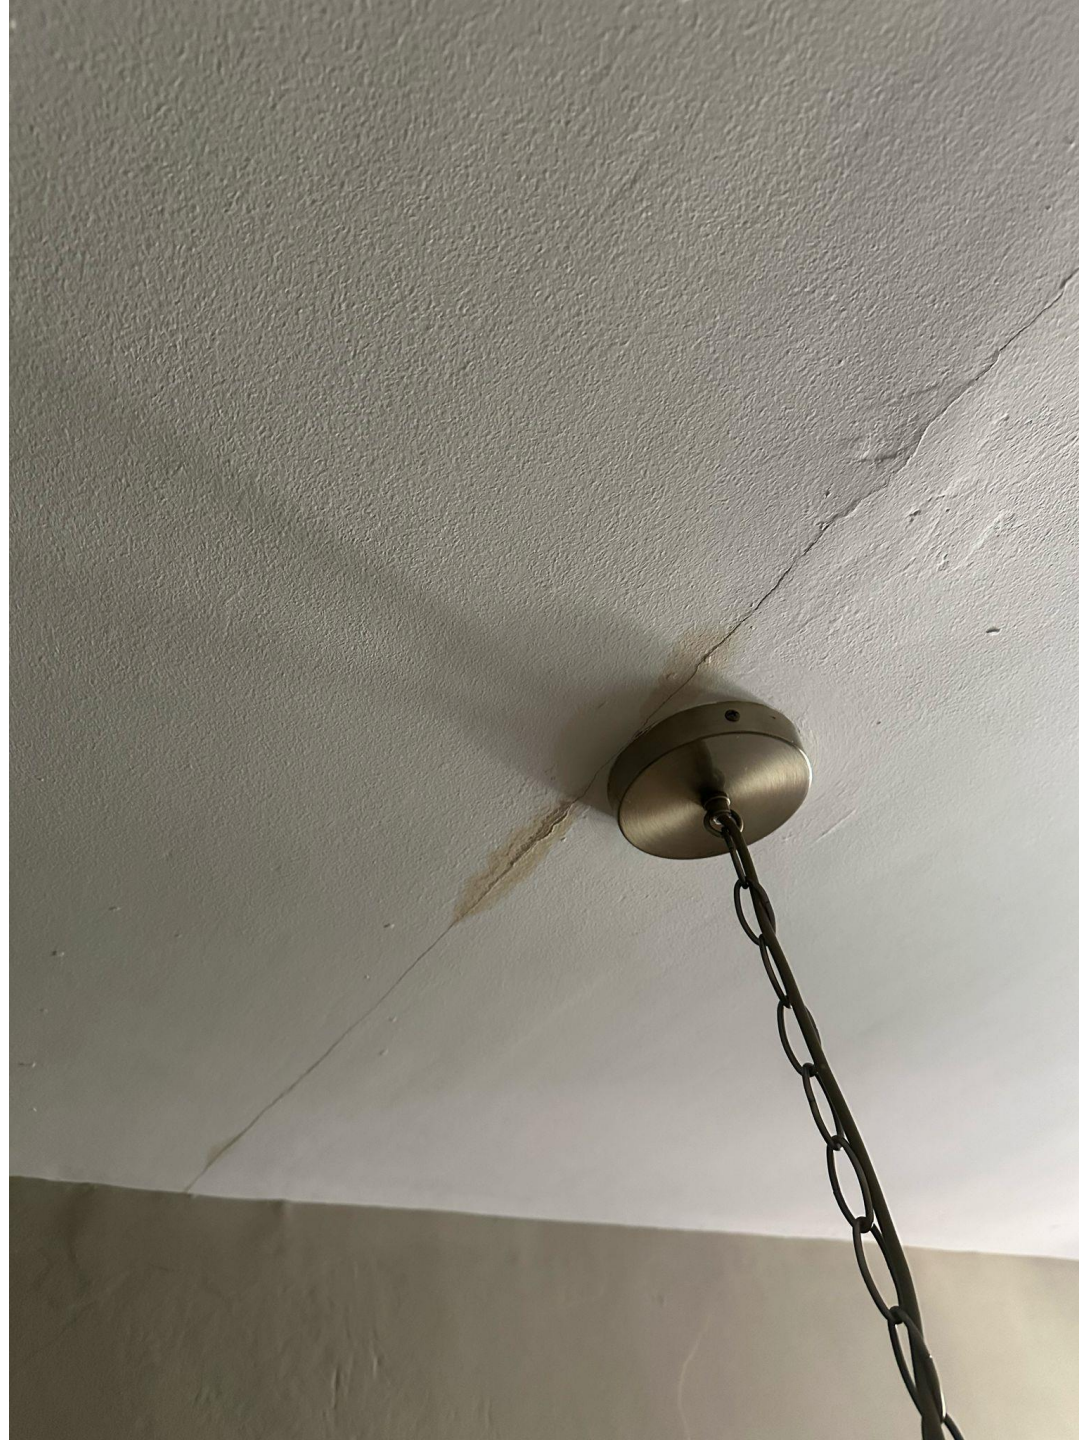
STAINING ON CEILING  
CAUSED BY COLLAPSED VALLEY AND HOLE IN  
FELT  
PROPOSE REINSTATING STRUCTURE, FELT AND  
VALLEY TILES

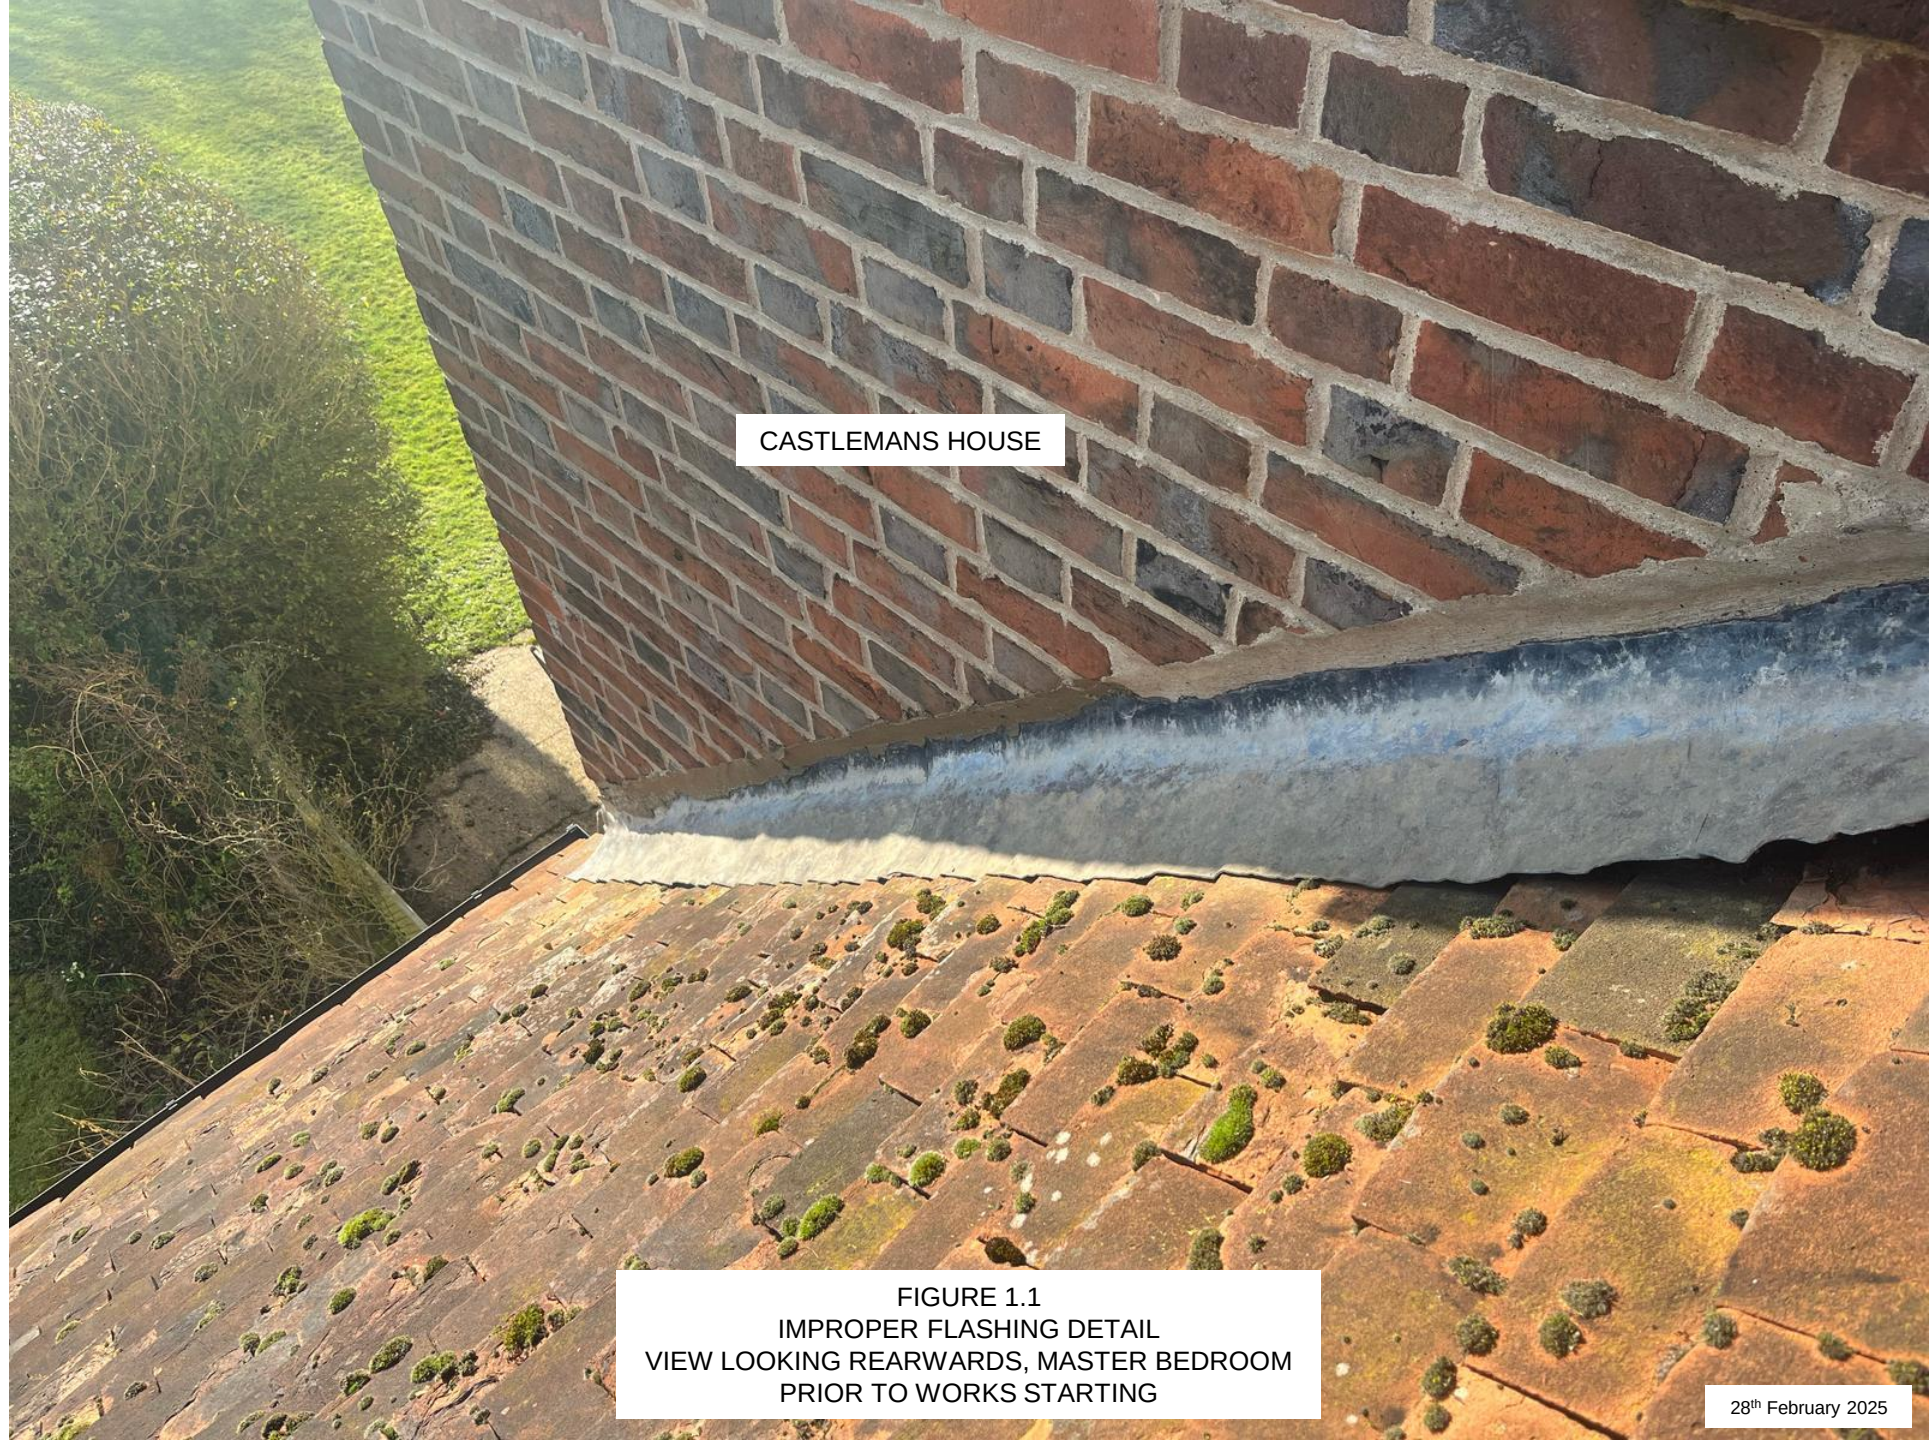
STAINING ON WALL  
CAUSED BY IMPROPER FLASHING/JOINT DETAIL TO  
ABUTTING WALL  
PROPOSED STEPPED LEAD FLASHING WITH  
SOAKERS (TO MATCH EXISTING DETAIL ON  
CHIMNEY)

FIGURE 1.1  
IMPROPER FLASHING DETAIL  
VIEW LOOKING REARWARDS, MASTER BEDROOM  
PRIOR TO WORKS STARTING

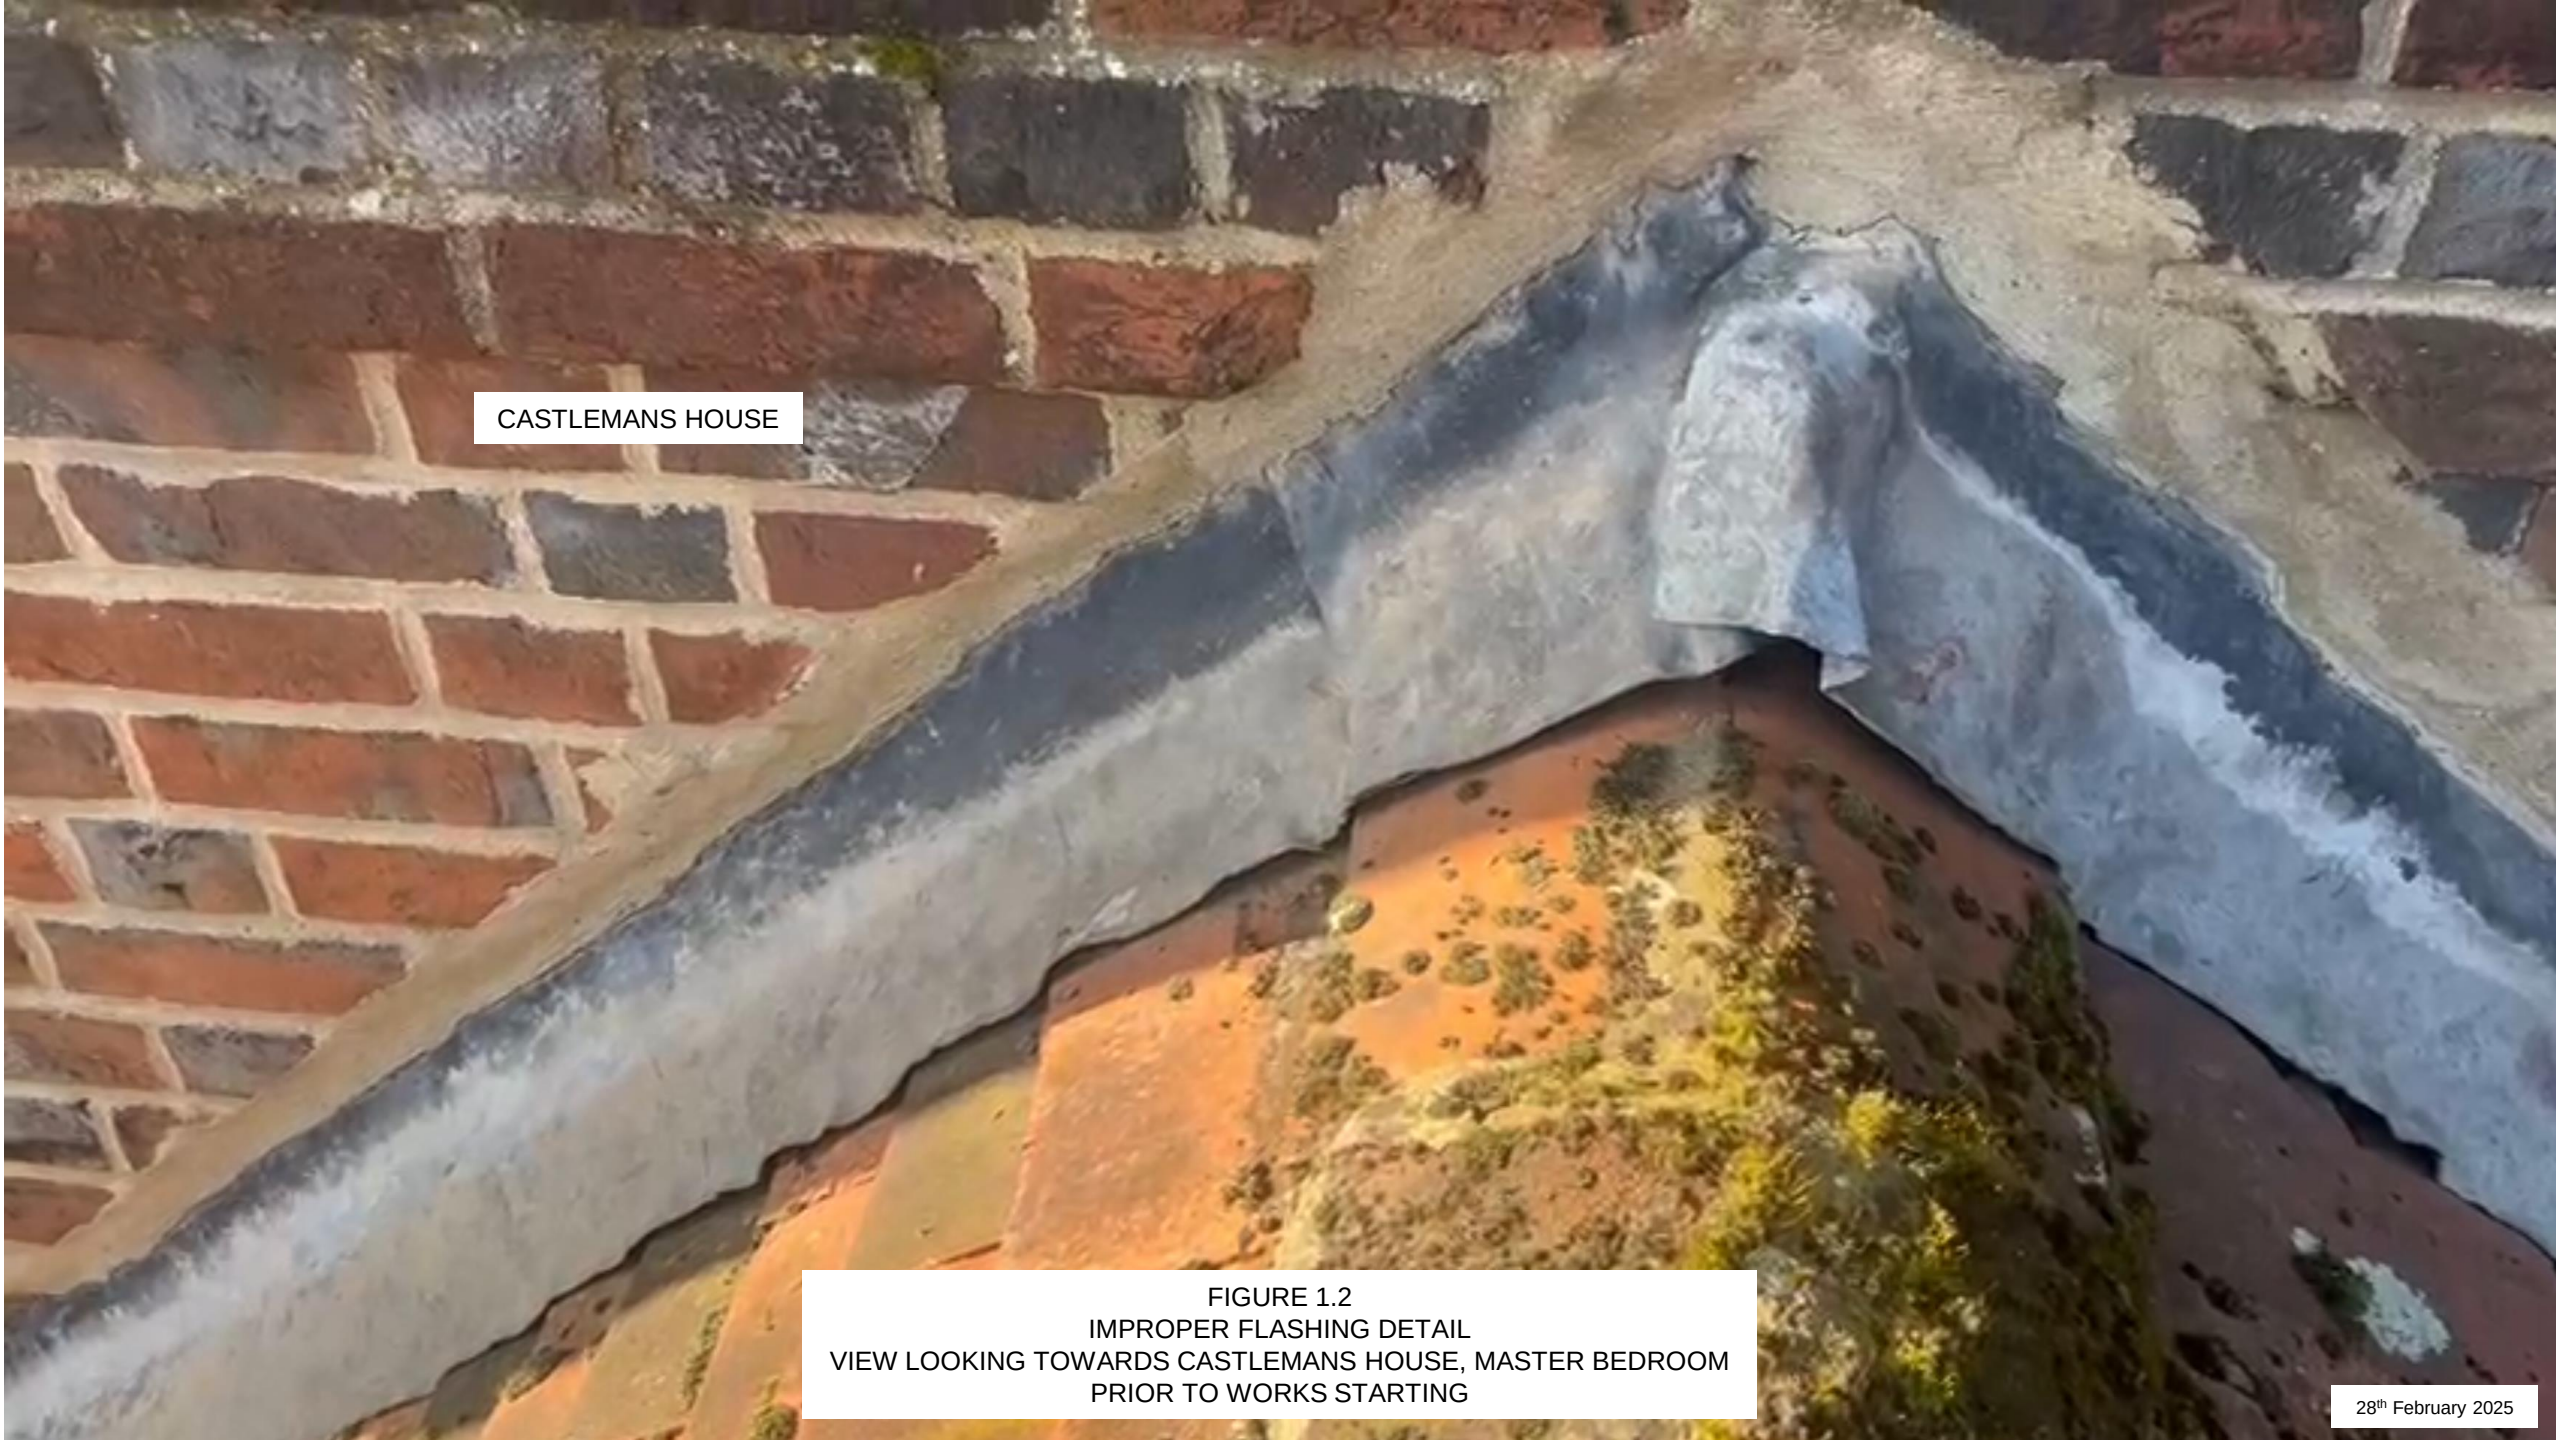
FIGURE 1.2  
IMPROPER FLASHING DETAIL  
VIEW LOOKING TOWARDS CASTLEMANS HOUSE, MASTER BEDROOM  
PRIOR TO WORKS STARTING

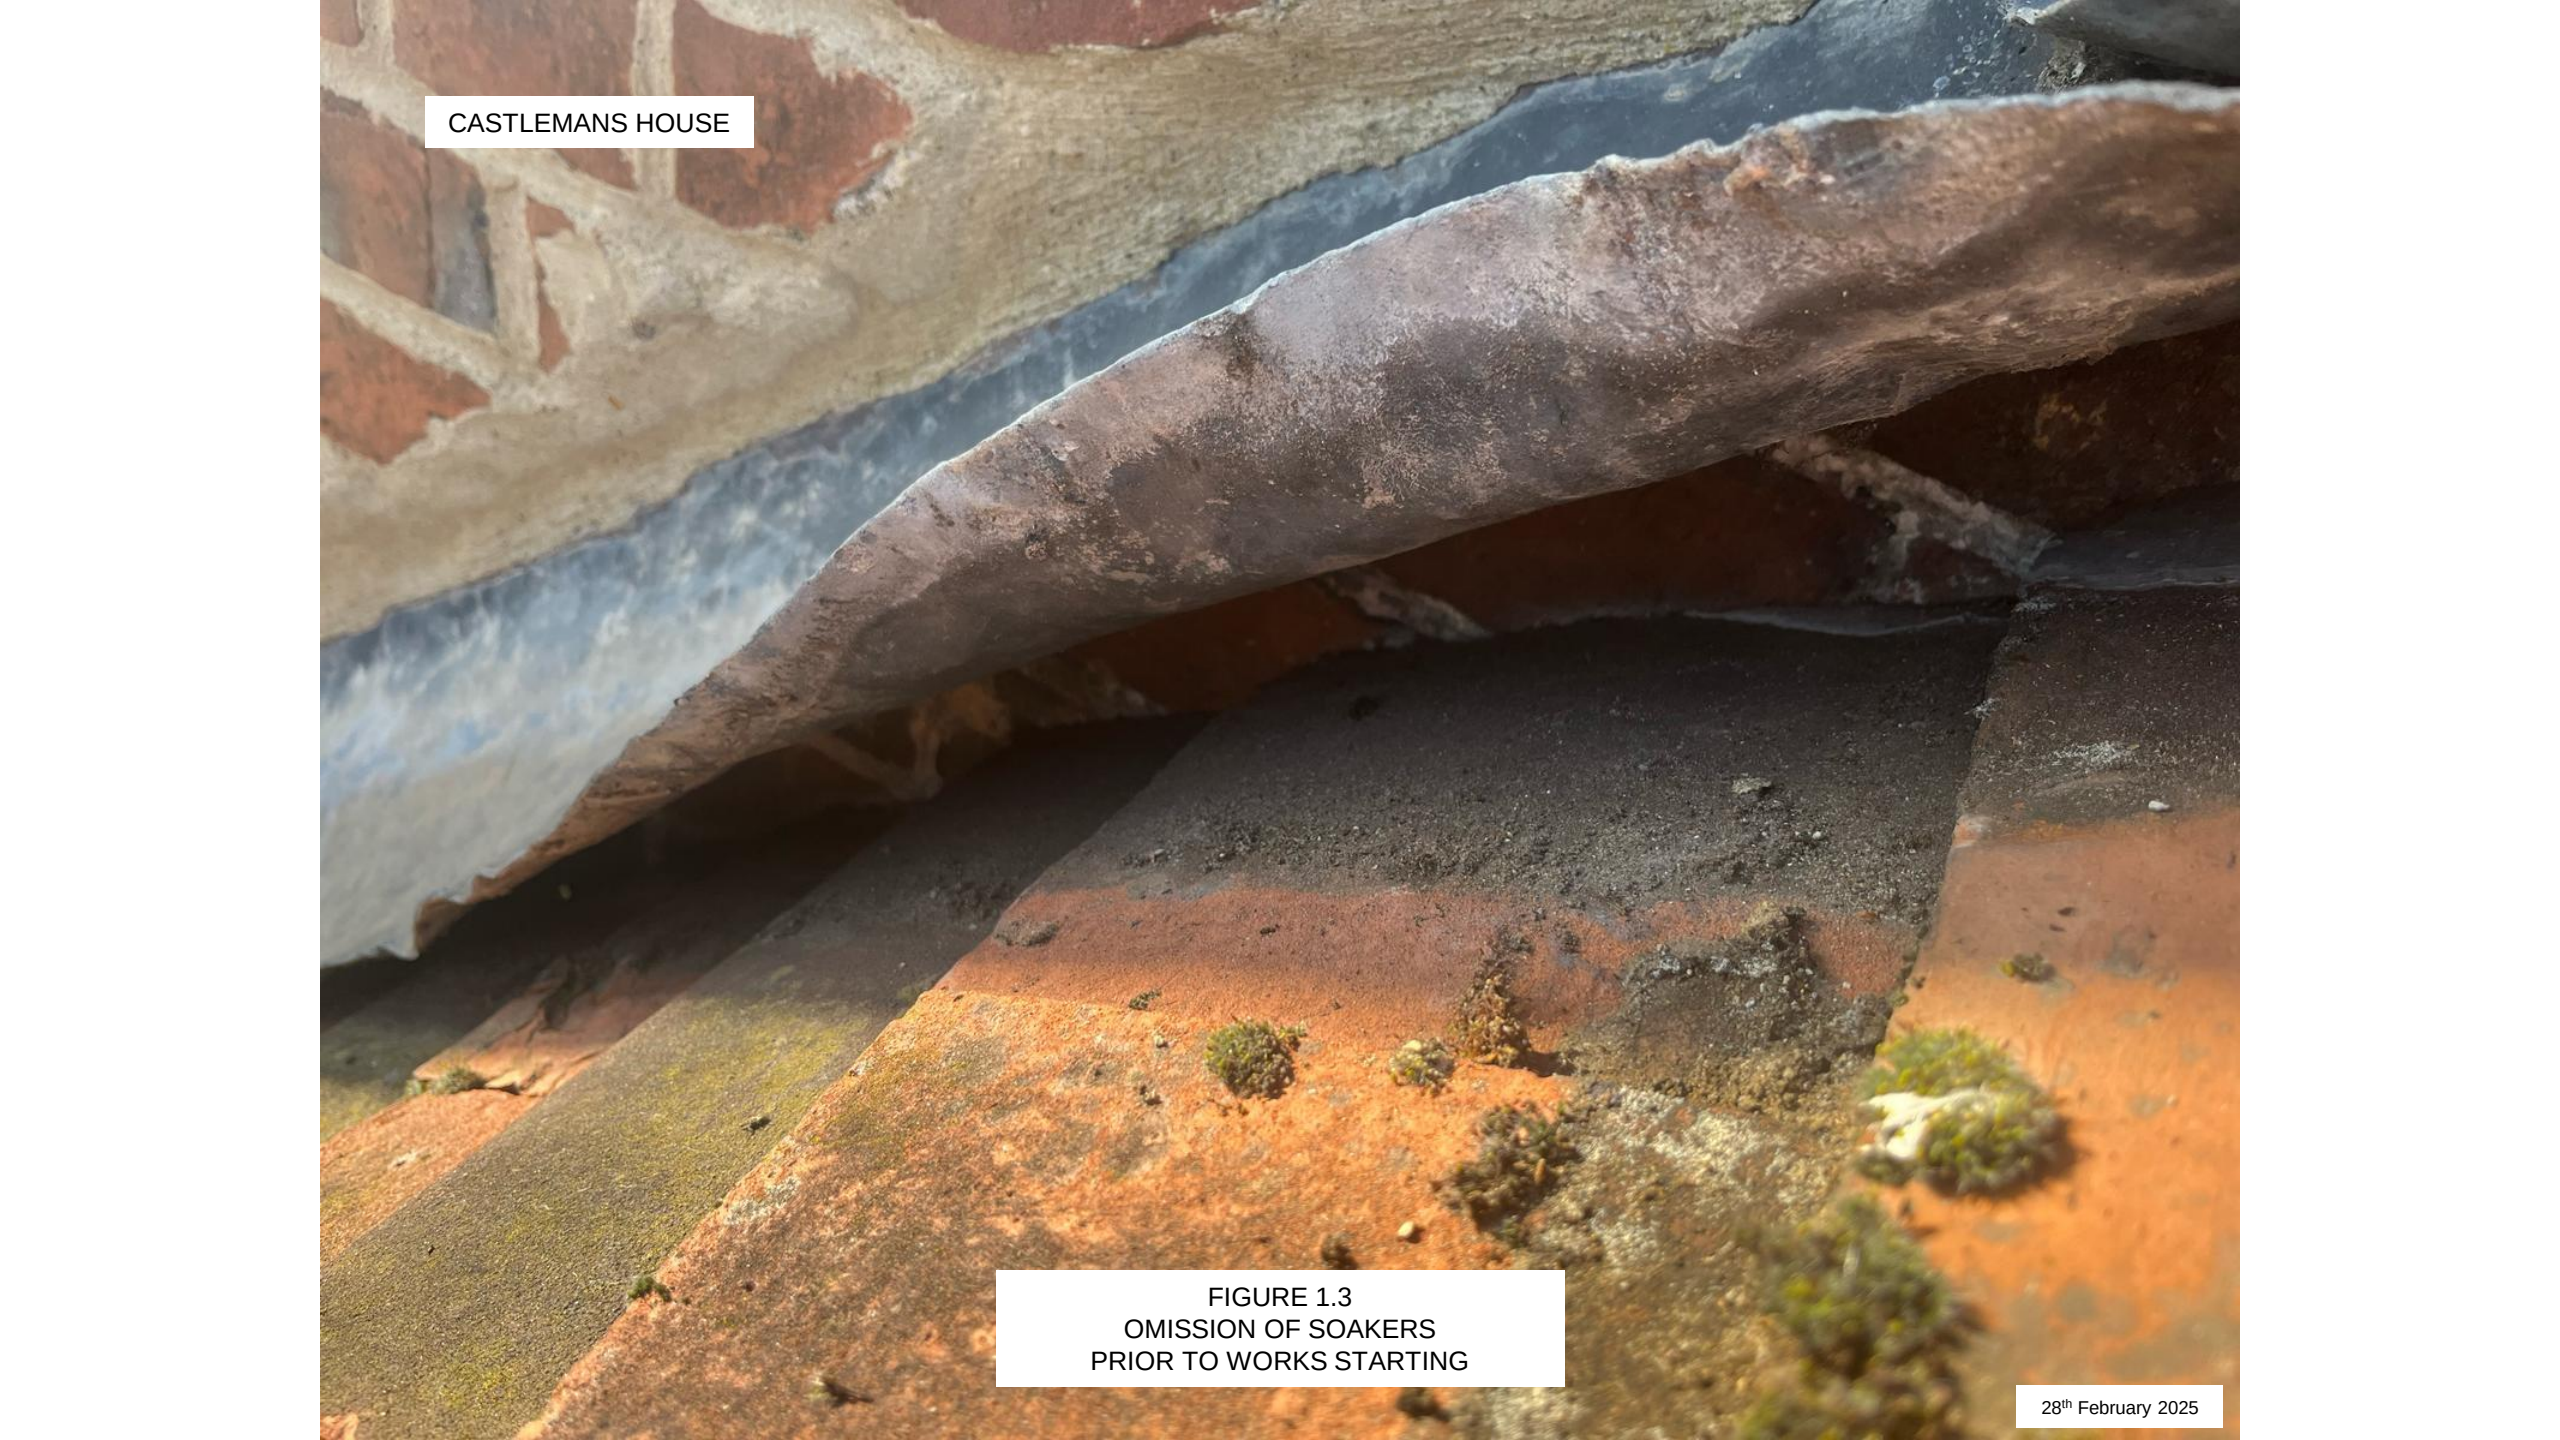
FIGURE 1.3  
OMISSION OF SOAKERS  
PRIOR TO WORKS STARTING

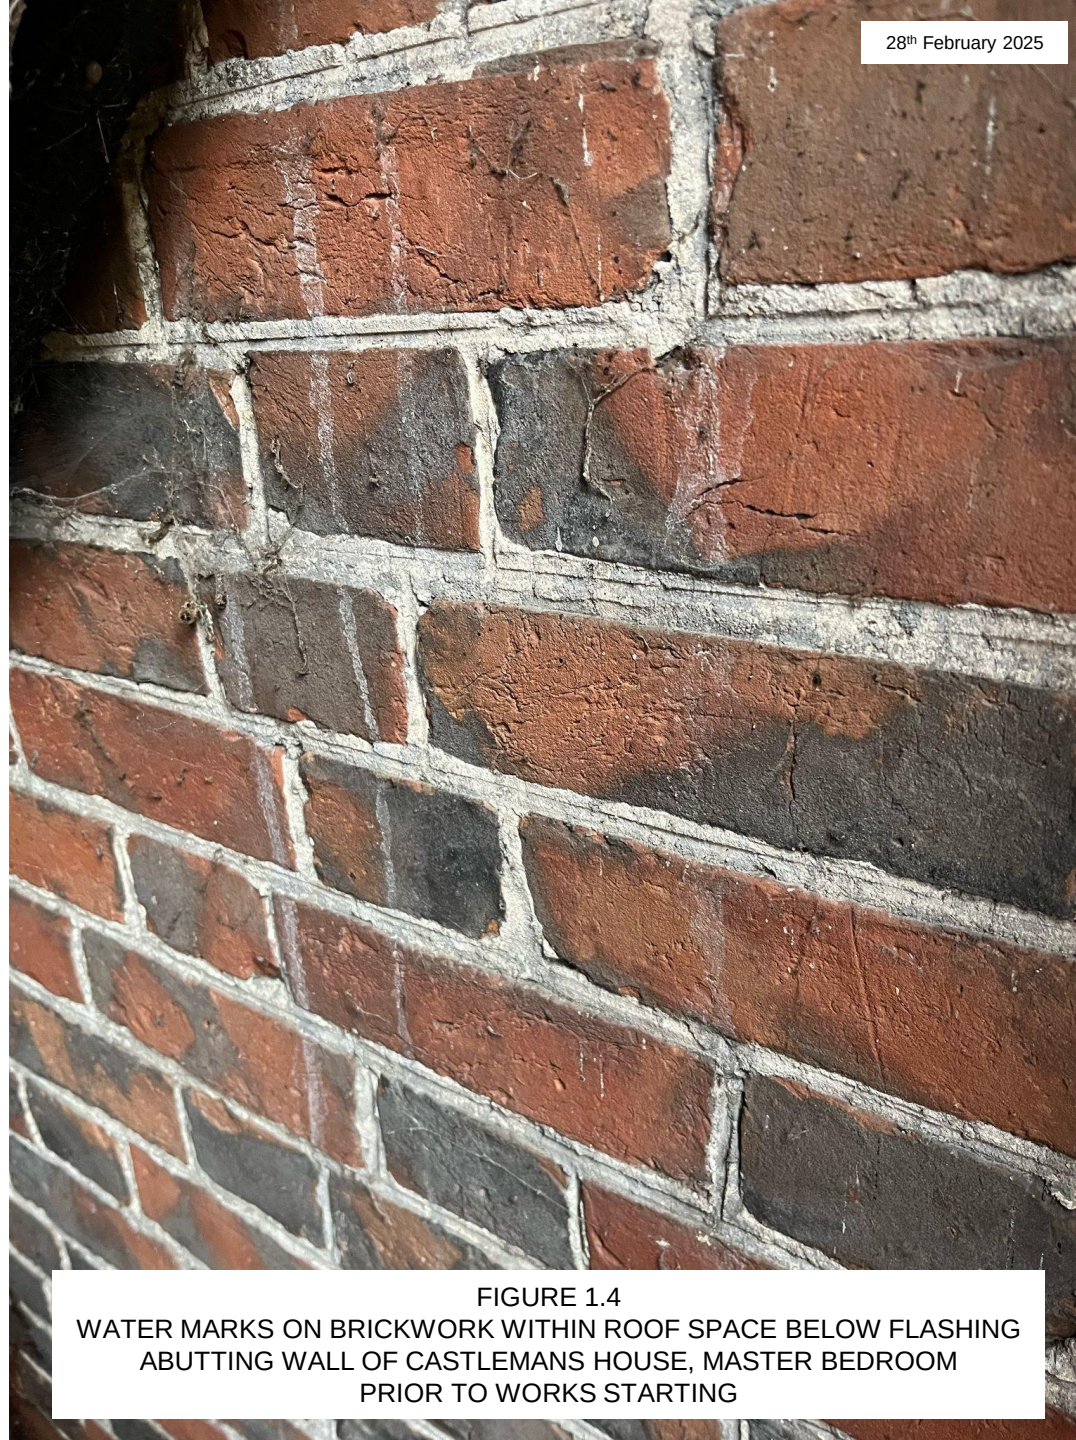
FIGURE 1.4  
WATER MARKS ON BRICKWORK WITHIN ROOF SPACE BELOW FLASHING  
ABUTTING WALL OF CASTLEMANS HOUSE, MASTER BEDROOM  
PRIOR TO WORKS STARTING

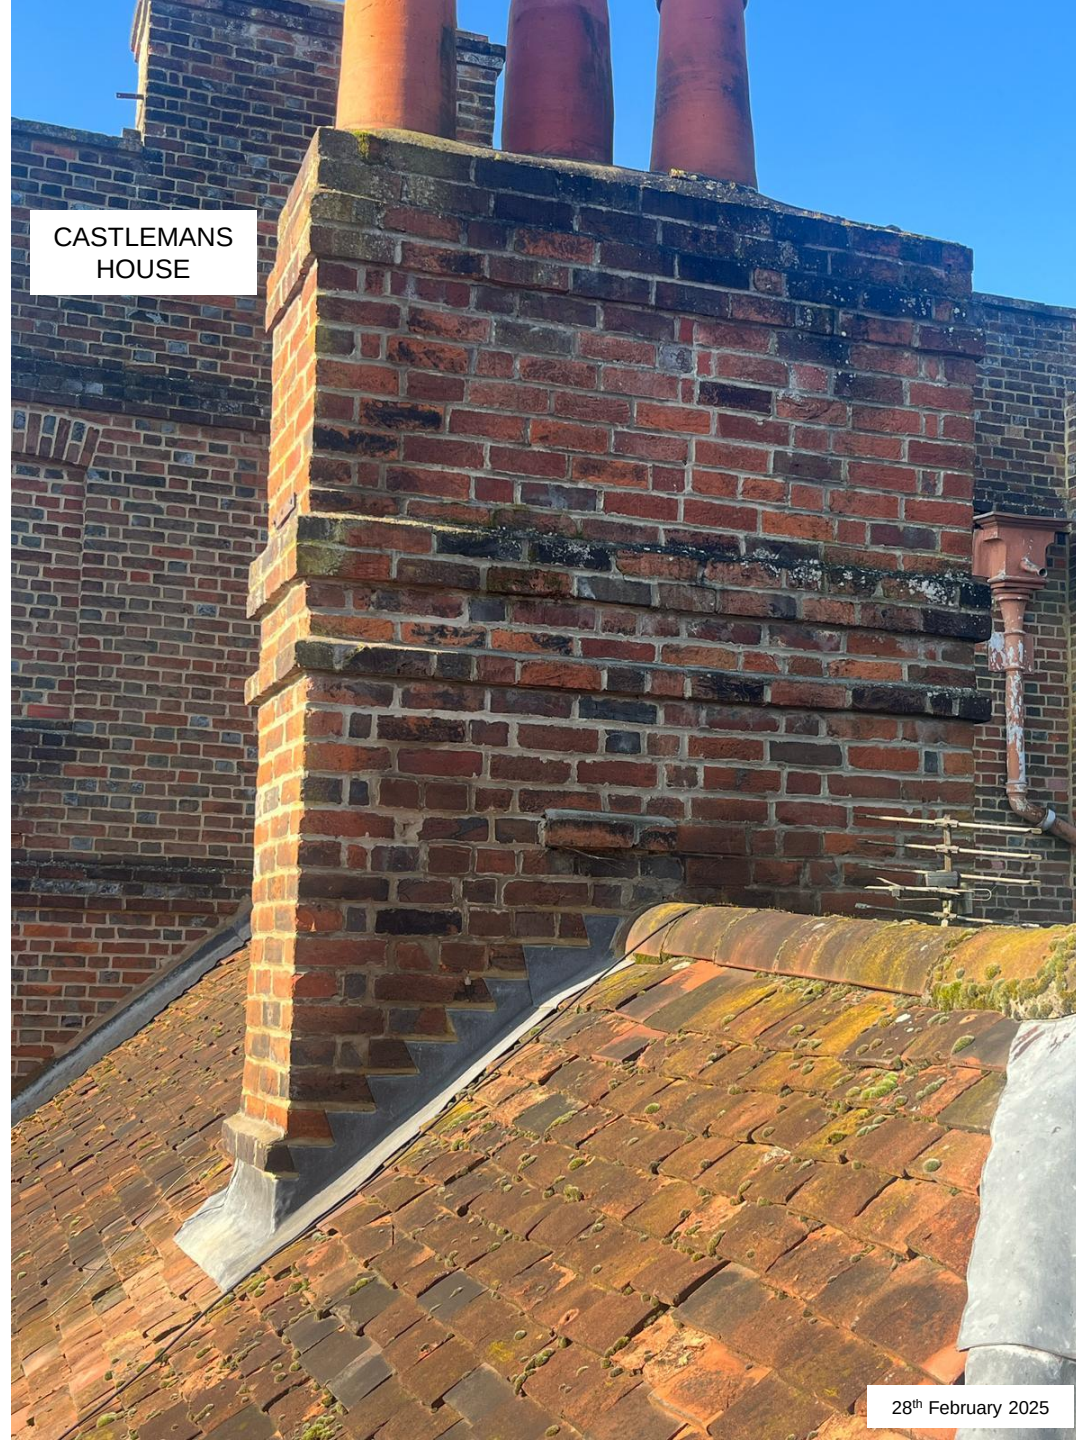
FIGURE 1.5  
EXISTING STEPPED FLASHING ON CHIMNEY  
PRIOR TO WORKS STARTING

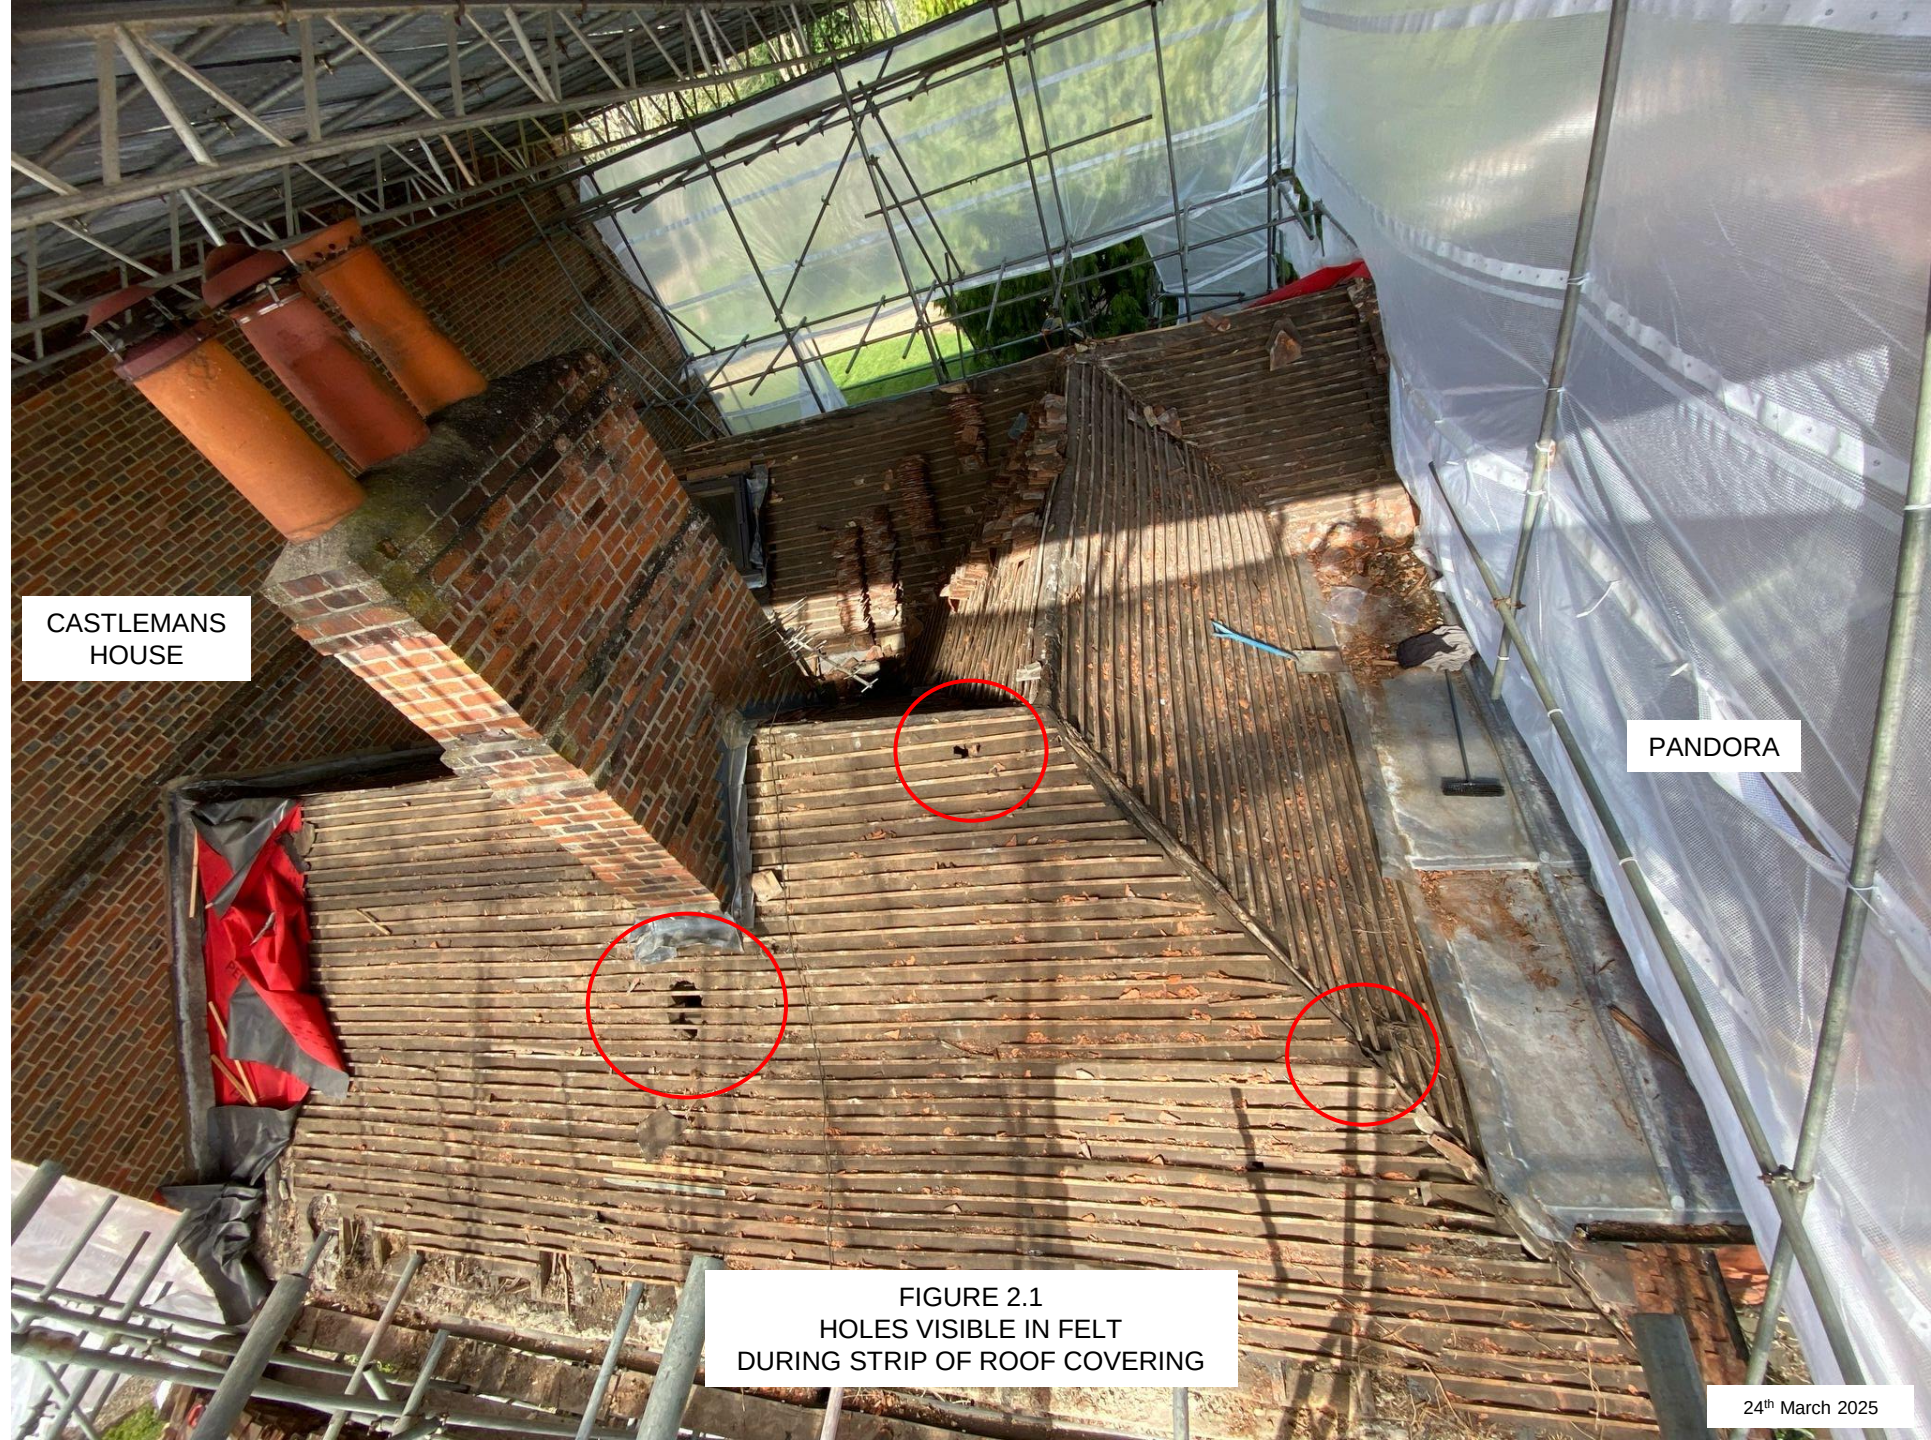
CEILING TIMBERS DAMP, CHIMNEY BRICKWORK IN  
LOFT SPACE DAMP/DISINTEGRATING  
CAUSE LIKELY IMPROPER FLASHING DETAIL, HOLE  
IN FELT, BROKEN TILES  
PROPOSED STEPPED LEAD FLASHING WITH  
SOAKERS AND BREATHABLE FELT  
FIGURE 2.1 / PAGE 21

FIGURE 2.1  
HOLES VISIBLE IN FELT  
DURING STRIP OF ROOF COVERING

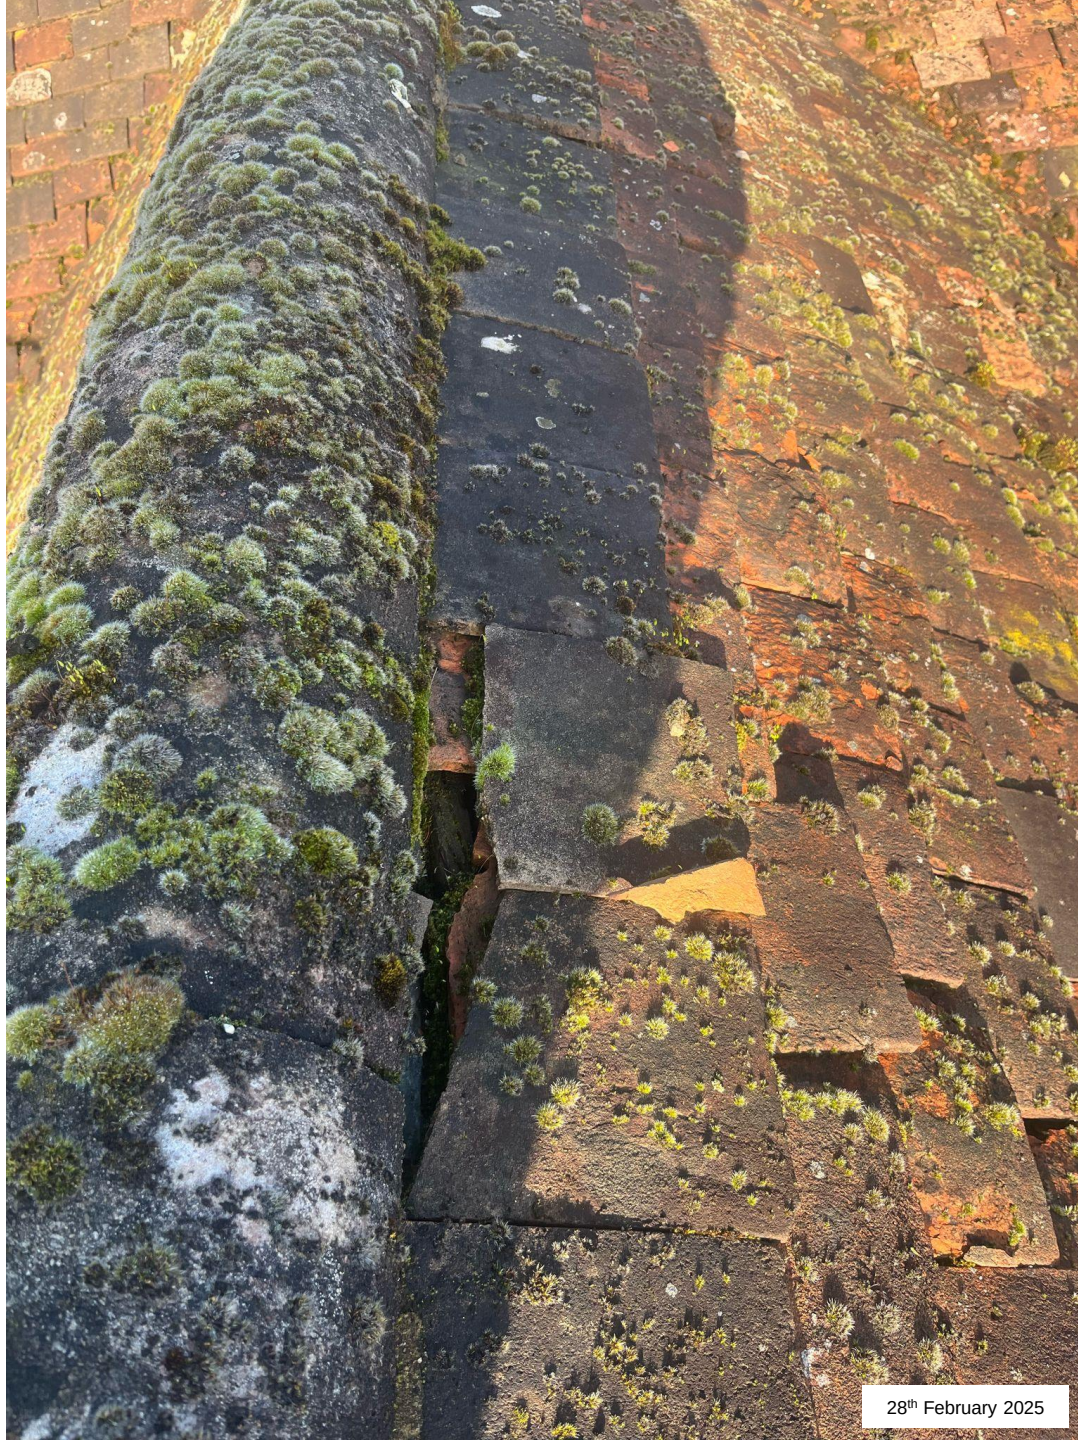
CEILING STAINED AND DISINTEGRATING  
CAUSED BY BROKEN TILES, LOOSE RIDGE TILES,  
FAILED FELT  
PROPOSE BONNET TILES TO BE INSTALLED ON HIP  
MIMICKING NEIGHBOUR'S HIP OPPOSITE  
FIGURE 3.1 / PAGE 22

FIGURE 3.1  
BROKEN TILES  
BEDROOM 2  
PRIOR TO WORKS STARTING

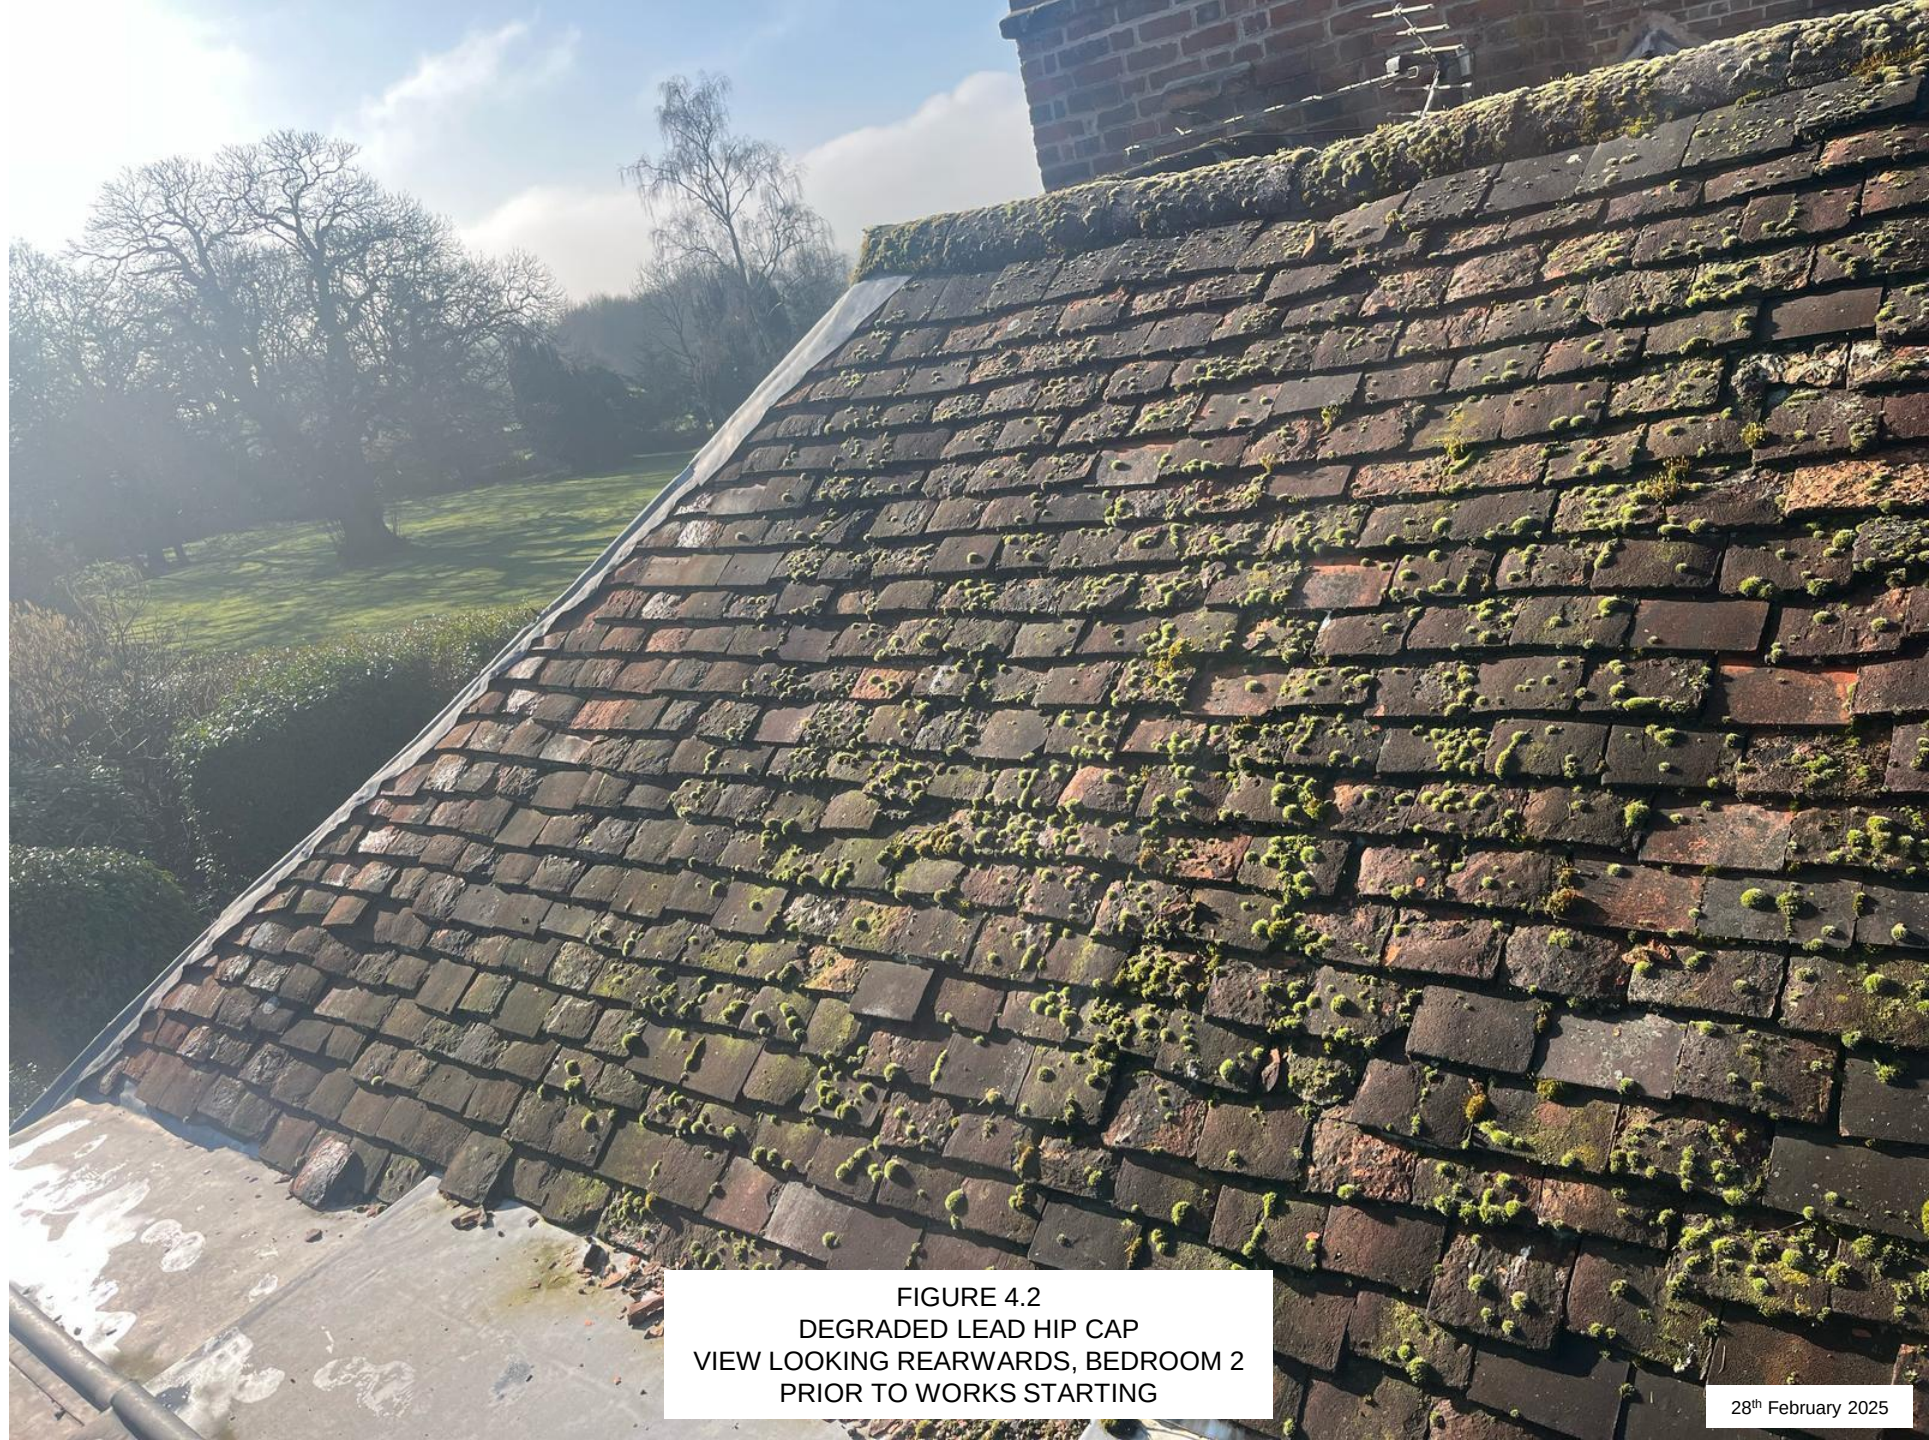
FIGURE 4.2  
DEGRADED LEAD HIP CAP  
VIEW LOOKING REARWARDS, BEDROOM 2  
PRIOR TO WORKS STARTING
