# CASTLEMANS COTTAGE ROOF REPAIRS

**Planning Portal Reference: PP-13905061**

**BCS Reference: 25/0784/OTHBN**

This document forms part of an application for listed building consent sought for the repairs to the existing second storey tiled roof.

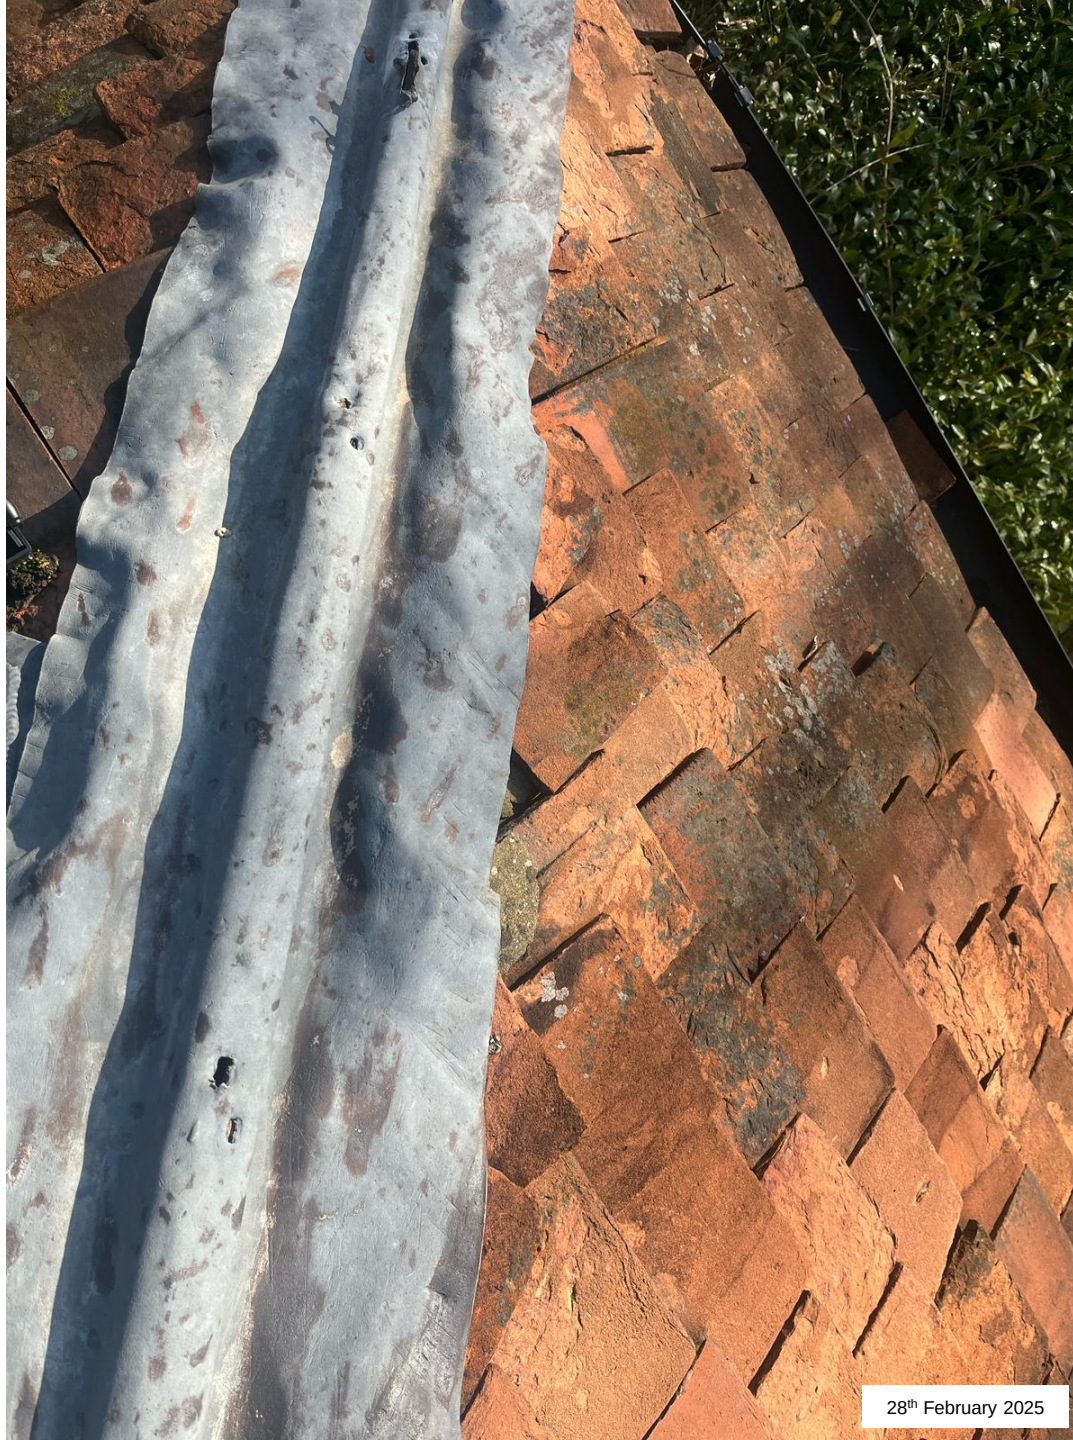
FIGURE 4.3  
DISLODGED TILES  
VIEW LOOKING REARWARDS, BEDROOM 2  
PRIOR TO WORKS STARTING

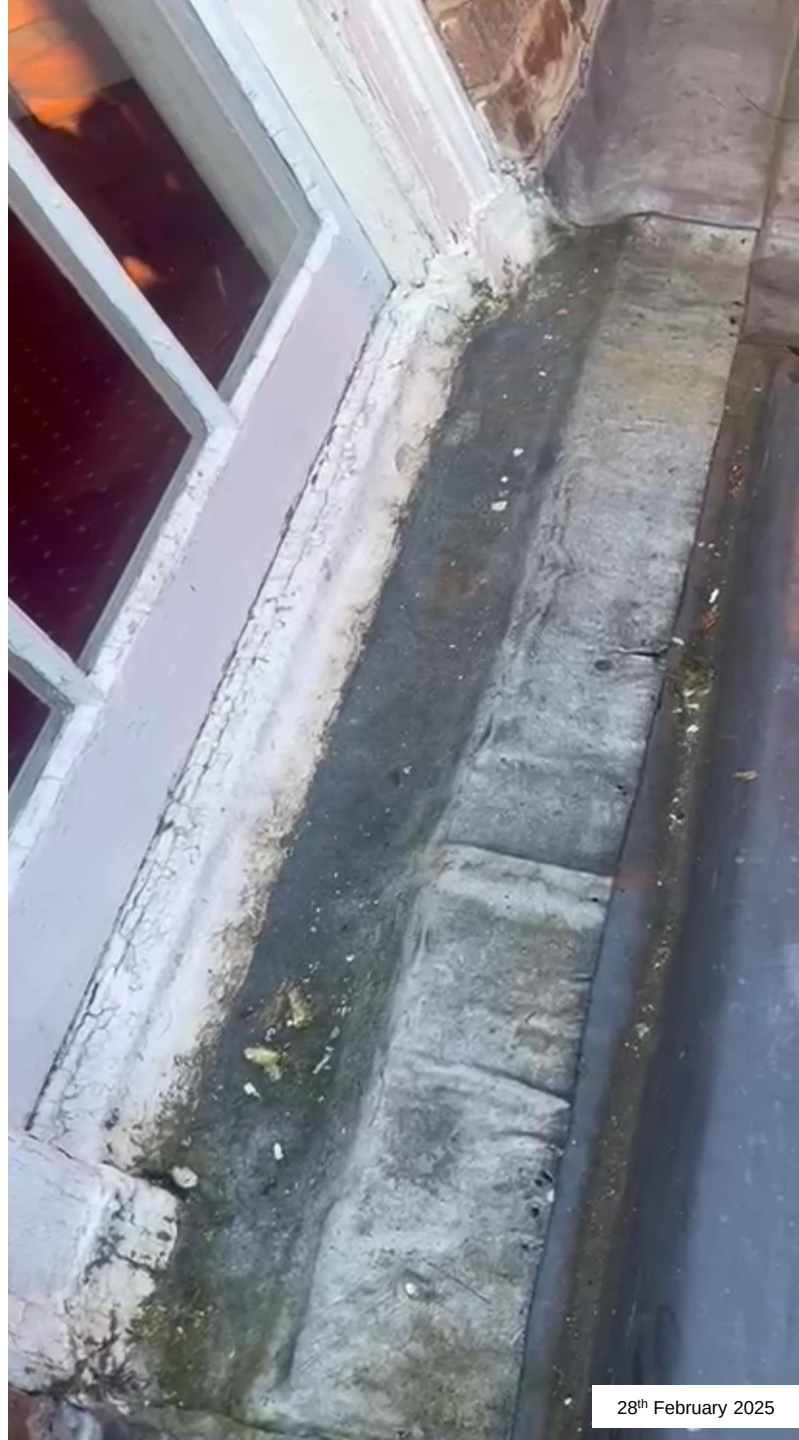
STAINING ON SKYLIGHT FRAME  
CAUSED BY DEGRADED AND DAMAGED LEAD  
FLASHING SURROUNDING SKYLIGHT  
PROPOSE RENEW FLASHING  
FIGURE 5.1 / PAGE 26

FIGURE 5.1  
DEGRADED AND DAMAGED LEAD FLASHING  
WINDOW TO CASTLEMANS HOUSE  
PRIOR TO WORKS STARTING

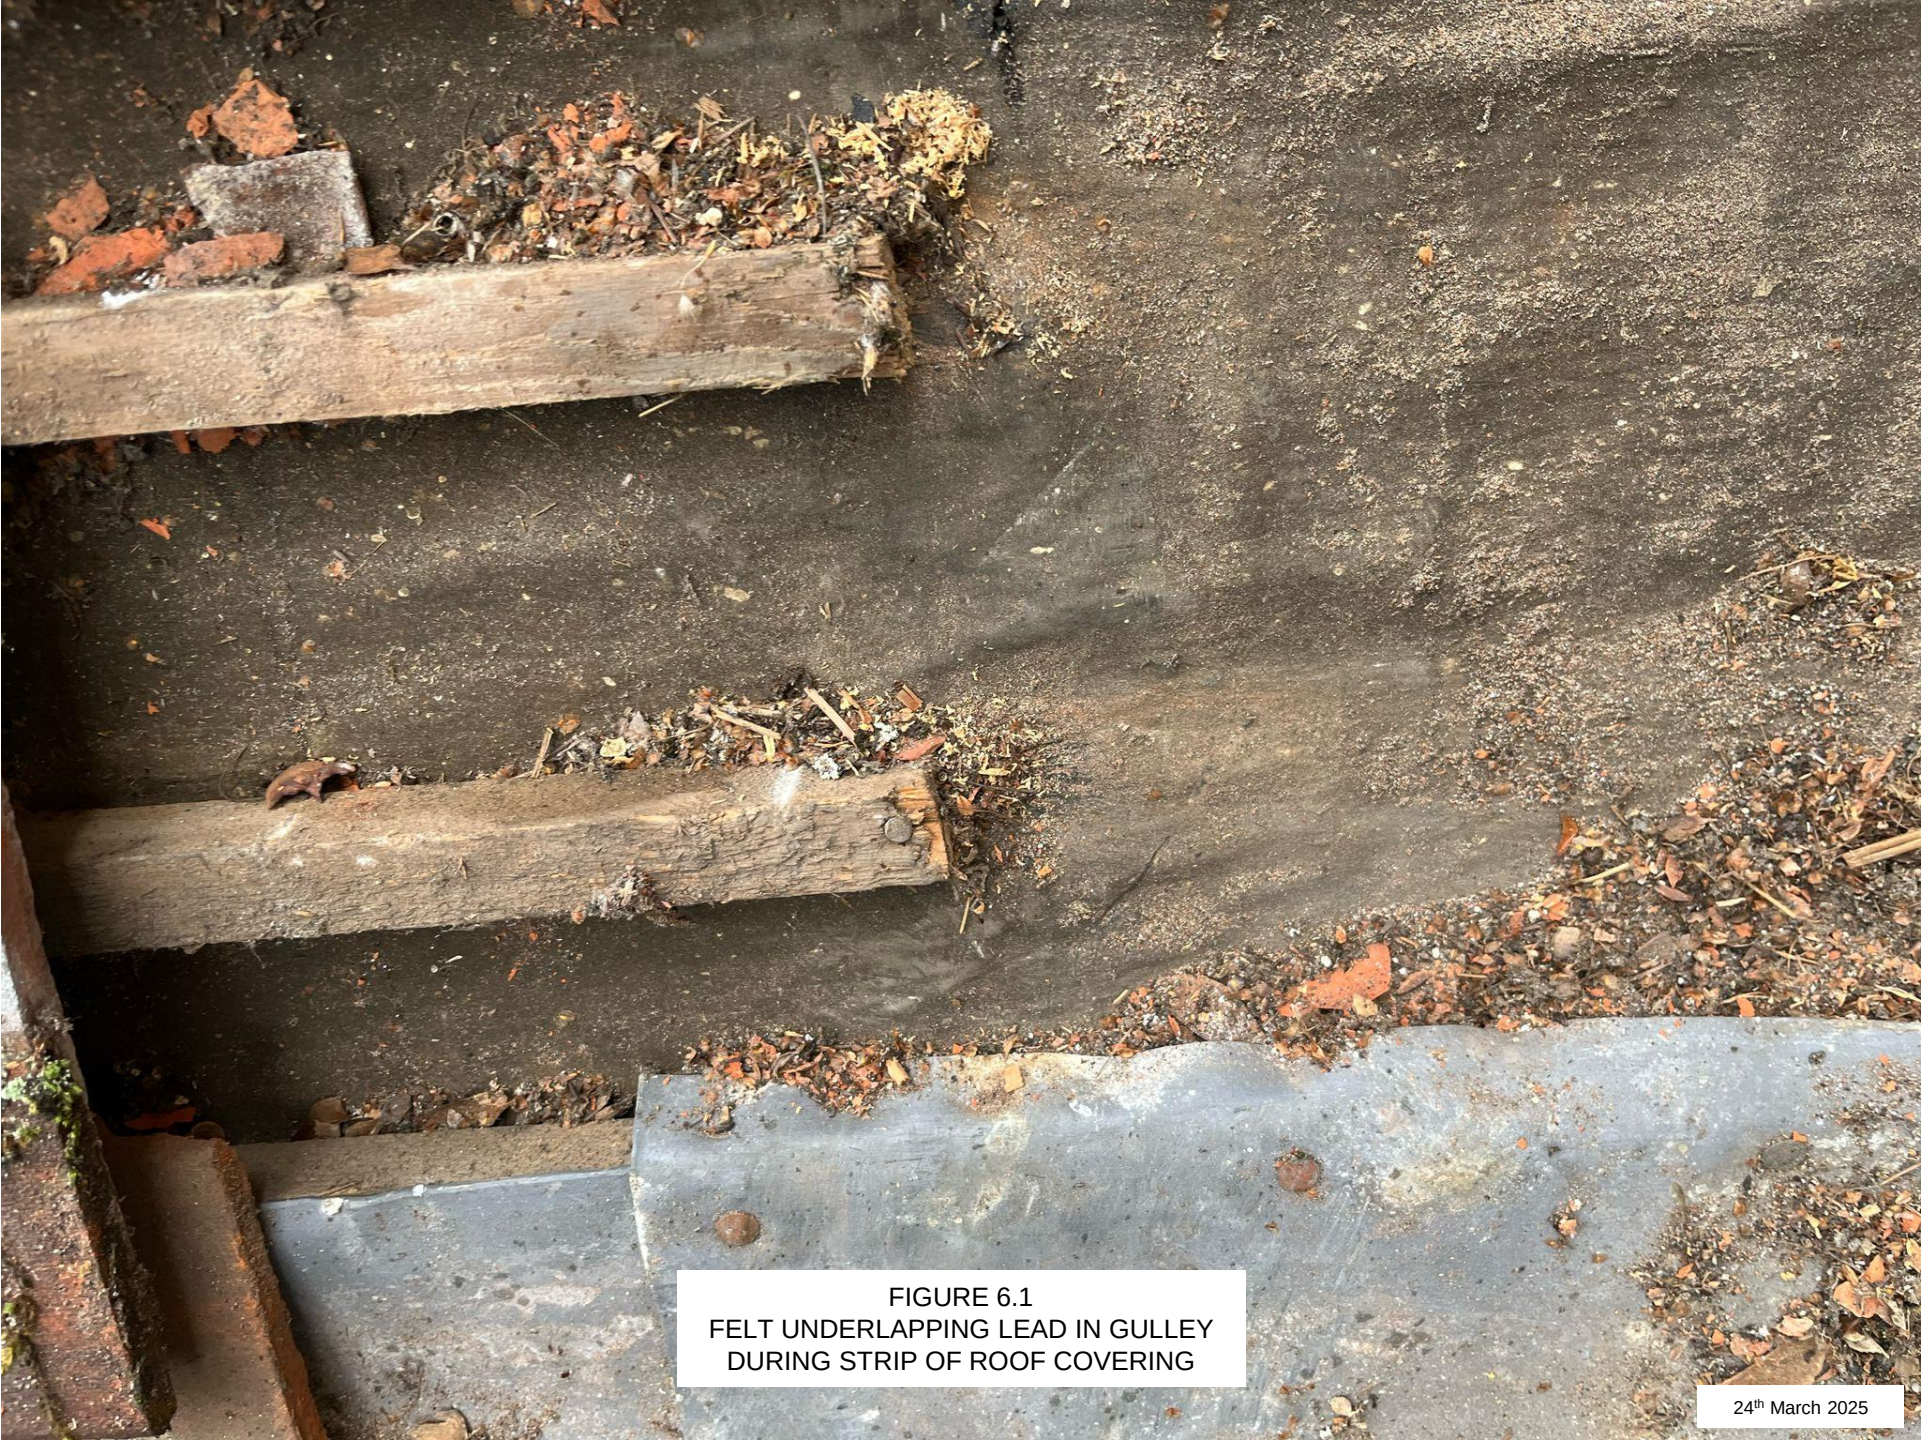
TIMBER BOARDS UNDER LEAD ROTTEN  
CAUSED BY FELT UNDERLAPPING LEAD  
PROPOSE TO OVERLAP FELT ONTO LEAD AND  
REPLACE ROTTEN BOARDS WHERE NECESSARY  
FIGURE 6.1 / PAGE 27

FIGURE 6.1  
FELT UNDERLAPPING LEAD IN GULLEY  
DURING STRIP OF ROOF COVERING

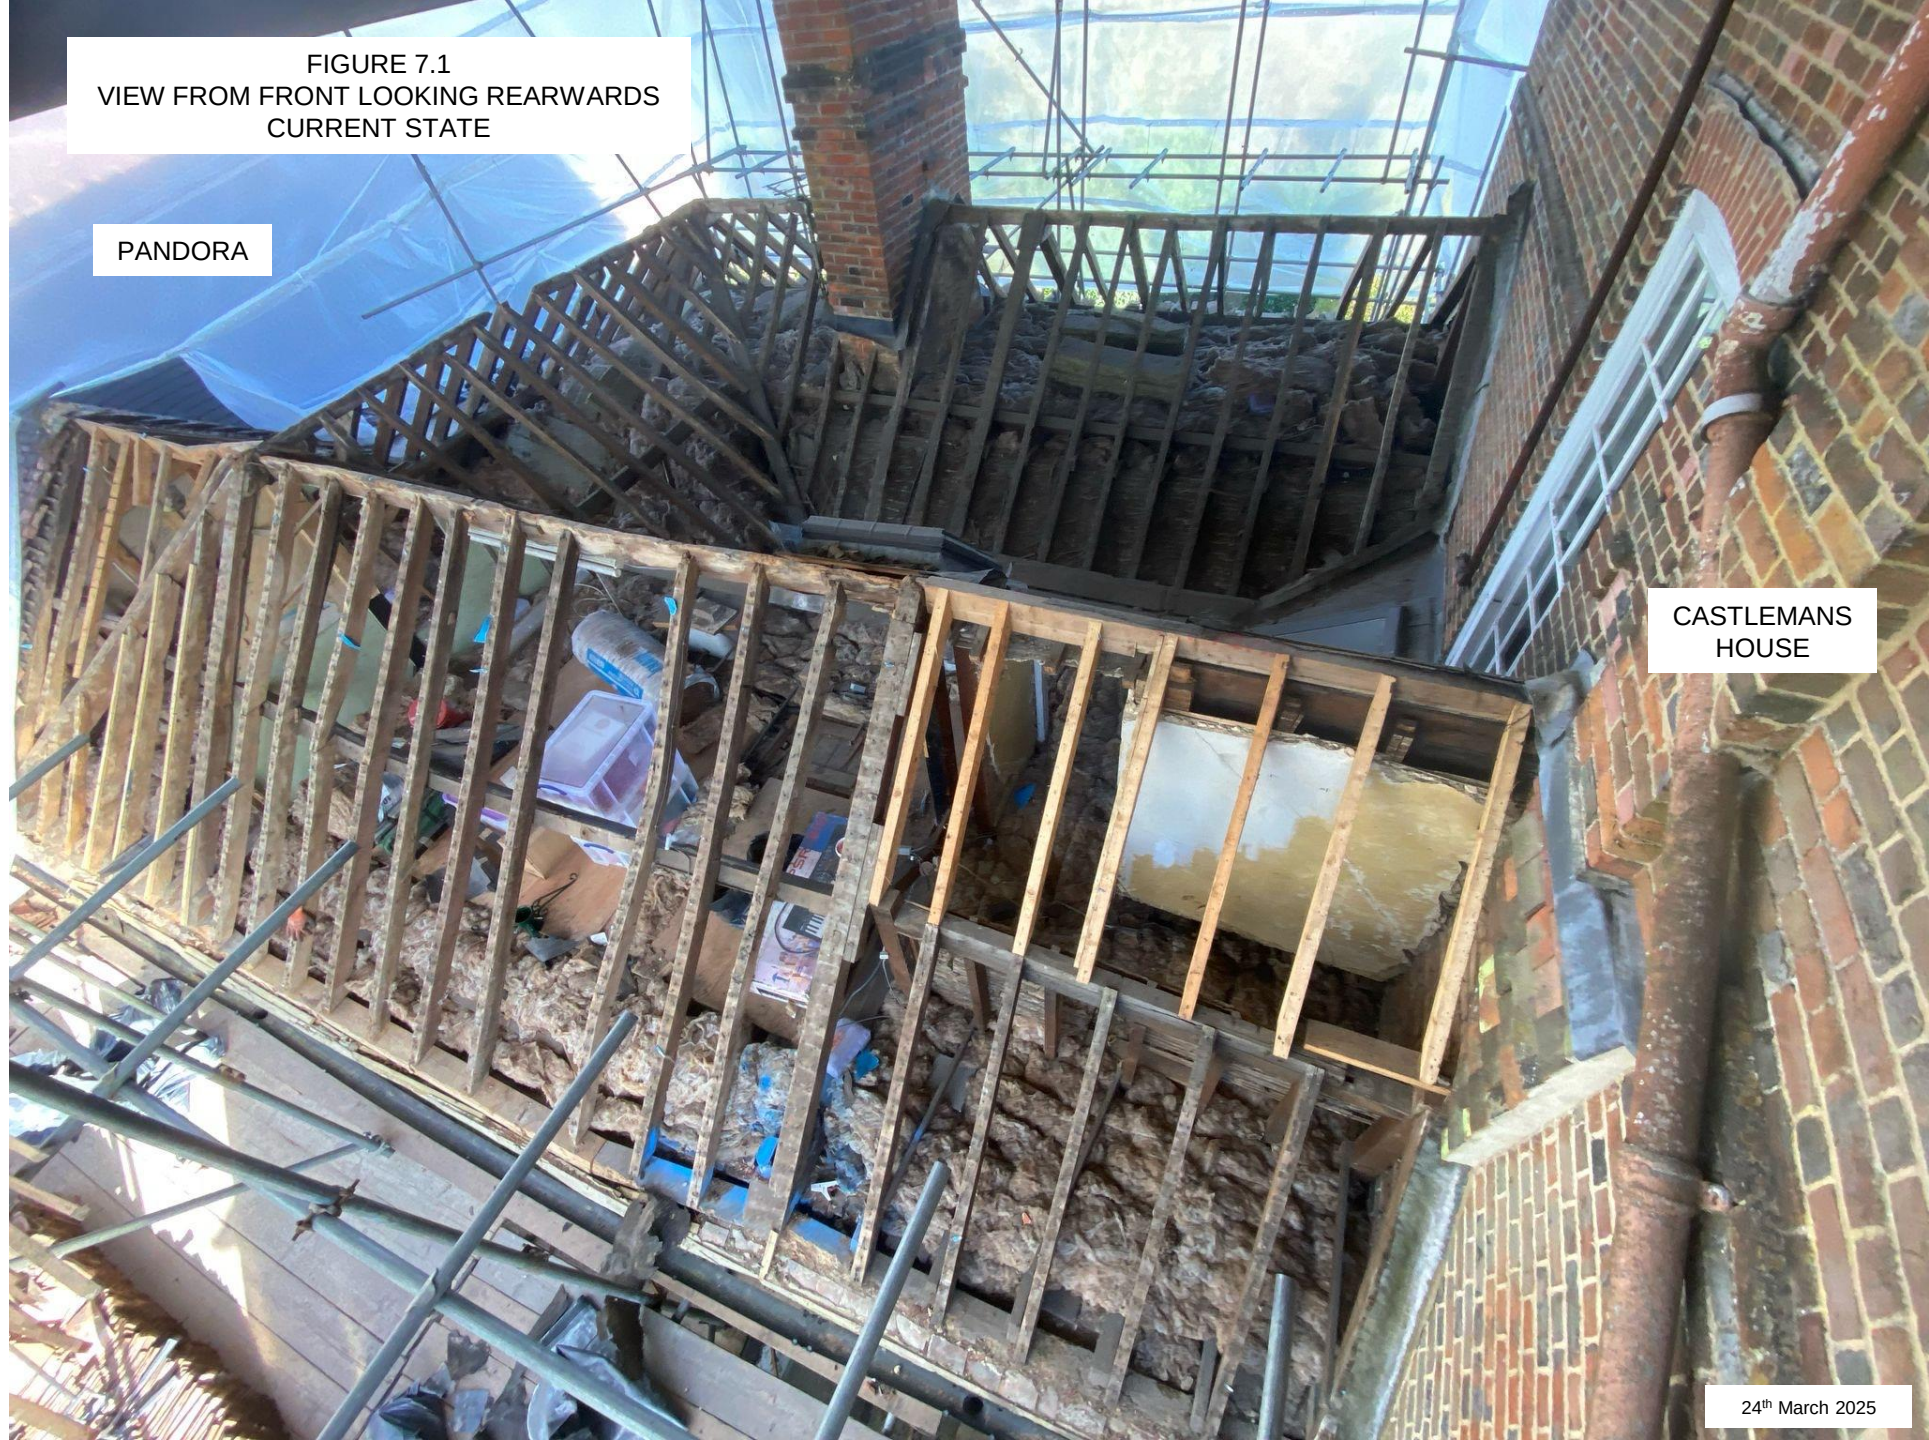
FIGURE 7.2  
VIEW FROM REAR LOOKING FORWARDS  
CURRENT STATE

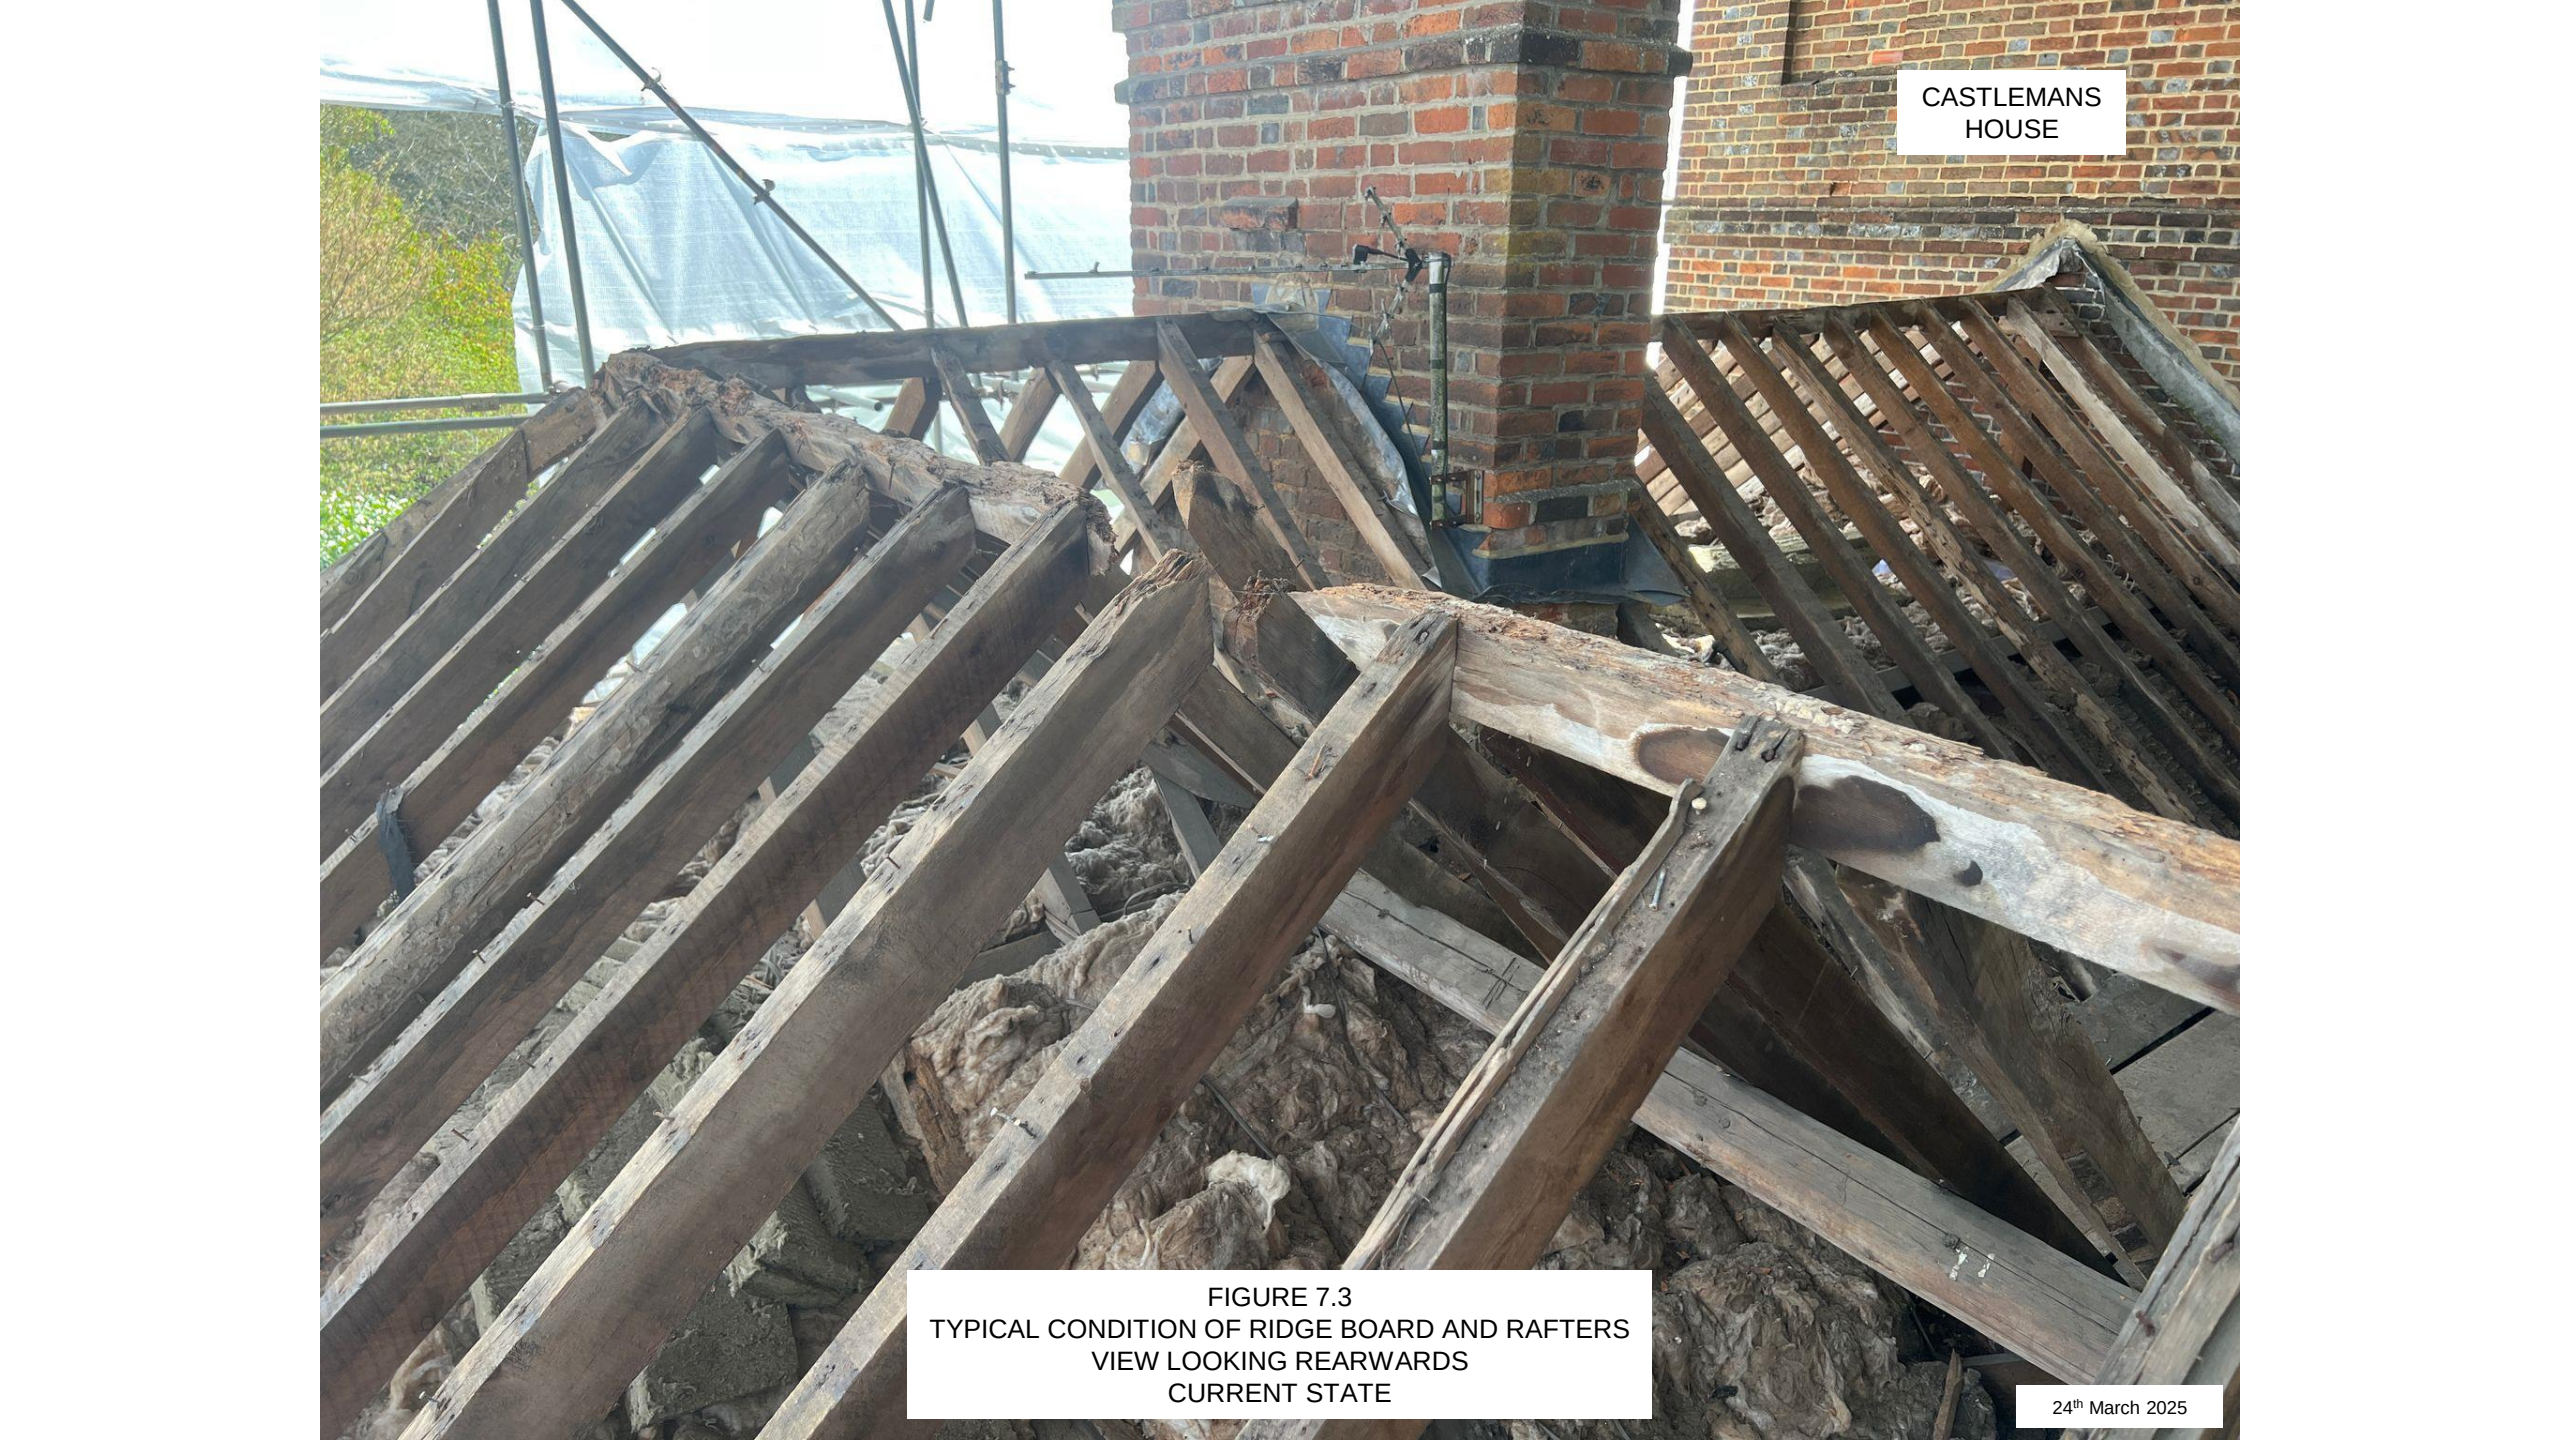
FIGURE 7.3  
TYPICAL CONDITION OF RIDGE BOARD AND RAFTERS  
VIEW LOOKING REARWARDS  
CURRENT STATE

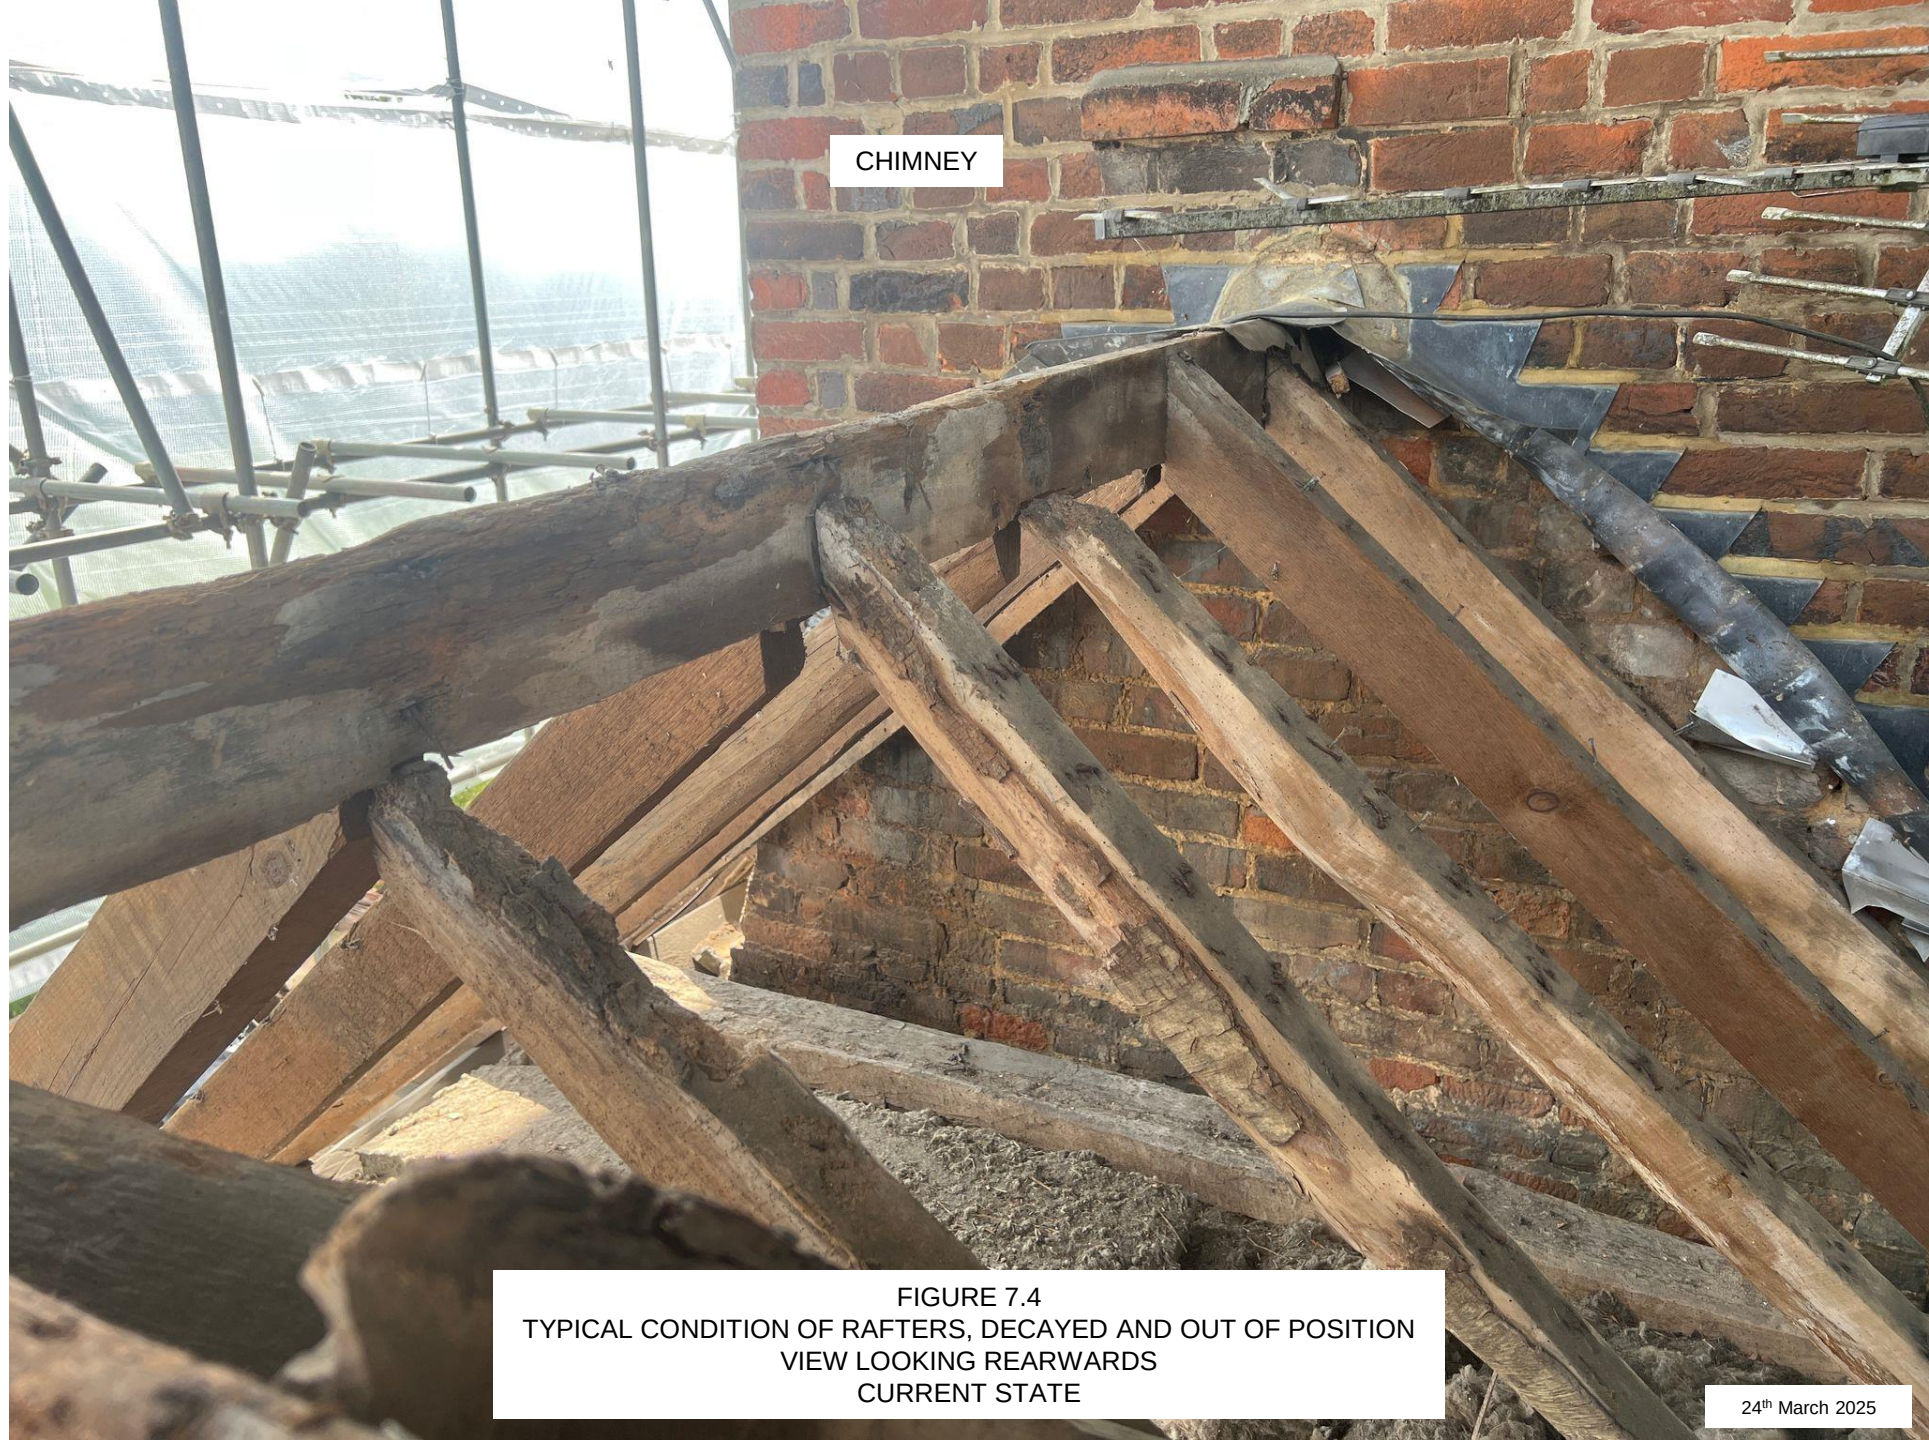
FIGURE 7.4  
TYPICAL CONDITION OF RAFTERS, DECAYED AND OUT OF POSITION  
VIEW LOOKING REARWARDS  
CURRENT STATE

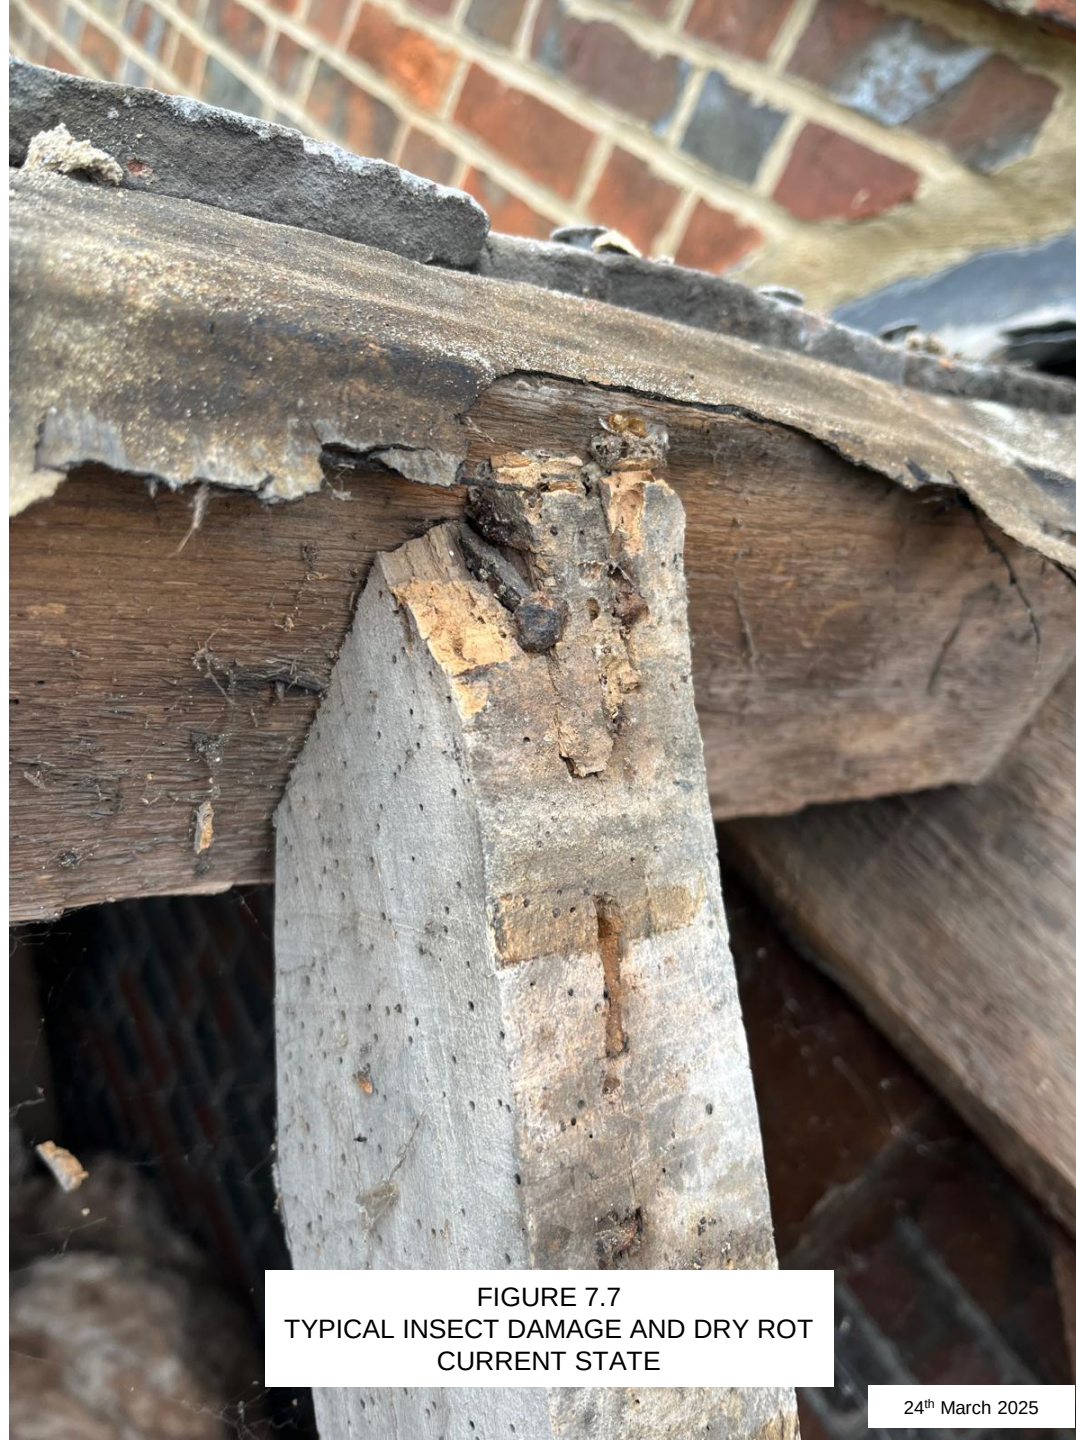
FIGURE 7.7  
TYPICAL INSECT DAMAGE AND DRY ROT  
CURRENT STATE

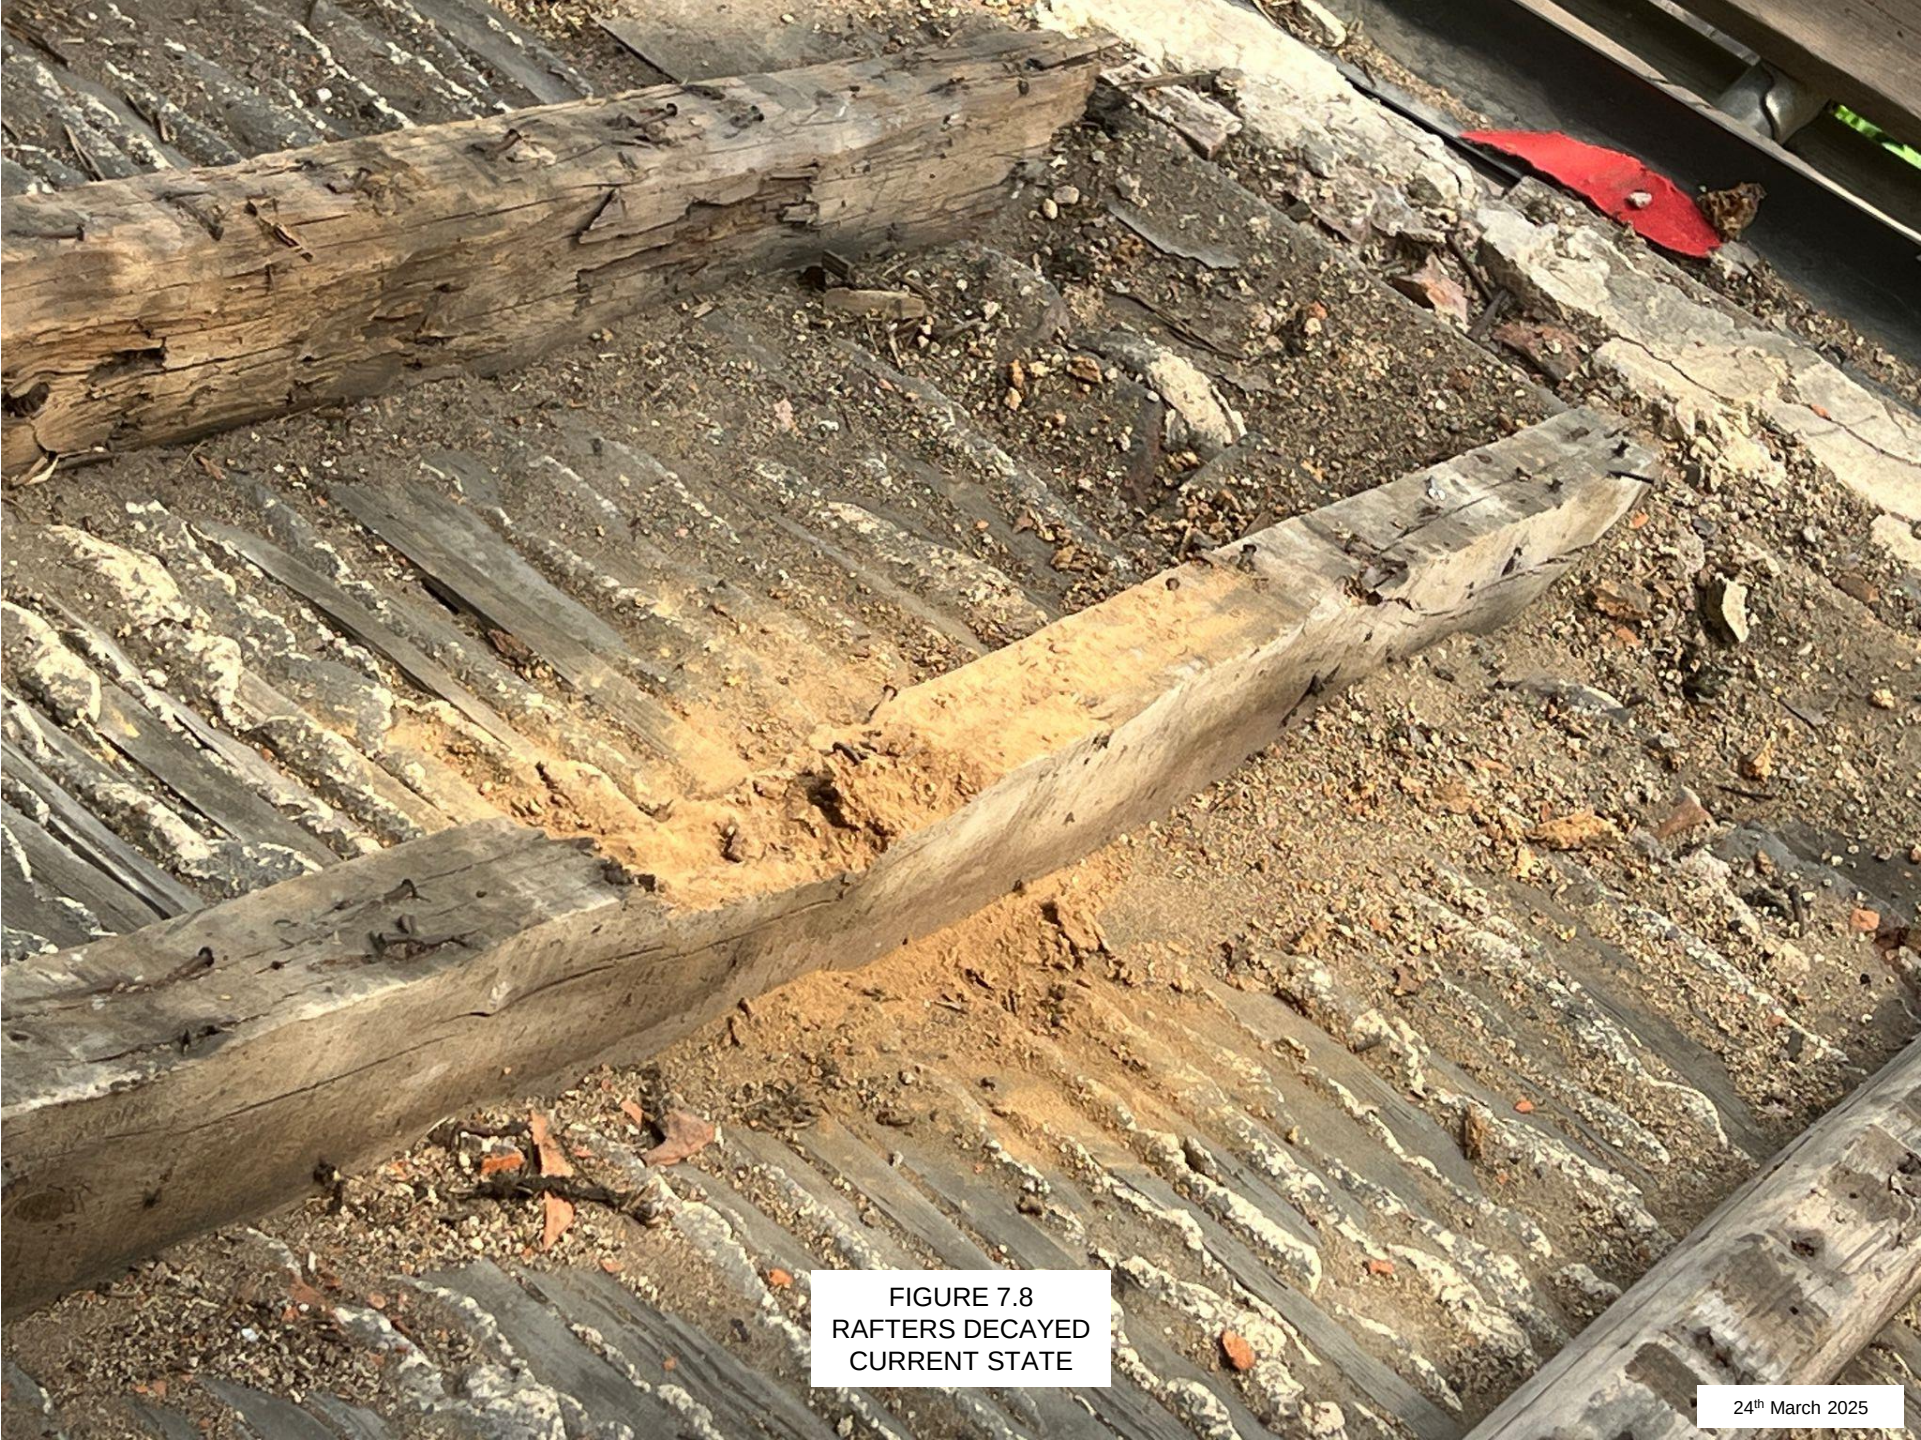
FIGURE 7.8  
RAFTERS DECAYED  
CURRENT STATE

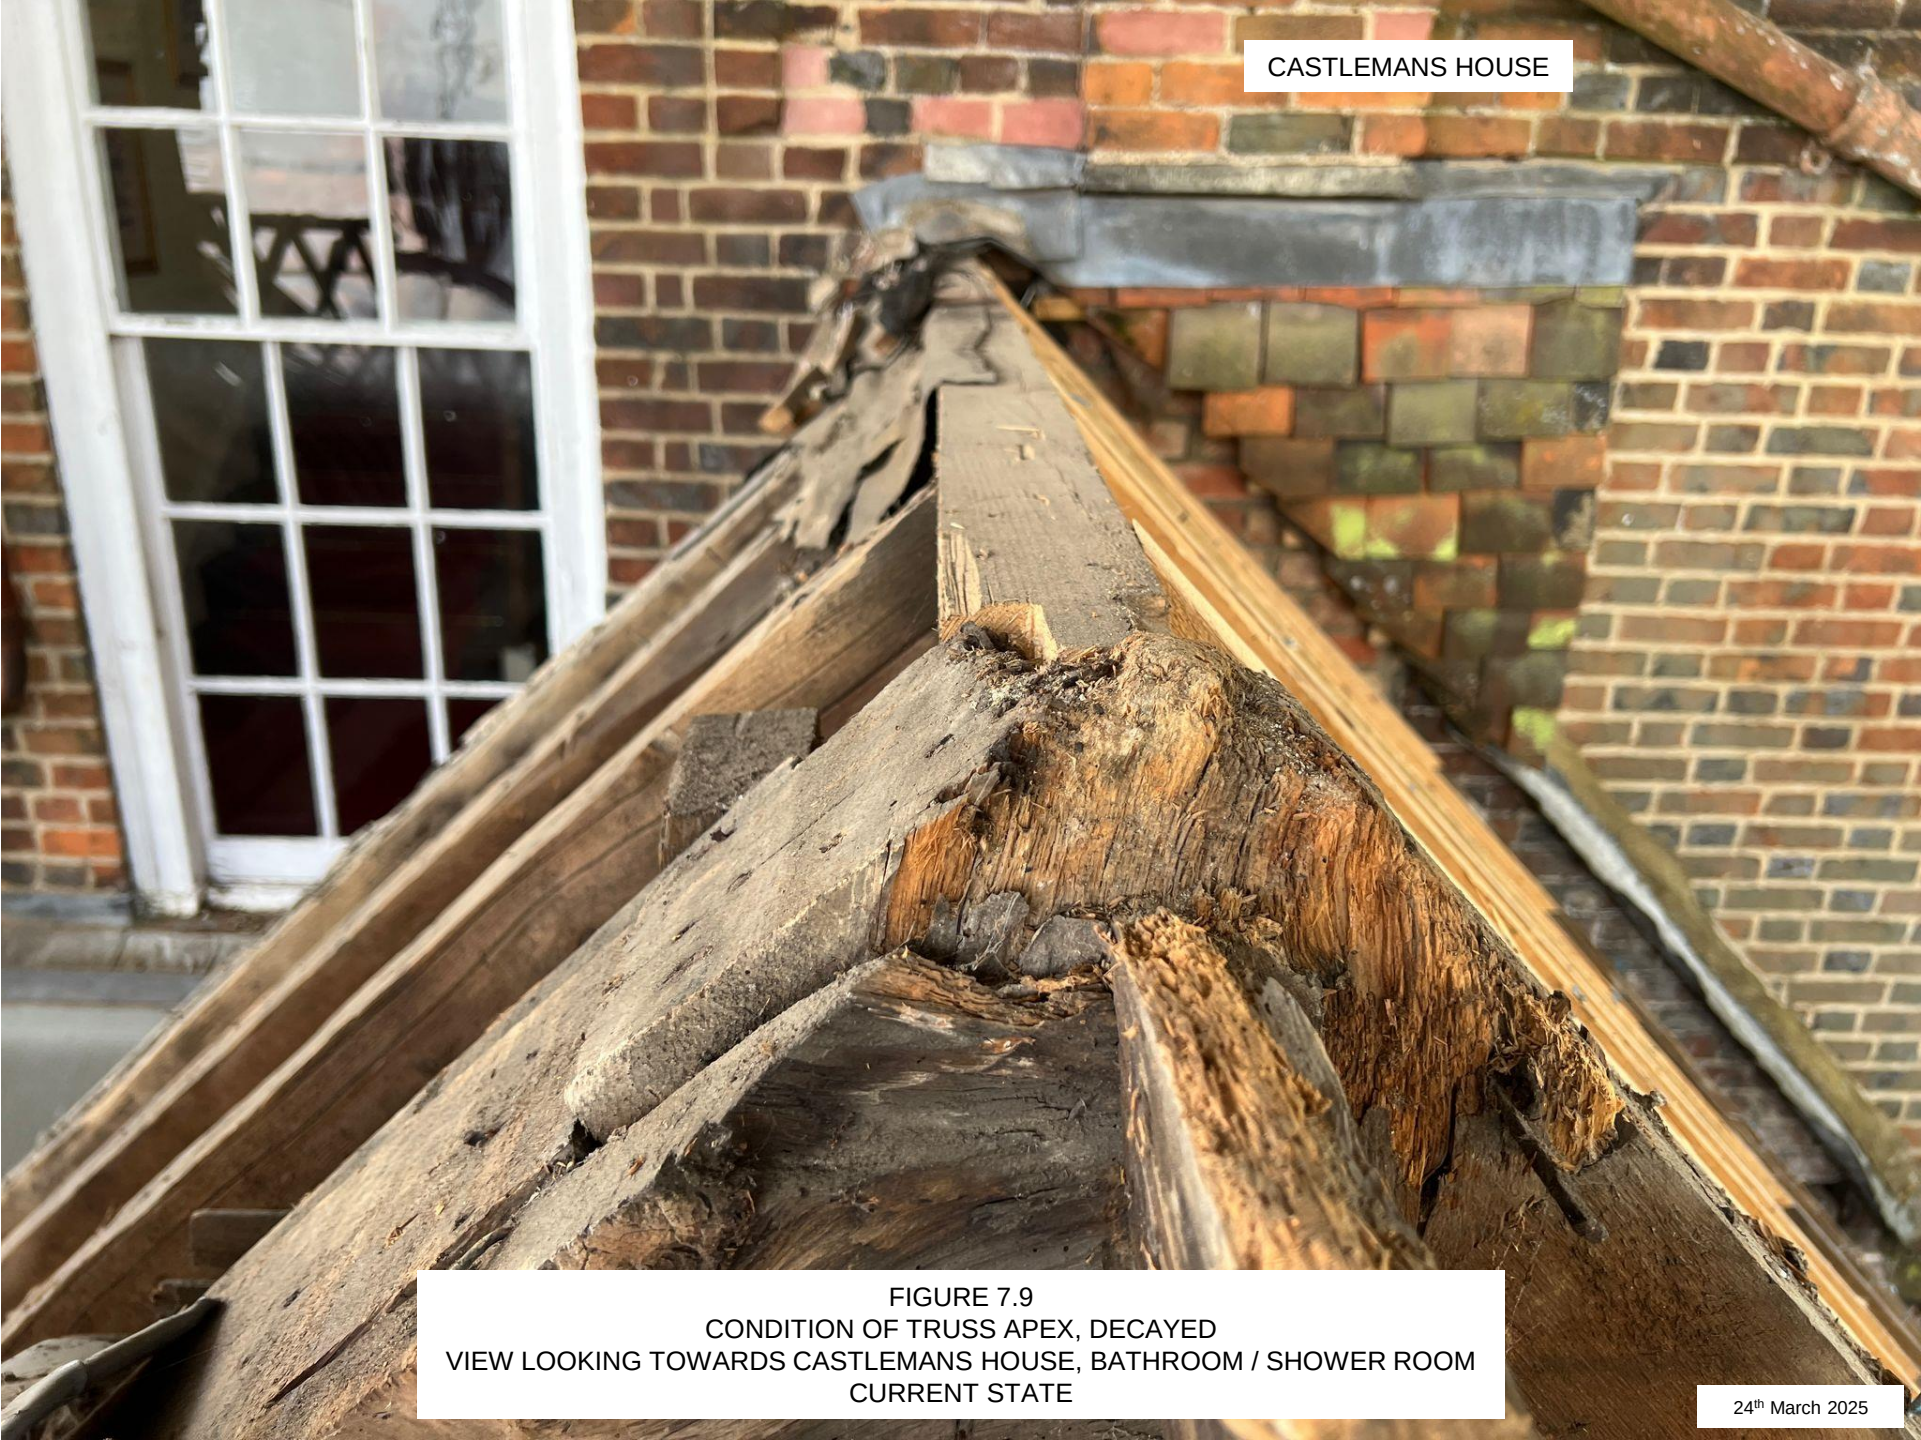
FIGURE 7.9  
CONDITION OF TRUSS APEX, DECAYED  
VIEW LOOKING TOWARDS CASTLEMANS HOUSE, BATHROOM / SHOWER ROOM  
CURRENT STATE
