# CASTLEMANS COTTAGE ROOF REPAIRS

**Planning Portal Reference: PP-13905061**

**BCS Reference: 25/0784/OTHBN**

This document forms part of an application for listed building consent sought for the repairs to the existing second storey tiled roof.

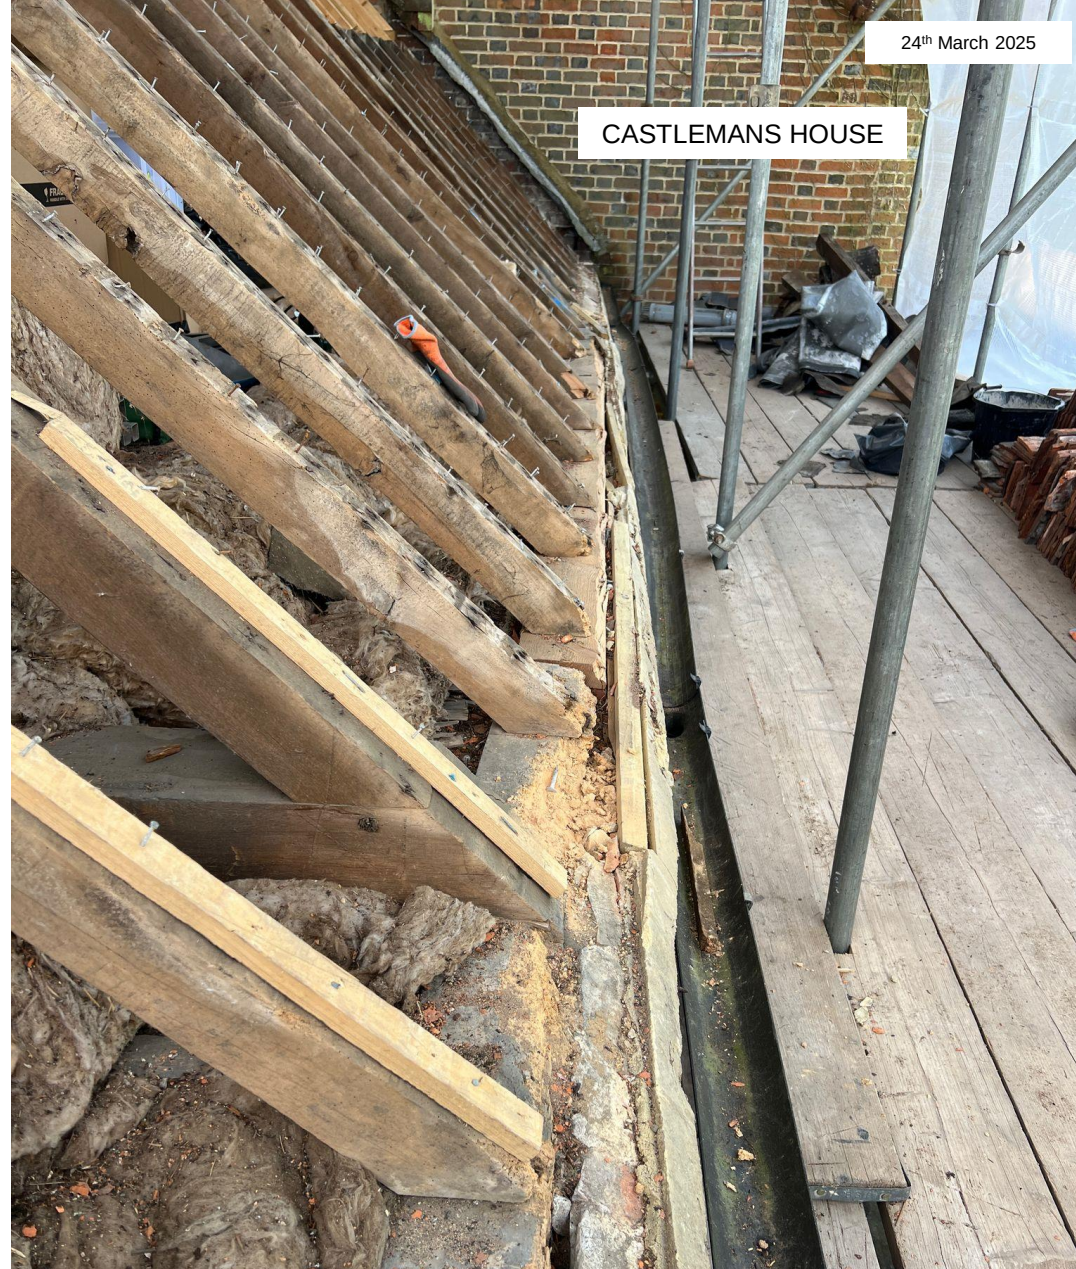
FIGURE 7.11  
TYPICAL CONDITION OF WALL PLATE, DISINTEGRATING  
VIEW LOOKING TOWARDS CASTLEMANS HOUSE, ALONG FRONT ELEVATION  
CURRENT STATE

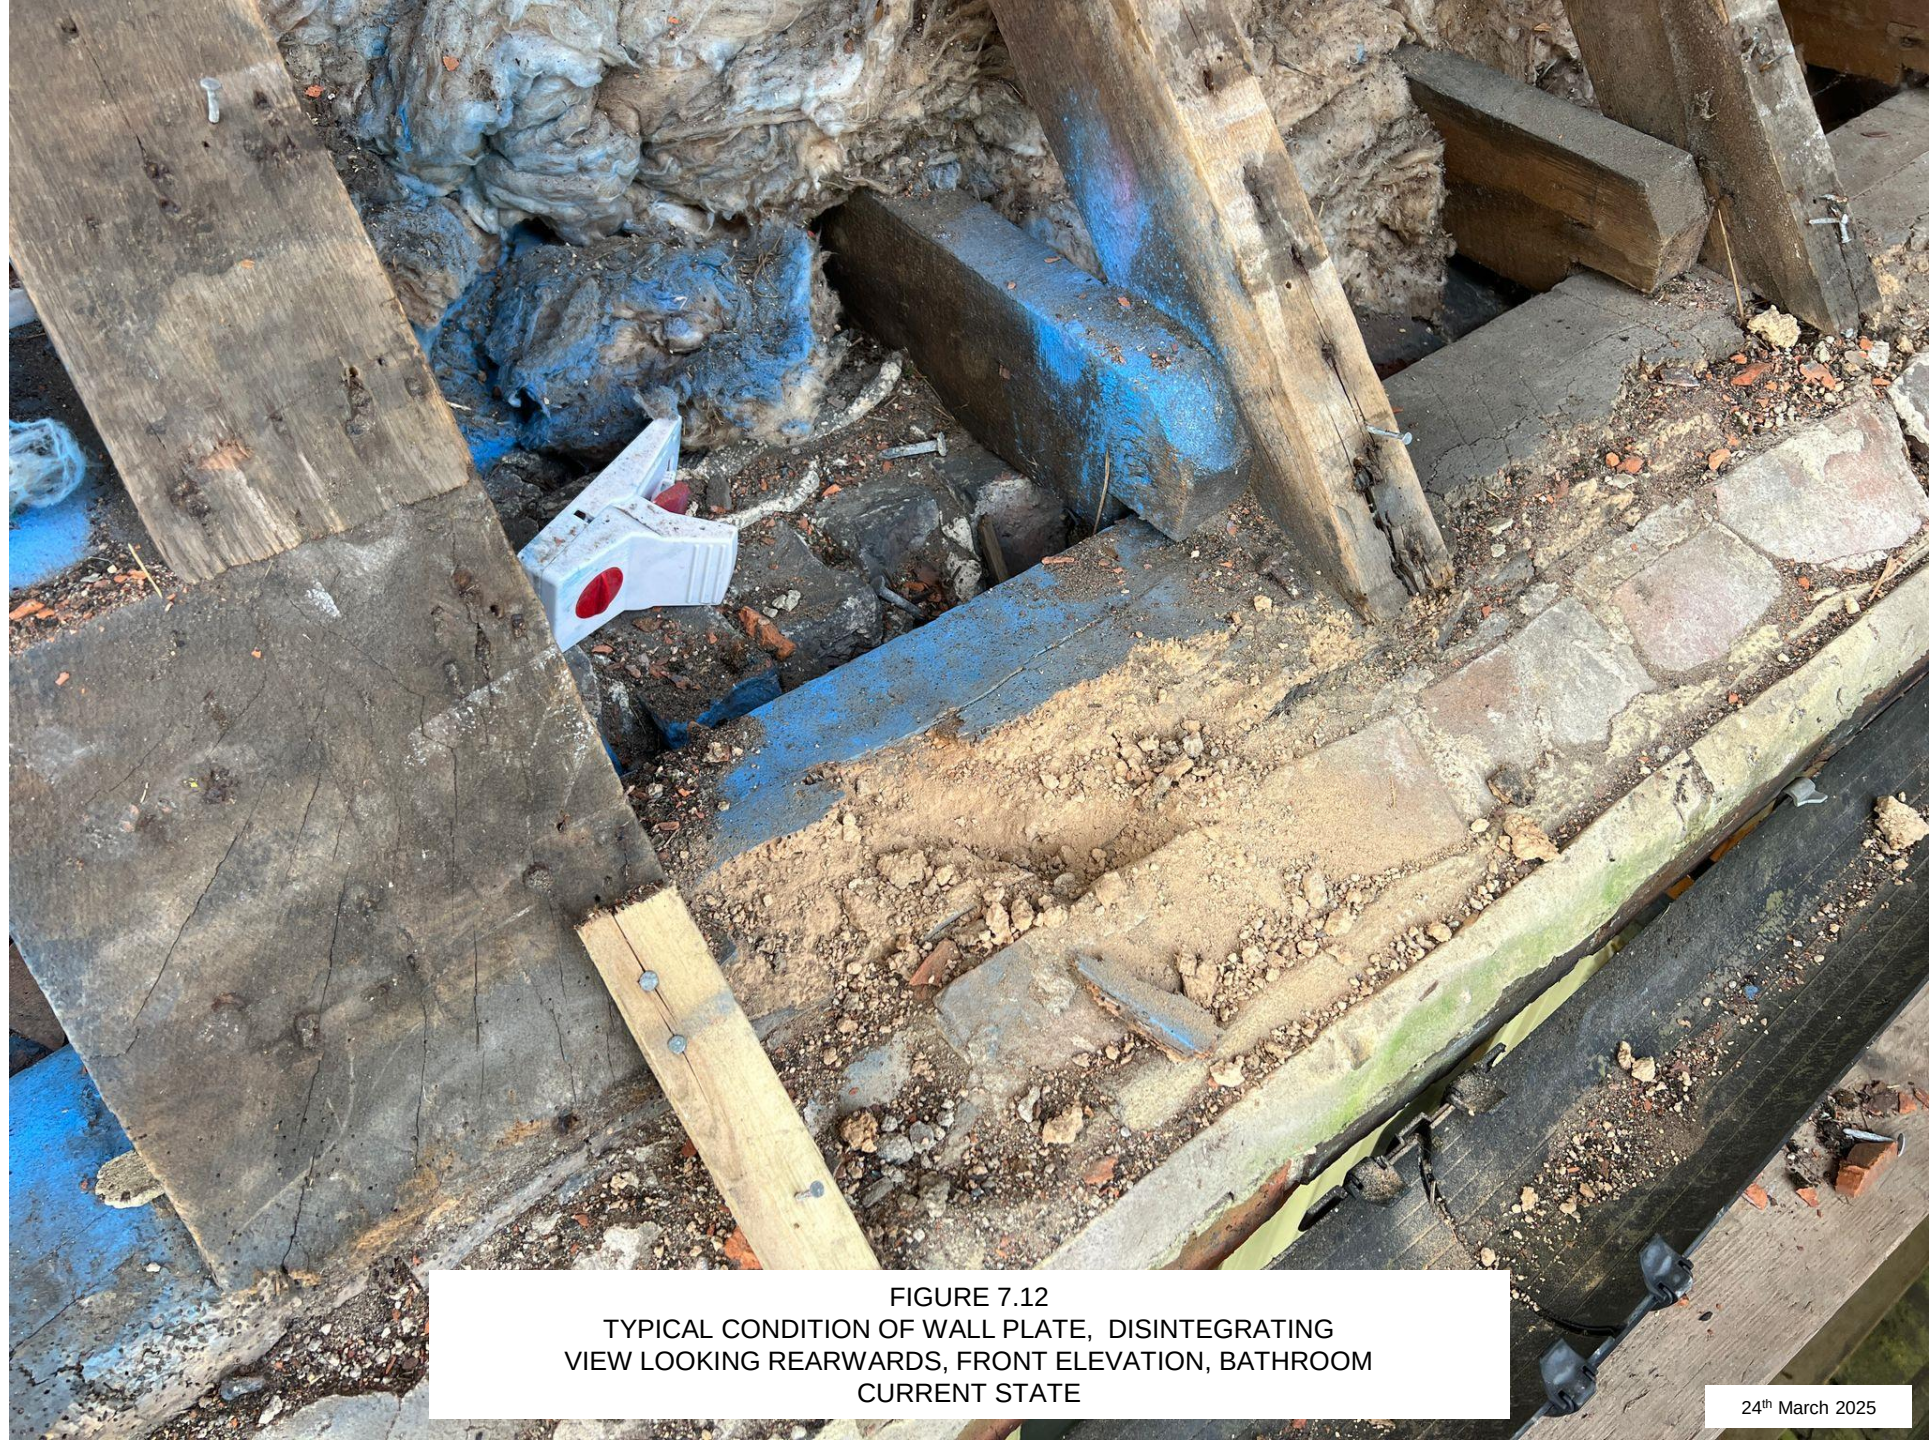
FIGURE 7.12  
TYPICAL CONDITION OF WALL PLATE, DISINTEGRATING  
VIEW LOOKING REARWARDS, FRONT ELEVATION, BATHROOM  
CURRENT STATE

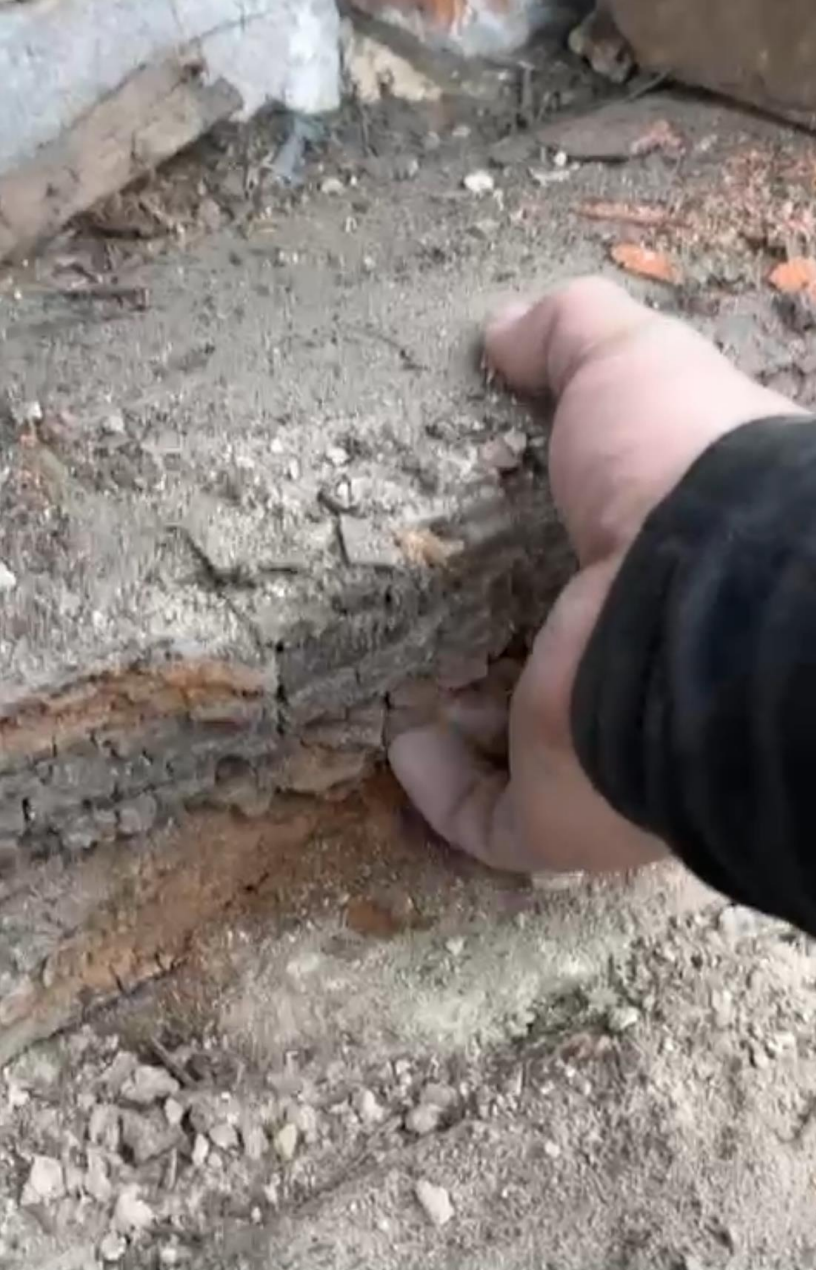
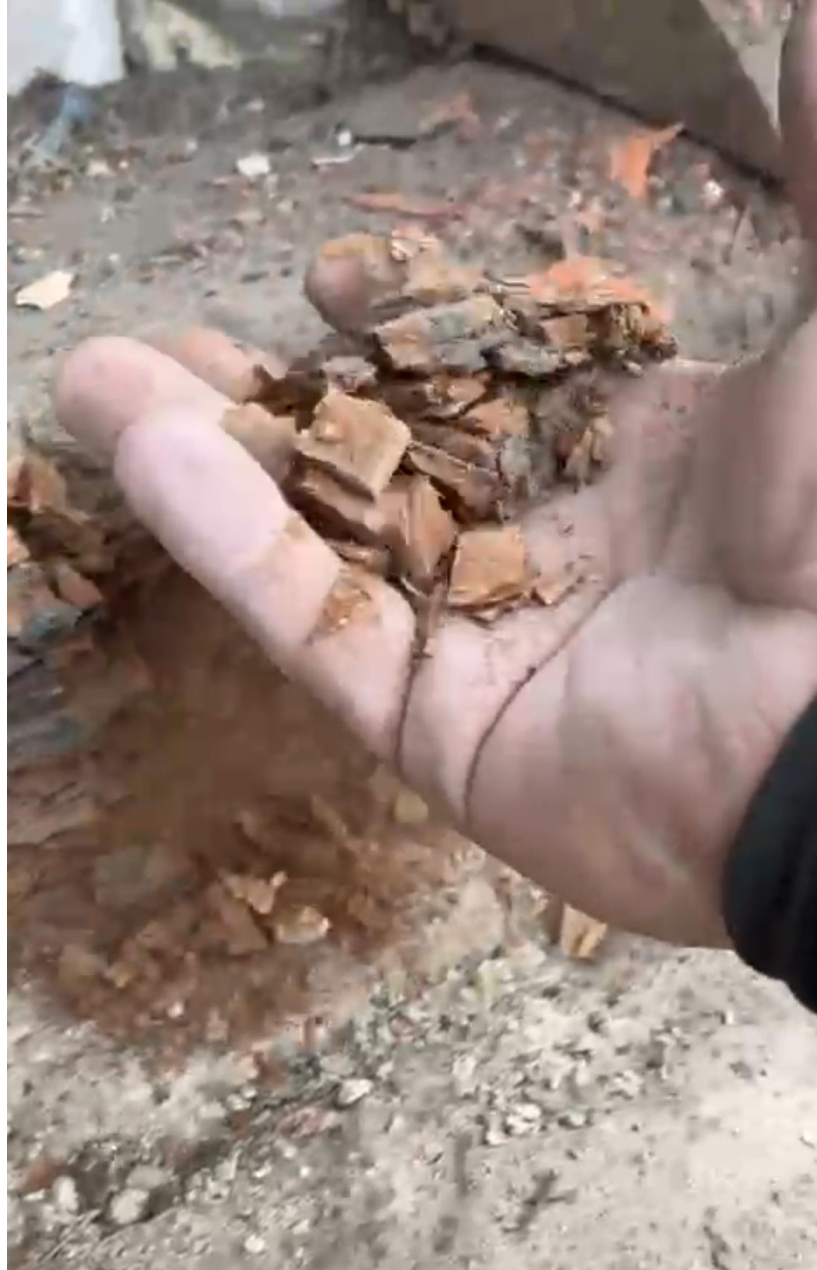
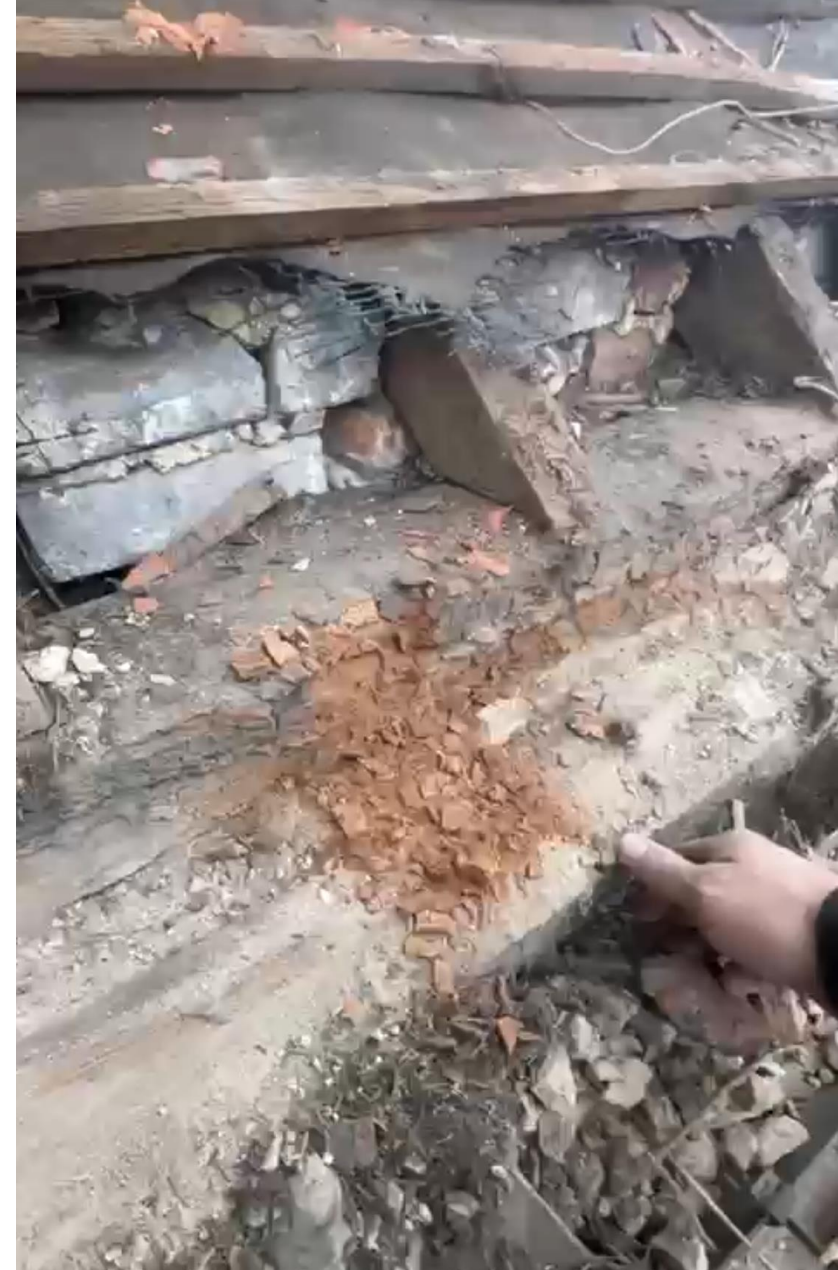
FIGURE 7.13  
TYPICAL CONDITION OF WALL PLATE, DISINTEGRATING, CUBOIDAL CRACKING  
CURRENT STATE  
(IMAGES TAKEN FROM VIDEO)
