# MEMORANDUM

| <b>Application No.</b> | 260979 | <b>Site Visit Made:</b> | Yes (12/05/26) |
| <b>Address:</b> | The Old Cottage, Pearson Road, Sonning, RG4 6UH. | | |
| <b>Proposal:</b> | Application for submission of details to comply with Condition 4 (structural repairs method statement) of listed building consent 232278 dated 09/01/2024. | | |

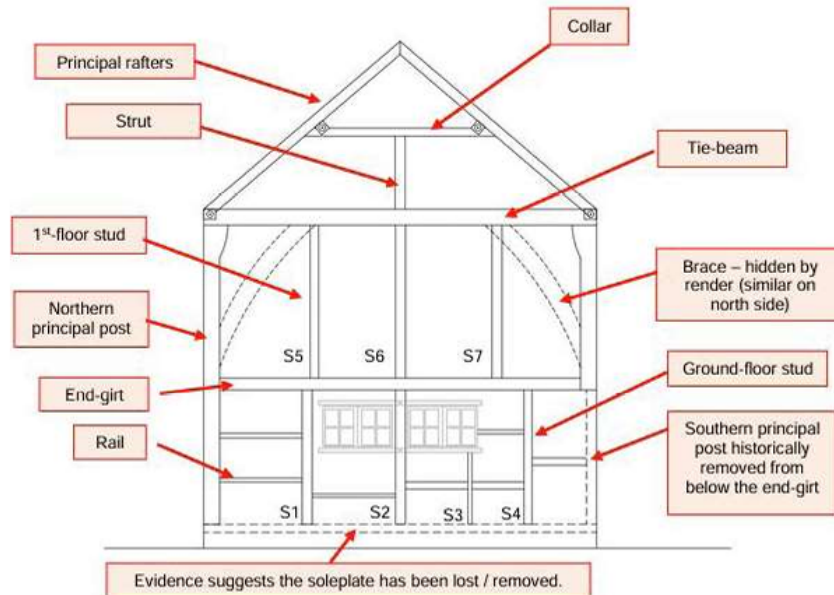
Fig. 1: Extract from the Clive Hudson Associates' structural report on the west gable

The Clive Hudson structural report on the west gable identifies secondary studs 1-4 as the vertical timber studs at the ground floor between the 'end girt' (see Fig.1 for reference).

Figure 6. Elevation of the west gable with constituent elements of the timber frame indicated

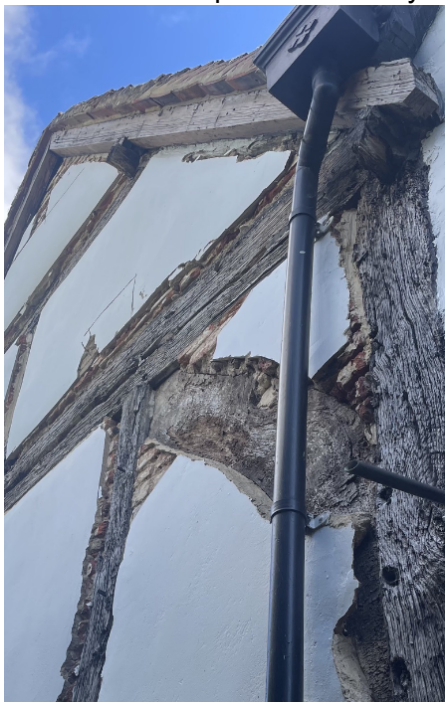
Extract from Heritage Revival Method Statement – here it should be noted the braces at first-floor level previously hidden under the cementitious render finish have now exposed along their lengths (along with directly adjacent brick infill) as a result of the render covering them. Furthermore, removal of the existing render covering for the southern principal post appears shows the lower portion severely eroded rather than having been historically removed.

Revealed brace timber.

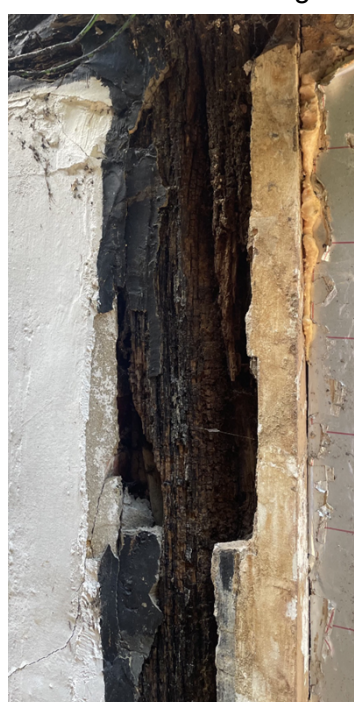
Remains of lower portion of southern principal post.

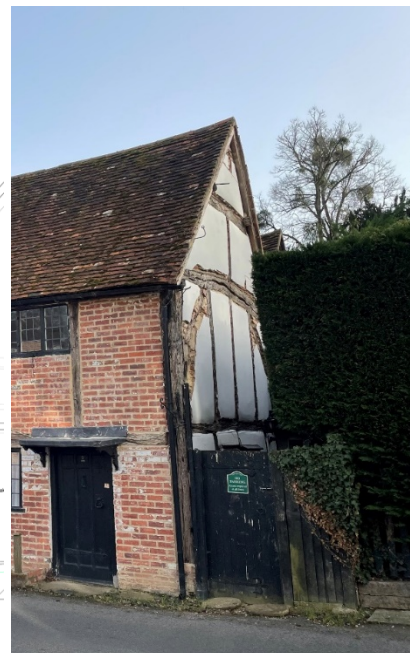
West Gable End – phot shows the braces have now been exposed

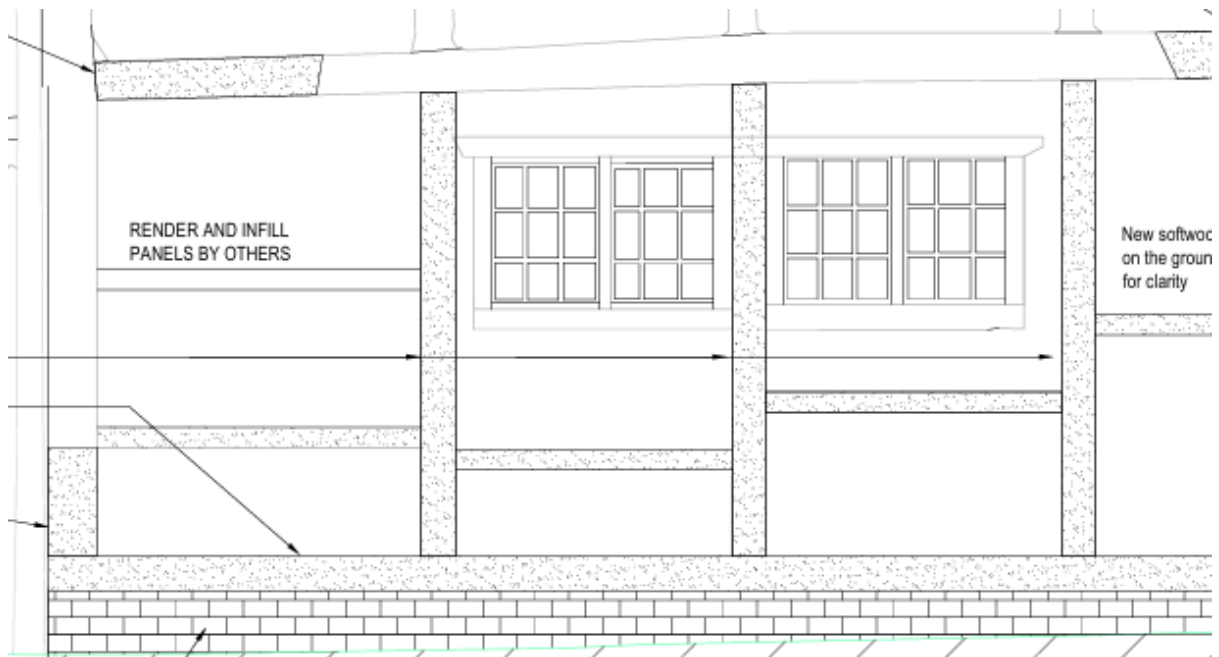
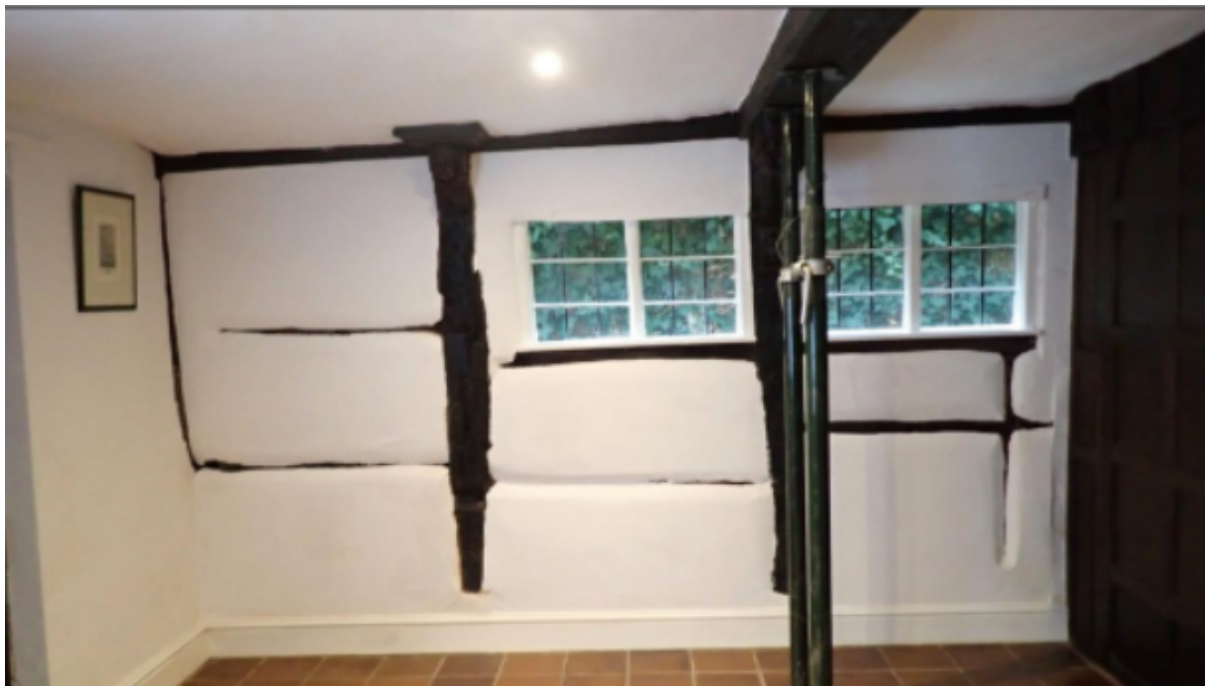
- The replacement of these element would not faithfully replicate the existing arrangement of the historic rail timbers, as several of the ones not necessary visible externally but visible from inside the building including the rails timber apparently directly under the two windows are not shown.

Reversed image of the interior view -so as to match with external drawing above

- That oak is used for the replacement rails and studs of the west gable end, and not a softwood ,
- The arrangement of replaced rails and studs replicate that which presently exists.
