**Damaged Structures  
(within the attached outbuilding)  
Method Statement & Justification for Replacement**

15/01/25

Sussex Lodge

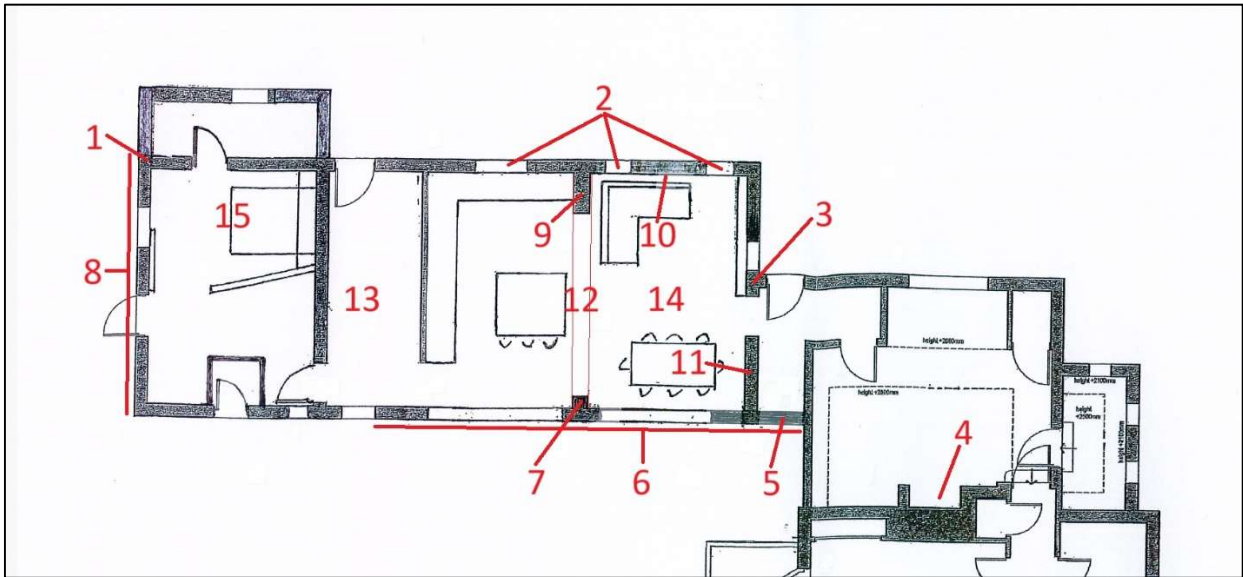
Fig.1.

The areas affected are within the attached outbuilding:

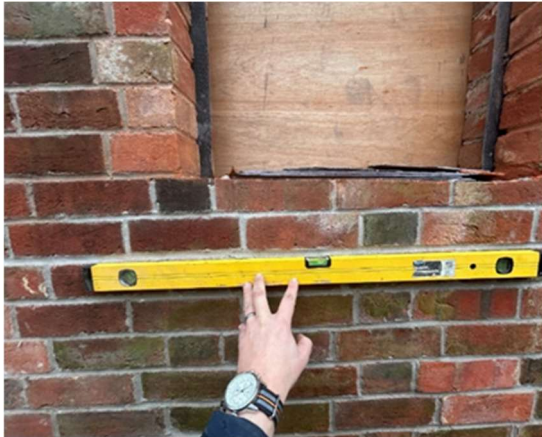
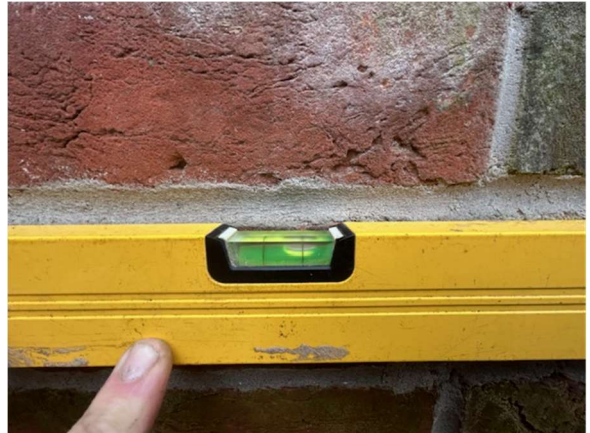
Previous permissions (223175/223176) approved three windows to the western elevation. Upon installation of these openings, it was apparent that the outbuilding has suffered from historic settlement around the north-west corner, resulting in the brickwork leading up to this corner dropping and being off-level. Example below.

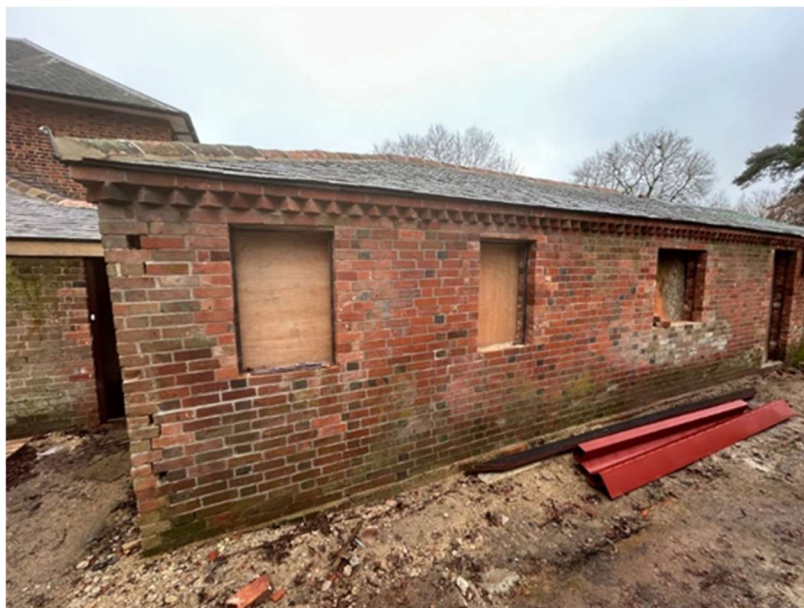
It has therefore been impossible for the proposed window openings to be positioned in the brickwork as previously approved, ie level with each other and tight to the underside of the dog tooth eaves detail.

To work with the existing structure, each opening has been lowered from the dogtooth to ensure they can go in level without impacting the dog-tooth; level with the other new windows; and level with the existing window on the north elevation, resulting in varying degrees of gap between the window head and the underside of the dogtooth brick detail above.

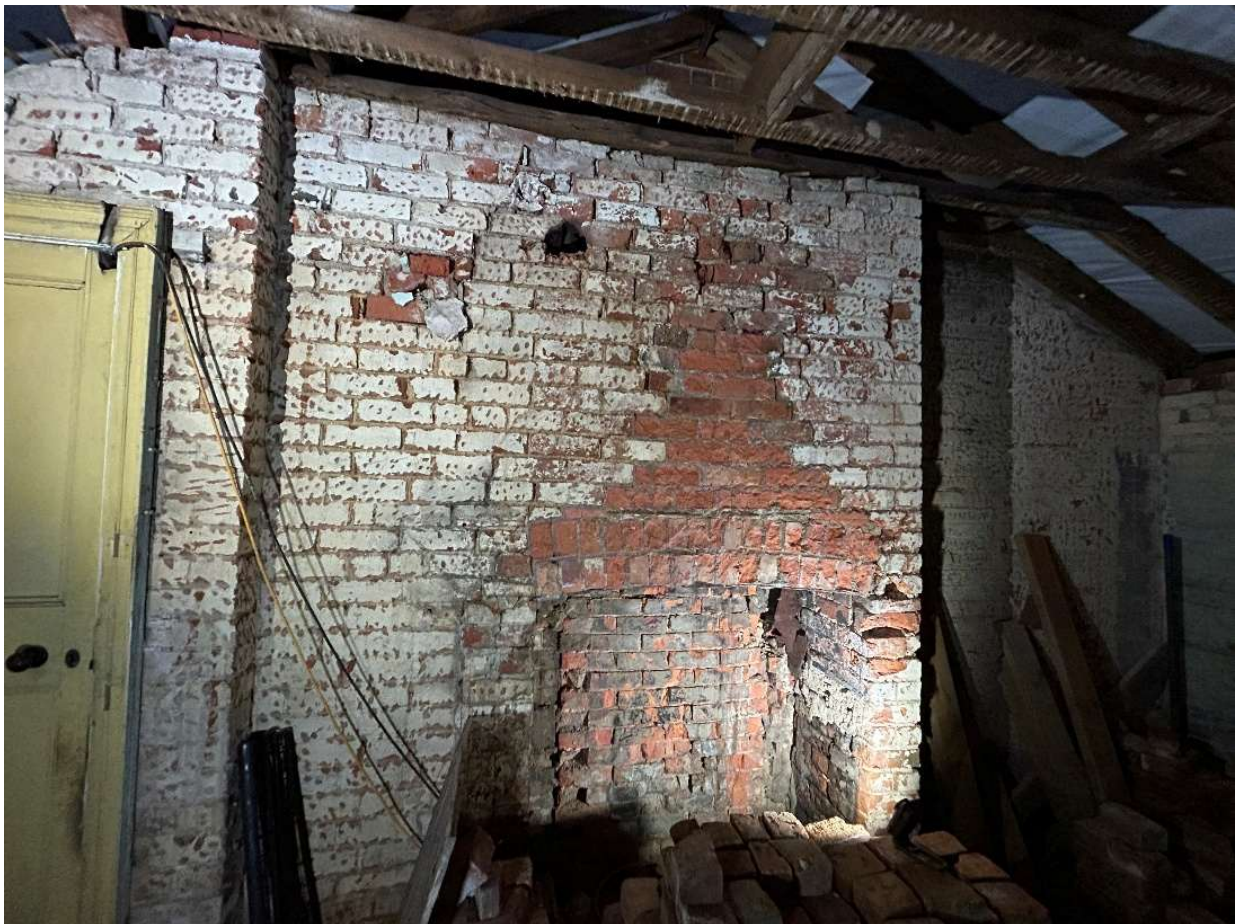
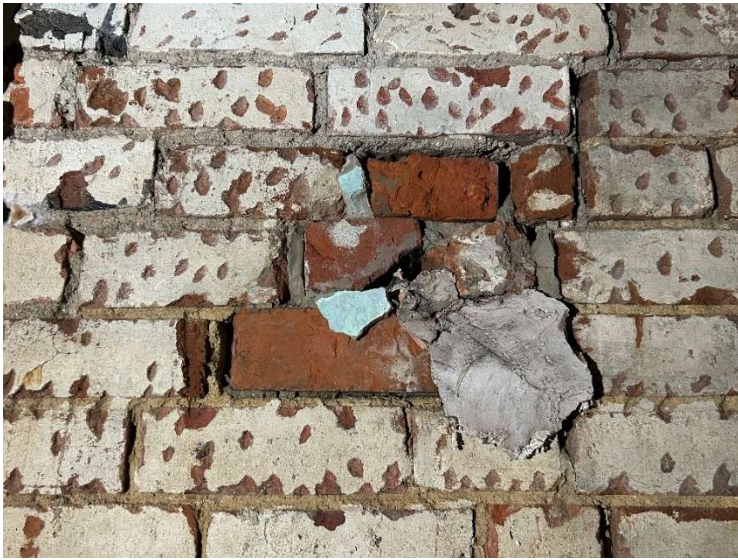
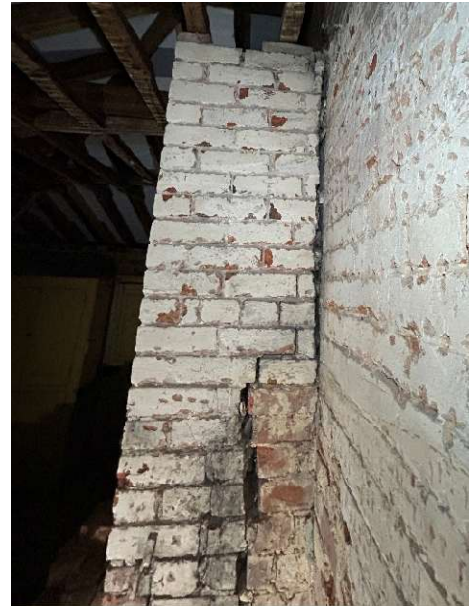
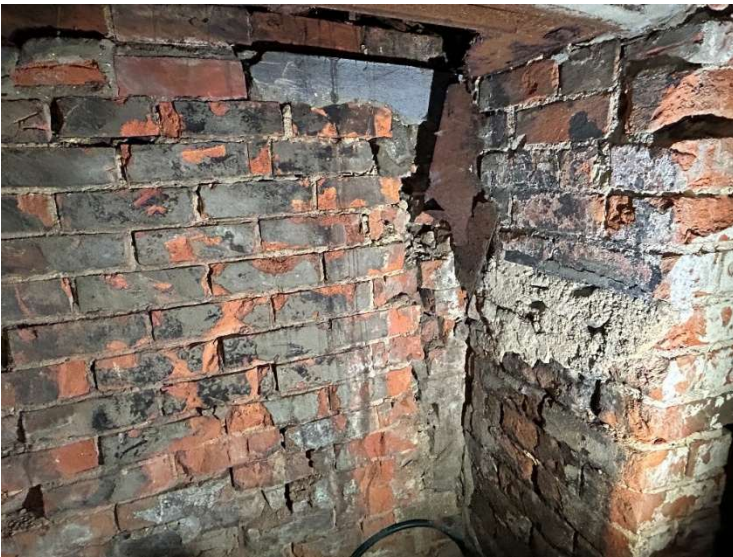
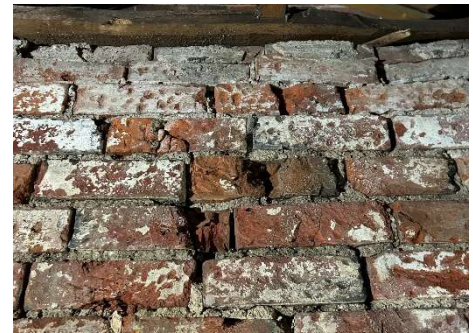
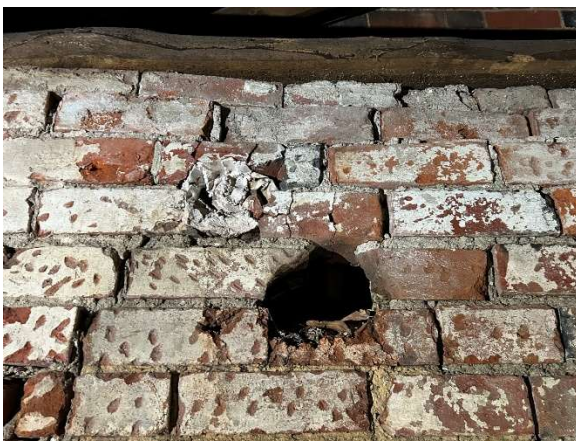
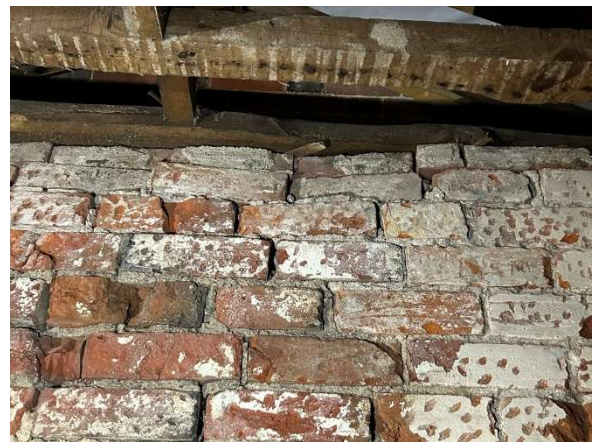
#### CHIMNEY BREAST (Fig.1 No.4)

The chimney breast to the eastern side of the outbuilding is in a poor state of repair.

The original construction appears to have been completed at different times, with different sections of brickwork of poor quality. There is no physical connection to the flank wall of the house and the top courses of brickwork are now un-bonded and loose. Much of the brickwork has been repaired, patched, damaged or filled.

The proposal is to carefully dismantle the chimney breast, and re-build it with the existing bricks, following the current pattern of brickwork.

In doing so the structure will be stabilized and the chimney prepared for the installation of a log burner flue. The brickwork itself will be left un-plastered and exposed, to be appreciated by the occupants of the house.

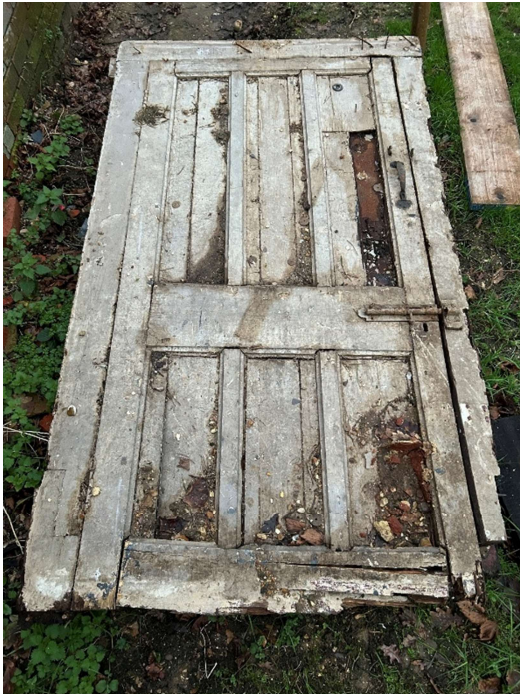
#### EXTERNAL DOOR (Fig.1 No.5)

The external door on the east elevation was beyond the point of repair.

With a small hallway on the inside and a covered store area on the outside, the doorway itself is positioned such that if replaced with a new door and the doorway used, it would render the areas either side of it useless. Instead, the preferred option was to brick up the doorway and allow the proper use of the external store area, and for the proposed insulation to continue across this area internally.

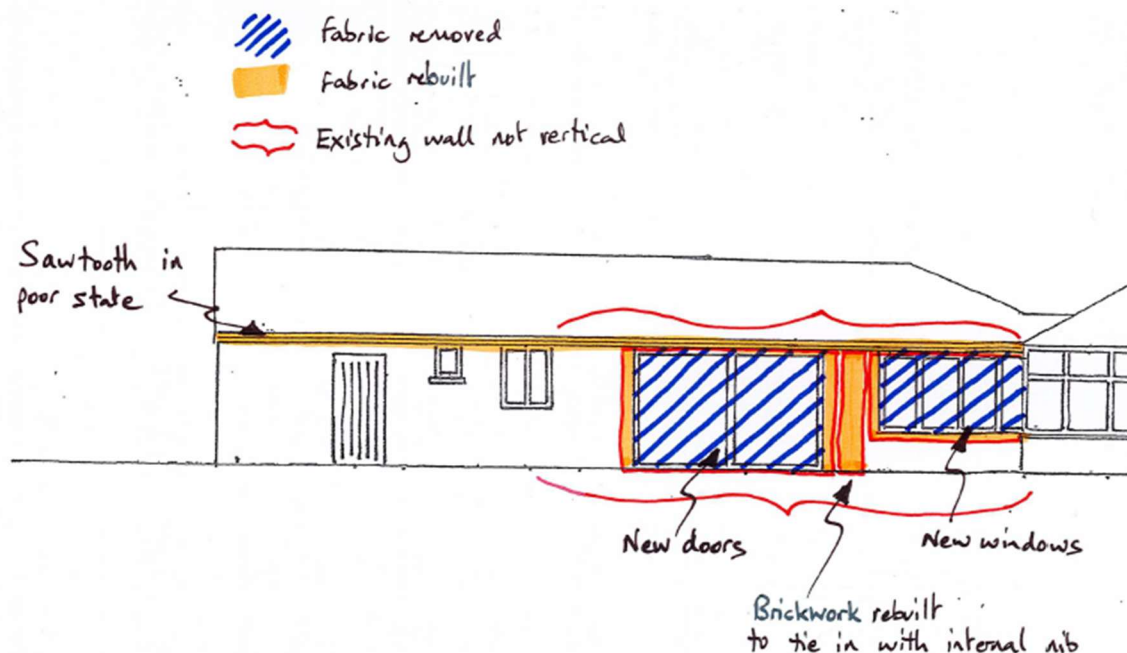
#### EXTERNAL WALL ON EASTERN ELEVATION (Fig.1 No.6)

The east elevation to the outbuilding has proved to be more damaged than originally thought. In addition to the new openings for the window and glass doors (approved by applications 223175 & 223176), there were large areas where repairs/re-instatement were required, which would leave a relatively small area of fully untouched original brickwork.

With this in mind the end finish and structural integrity would benefit significantly from approaching the whole wall in one go rather than a patchwork of repairs amounting to somewhere in the region of 90% of the original wall being affected.

The section of wall was carefully dismantled brick by brick and stacked for re-use, before re-building with the same brick bond and combination of burnt and non-burnt headers.

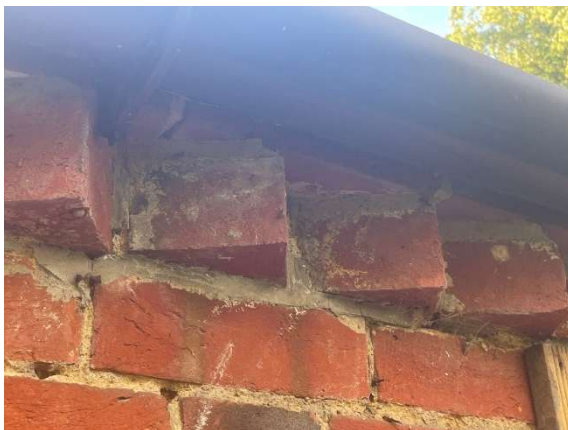
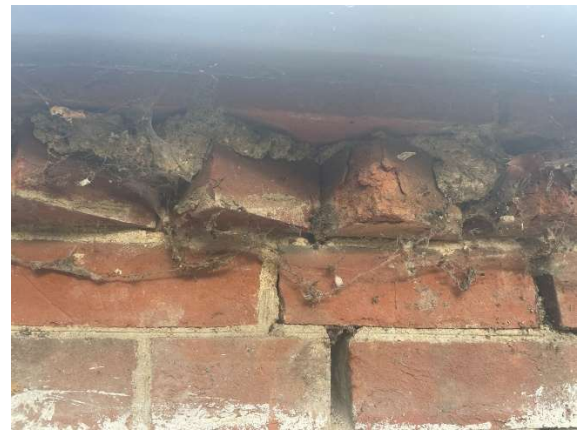
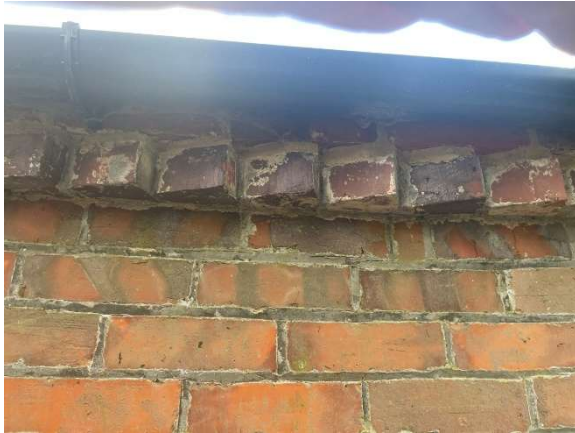
A - Saw-tooth band - most of the saw-tooth band was in poor condition and required replacing

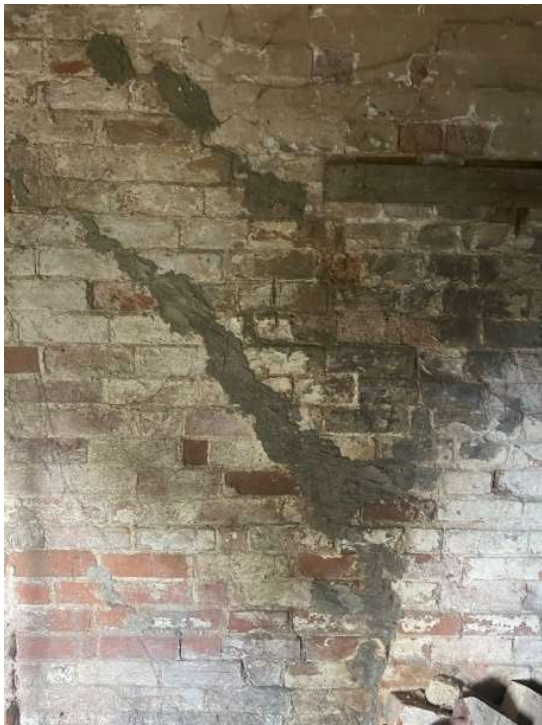
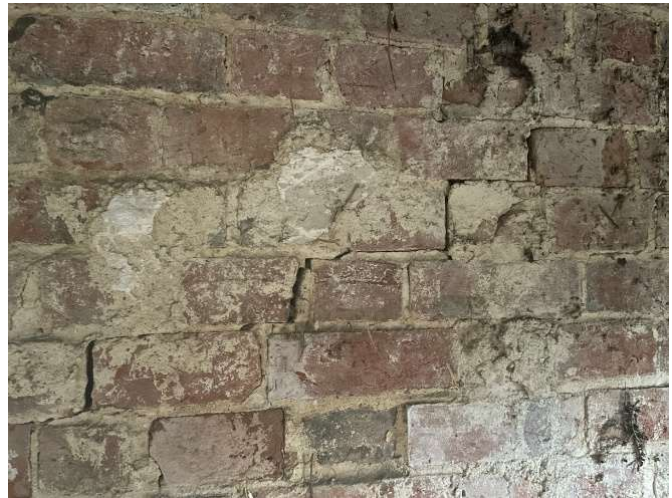
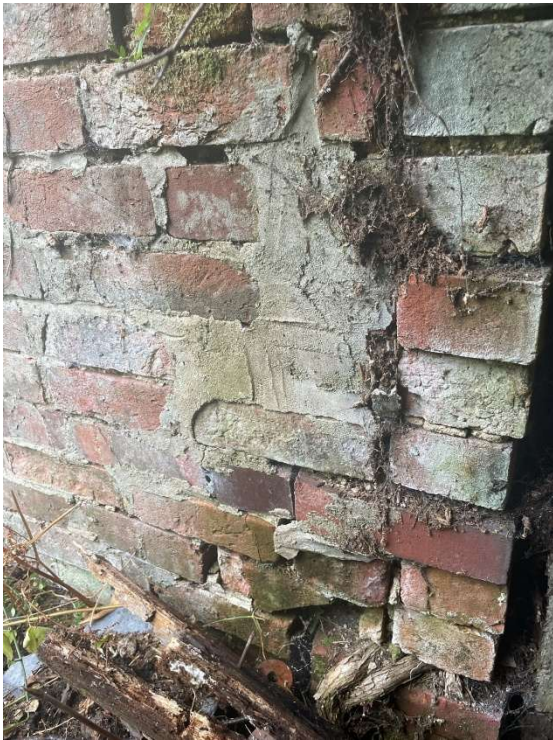
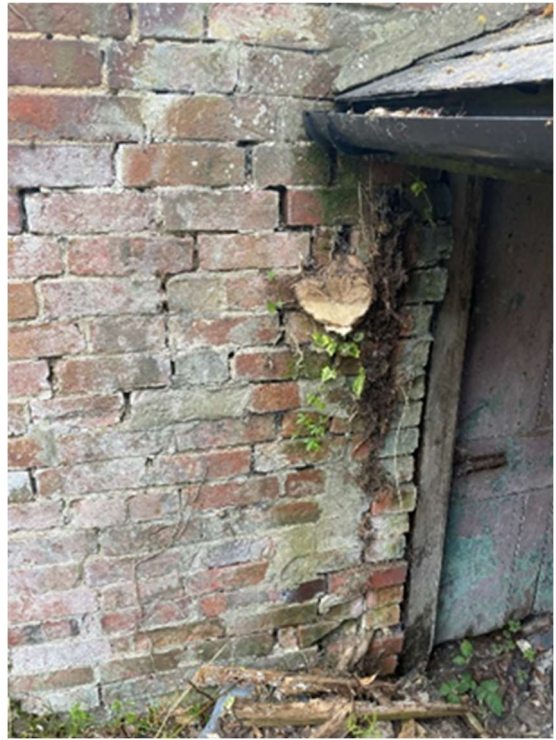
B - Cracks internally and externally - areas of diagonal cracking, significant vegetation/root damage, making good historic repairs

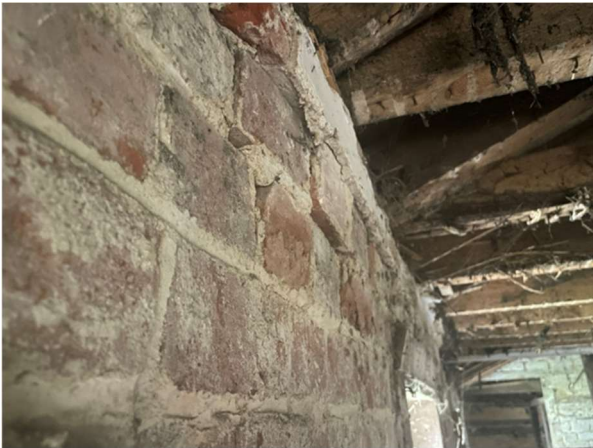
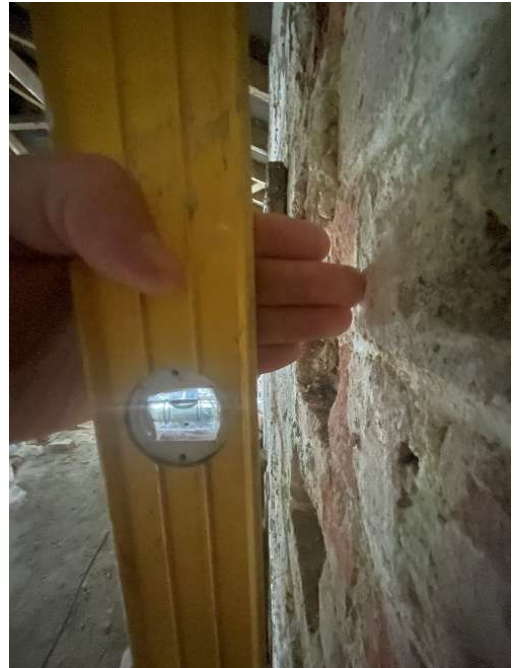
D – Large sections of wall were off vertical - These needed to be re-built vertical for structural integrity, especially due to the level of structural loadings being applied, but also to allow the vertical installation of windows.

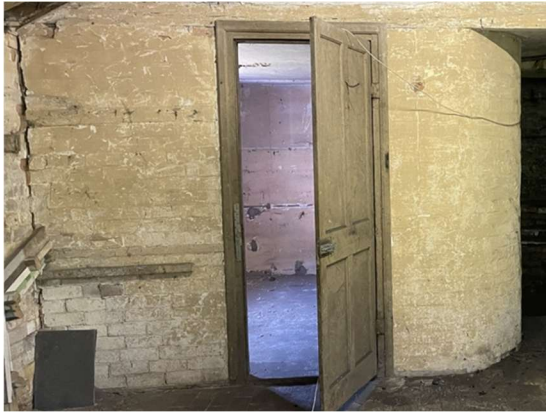
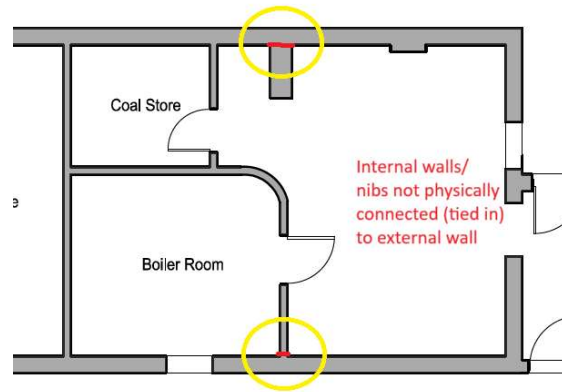
E - Tie in structural piers - None of the internal wall nibs that were shown to be retained in approvals 223175 & 223176 were tied into the external wall. The nibs would have remained as structurally unsound stack of bricks with nothing preventing their collapse.

For structural stability these would have been too weak if left and therefore the associated areas of external wall needed to be re-built to tie in to the nibs, to create suitably cohesive piers. This was especially so for the nib/pier on the eastern elevation that is required to support the lintels over the two new openings.

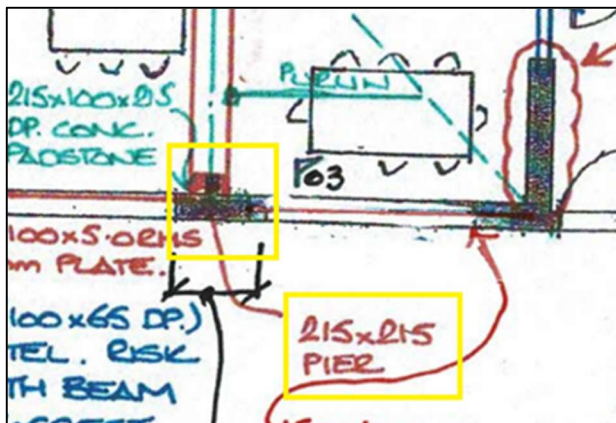
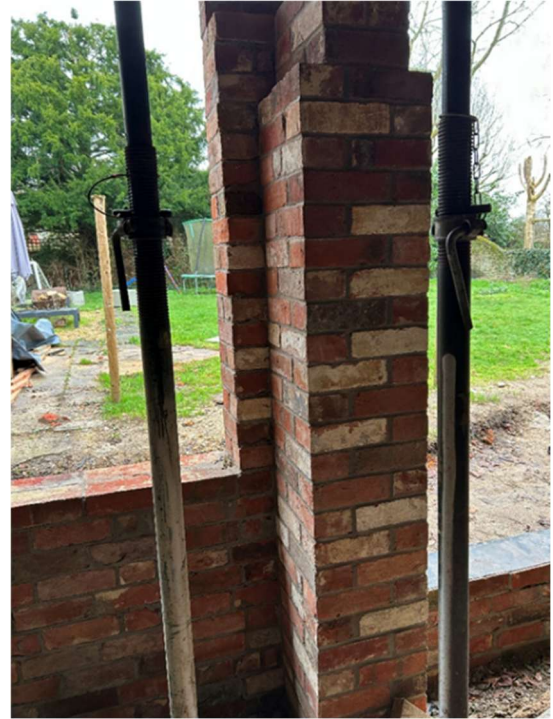
#### INTERNAL NIB WALL ON EASTERN ELEVATION (Fig.1 No.7)

In addition to needing to be tied-in to the external wall, this nib also needed to be enlarged to meet the requirements of the structural engineer.

Rather than just building it larger, it has replicated the form of the nib to the western side ie narrowing at the top.

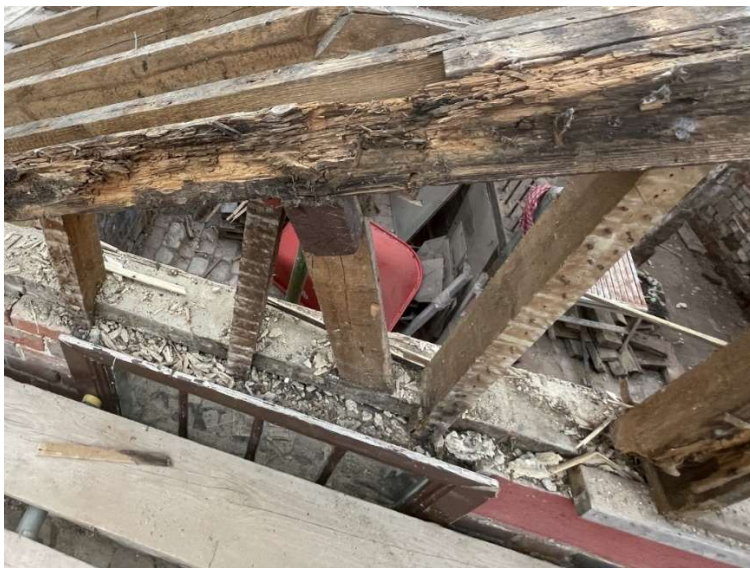
#### SOUTHERN GABLE END (Fig.1 No.8)

The render to the gable end had blown in many areas and the structural timbers rotten. This gable has been rebuilt and the area of render proposed to be replaced with horizontal lap boarding to be consistent with other proposed boarding.

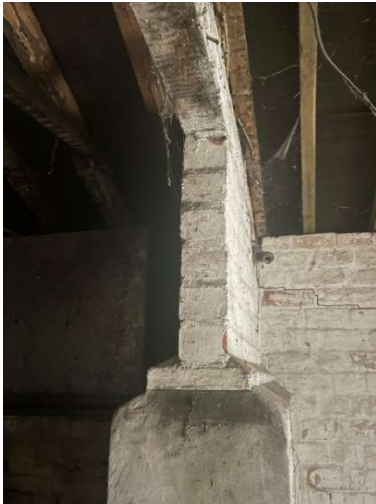
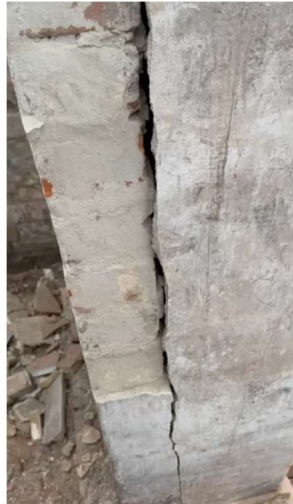
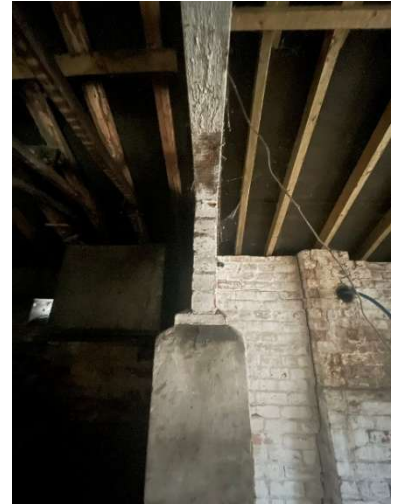
### INTERNAL NIB WALL ON WESTERN ELEVATION (Fig.1 No.9)

The existing nib, although looking substantial, lacked any bonding between the three brickwork 'skins' that the base of the nib was made up of, and lacked any form of foundation, as well as being undermined by rodent activity. In addition, the top single skin section of brickwork was off vertical.

With this nib needed to be the structural support for the beam and roof above, it was re-built, allowing for a fully bonded pier at the base and although still narrower at the top, an increase to 9" brickwork providing a better support for the beam.

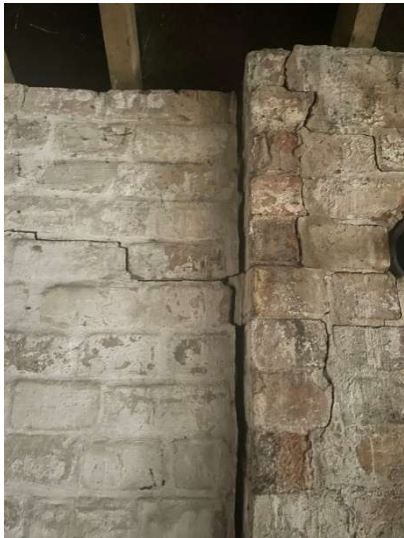
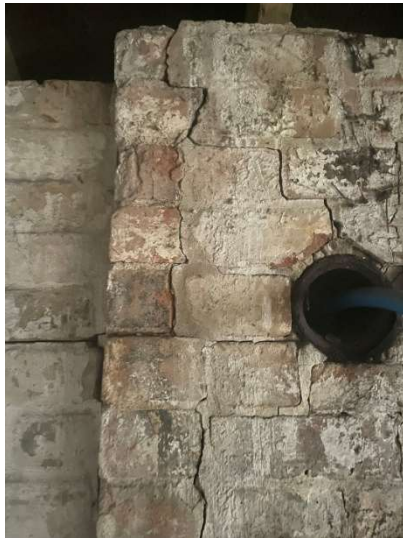
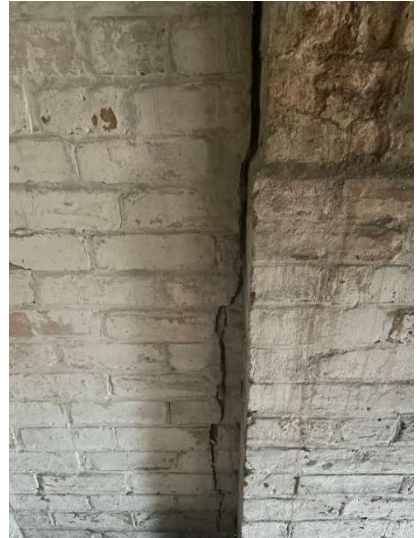
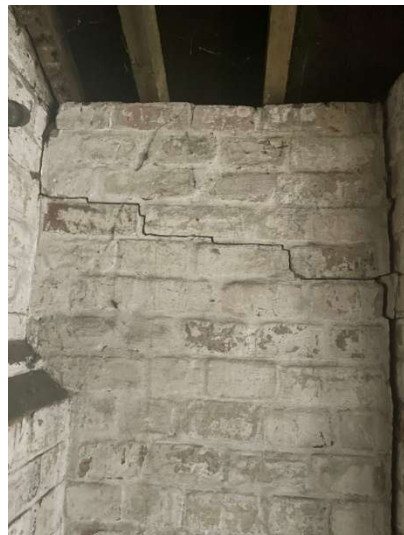
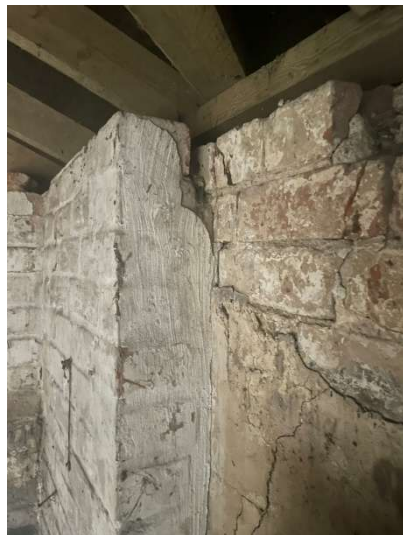
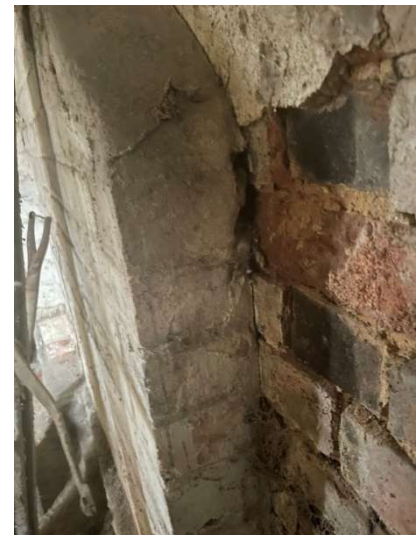
## SECOND 'SKIN' OF BRICKWORK TO WESTERN INTERNAL ELEVATION (Fig.1 No.10)

The additional internal skin of brickwork to part of the western elevation appears to serve a limited purpose with no evidence of its origins. The brickwork itself had significant diagonal and vertical cracking, as well as no tie-in to the external wall, rendering it unsafe.

This damaged brickwork has been removed and it is deemed unnecessary to replace it.

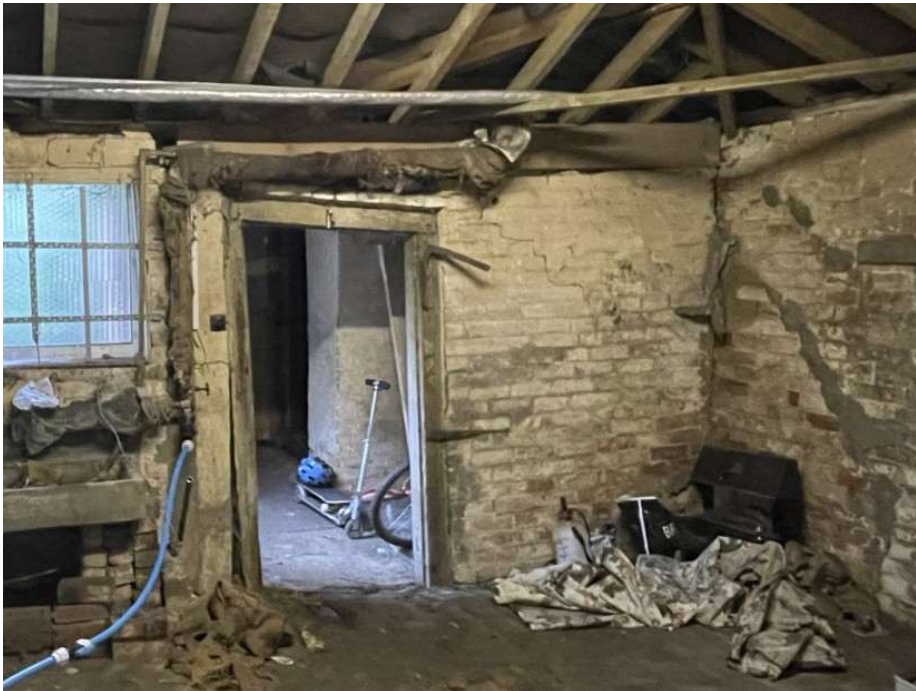
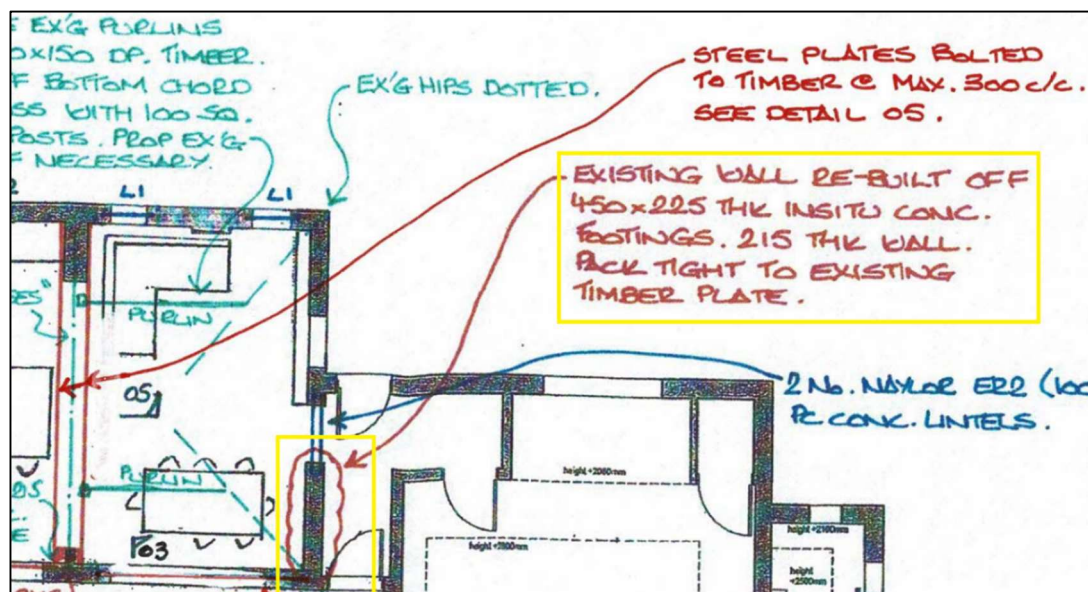
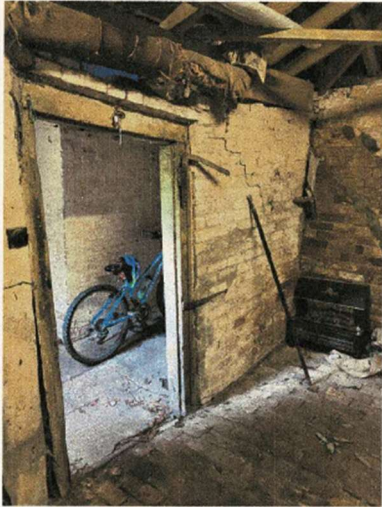
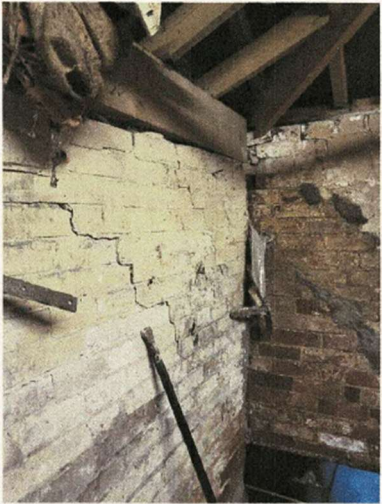
## SEPARATING WALL TO NORTHERN END (Fig.1 No.11)

This internal wall showed significant settlement with the floor dropping and the wall coming away from wallplate by some margin.

In the vertical plane there was a significant bow to the brickwork and large diagonal cracks.

Much like many of the other internal dividing walls there was no tie to the eastern external wall.

Views showing settled floor and wall. Note cracking, gap beneath wallplate, bow/bulge in wall, significant floor settlement, lack of tie to front wall.

The wall was unsafe and had to be dismantled. It is proposed to be re-built using bricks recovered from it and elsewhere and finished as un-plastered facing brickwork.

The modern softwood timber beam spanning the wall and doorway will be replaced with an oak beam to be left exposed.

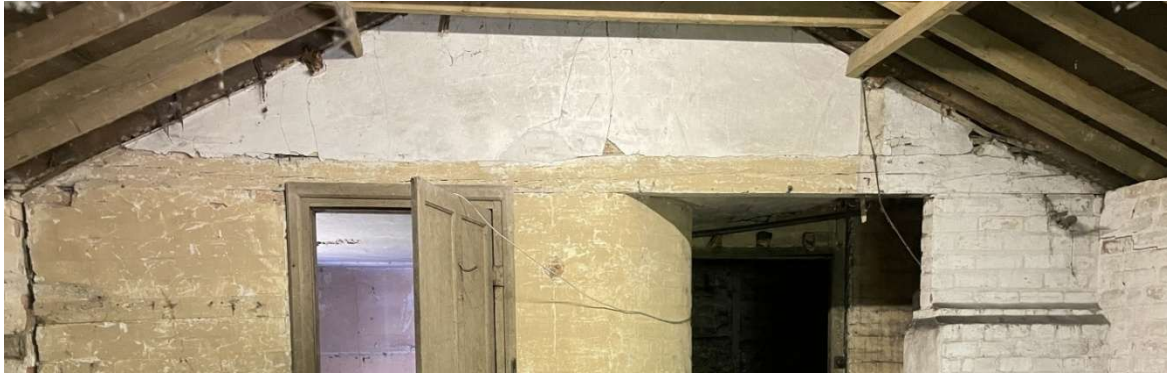
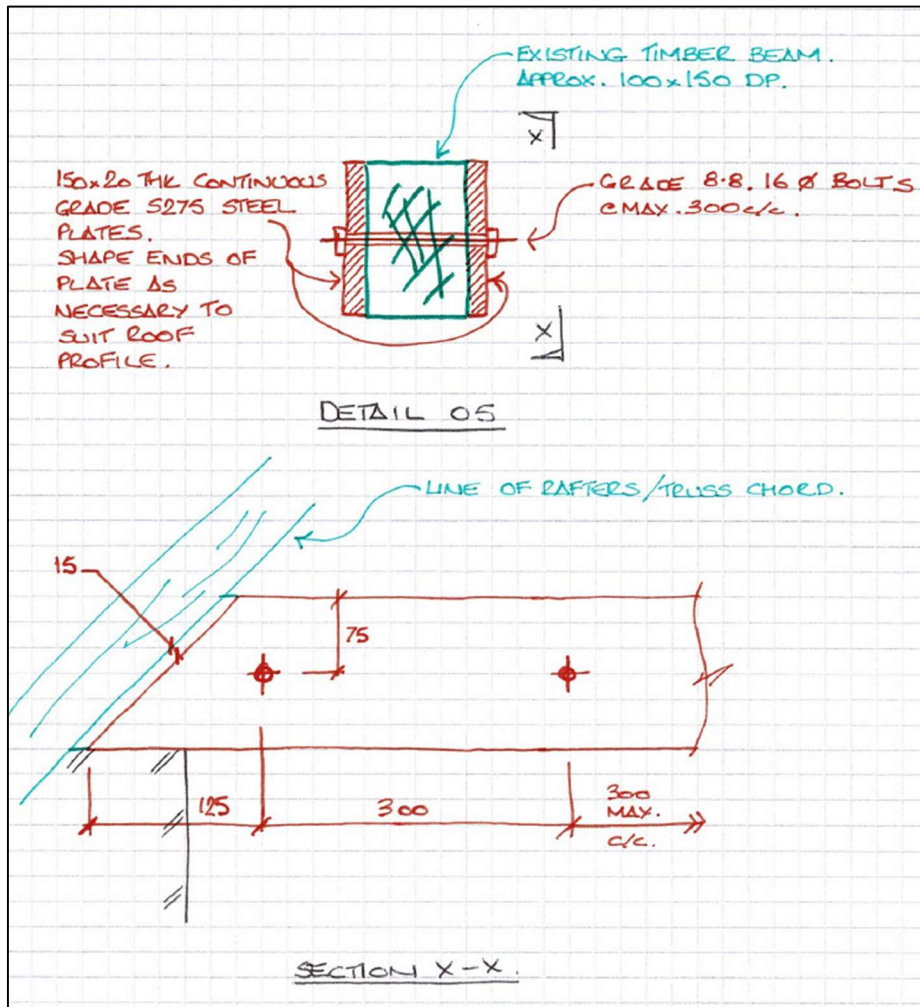
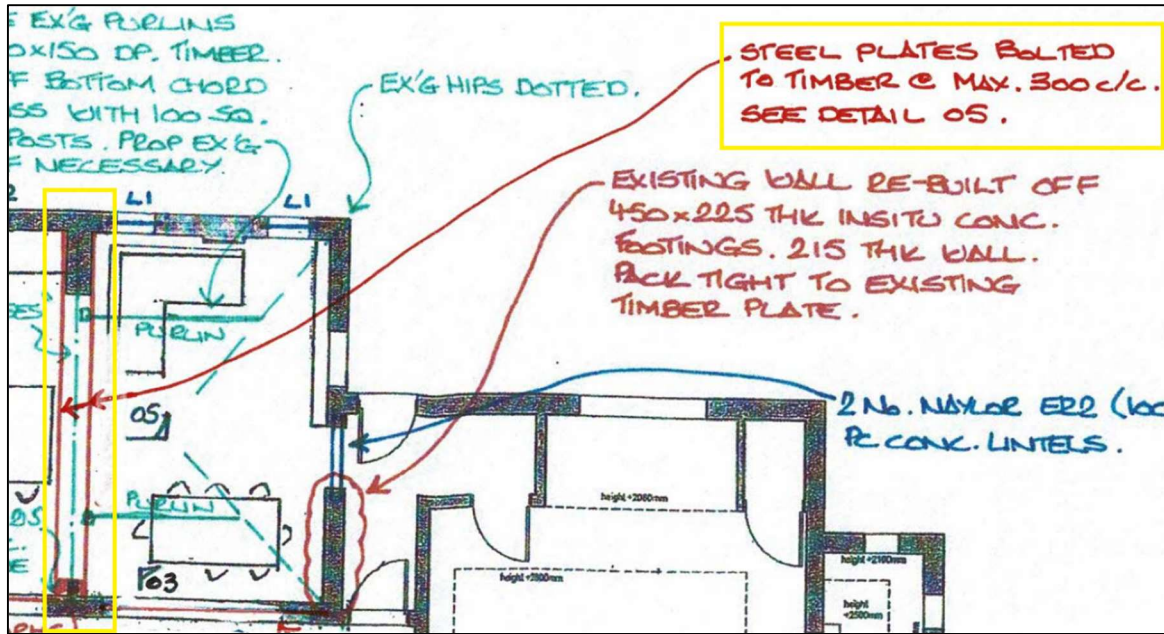
#### FLITCH PLATES TO TIMBER BEAM (Fig.1 No.12)

The existing timber beam spanning from east to west is fundamental to the roof structure, however its structural integrity cannot be guaranteed. The structural engineer requires steel flitch plates to be bolted either side of this beam to provide the necessary supports, as per the below design drawings. These plates will need to be bolted through the timber beam every 300mm.

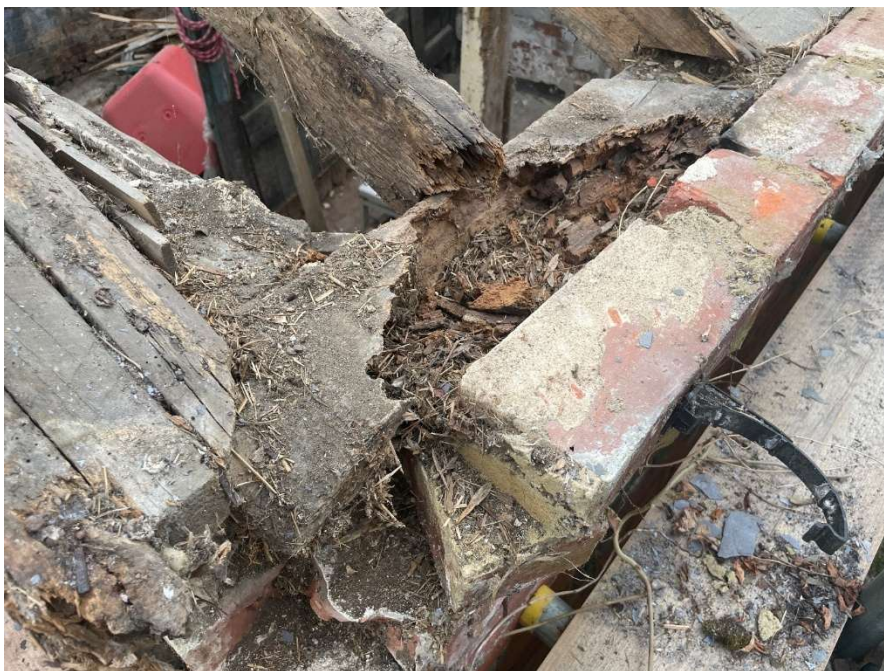
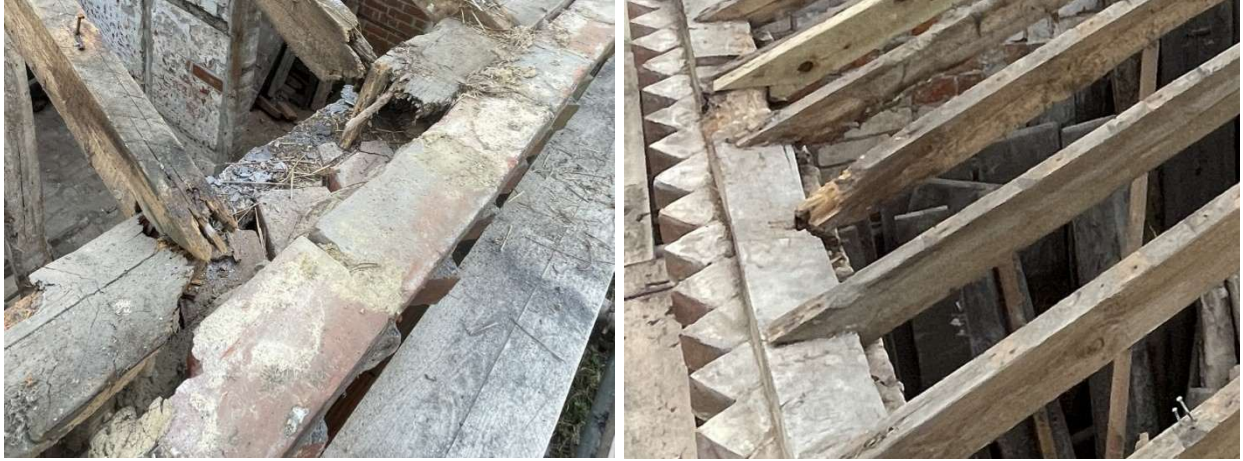
ROTTEN RAFTERS AND WALL PLATES (Fig.1 No.13)

Photos below provide an example of the state of the roof timbers, with significant rot to the rafter feet and wall plates.

The rotten sections have been cut out as required and braced with new timbers bolted in their place to reinforce the roof structure

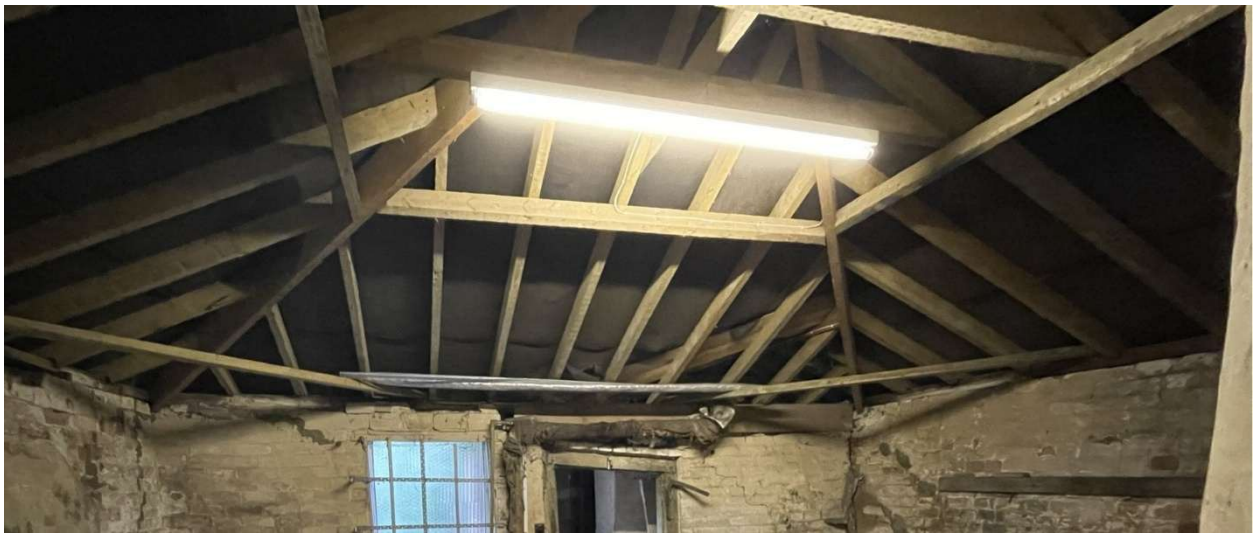
#### RAFTERS TO MIDDLE SECTION (Fig.1 No.14)

All roof timbers to the middle section of the outbuilding appear to have been replaced some time ago (certainly prior to the current owner's purchase in 2021), presumably due to significant rot to the original timbers and potentially a collapsed roof.

This area has generally been left untouched as there has been no rot to the modern timber, however some reinforcement has now taken place to ensure the longevity and stability of the roof structure.

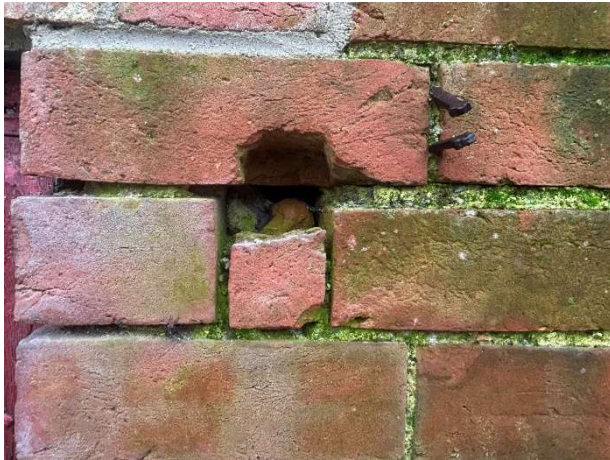
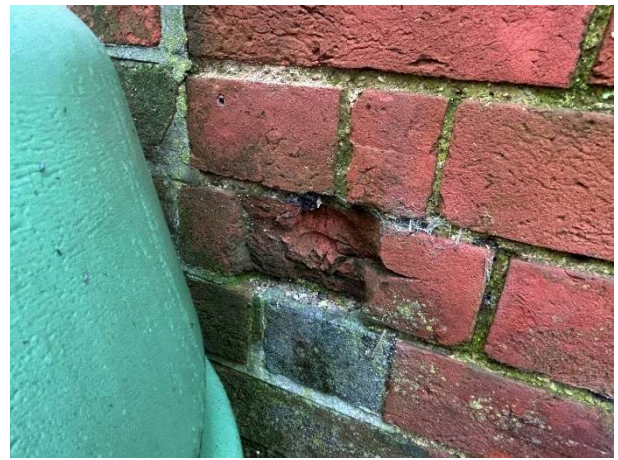
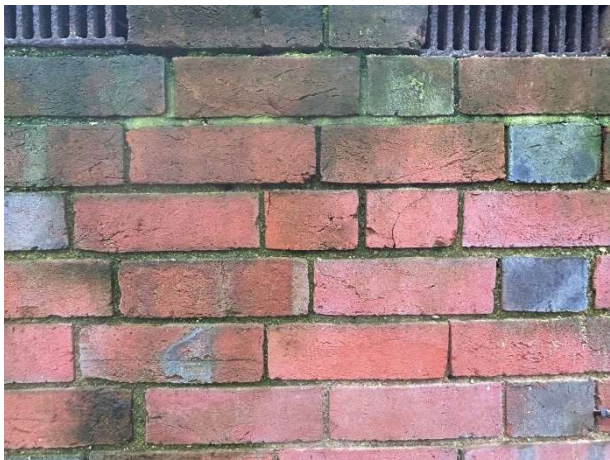
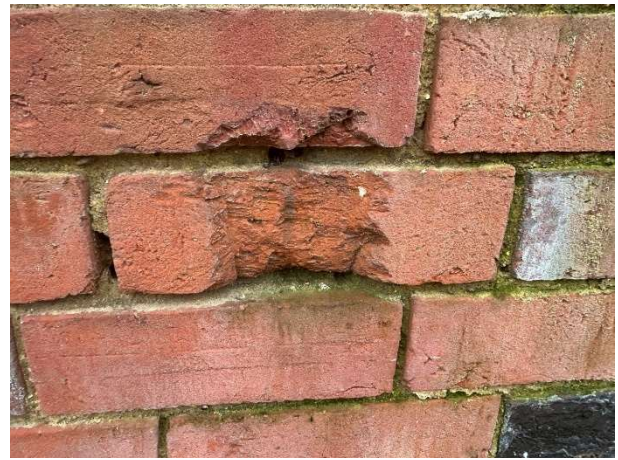
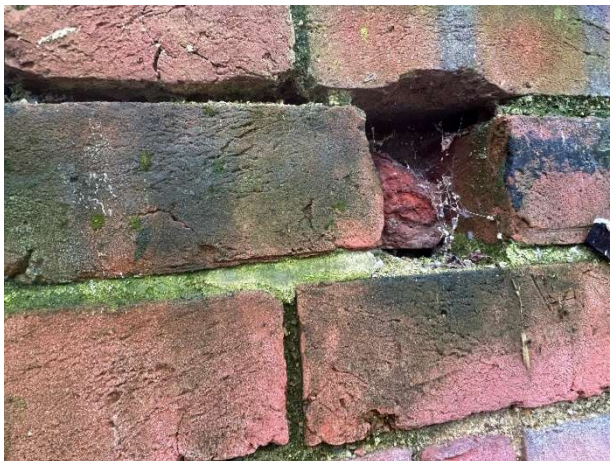
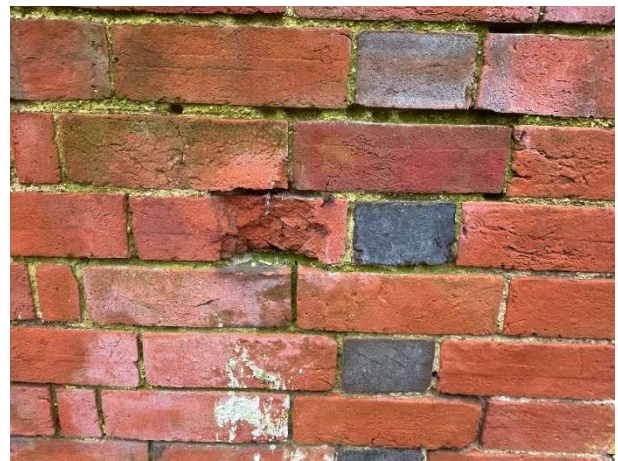
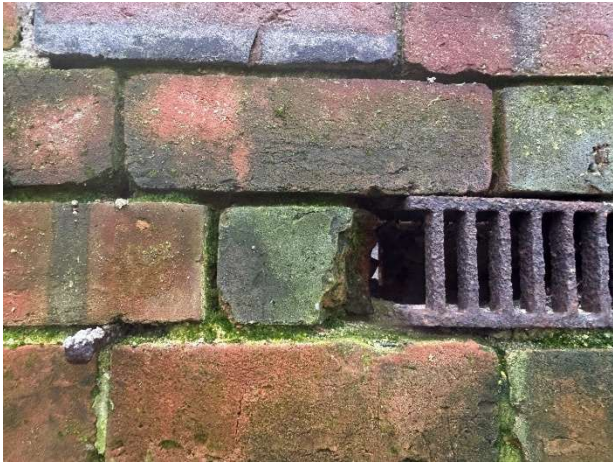
There are also a number of bricks/ areas of brickwork within the existing external walls of the outbuilding that require replacement.

Examples of brickwork repairs that are required:

As required, bricks will be carefully removed from the relevant section of wall and replaced with either the same brick turned around, or bricks salvaged from elsewhere within the property during the renovation works.
