Plot 47, 34 Copenhagen Rise,  
Spencers' Wood, RG7 1YT

## **Arboricultural report**

Inspection carried out on 4<sup>th</sup> June 2025  
by David White

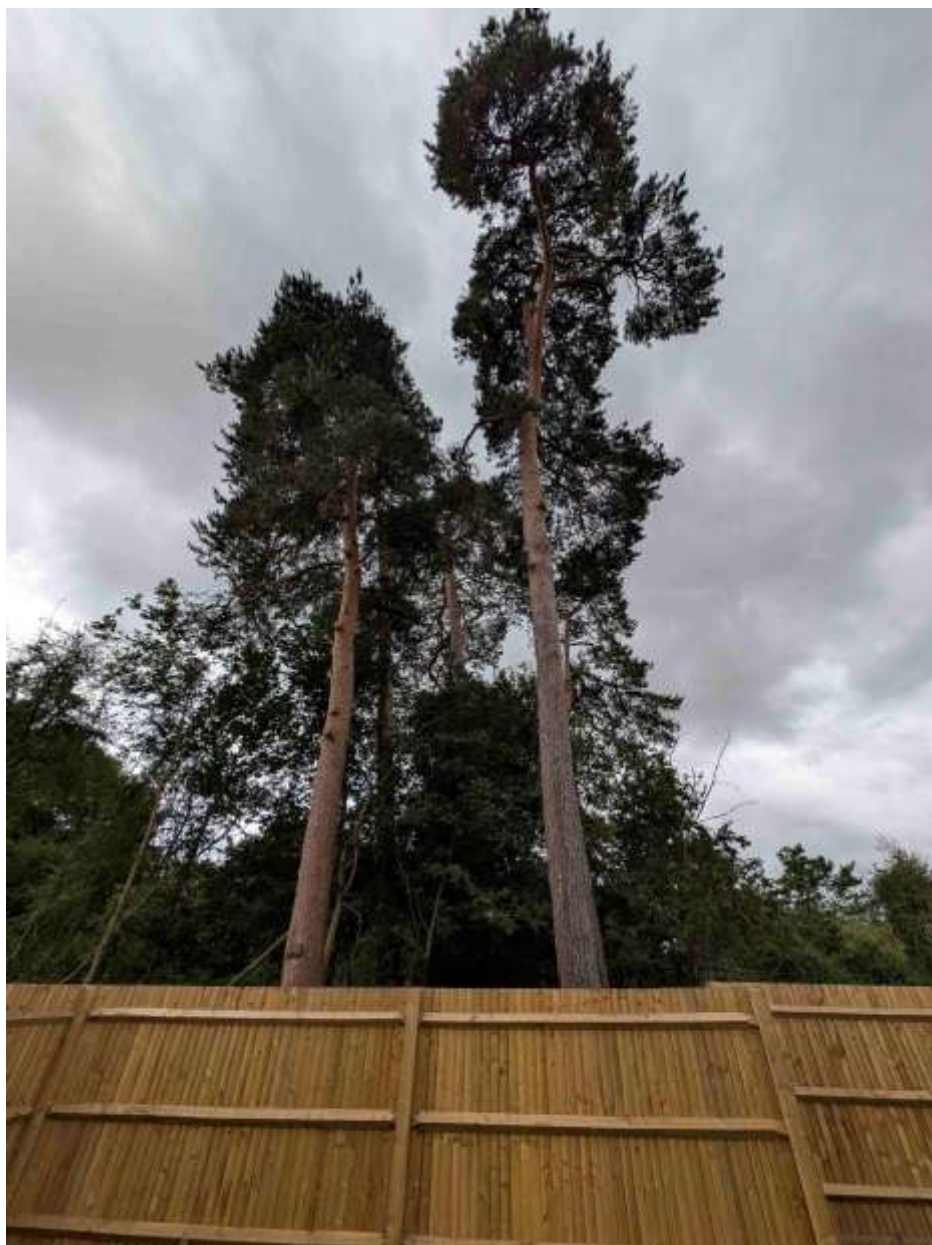
*Figure 1: T1 on right of photo, T2 on left of photo*

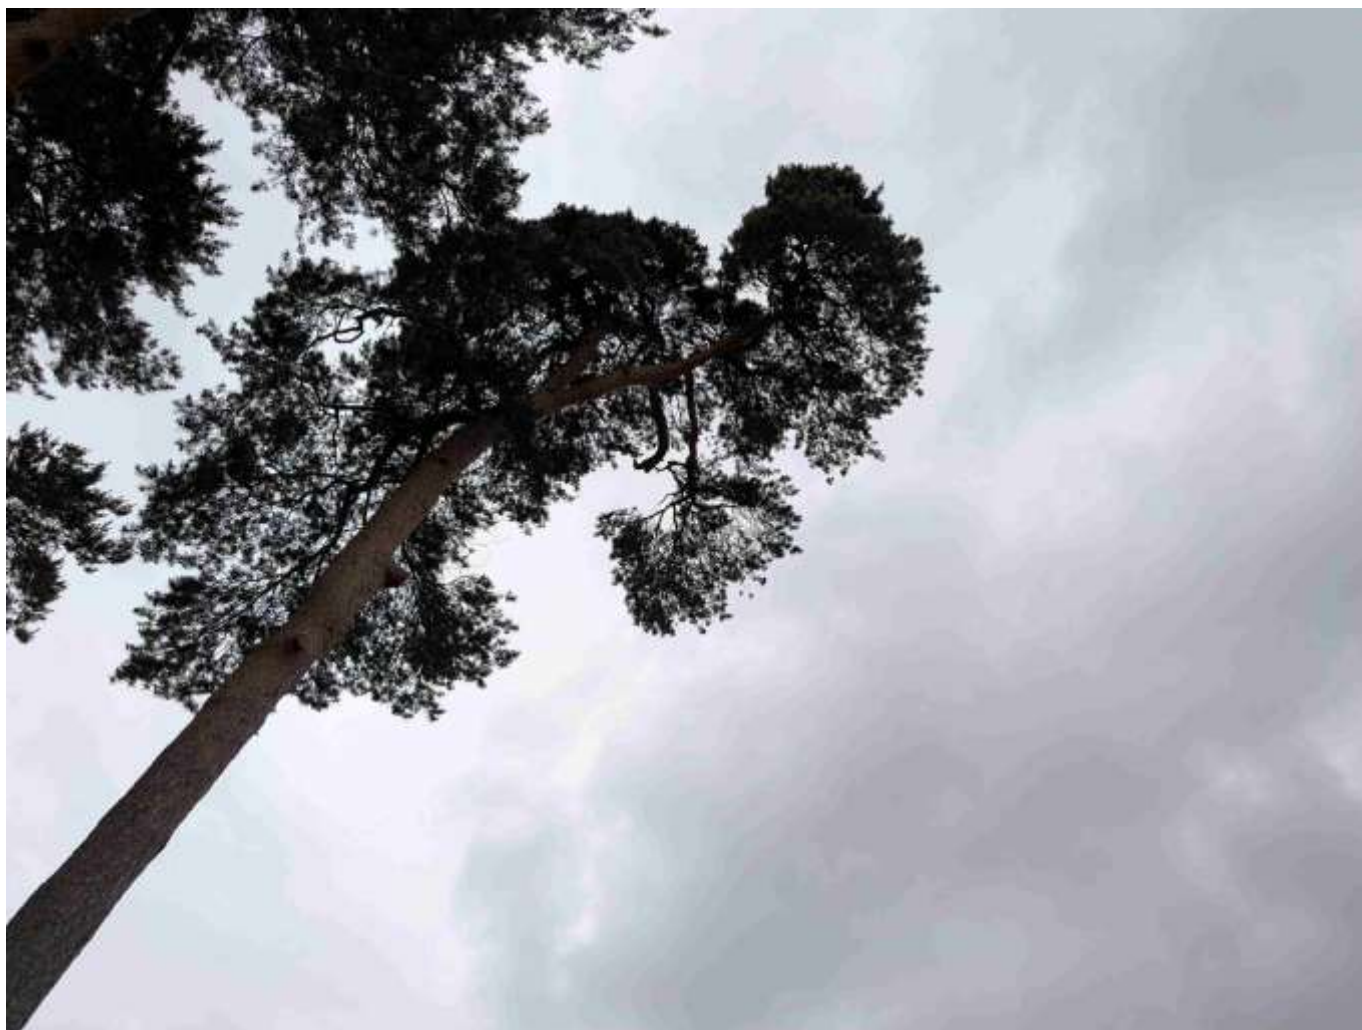
The admittedly healthy (and therefore heavy) but asymmetric crown, heavily weighted to the North, will also be applying a significant torque (turning force) to the compromised main stem. Shortening the extent of the canopy spread to the North may be enough to mitigate the risks posed by reducing the weight and leverage applied as well as reducing the sail area presented to the wind. However, due to the significant lean combined with the size and extent of the wound near the base, this would not satisfactorily deal with the risk in the medium-long term. As such I would recommend removing or monolithing this tree.

*Figure 2: T1, asymmetric crown*

T1: Dismantle T1 to a high stump, approximately 1-2m above ground level, to retain as much habitat value as practicable.

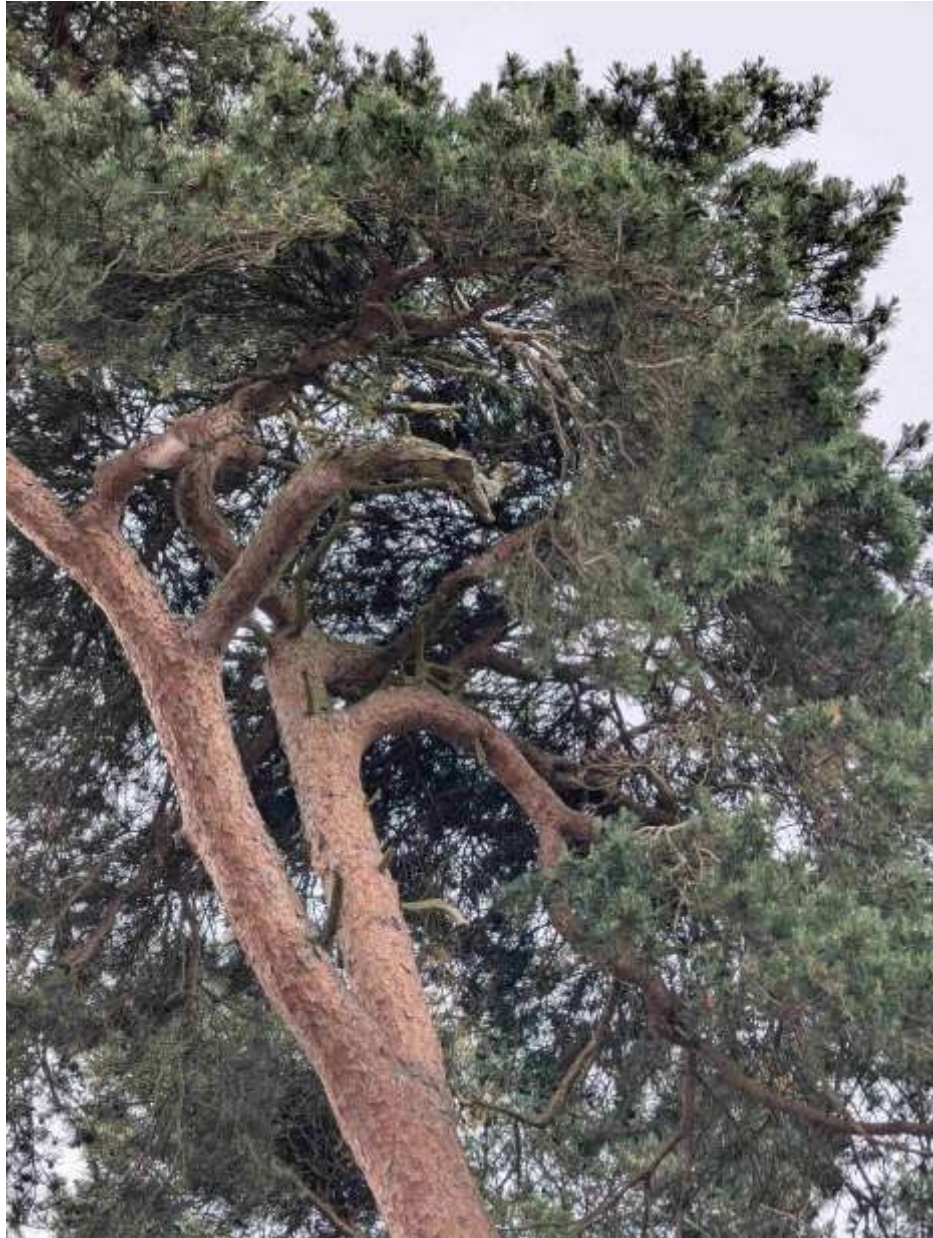
*Figure 3: T1 deadwood*

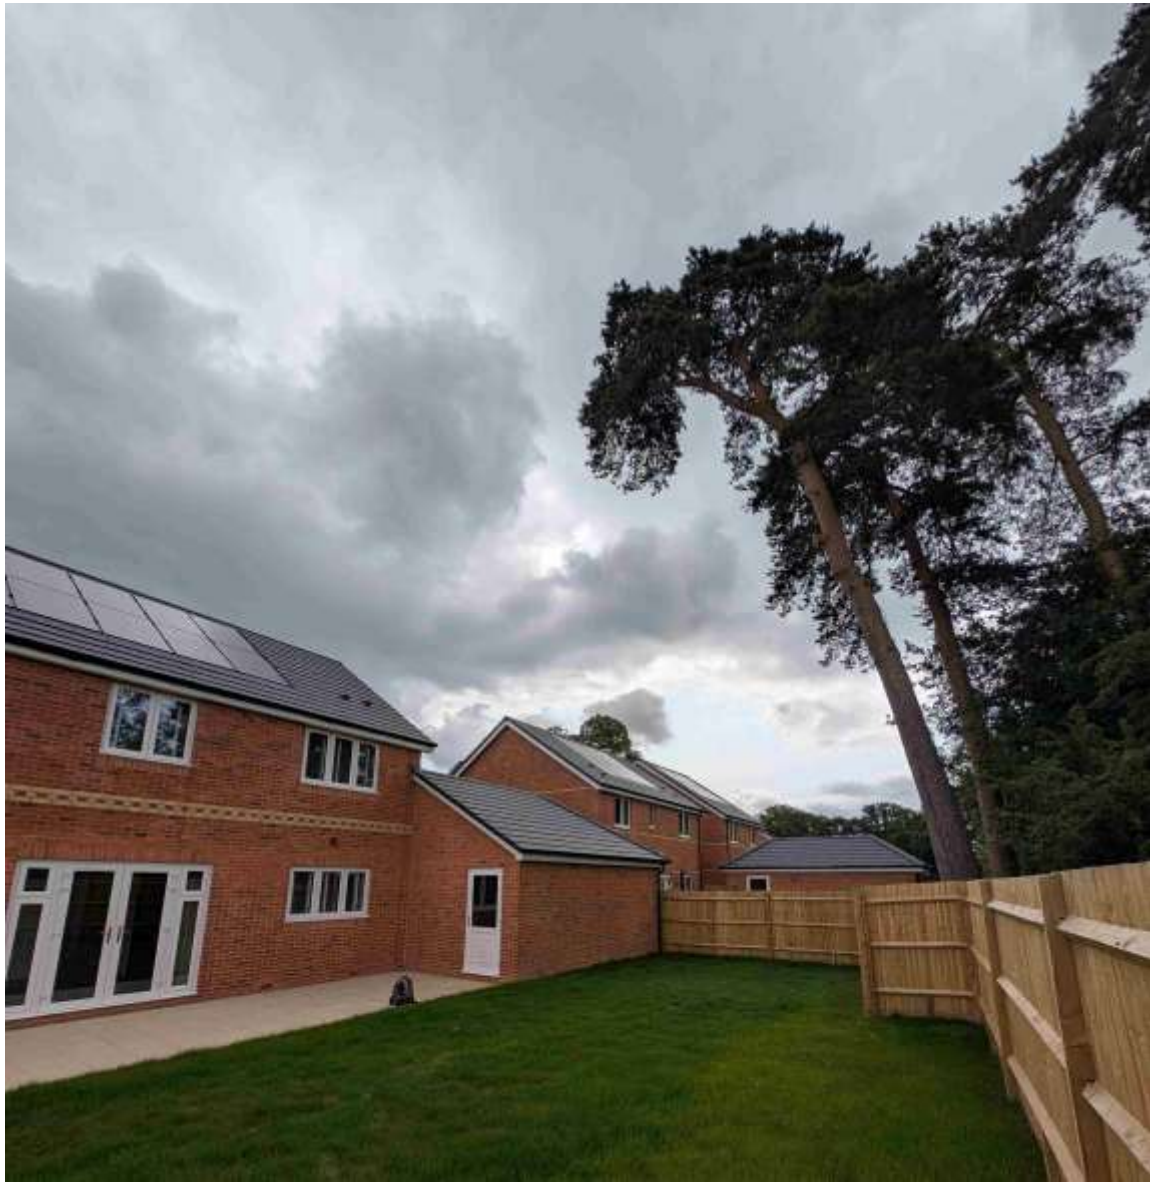
T1, the larger of the two trees, whilst displaying good vitality and general health, has some issues that are a cause for concern given the new proximity of a residential dwelling. The main stem leans very approximately  $14^{\circ}$  from vertical toward the house. A lean of over  $10^{\circ}$  from vertical is usually considered significant.

*Figure 4: T1 lean towards house*

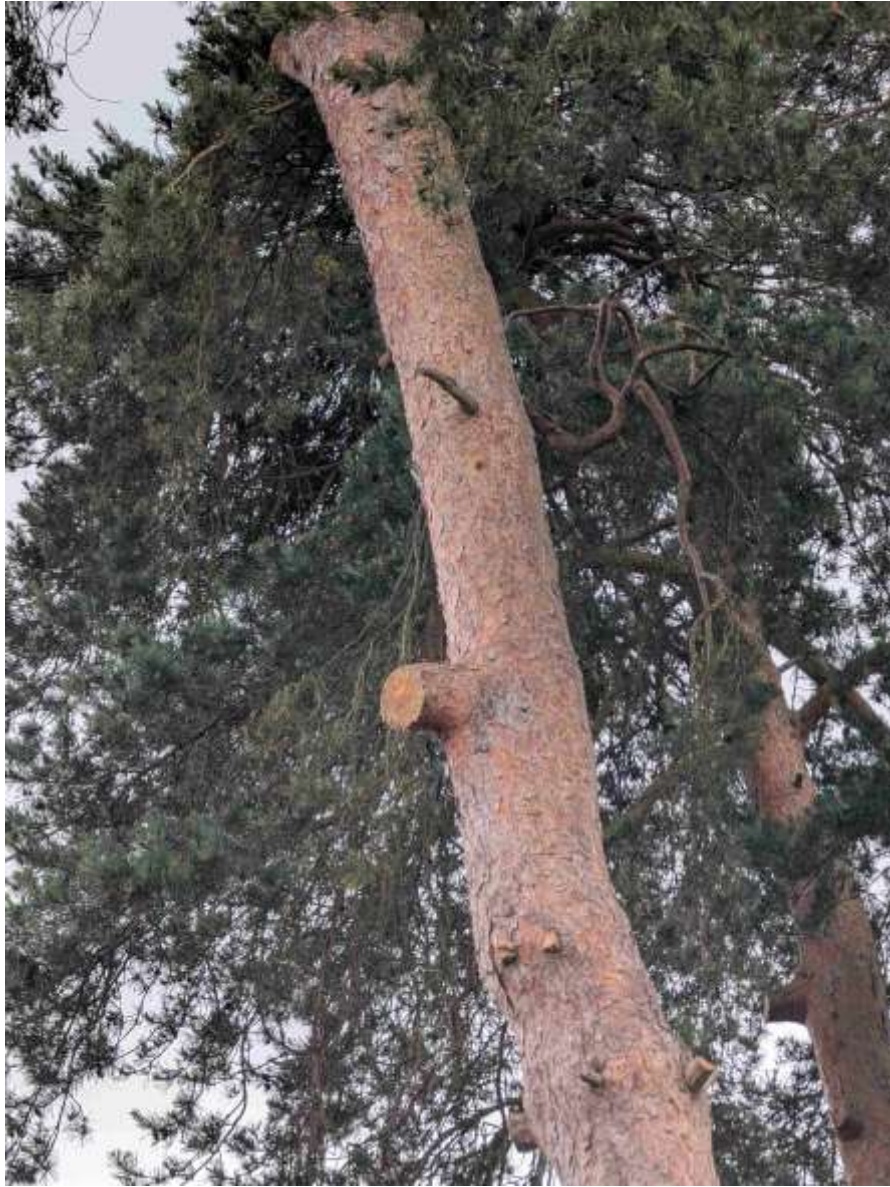
*Figure 5: Recent pruning wounds*

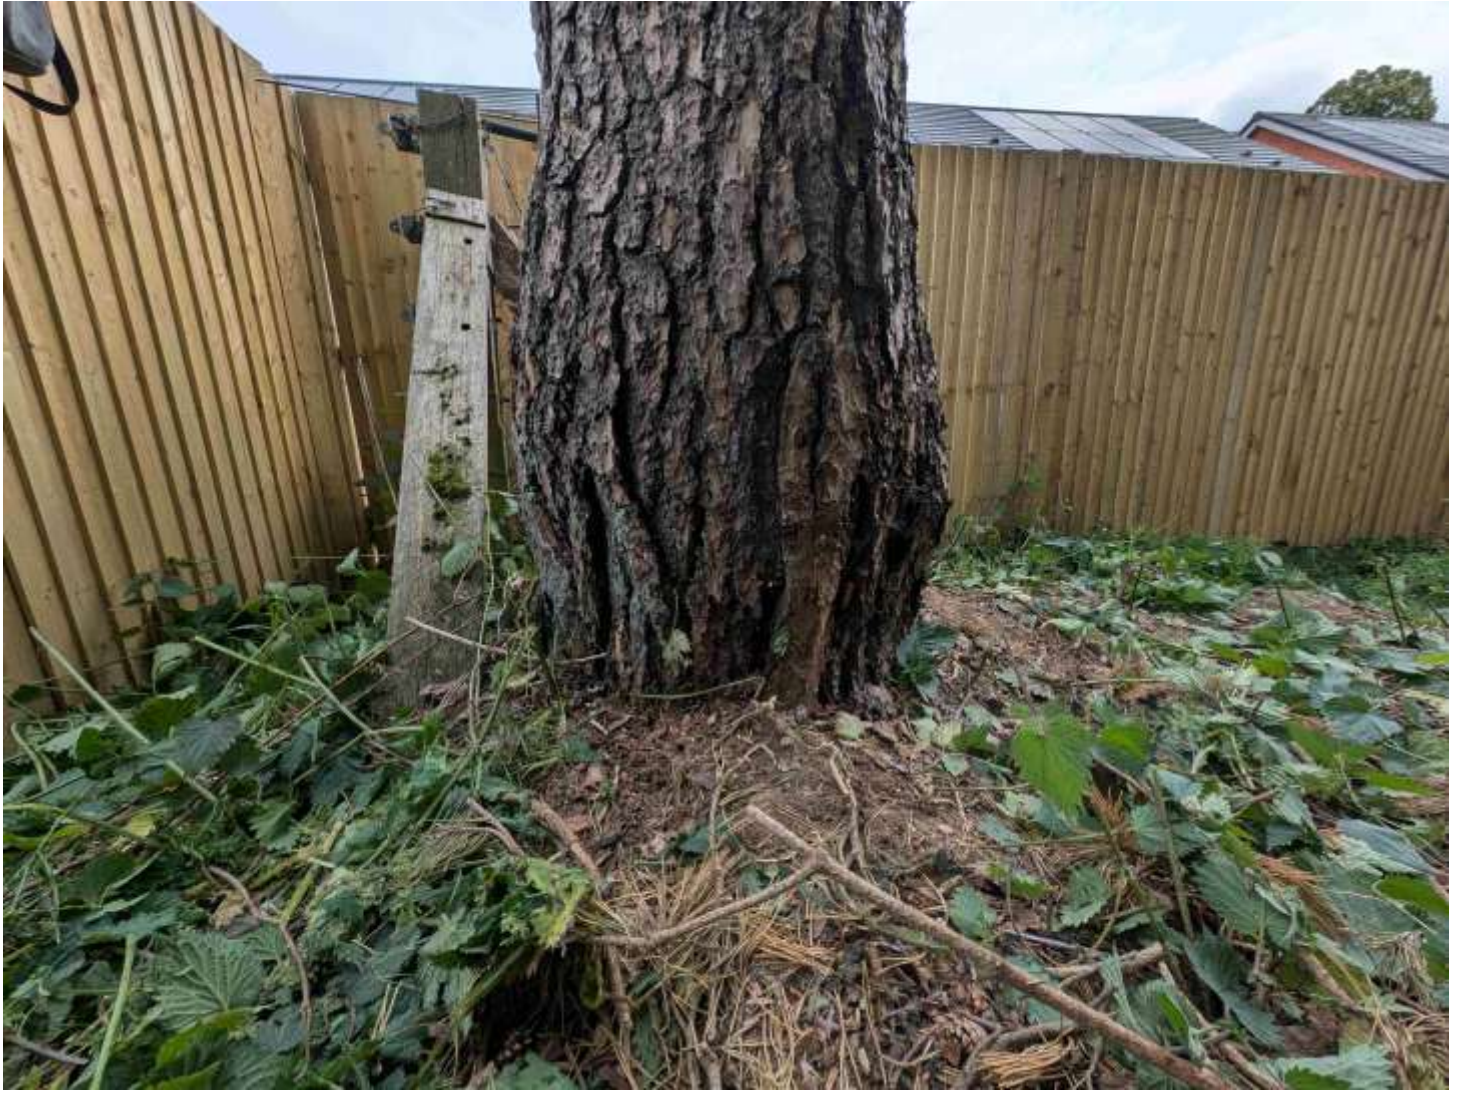
There is also significant bulging around and below the wound suggesting that the cambium is experiencing notable force/stress in this area in order to stimulate so much isolated reactive growth, further suggesting a non-negligible risk of potential stem failure.

*Figure 7: south side of T1 showing bulging stem*

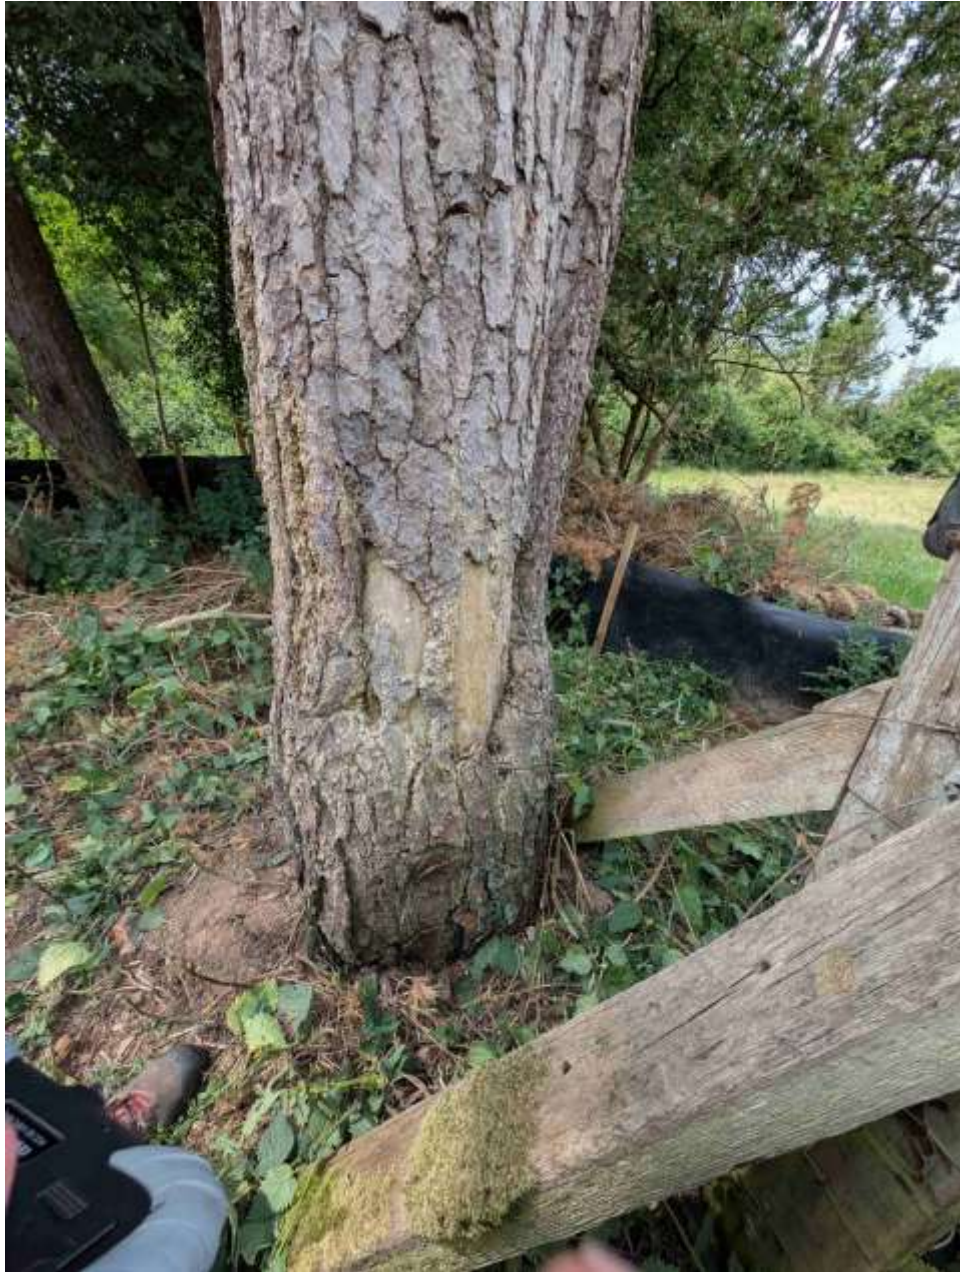
Compounding this is the historic wound at its base, which looks to have encompassed approximately 50% of the tree's circumference when the wound was originally inflicted. The wound is located on the compressive (under) side of the leaning stem. Pine trees are conifers and so tend to support themselves when required by building up layers of compression wood on the underside of a limb or leaning stem, due to this wound, T1 is unable to do this. The wound has also resulted in a flattened cross-section acting as a focal point for mechanical stress in the main stem increasing the likelihood of stem failure.

*Figure 9: North side of T1 base showing extensive historic wound*
