# Arboricultural Tree Survey<sup>©</sup>

Site: Liberty House, Earley, Reading RG6 4EA

Client: Reading Almshouse Charity   Date: May 2019   Surveyor: Hugo Loudon

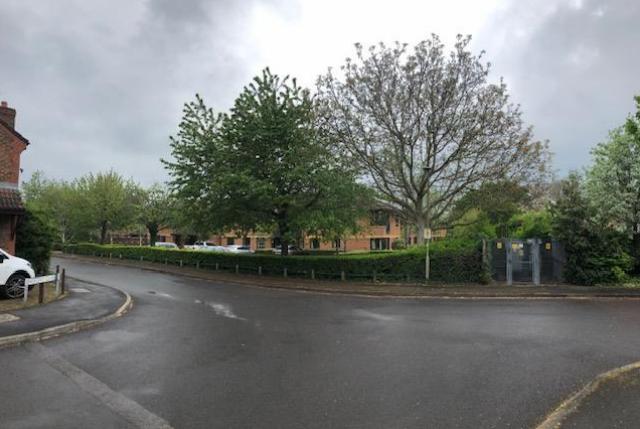
<p>T1 Walnut (right) with Wild Cherry (T2) to centre. T3 can be just seen to the left.</p>	<p>G7 – a linear group of Wild Cherries with important amenity value.</p>	<p>G6. Note suppressed tree to right (most likely lacking in rooting volume), which can be sacrificed for new parking.</p>

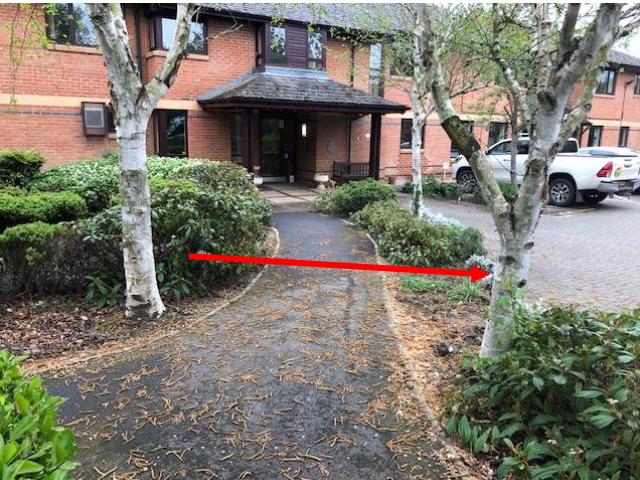
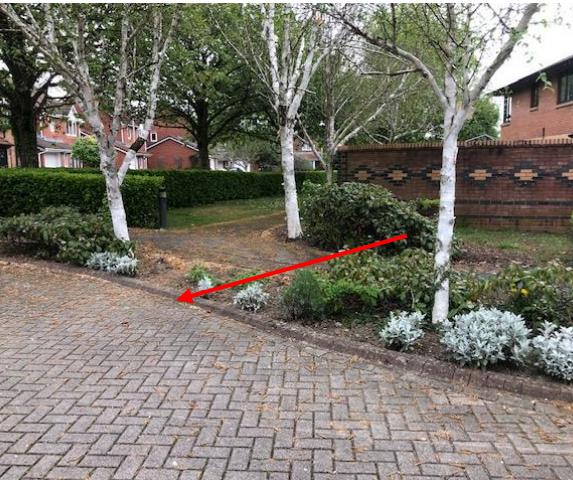
<p>G6. Red line indicates further parking beyond towards doorway.</p>	<p>G6. Red line indicates further parking beyond towards doorway.</p>

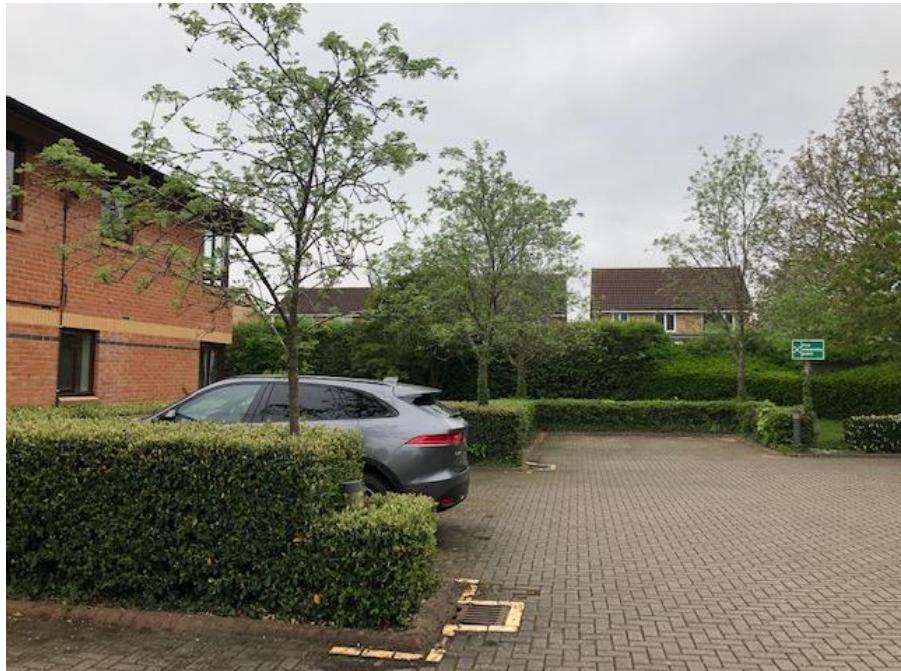
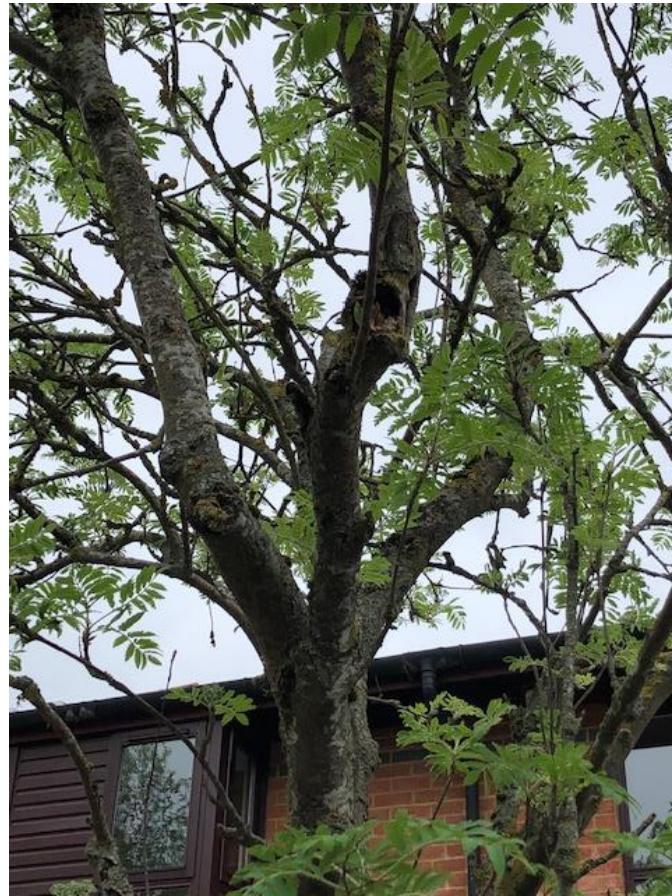
Rowan with some defects and breakages associated with vehicular activity.

In order to safeguard more superior trees (and their root protection areas), it is suggested that the Rowans be removed (G11). This will allow more parking in a broadly similar footprint.
