# ARBORICULTURAL REPORT

## TREE CONDITION SURVEY

47 HEATHERMOUNT DRIVE  
CROWTHORNE  
BERKSHIRE  
RG45 6HJ

Ref: 06517/2024

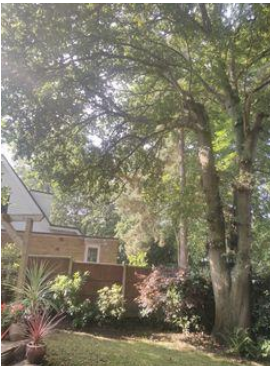
| Ref: | Species | Measurements | Survey Notes | Condition | Recommendations | Photo |
|---|---|---|---|---|---|---|
| T001 | Pedunculate oak<br>(Quercus robur) | Height (m): 17<br>Crown Radius (m): 9<br>DBH (cm): 96<br>Life Stage: Mature<br>Life Exp.: 40+ Years | <p>Log store and stacked wood partially obscures tree base and lower trunk. Concrete raft foundation on west side of base. Where accessible hammer test even and satisfactory. Bark intact. Small wounds southeast side, 100mm above ground level. There are a number of old nails (at least 7) on the trunk from ground level to 1.5m.</p> <p>Three-way stem fork at 1.8m. Fork well-formed and satisfactory. Epicormic growth lacking vitality on all three trunks. Stems topped at 7/8m. One stem on North side has failed to put on any meaningful new growth. Probably due to lack of light. Remaining two stems on south and west side has mature new growth up to 300mm diameter.</p> <p>Asymmetrical crown to South and West. Over neighbouring garage. 1-2m clearance to roofline. Minor deadwood in crown. Foliage density normal. Moderate vitality.</p> | Fair | <p>Reduce lateral spread on south and west side of crown by 2m to nearest suitable reduction points to reduce overhang over garage and reasonable clearance to neighbouring residential property.</p> <p><b>Timescale:</b><br/>19-Sep-2025<br/>(1 Year)</p> | |

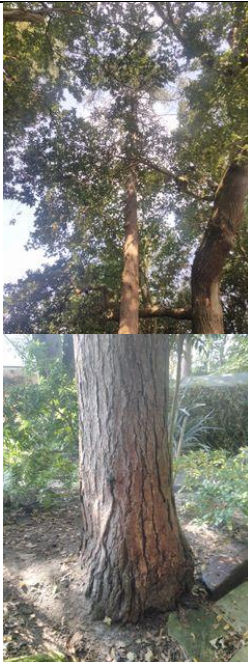
| Ref: | Species | Measurements | Survey Notes | Condition | Recommendations | Photo |
|---|---|---|---|---|---|---|
| T002 | European larch<br>(Larix decidua) | Height (m): 23<br>Crown Radius (m): 3<br>DBH (cm): 47<br>Life Stage: Mature | <p>Slender tree. Base clear, bark intact. Slightly bulbous base on west side with flat area and audible changes on North side of lower trunk.</p> <p>Metal probe can be pushed into trunk / bark 100mm at ground level. Areas of elevated bark are likely to be the cause of much of the uneven sound intonation in this region. Remaining trunk appears sound – no audible decay.</p> <p>Single, straight stem. Little tapering. Slender high crown.</p> <p>Minor deadwood in lower crown commensurate with species. Reasonable form and vitality.</p> | Fair | <p>Monitor base and rooting area for fungal growths throughout the year (see paragraph 3.5).</p> <p><b>Timescale:</b><br/>19-Sep-2025<br/>(1 Year)</p> | |

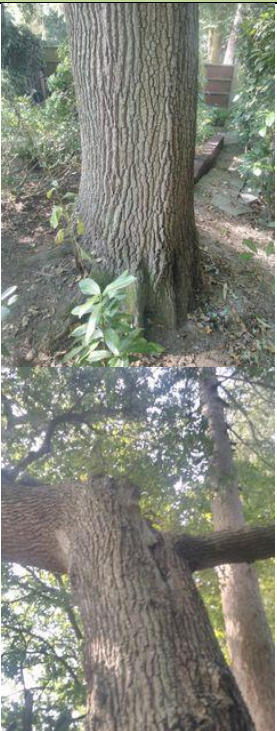
| Ref: | Species | Measurements | Survey Notes | Condition | Recommendations | Photo |
|---|---|---|---|---|---|---|
| T003 | Pedunculate oak<br>(Quercus robur) | Height (m): 20<br>Crown Radius (m): 10<br>DBH (cm): 71<br>Life Stage: Mature<br>Life Exp.: 40+ Years | <p>Healthy, pronounced even buttress roots. Slightly stilted on north side with indents in between buttress roots. Bark intact. No evidence of cavities or decay.</p> <p>Hammer test even and satisfactory. No fungal fruiting bodies evident. Single stem. Multiple nails on trunk.</p> <p>Historic sound from 4m to 5.5m where large stem failed at the trunk fork. This has created a large wound on the trunk, possible cavity and small wound wood formation. Crown now consists of growth on southern large stem. Some widening of the trunk where the trunk kinks, but the trees' ability to put on extra supporting wood is greatly undermined by the wound on the tension side of the stem.</p> <p>Tree topped around 11m with decay visible at topping point. Asymmetrical canopy formed of new growth under 300mm diameter on south side of crown from previous reduction points. Canopy over roof of 47 Heathermount Drive. Nylon rope restricting low branch over garden and well occluded into the trunk.</p> <p>Minor deadwood in crown. Foliage dense and even. Good vitality.</p> | Fair | <p>Reduce lateral spread on south side of crown by 2-3m to nearest suitable reduction points to reduce weight and exposure of asymmetrical crown above large stem wound.</p> <p><b>Timescale:</b><br/>19-Mar-2025<br/>(6 Months)</p> | |

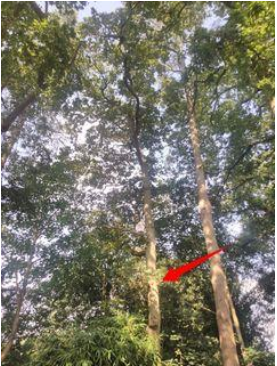
| Ref: | Species | Measurements | Survey Notes | Condition | Recommendations | Photo |
|---|---|---|---|---|---|---|
| T004 | Pedunculate oak<br>(Quercus robur) | Height (m): 17<br>Crown Radius (m): 6.5<br>DBH (cm): 47<br>Life Stage: Mature | <p>Slender tree. Root flare obscured. Possible ground level changes at base. Where visible, base clear, bark intact.</p> <p>Small area of bud proliferation and epicormic growth at base and where branches have been cut on the trunk. Bark intact. Sound intonation even and satisfactory. No audible decay.</p> <p>Vertical scars on trunk bark from previous stem wounding. Heavily crown lifted.</p> <p>Deadwood on crown over low occupancy area. Vertical stem. Small suppressed crown. Foliage slightly sparse. Moderate vitality.</p> <p><b>Inspection Limitations:</b> Root collar buried</p> | Fair | No works identified. | |

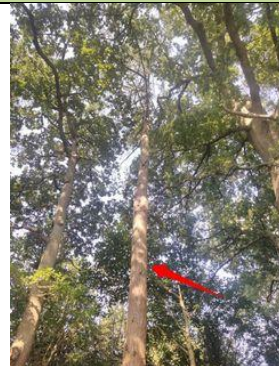
| Ref: | Species | Measurements | Survey Notes | Condition | Recommendations | Photo |
|---|---|---|---|---|---|---|
| T005 | European larch<br>( <i>Larix decidua</i> ) | Height (m): 25<br>Crown Radius (m): 4<br>DBH (cm): 49<br>Life Stage: Mature | Slender tree. Base clear, bark intact. Hammer test even and satisfactory. No audible decay.<br>Single stem with limited tapering. Slender dead branches in crown commensurate with species - over low occupancy area (reasonable to retain).<br>High overall canopy suppressed by adjacent trees. Needle density normal. Reasonable form and vitality. | Fair | No action required. | |

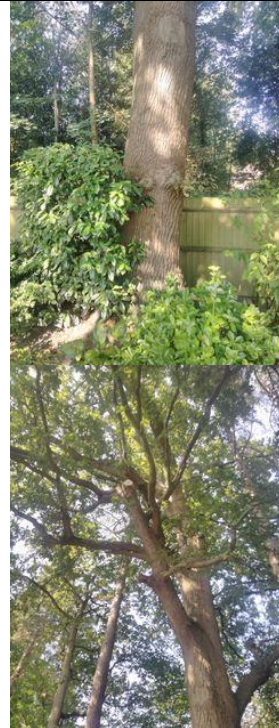
| Ref: | Species | Measurements | Survey Notes | Condition | Recommendations | Photo |
|---|---|---|---|---|---|---|
| T006 | Pedunculate oak<br>( <i>Quercus robur</i> ) | Height (m): 22<br>Crown Radius (m): 10.5<br>DBH (cm): 71<br>Life Stage: Mature<br>Life Exp.: 40+ Years | Small but healthy, pronounced even buttress roots around base. Bankside tree. Stilted buttressing on North side of trunk. Base clear, bark intact. No evidence of cavities or decay. Hammer test even and satisfactory. No fungal fruiting bodies evident. Single stem. Historic wounds on trunk from branch removal fully occluded.<br>Major stem fork around 11m above ground level. Appears open and under tension although form suggests it may be formed of regrowth from an old topping point and decay may be present.<br>Broad, asymmetrical crown formed of multiple large limbs on south side over garden of 47 Heathermount Drive. These have previously been reduced and gave 3-4m new growth on previous reduction points.<br>Deadwood over garden and prow. Broken, split stem on south side 200mm diameter resting on lower branches. Foliage dense and even. Good vitality. | Fair | Remove split limb.<br>Reduce lateral spread on south half of crown (towards dwelling) by 3-4m back to previous reduction points where present or nearest suitable reduction points to reduce overbearing nature of tree in relation to 47 Heathermount Drive.<br>Remove deadwood.<br><br><b>Timescale:</b><br>19-Mar-2025<br>(6 Months) | |

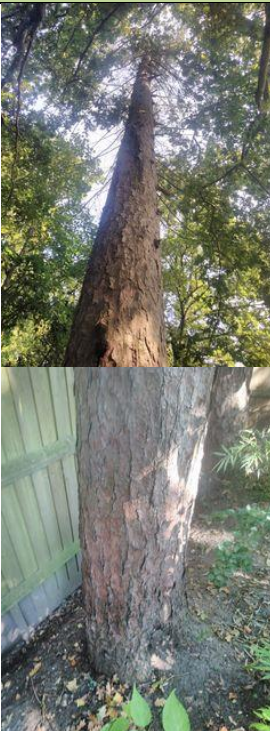
| Ref: | Species | Measurements | Survey Notes | Condition | Recommendations | Photo |
|---|---|---|---|---|---|---|
| T007 | European larch<br>(Larix decidua) | Height (m): 25<br>Crown Radius (m): 3<br>DBH (cm): 43<br>Life Stage: Mature<br>Life Exp.: 20+ Years | <p>Slender tree. Base clear, bark intact. No fungal fruiting bodies evident. Hammer test sound extremely hollow on lower trunk up to around 1.5m above ground level.</p> <p>Three vertical cracks / ridges on trunk. Resident advises that this tree moves more in high winds than any of the others on the property.</p> <p>High, slender crown. Minor deadwood. needle density normal.</p> | Poor | <p>Fell to ground level.</p> <p><b>Timescale:</b><br/>19-Dec-2024<br/>(3 Months)</p> | |

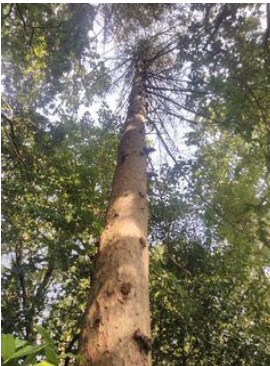
| Ref: | Species | Measurements | Survey Notes | Condition | Recommendations | Photo |
|---|---|---|---|---|---|---|
| T008 | European larch<br>(Larix decidua) | Height (m): 25<br>Crown Radius (m): 4<br>DBH (cm): 48<br>Life Stage: Mature<br>Life Exp.: 20+ Years | <p>Bankside tree partially obscured by boundary fence. Chain-link fence wire occluded into trunk.</p> <p>Hammer test even and satisfactory. No fungal fruiting bodies evident or audible decay. Single stem.</p> <p>Asymmetrical canopy due to suppression from adjacent trees. Needle density slightly sparse.</p> <p>Slender dead branches in crown over neighbouring garden and row.</p> <p><b>Inspection Limitations:</b> Access</p> | Fair | <p>Remove deadwood.</p> <p><b>Timescale:</b><br/>19-Oct-2024<br/>(1 Month)</p> | |
