**Lime Trees, 2 Ruscombe Road, Twyford, RG10 9JS**

**WINDOW HISTORY AND DETAILS OF REPLACEMENT**

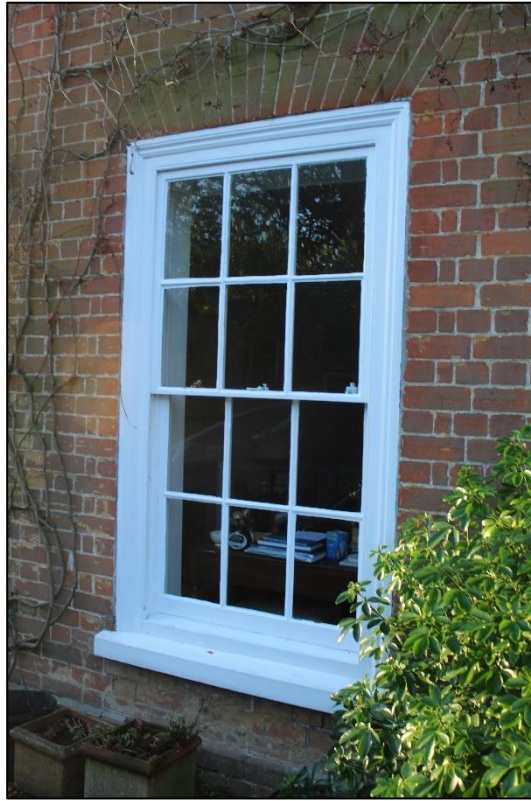
*Photograph 1 – Typical six over six pane sash window on the ground floor of the original dwelling with the rebate infilled with a Georgian style architrave*

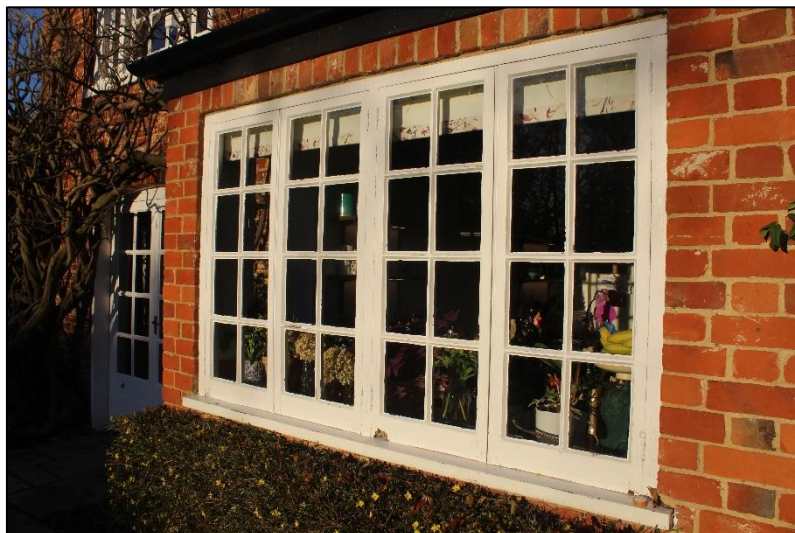
*Photograph 2 – Kitchen window of rear extension likely built in the 1950s*

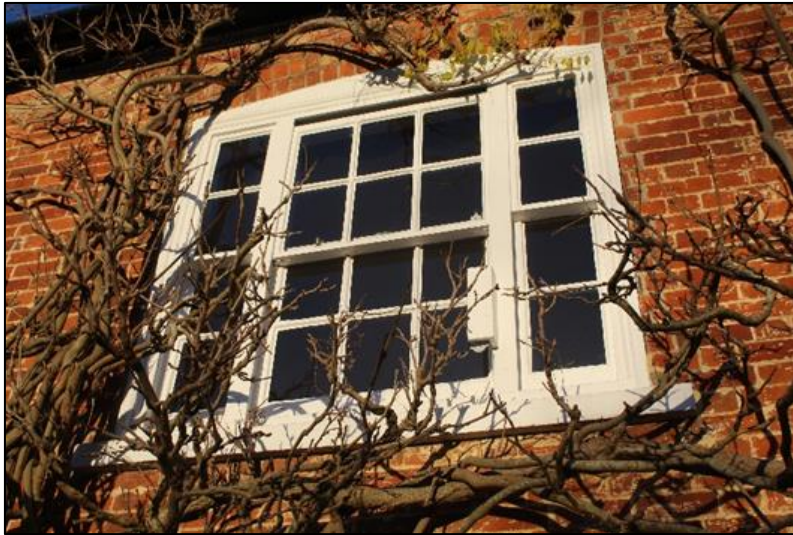
*Photograph 3 – First-floor bedroom window to two-storey side extension with similar Georgian architrave to the exterior edge.*

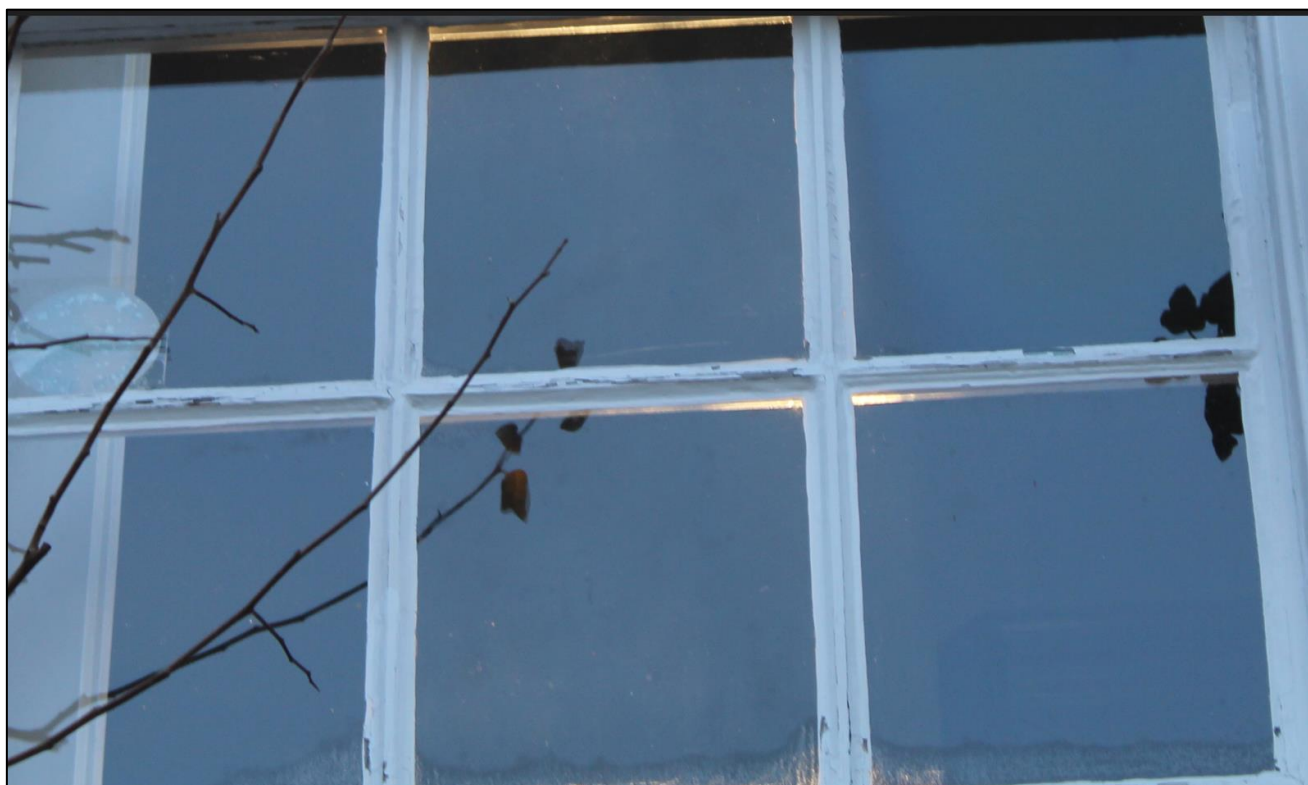
An example of the glazing bars are shown in **Photograph 5**, with the glazing bars of the original dwelling underneath it for direct comparison (**Photograph 6**). We would argue that the proposed new glazing bars are within an acceptable level of variance from the original and would actually provide a renewed, clearer moulding profile. It is clear from **Photograph 6**, that due to the age of the windows some of the glazing profiles are clearly damaged and beyond repair.

*Photograph 6 –An example of the glazing bars to the existing windows. The damage to these profiles clearly visible in the above photograph.*

Historically these windows have been well maintained and have been painted regularly in an effort to keep the windows in good working order. However, the constant painting over a number of years combined with localized repairs has led to the clear detailed profile of the glazing bars to be distorted and partly lost due to the coats of paint required to prevent water ingress to the existing timber frame of the windows and areas where the glazing profiles have weathered over the years. This is shown clearly in **Photograph 6**. Continued stripping and repainting of the glazing bars will likely lead to the glazing profiles being lost completely if this process continues. Despite regular painting there is still evidence of decay. The extent of the decay was not examined further to ensure the existing timber frames were not damaged further with crumbling of the window casement itself possible.

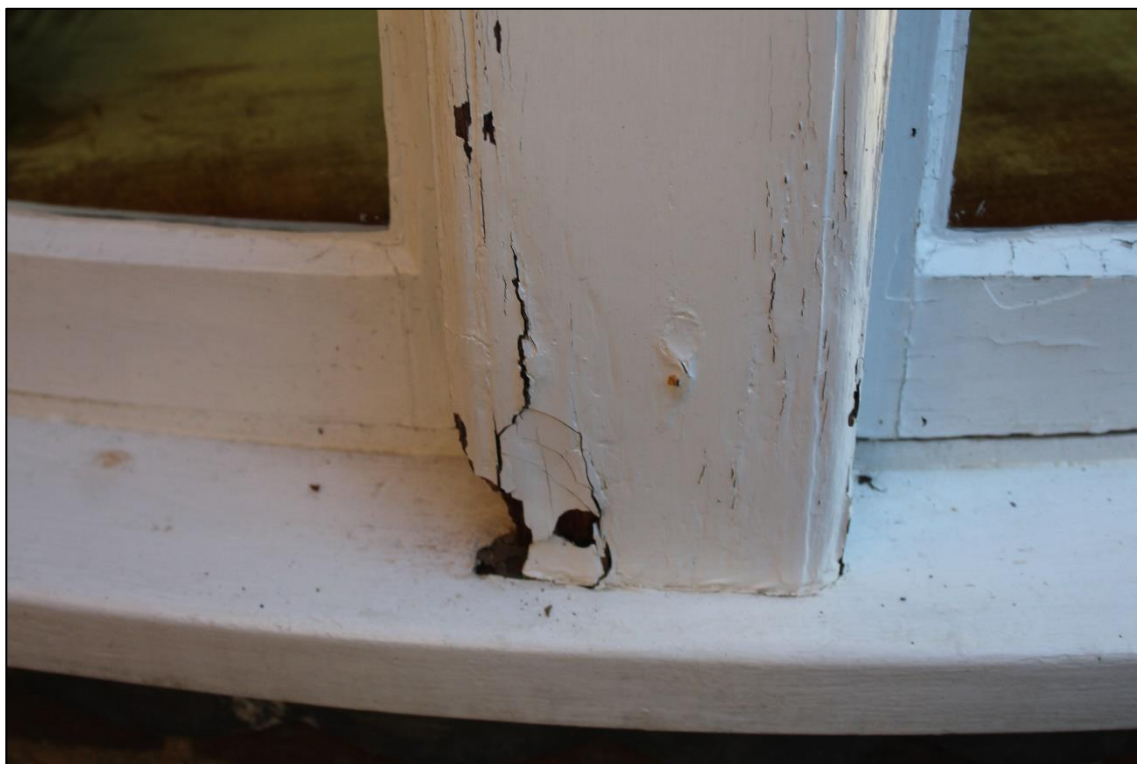
All windows to the main dwelling are also non-openable/ partially openable as a direct result of general wear and tear. Whilst the sash cord mechanisms are still working to the most part, the window casements do not run freely within the box frame and often jam, so the windows cannot be used. This is also a likely result of repetitive painting and patch repairs of the existing timber. The windows to the main dwelling have been well looked after for a considerable amount of time but are now beyond localized repair. Photographs 7 – 10 provide evidence of localized areas of decay and damage, despite good general care of the windows.

*Photograph 7 – Areas of decay to the existing bay window*

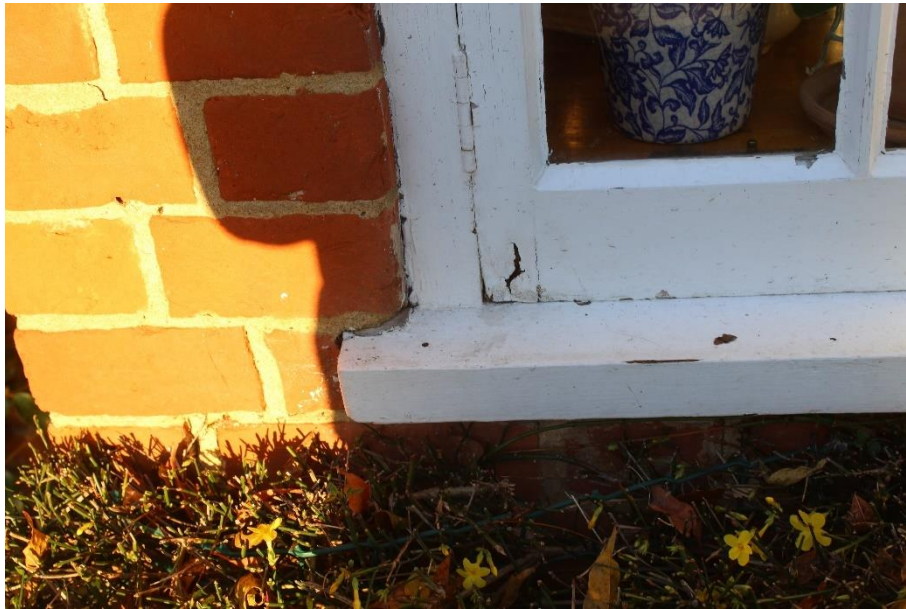
*Photograph 8 – Areas of decay to the ground-floor rear elevation window*

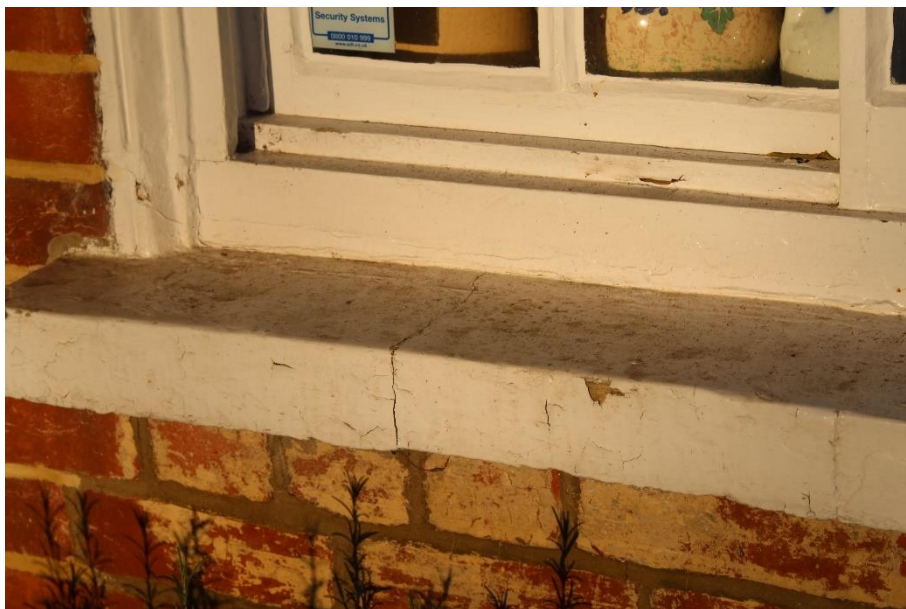
*Photograph 9 – Areas of decay and cracked paintwork to the utility room Yorkshire Sash*

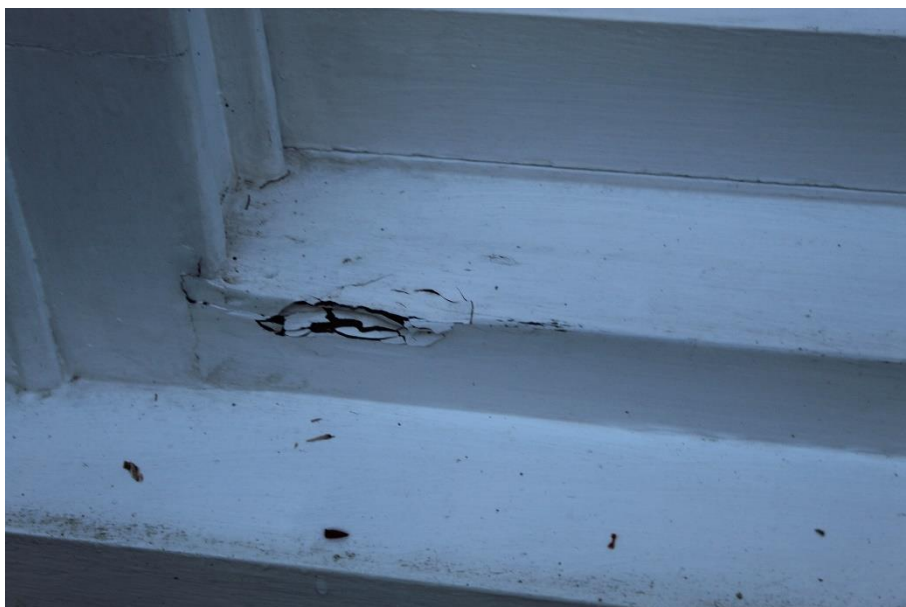
*Photograph 10 – Areas of decay and cracked paintwork to the side elevation sash window*
