**To:** Stuart Slatter  
**From:** Andrew Dannatt  
(Technical Director, Hydrology)  
**Company:** MacTaggart & Mickel Homes England **SLR Consulting Limited**  
**cc:** Charlotte Parry, Planning  
Potential: Dan Eddon, SLR Consulting **Date:** 8 April 2025  
**RE:** Land East of Lodge Road, Hurst: Site Visit & Drainage Review

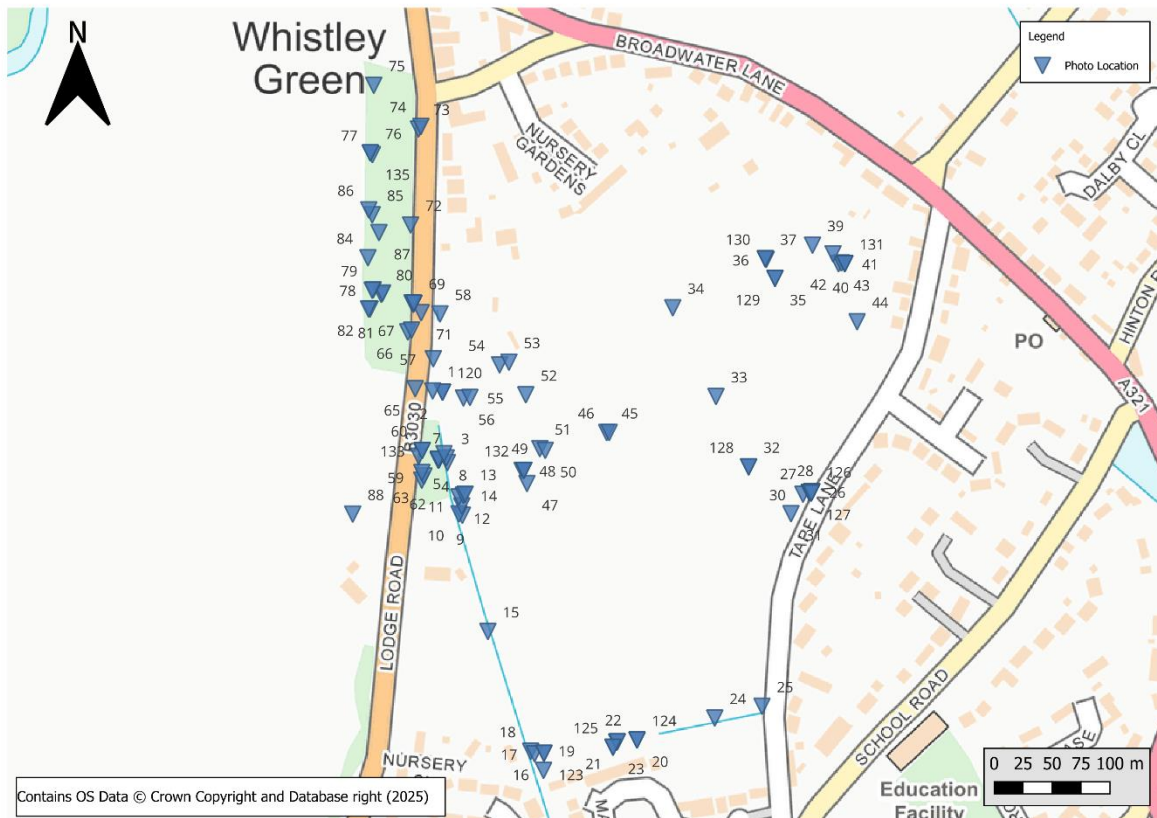
**Figure 1 Development Site Photo Locations**

A site visit was undertaken on Thursday 20<sup>th</sup> March 2025. On the day of the site visit the weather was dry, and whilst there had not been recent rain, there was evidence of small areas of standing water in hollows around the site. Photographs from the site visit can be found in **Appendix D** with locations found in Figure 1 below.

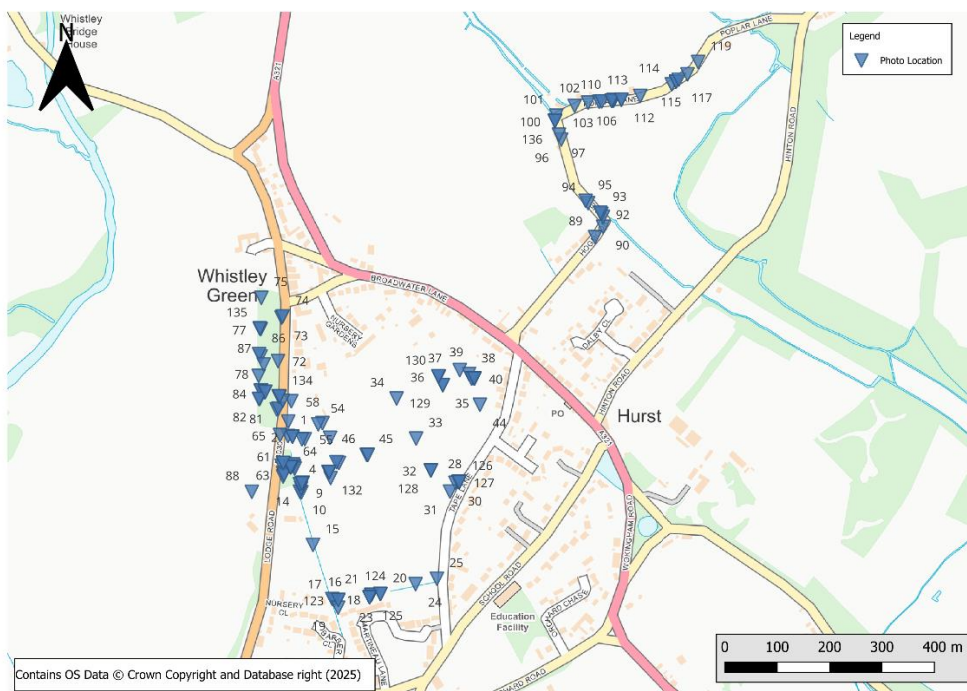
**Figure 2 Proximity of Section 19 Site 1 to the Development Site**

A site visit of the Section 19 reporting was requested, and a review of these locations showed that only one (Site 1) was in closer proximity to the development site. Refer to Figure 2 for the proximity of the sites. The other two sites were more distant, and whilst these were visited, no further detail was deemed necessary, as they were not deemed to be in hydraulic connectivity.

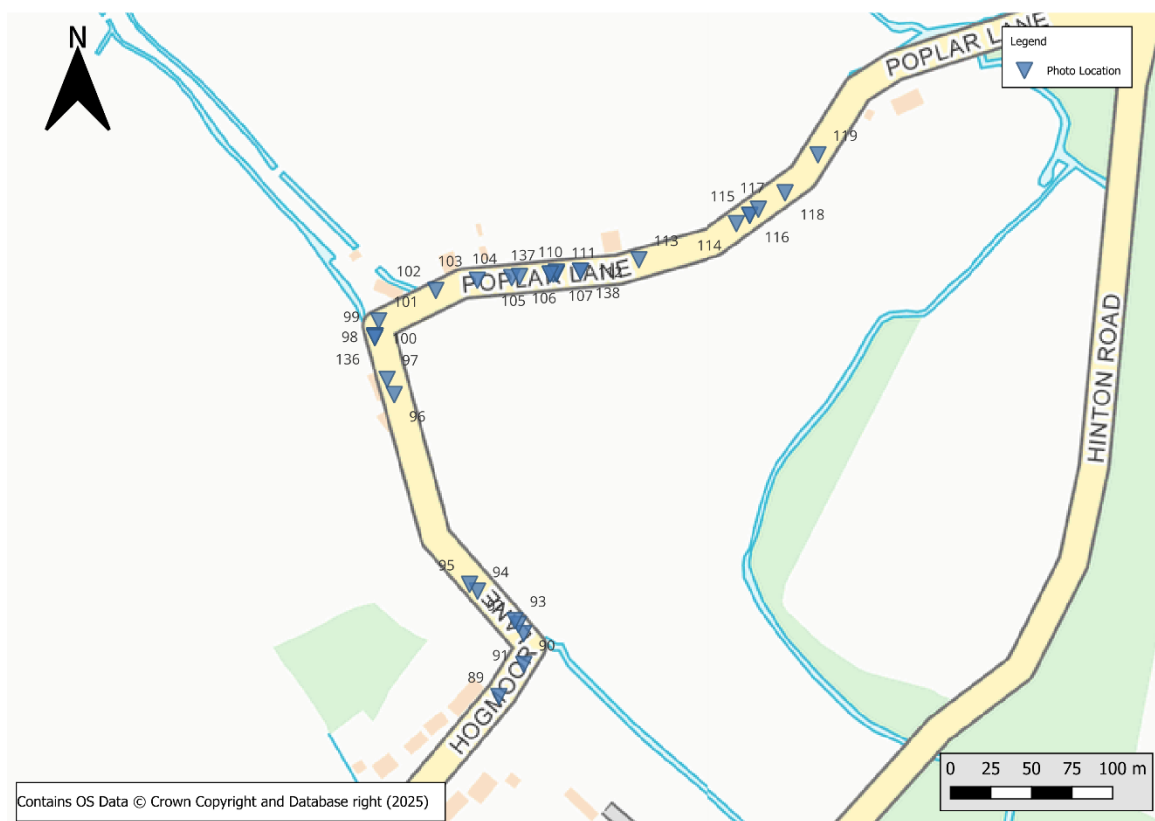
**Figure 3 Site 1 Photo Locations**

Aerial imagery for the site visit suggests that while this flat topography should be noted as a risk for the site, flooding due to proximity to the development is unlikely. This area was observed to be relatively flat with drainage systems easily accessible and open to overflowing on to the road with little attenuation storage available (refer to **Photograph 13, 14 and 16** at locations shown in Figure 3).
