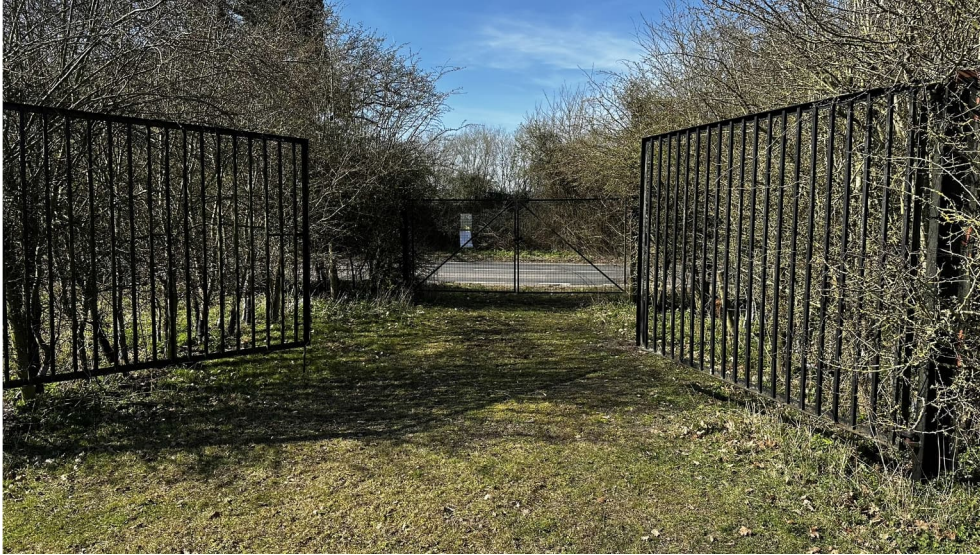
Photograph 1: Site entrance from Lodge Rd

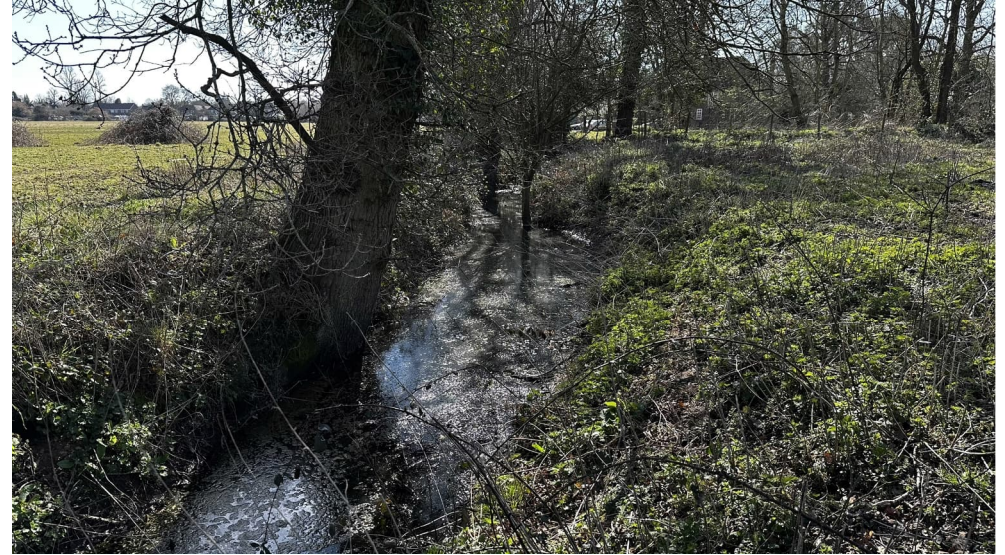
Photograph 2: Possible main river looking south

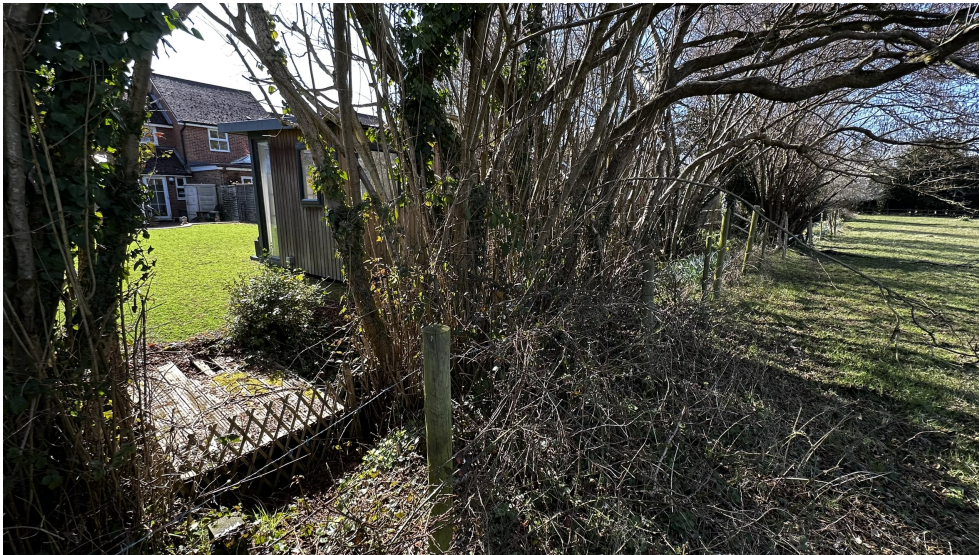
Photograph 3: Structure over waterway

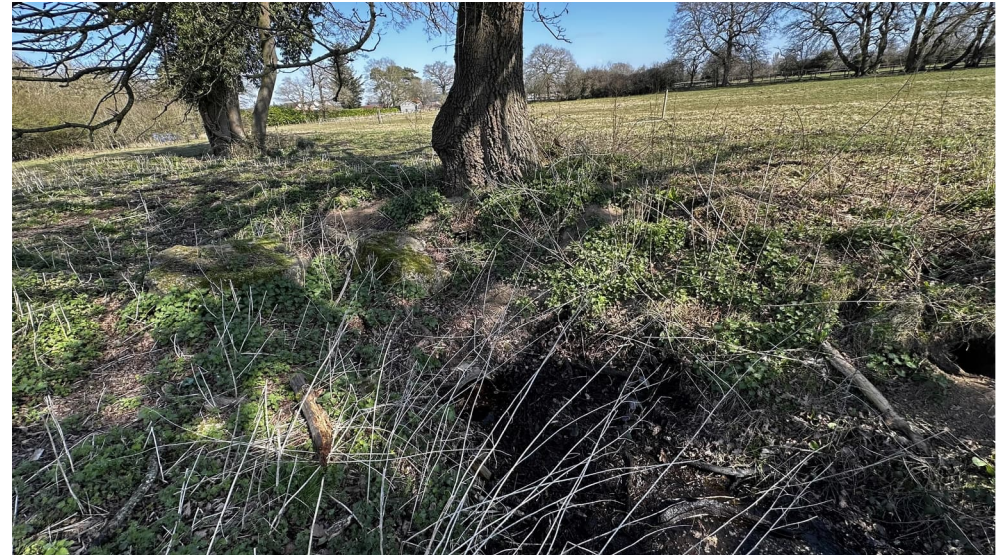
Photograph 4: Culvert in northern direction

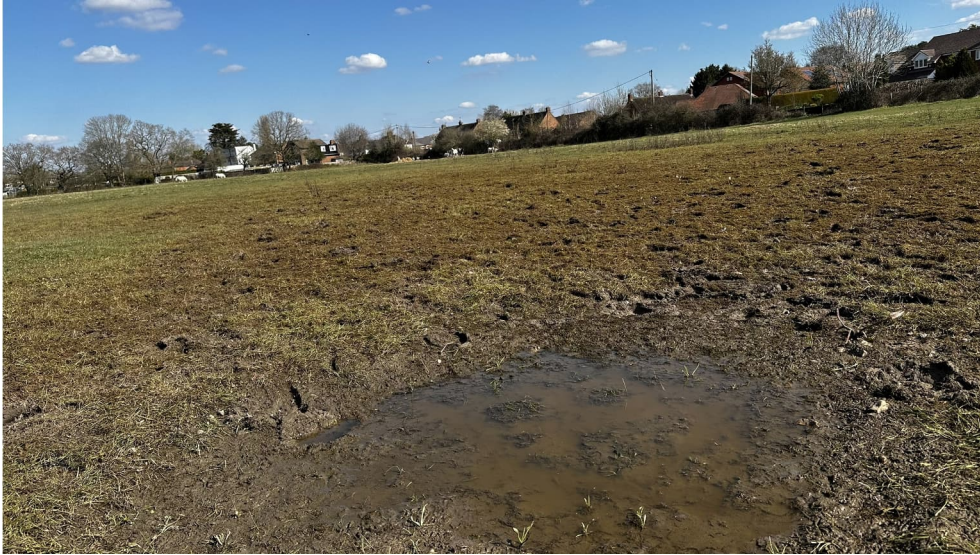
Photograph 5: Ponding at eastern side of site

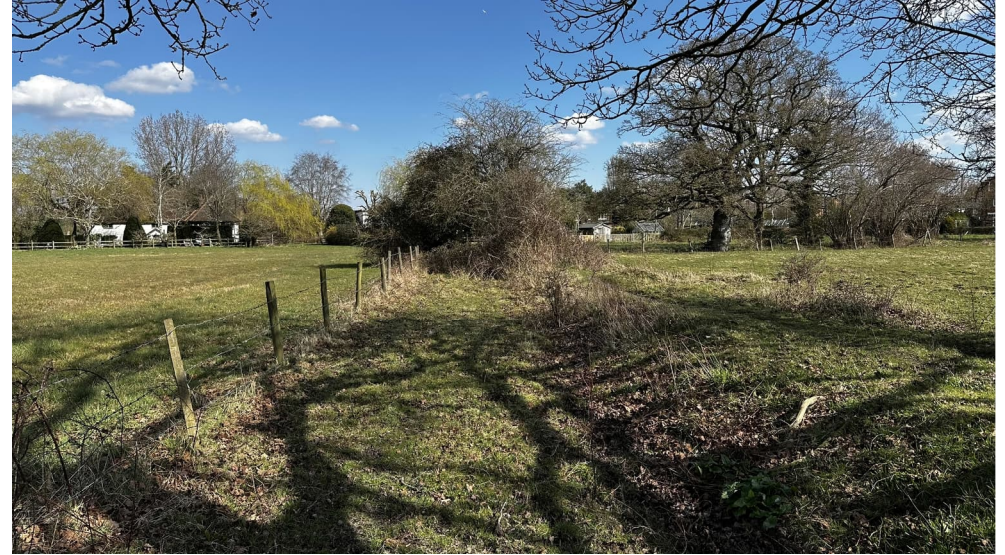
Photograph 6: Northern site boundary depression

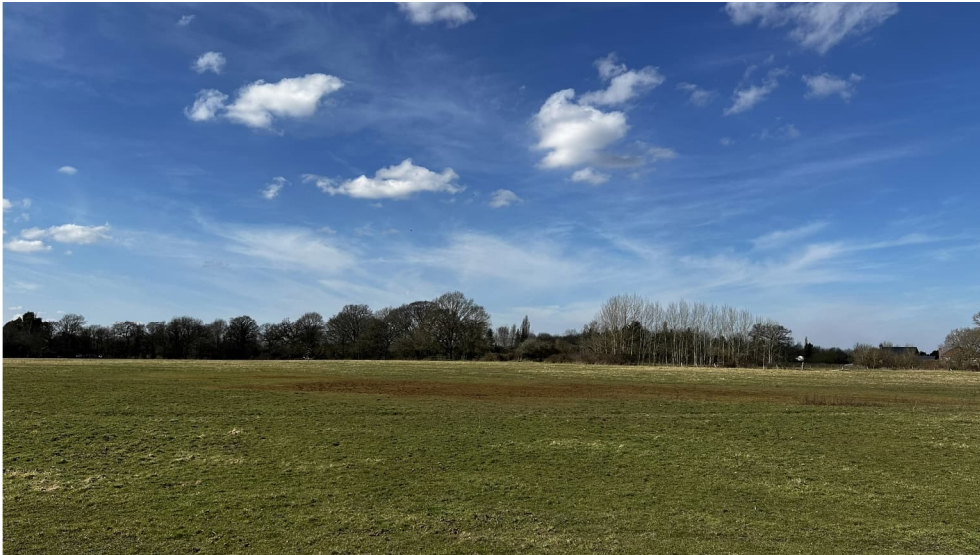
Photograph 7: Wet area in eastern area of site

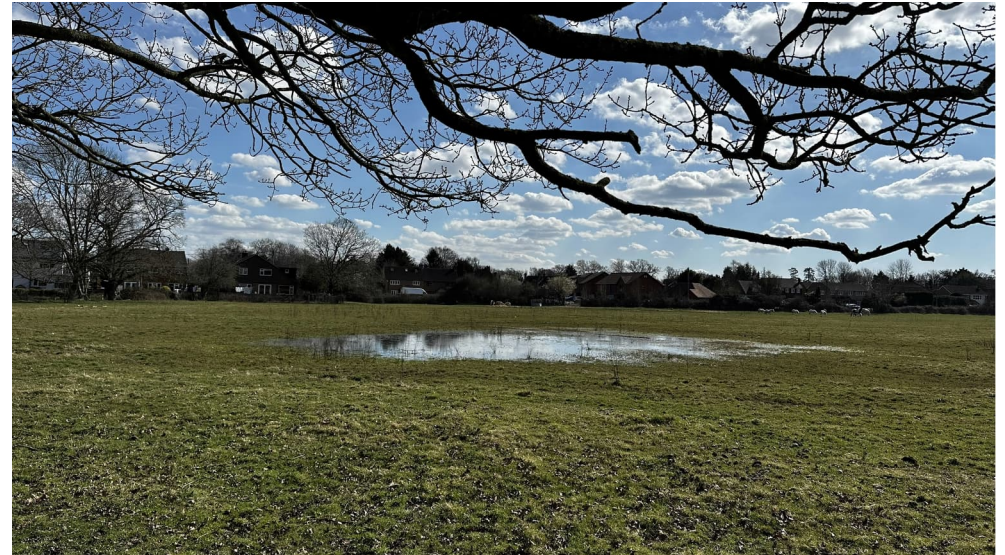
Photograph 8: Ponding at northeastern boundary

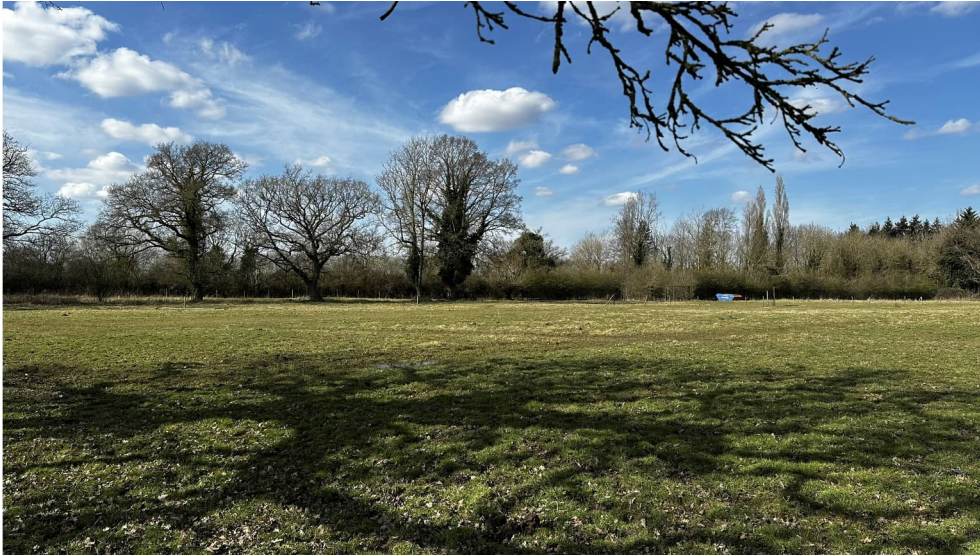
Photograph 9: Slight ponding at northwestern site edge

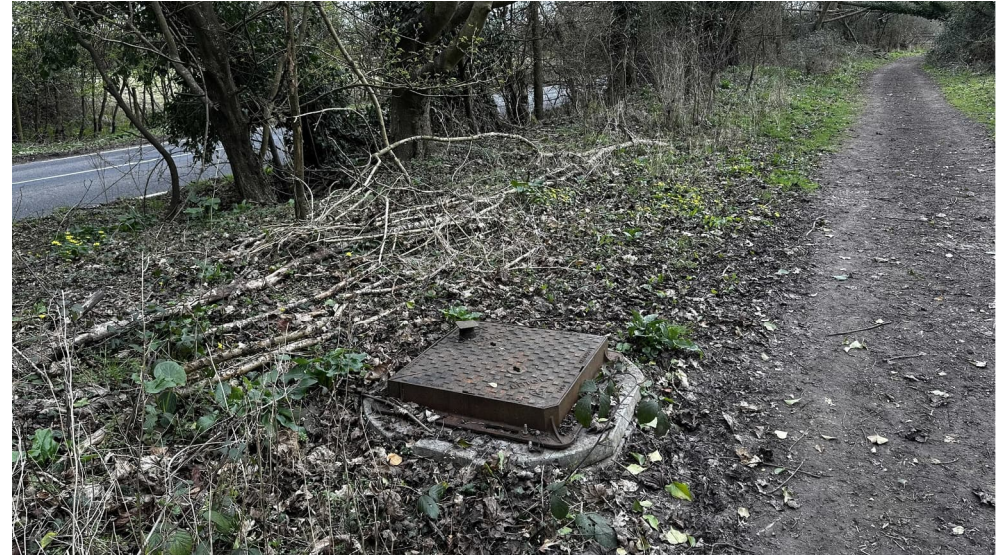
Photograph 10: Manhole in a northeastern direction from site

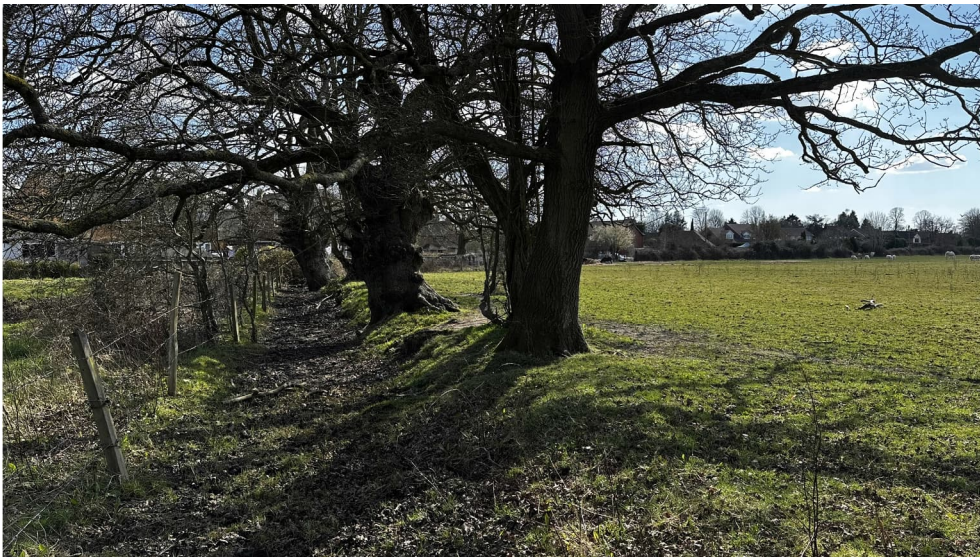
Photograph 11: Depression at northern boundary

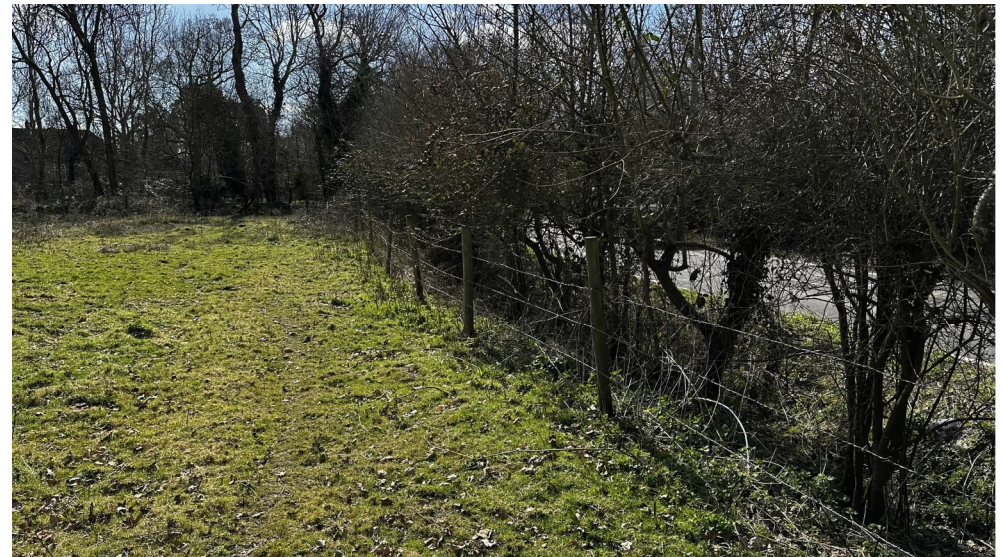
Photograph 12: Ditch along western site boundary

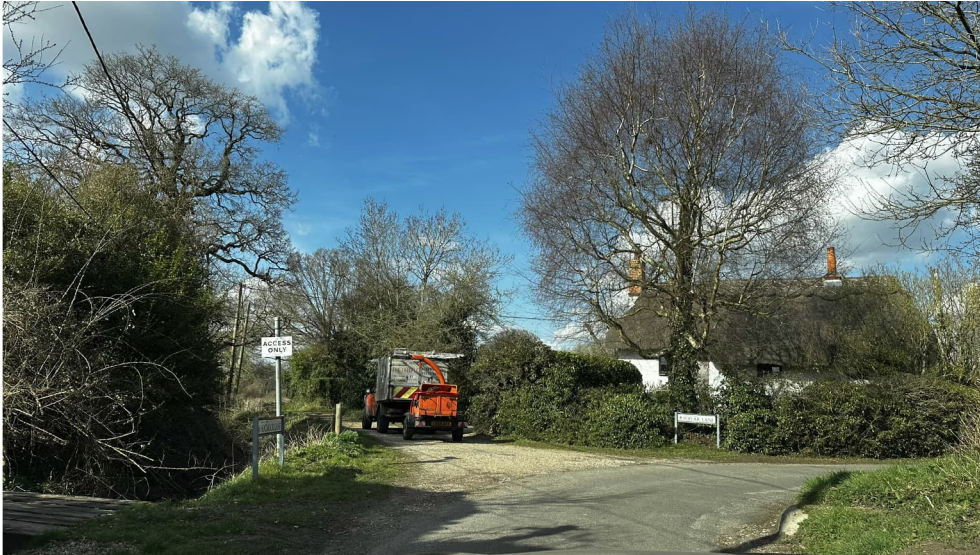
Photograph 13: Corner of Hogmoor and Poplar Lane

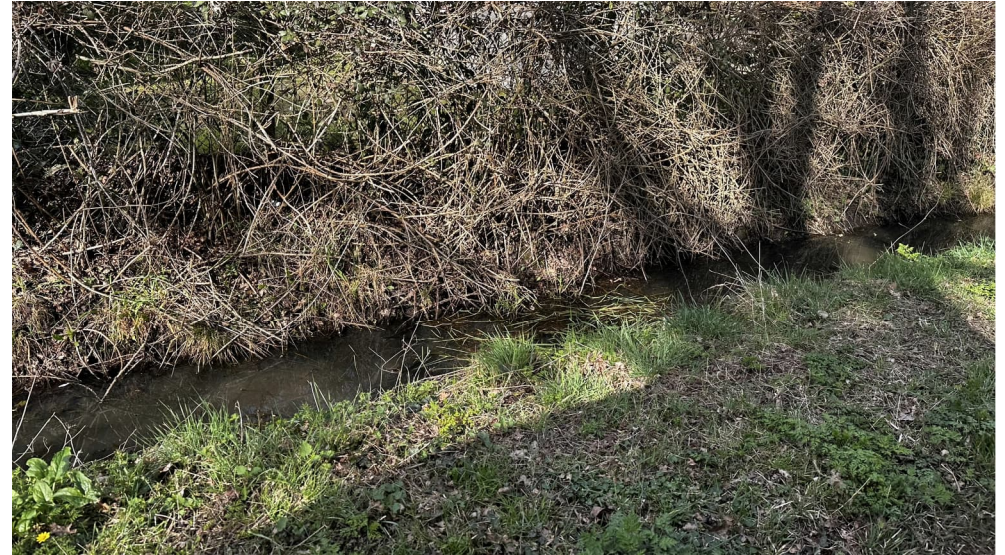
Photograph 14: Ditch at site of Poplar Lane

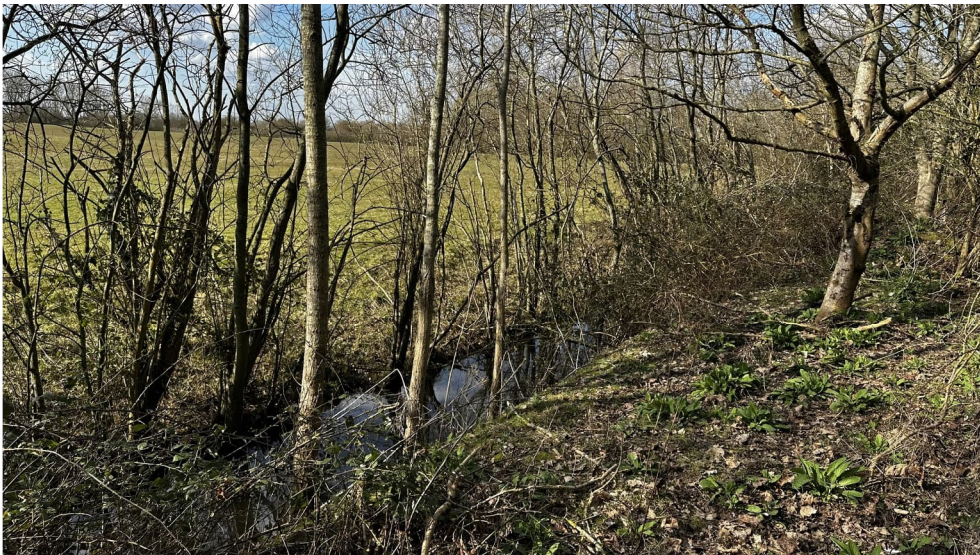
Photograph 15: Main river northeast of site

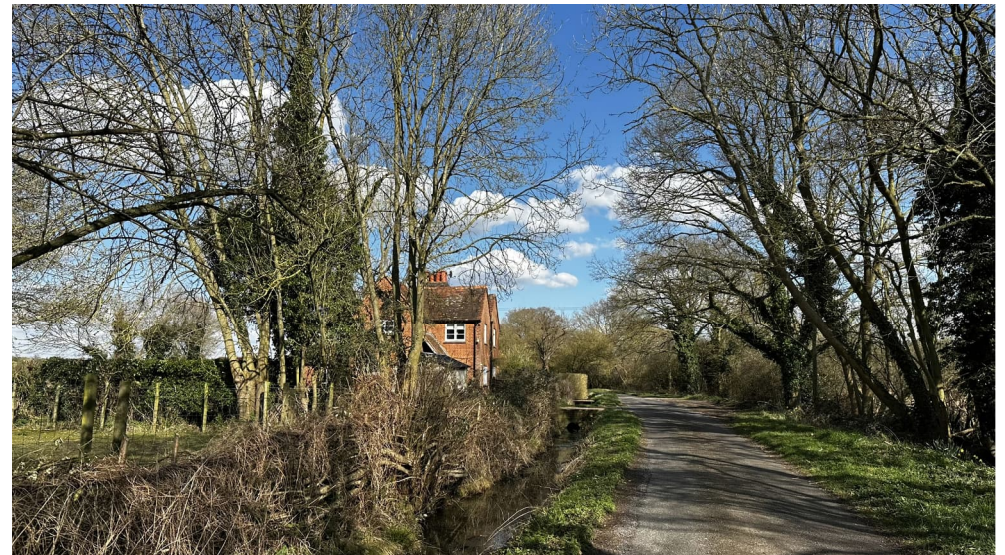
Photograph 16: Poplar Lane
