## **Tree inspection and report**

**Ref: SW4L29072024**

Sharon Whitehead  
4 Lupin Ride  
Crowthorne  
RG456UR

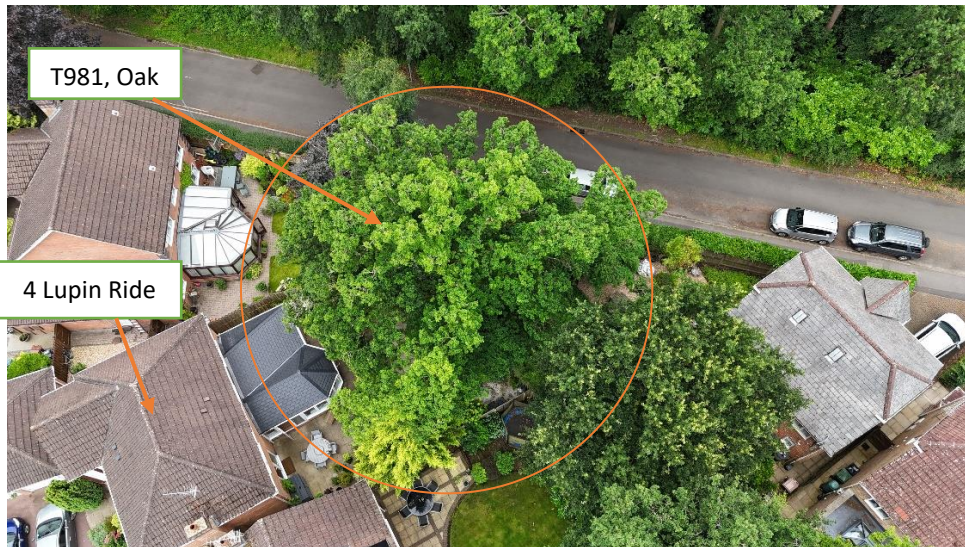
Picture 1

This tree is an excellent height feature within the rear garden and has good amenity value to the immediate neighbouring properties. See picture 1

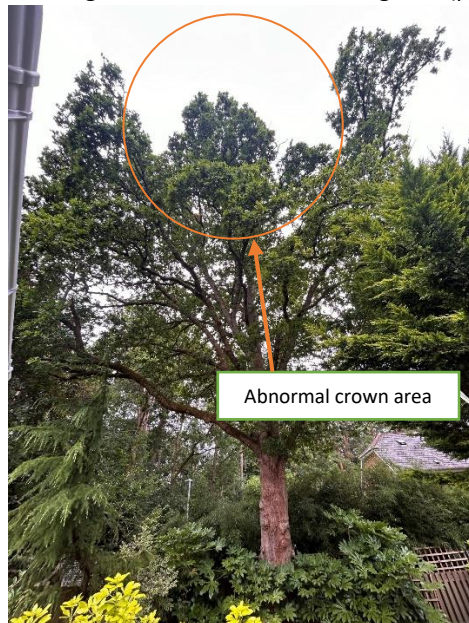
1.7: The tree is growing tight on the rear garden's west boundary fence line, with the root system and crown encroaching on neighbouring properties. The centre crown of this tree appears abnormal, with the centre spire area missing (picture 2). The overall crown I would class as fair, with sections of prominent dead wood showing in various locations throughout (picture 3). The crown has produced areas of epicormic growth.

Picture 2 shows the "missing" central spire.

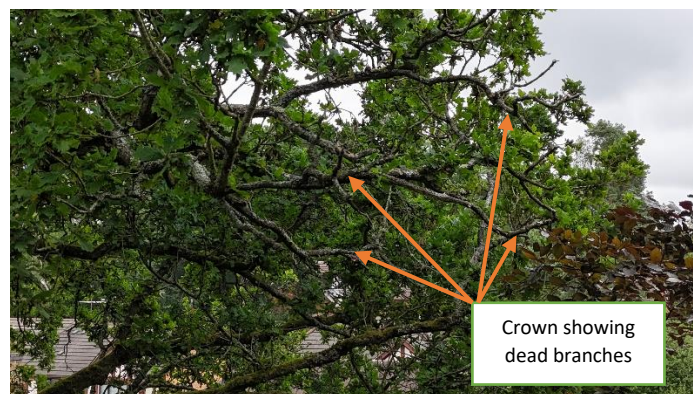
Picture 3 shows the concentration of dead wood.

2.6: this tree has been infected for many years and is now advancing through the root system and causing premature leaf drop and dead branches, also evident with the sparse crown, > 20%. I am confident the introduction of honey fungus to this tree was caused by poor construction methods when laying the railway sleeper-style edging and the concrete pad. There would have been direct damage to living wood below the ground within the root system, along with possible indirect damage through laying the slabs, causing compaction on the north, east and north sides of this tree.

3.0: Remove all deadwood from the crown; this will enable close monitoring of further dieback.

3.1 This tree must be inspected yearly for further dead wood as honey fungus advances.

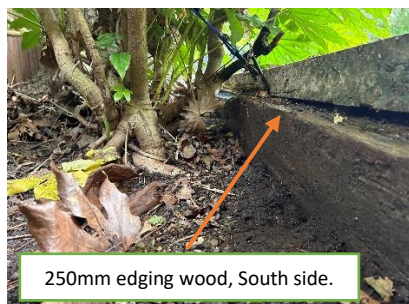
Picture 4

1.8: There has been historic landscaping in the rear garden, and within the root area of this tree on the east of the trunk, the slabbed patio has been raised from the original garden level approximately 300mm; there is railway sleeper-style edging with the slabs laid in between, pictures 4 and 5 with picture 5 showing how close the wooden sleepers and slabs have been laid to the trunk.

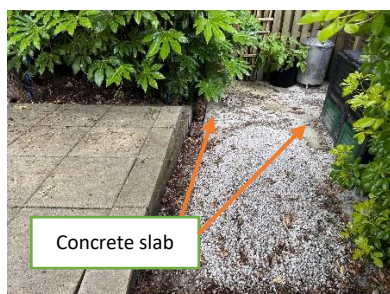
Picture 6

1.9: To the north, at 3 meters, there is a bare concrete sub-base for a garden structure laid for a shed or storage area; this impacts the soil to at least 100mm. See picture 6.

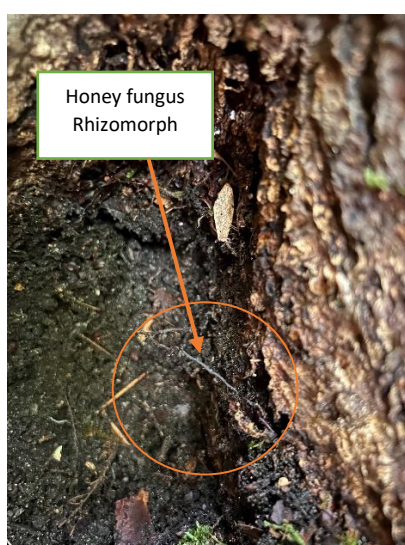
Picture 7: Southside of the trunk.

2.0: Removing away the soil around the areas of the lower trunk flair and the top root systems on the north and south sides, I found black rhizomorphs, circled in picture 7, that have entered the bark and sapwood area; these are indicative of Amilaria or Honey fungus.

2.1: I did not find any areas of dead or loose bark; in advanced stages, there may well be Mycelium present beneath this, along with the Compartmentalization of Decay in Trees (CODIT barriers ) visible on the wood.

2.3: This tree, unfortunately, has been found to have a colonisation of a honey fungus, as proven by the discovery of the rhizomorphs within the buttress on the north and south sides of this tree. This has the appearance of black or brown boot lacey strings; these can be confused with woody roots; the overall condition of the tree would fall under fair due to the tree attributes of the crown, canopy and the areas within the north and south buttresses.

2.7: Currently, I do not believe there is justification for removing this tree. However, there will be a point when this decision will have to be made for the safety of people and property.

2.8: This tree may only have a few years before it becomes too dangerous to retain.
