URS Building

Structural Repair Strategy Report

Curtins Ref: 085585- CUR-W033-XX-T-S-00003

Revision: P02  
Issue Date: 20 November 2024

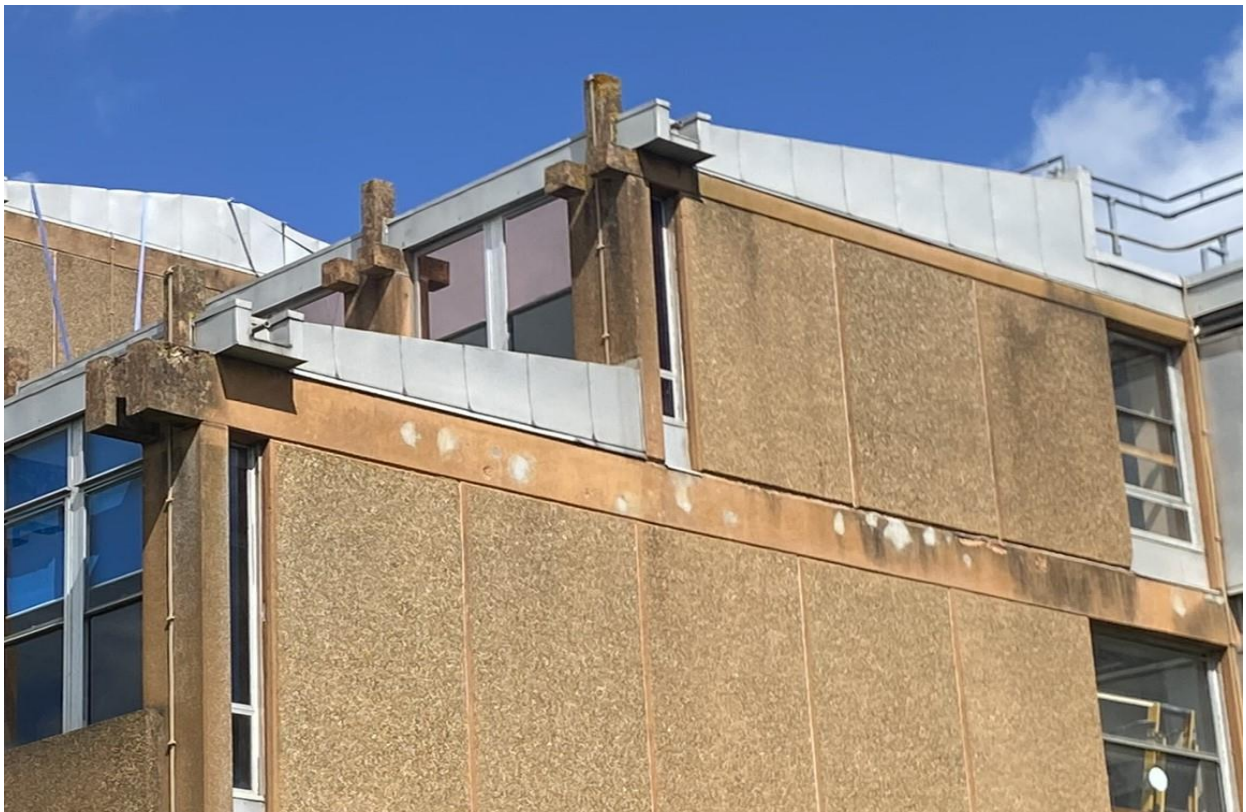
Previous poor quality concrete patch repairs have also negatively affected the building’s external appearance. These conventional concrete repairs have used a grey pigmented product which does not resemble the surrounding ochre-coloured concrete (see figure 3).

The condition and durability of these previous repairs appears to be intact with no delamination or further spalling at these locations. However, the removal of these grey patch repairs is to be considered based on their heritage impact. Reinstatement with a suitable repair that matches the colour and texture of the original structure is recommend, in line with Purcell’s recent Concrete Repair Strategy.

Figure 3 Poor quality previous concrete repairs on east elevation façade

- a) **Removal of existing poor quality concrete repairs**, priority is to be based on heritage impact defined by Purcell.
- b) **Clean and prepare** external concrete surfaces for application of protection measures. Cleaning requirements will be defined by the product manufacturer and Purcell.

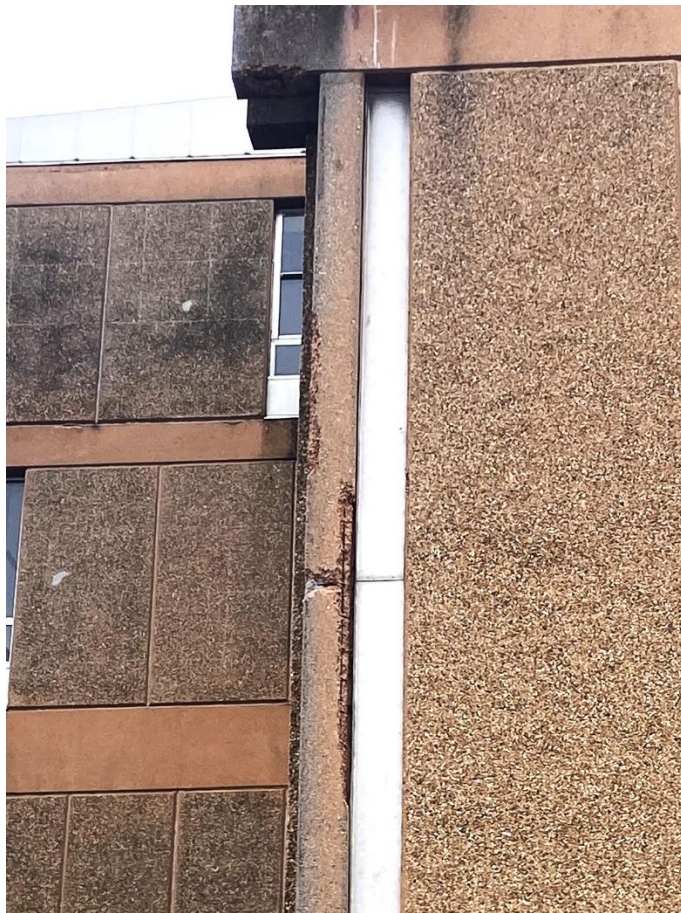
- a) Spalling of external RC elements (see figure 5). The possible causes for this defect are as follows:
- Carbonation of external exposed concrete elements which eventually cause the embedded reinforcement to corrode and expand.
  - Freeze thaw action due to weathering.

Figure 5 Spalling of exposed post-tensioned beam end

- c) **Patch concrete repairs** to areas of spalled, cracked concrete and previous repair reinstatement.
  - Repairs with exposed reinforcement should be primed with a protective coating to reduce further corrosion and enable re-passivation of the reinforcement steel.

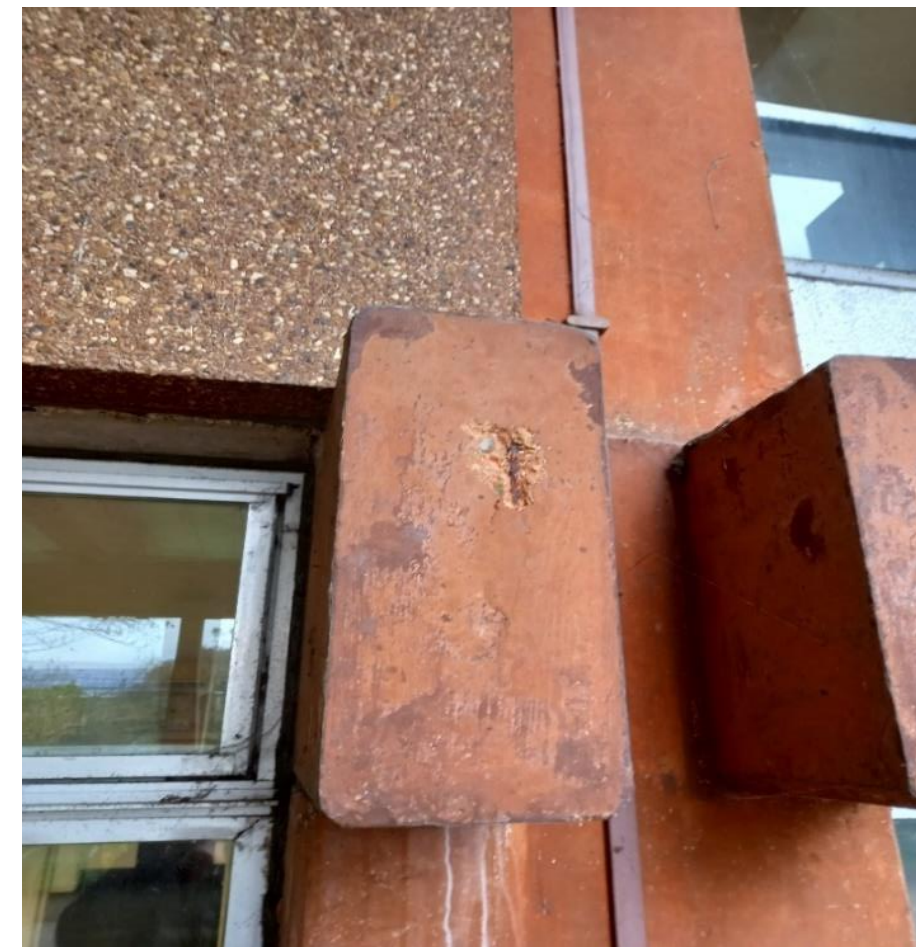
- b) Corrosion of embedded steel reinforcement within concrete (see figure 6)

- This is suspected due to carbonation of the concrete, where carbonation depths exceed the reinforcement cover.
- Possible areas of localised low cover which are less than the required cover. This is caused by poor workmanship during the original concrete pour.

Figure 6 Steel reinforcement exposed on Post Tensioned RC beam end

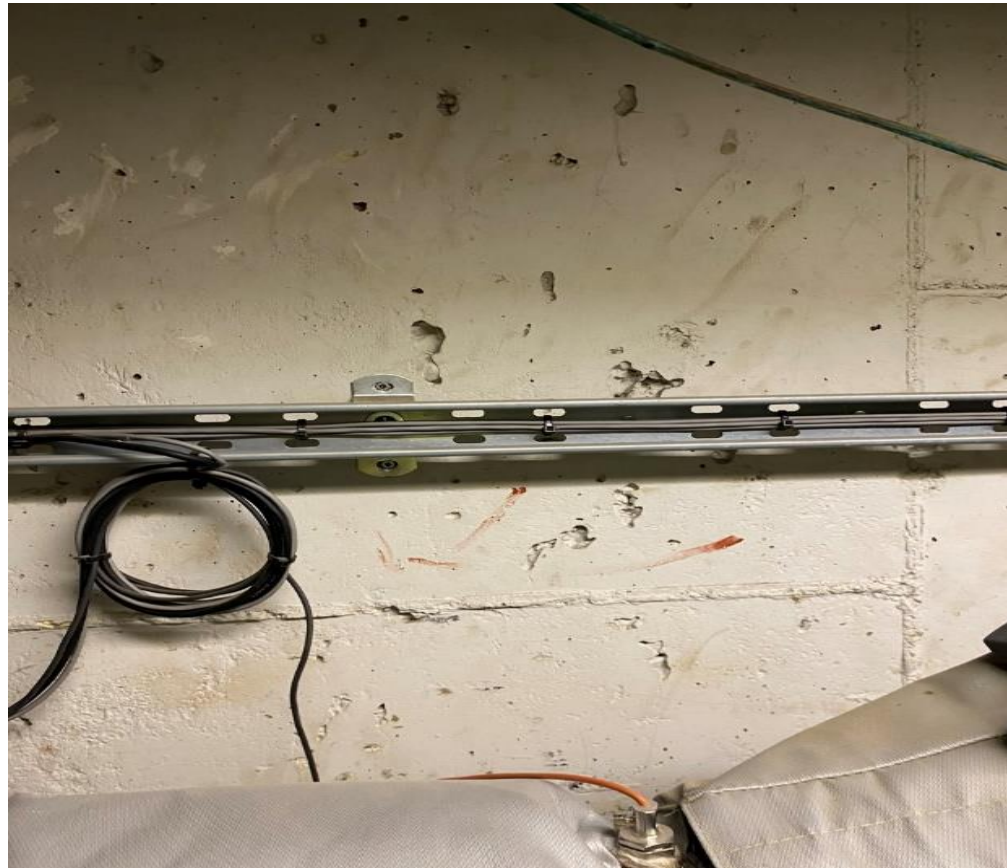
- c) Honeycombing of concrete faces particularly columns and basement walls.
- This is caused by poor concrete mix design and workmanship issues during the original build. Refer to figure 7 below.

Figure 7 Honeycombing on internal face of basement RC retaining wall

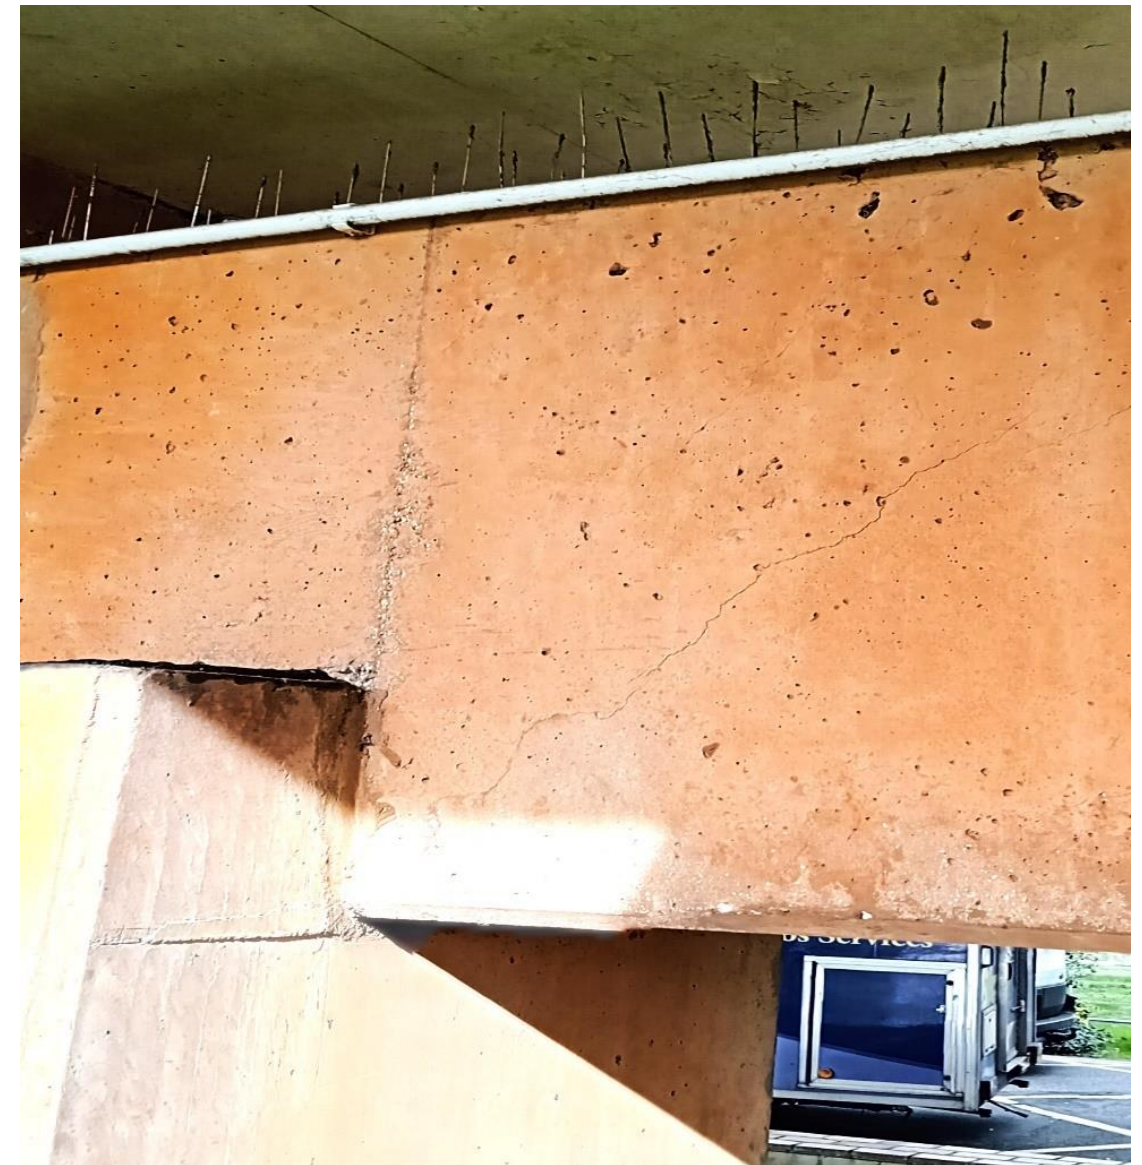
- d) Visible deflections and diagonal hairline cracking on some RC transfer beams. Refer to figure 8 below.

Figure 8 Diagonal cracking and honeycombing on RC transfer beam near external pond

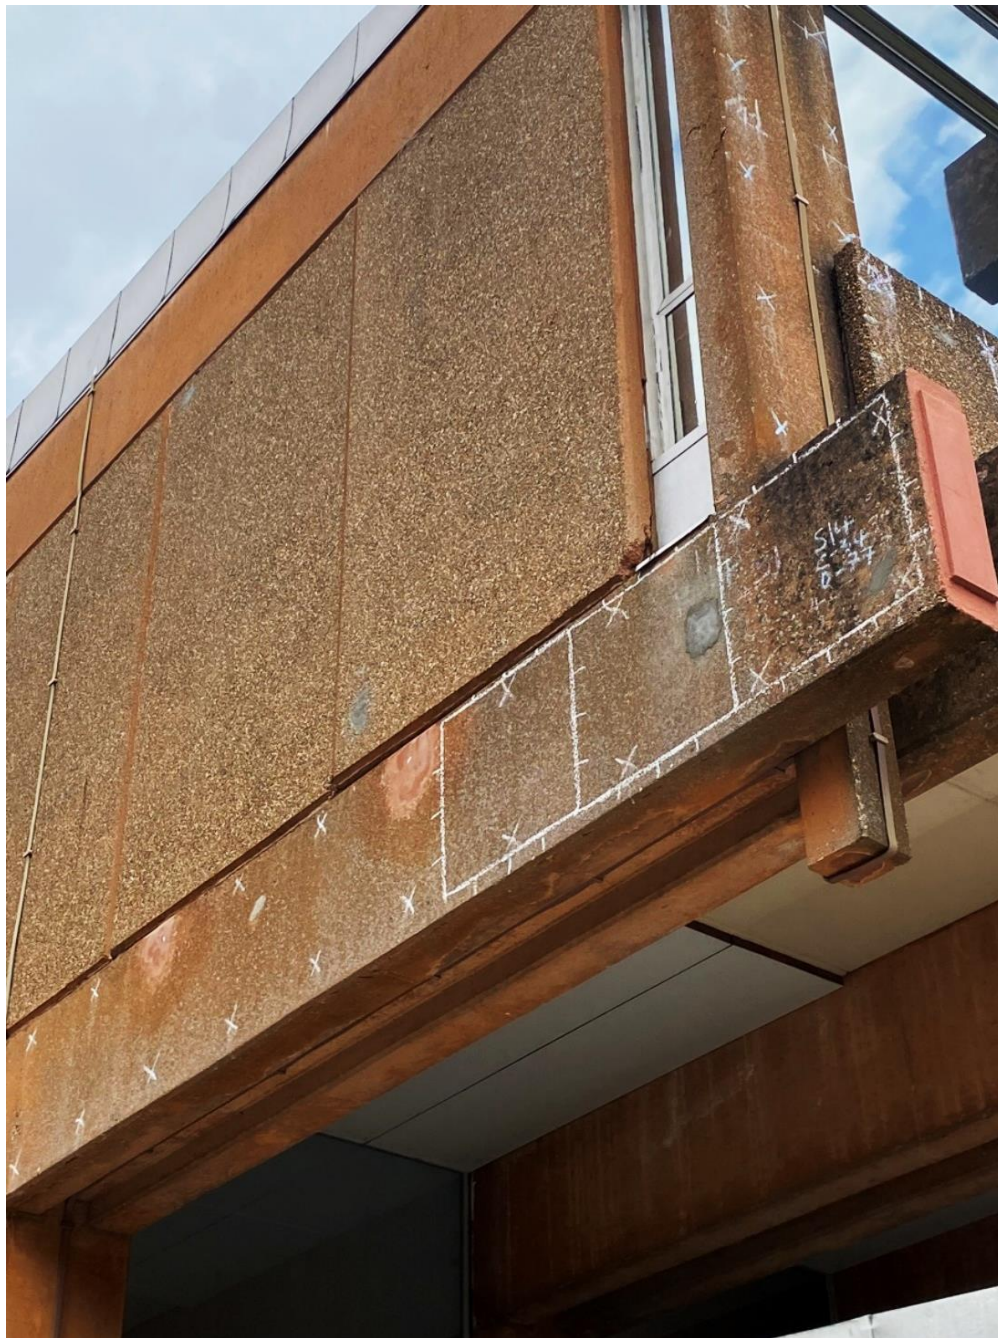
- e) A number of precast cladding panels are noticeably out of plumb with failed mastic seals (see figure 9). Cracking and spalling to the bottom edge of the cladding panels was also evident.
- Cracking and spalling damage evident on cladding panel edges.

**Figure 9 Out of plumb cladding panel above PT beam with hairline cracking at panel bottom edge.**

- Chloride content within the original mix of the concrete is low and is deemed to be unlikely to cause corrosion.
- The external precast panels have defects beyond the reinforced concrete including degraded mastic and ungrouted connections. Mastic will need to be replaced to prevent moisture ingress and joints are to be grouted to ensure sufficient connection back to the structure.

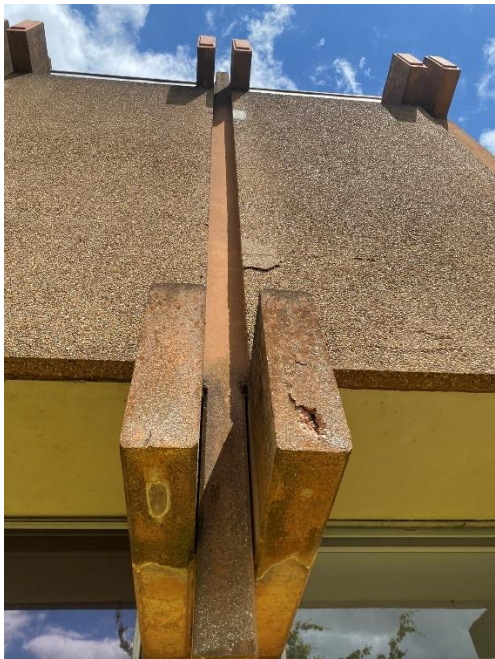
Photograph 7 - Concrete spalling on PT beam ends on south elevation level 1.

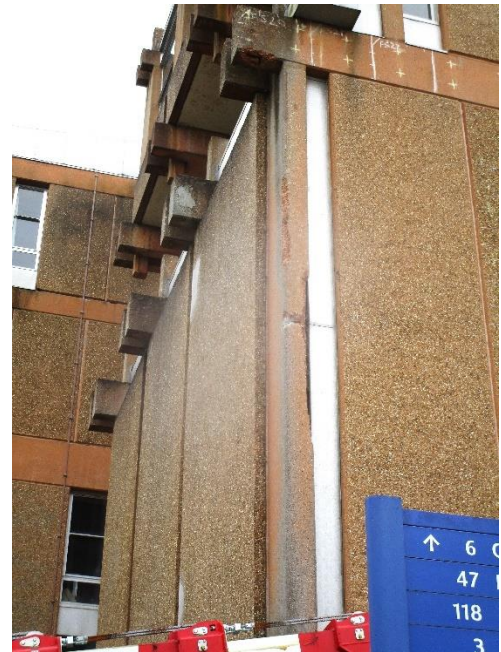
Photograph 8. Concrete spalling on concrete column located on southeast corner

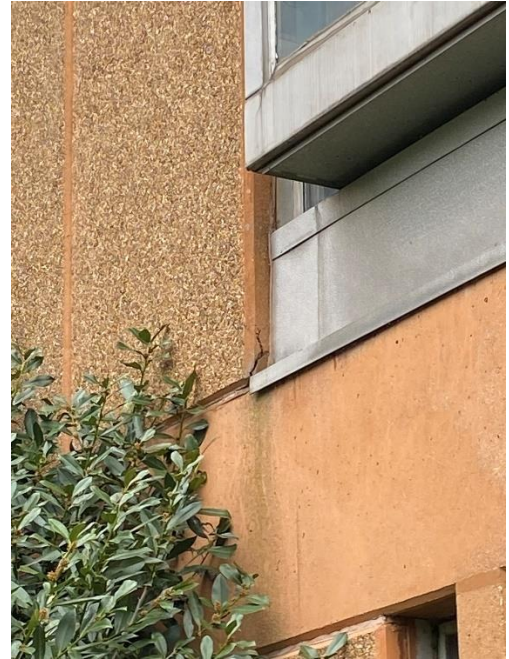
Photograph 10 – Horizontal displacement of precast cladding panel at base. Concrete cracking also evident. Panel located on south elevation

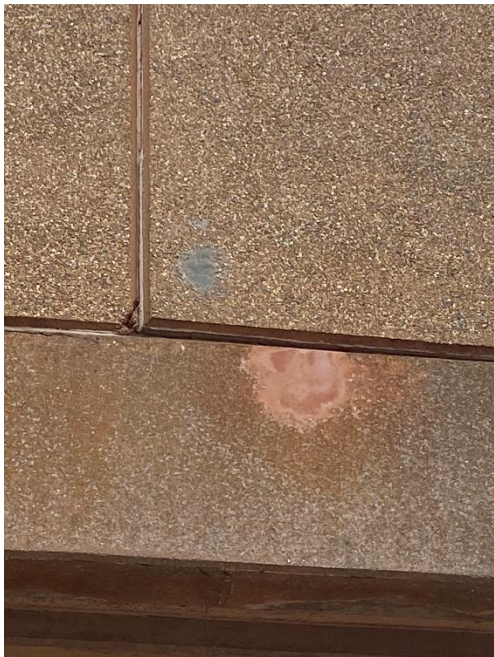
Photograph 11 – Horizontal displacement of precast cladding panel at base. Concrete cracking also evident. Panel located on south elevation

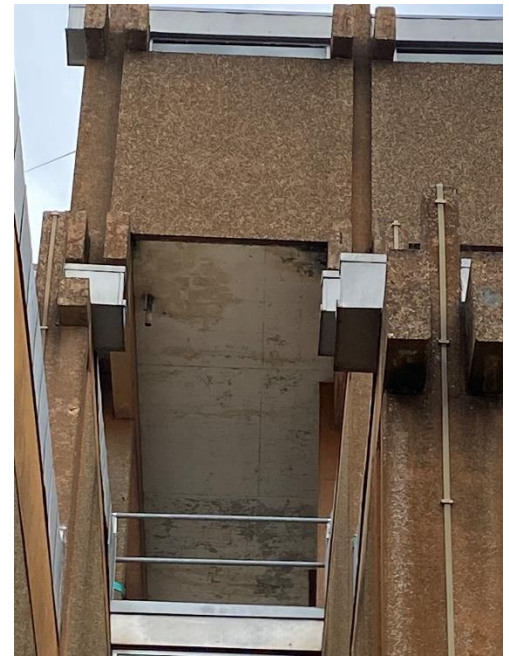
Photograph 12 – Water damage to insulation cladding panel boards located on overhang soffits.

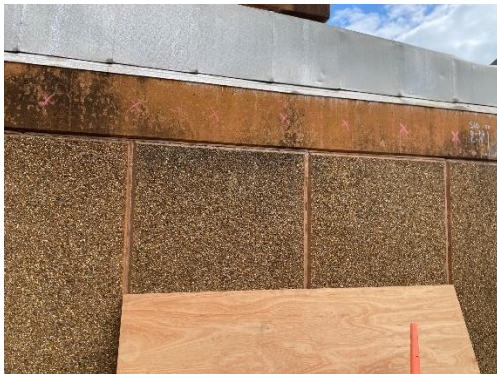
Photograph 15 – Moss and algae growth on beam and cladding panels (general comment).

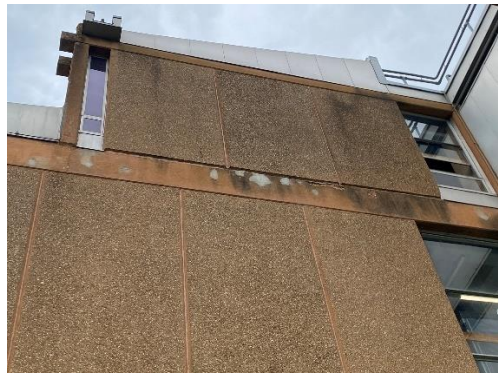
Photograph 16 – Previous concrete repair mortar repairs to concrete PT beam (level 3) on south elevation.

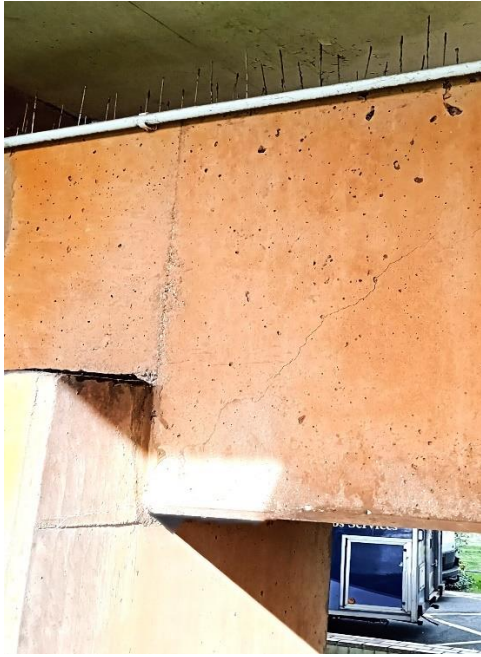
Photograph 17 – Diagonal hairline cracking on level 1 transfer beam above garden pond.

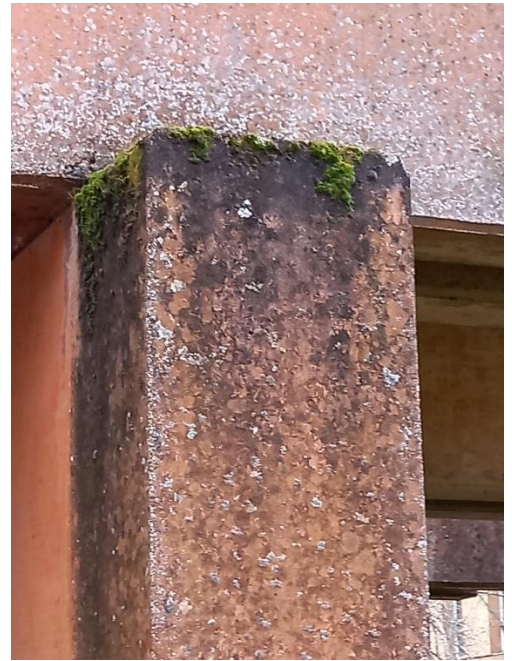
Photograph 18 – Moss and algae growth on concrete PT beam ends (level 1) on south elevation.

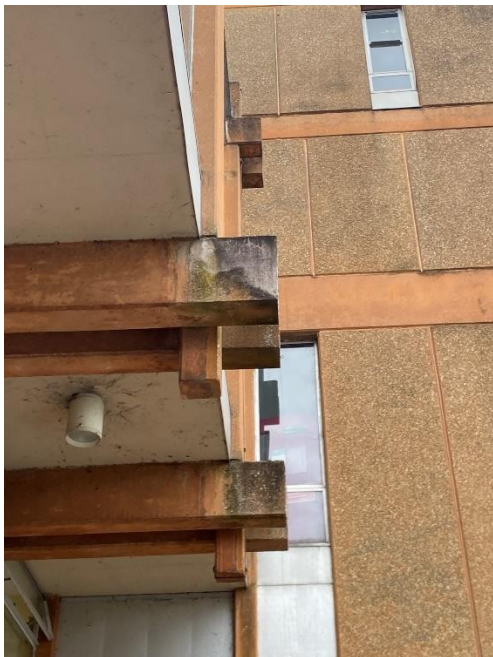
Photograph 19 – Vegetation growth on top surface of beam end tips (south elevation)

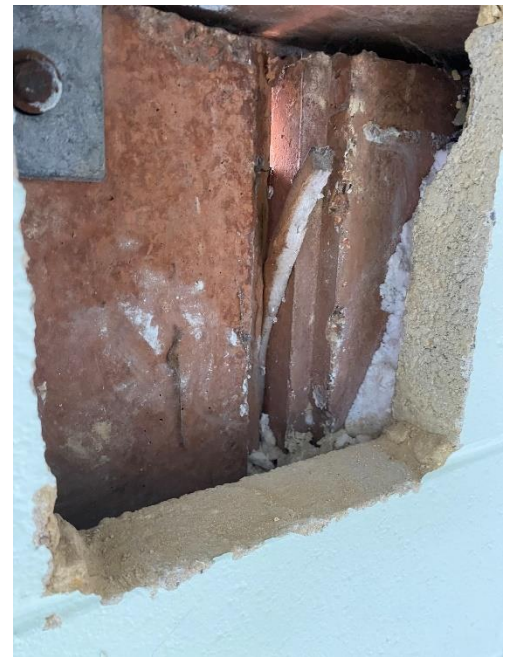
Photograph 20 – Failed mastic seals on precast cladding panels with daylight visible.

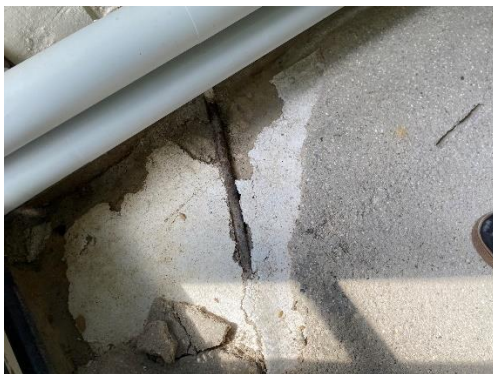
Photograph 25. – Damage to floor screed (50mm) on upper floor slabs

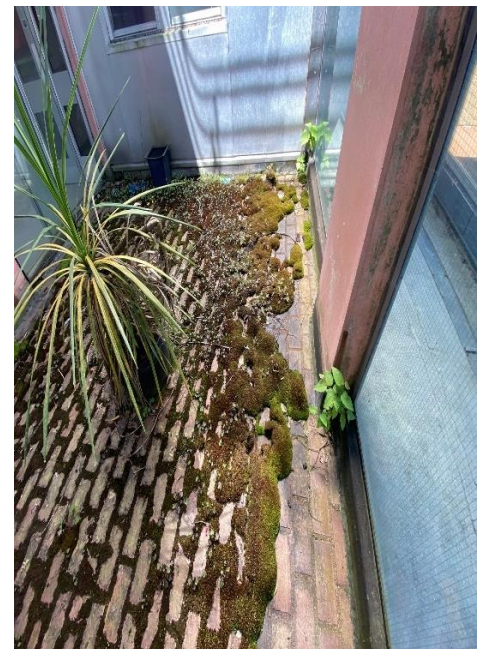
Photograph 32 – vegetation growth on level 2 roof surface within light well.

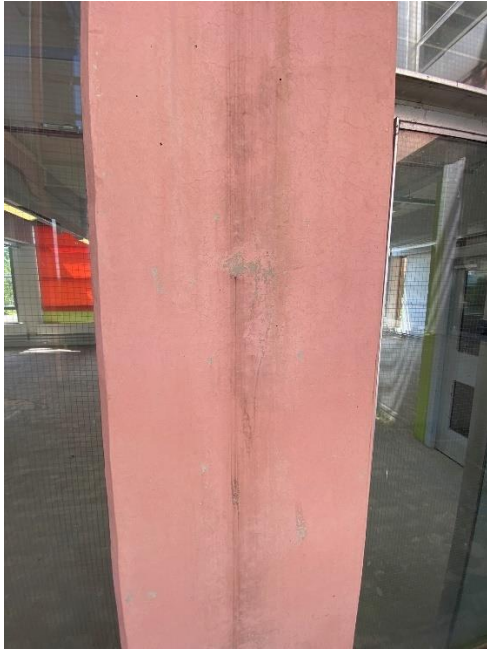
Photograph 33. Grazing cracks and peeling paint on level 2 columns within light well

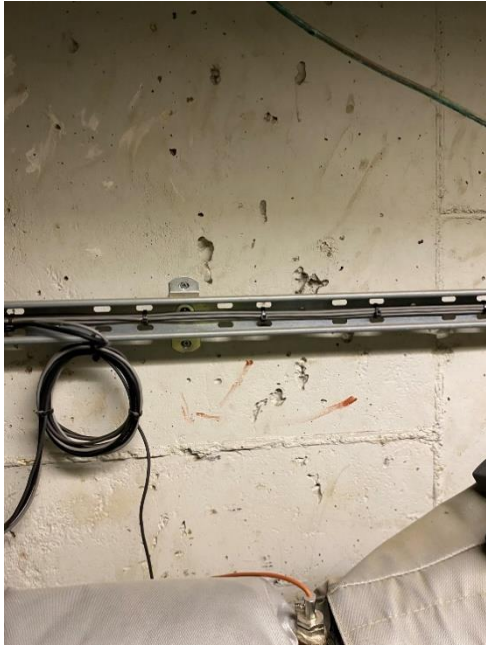
Photograph 41. Honeycombing on basement retaining wall

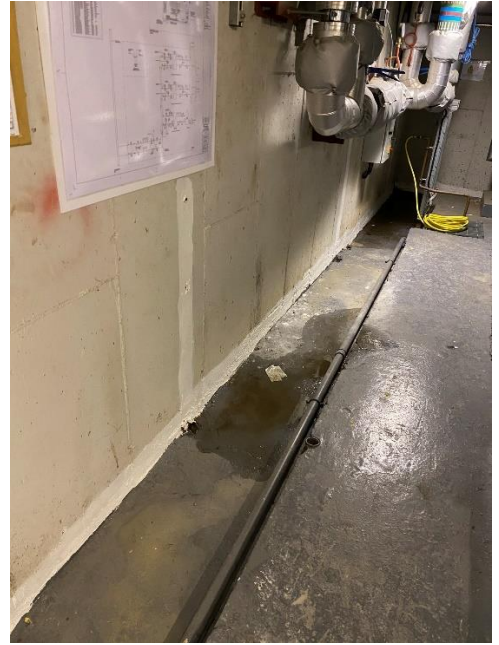
Photograph 42 – Water leak from pipework above. Basement space notably humid.

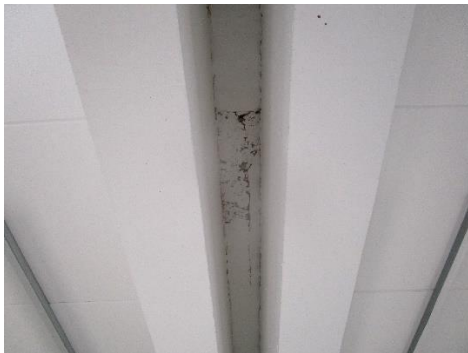
Photograph 43 - Poor compaction and honeycombing issues on slab soffit between PT double beams.

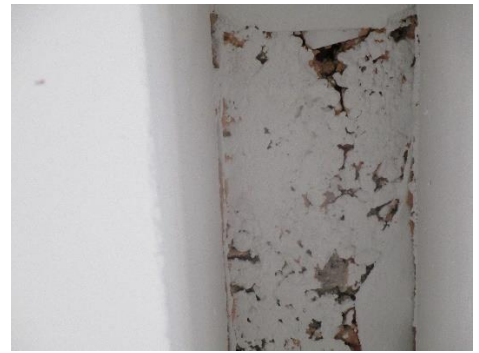
Photograph 44 – Poor compaction and honeycombing issues on slab soffit between PT double beams.
