## **Planning Application Structural Report**

Bird Place  
Henley Bridge  
Henley-on-Thames  
Berkshire  
RG9 2LN

03 April 2025

25-2795

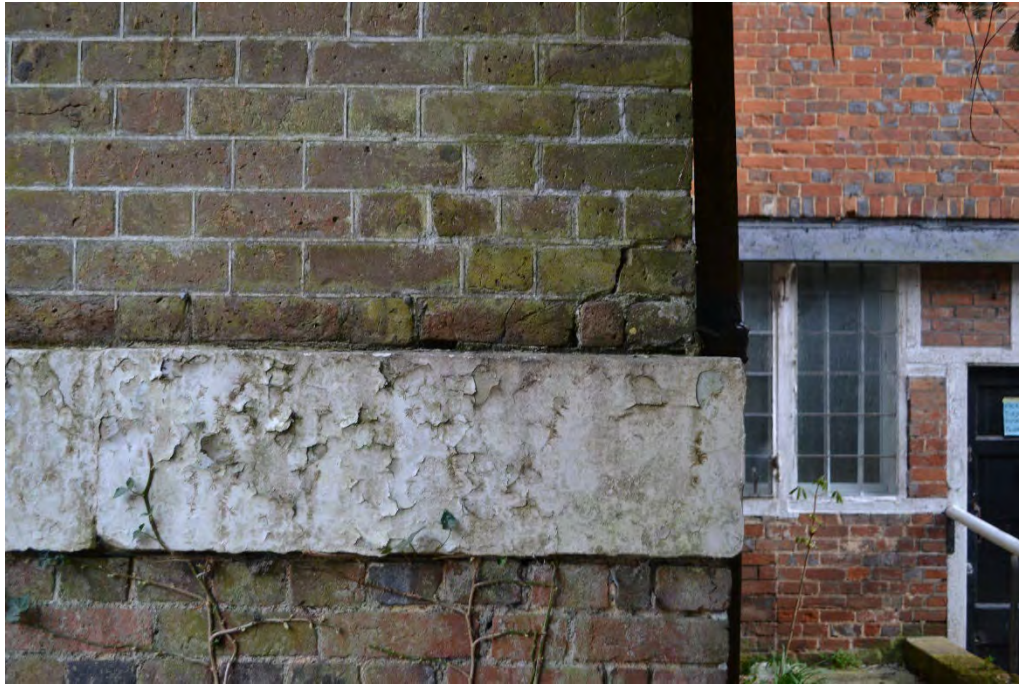
- 4.5 In relation to the main walls there are three areas of concern:
- a) Cracking at the front, right-hand corner - probably caused by the proximity to the yew tree.
  - b) Cracking at the front, left-hand corner – cause not yet determined.
  - c) Cracking and distortion of the rear window to the rear hallway and stairwell.

**P25 Front right-hand corner – cracking**

On this basis, it would appear prudent to investigate the foundation depths together with the extent of tree roots and effect on the underground drainage. Subject to this, it would also be prudent to consider the removal of the yew tree to prevent further movement. Once this mitigation measure has been carried out, further investigation may be necessary regarding the condition of the wall panelling. Subject to this, repairs would need to be undertaken to both the external masonry and also any timber framing internally. Windows would also need to be straightened.

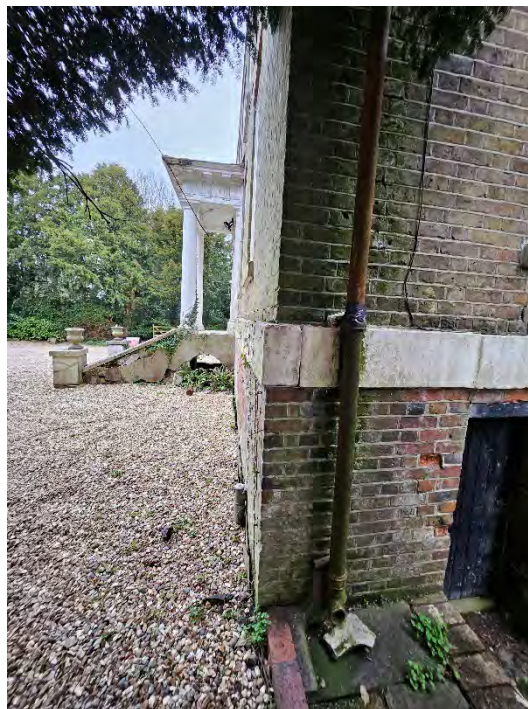
**P26 Displacement to corner**

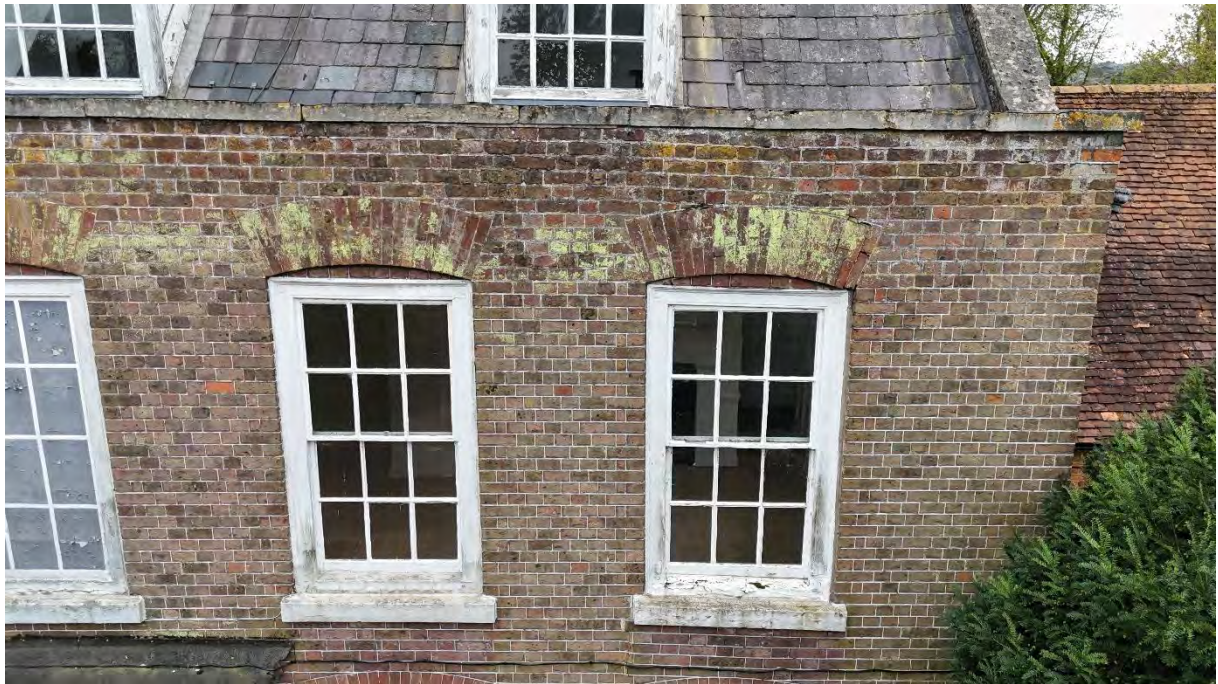
**P27 Crack in front elevation continues to eaves**

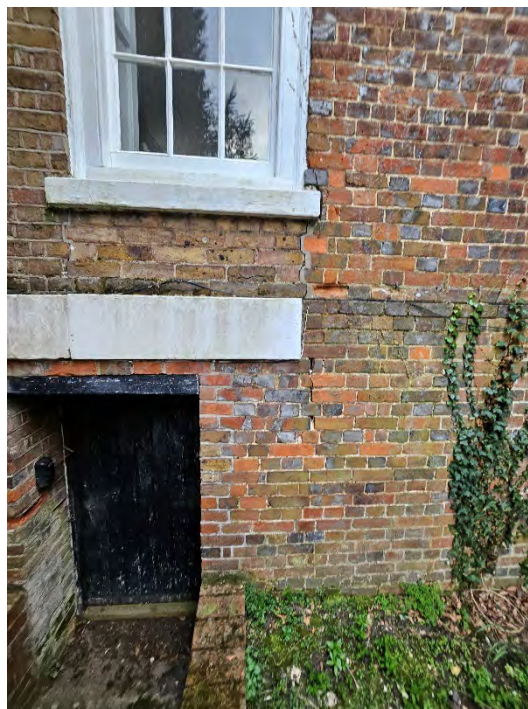
**P28 Displacement to render course at basement door**

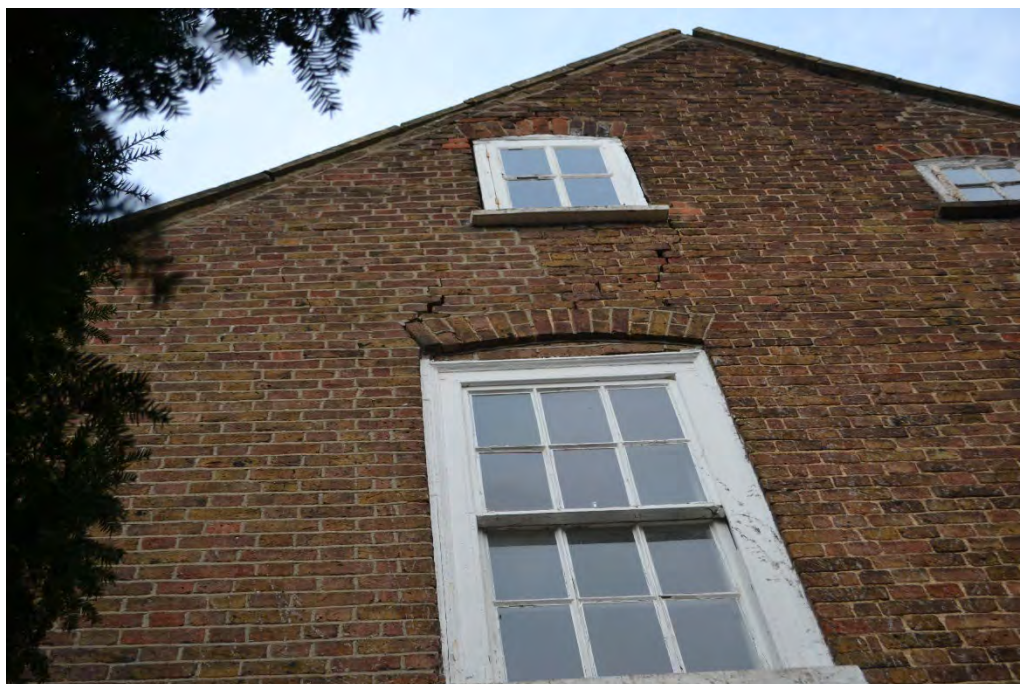
**P29 Right-hand elevation – re-pointed brick to front**

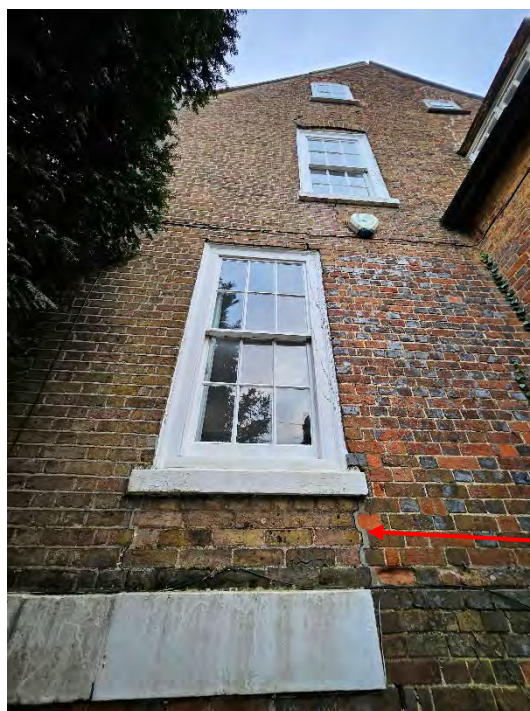
**P30 Right-hand gable**

Crack  
continues from  
basement to  
roof

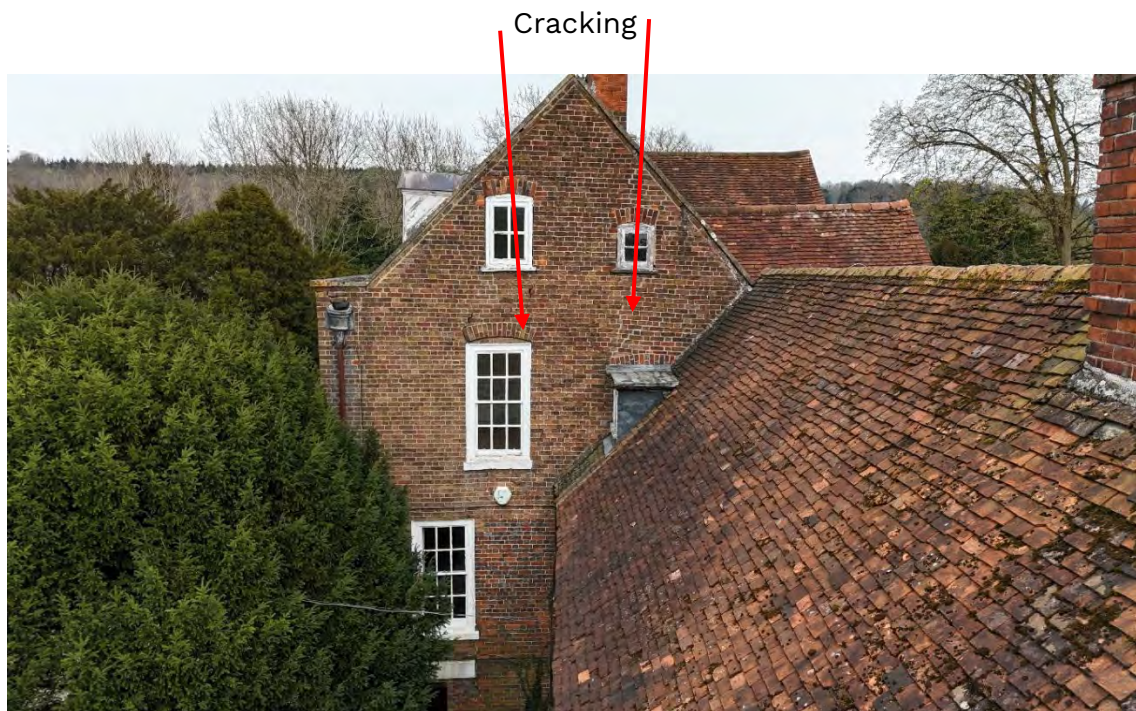
**P31 Cracking to gable wall although previously repaired, continues to roof**

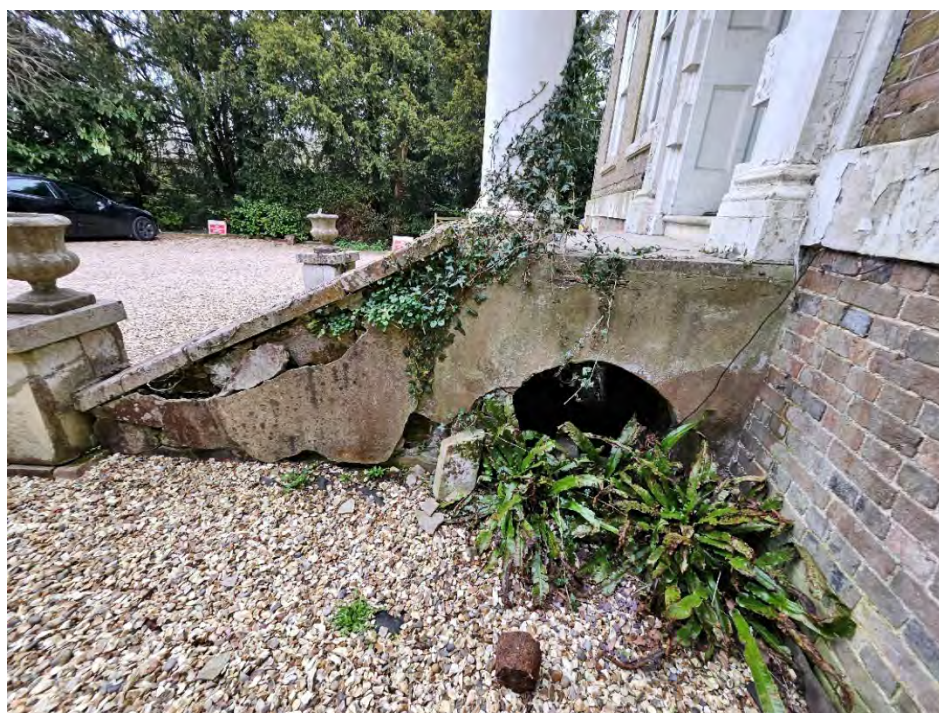
**P31 Front steps – failed render**

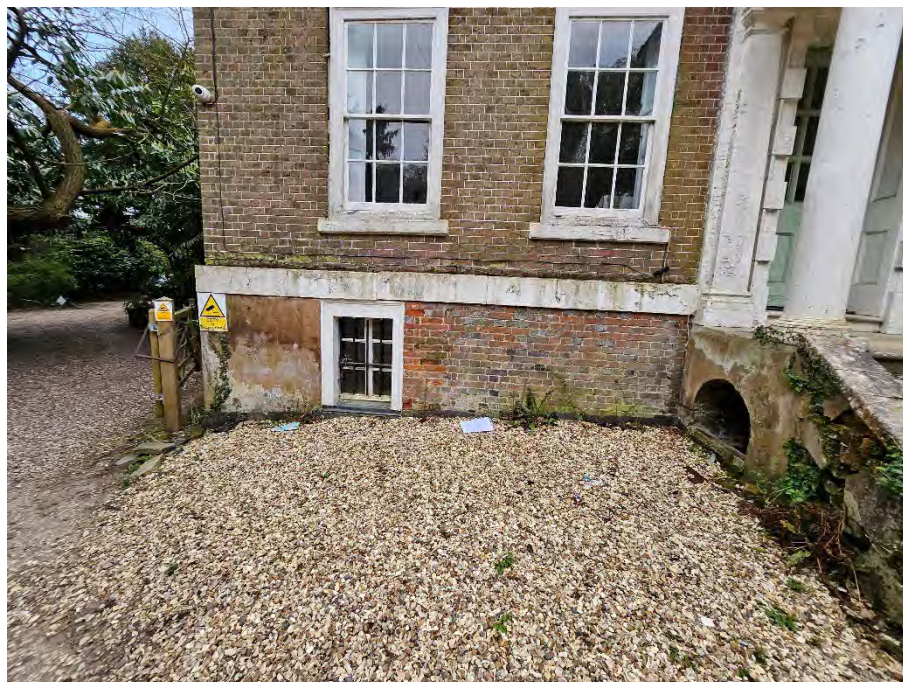
**P34 Left-hand corner – note slope**

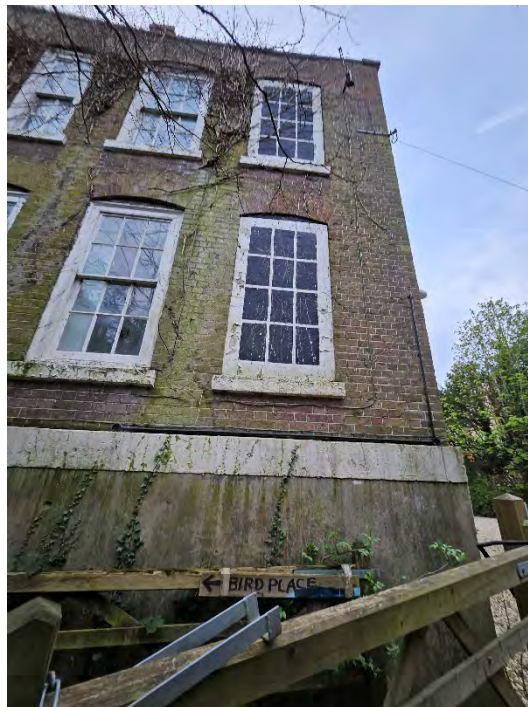
**P36 Crack above window**

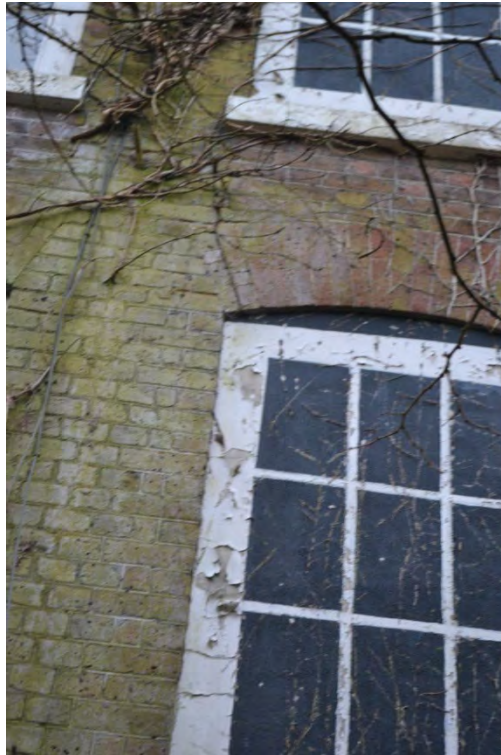
**P37 Note displacement to arch**

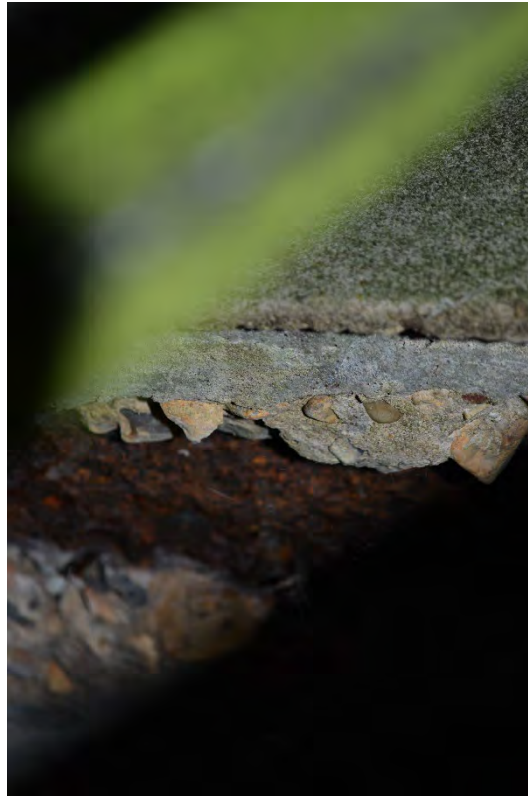
**P39 Corroding steel below steps**

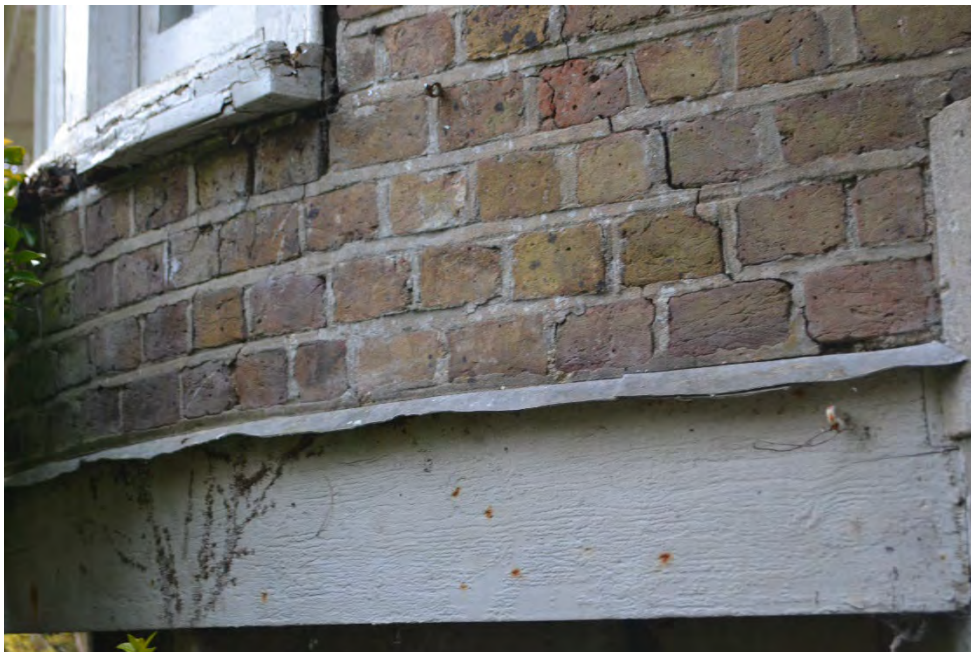
**P40 Rear bay window ground floor – crack above ring beam**

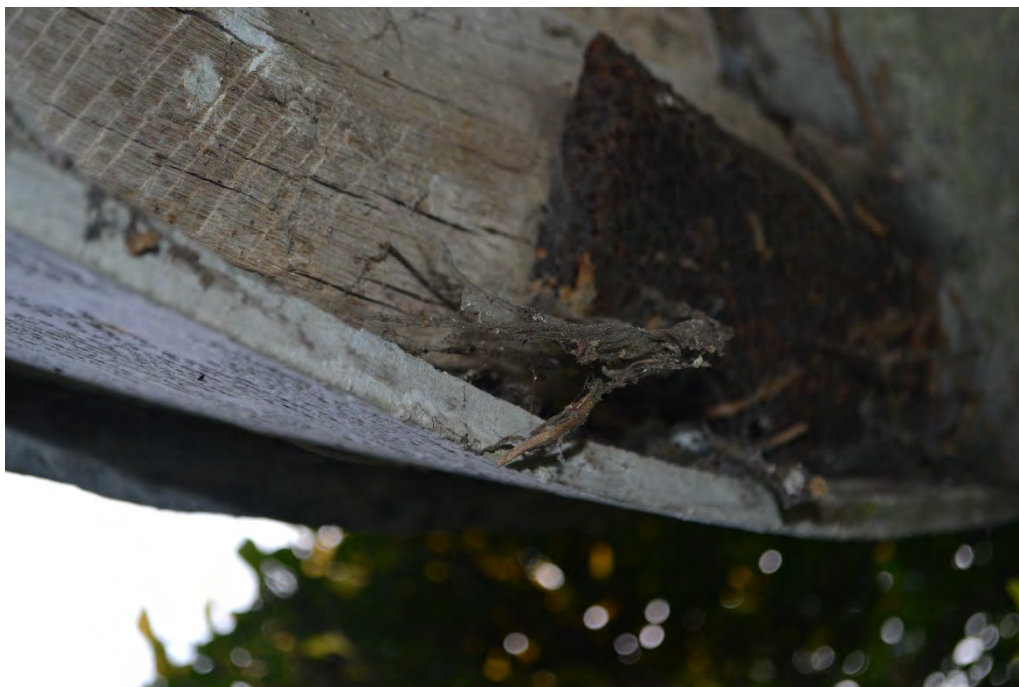
The rear bow window is supported on framing at ground floor level which is supported on two brick piers. This is clearly an addition to the building and it appears there has been some settlement down of the piers and also potential corrosion of the steel strapping within the bow window.

**P41 Corroding steel in bay window support**

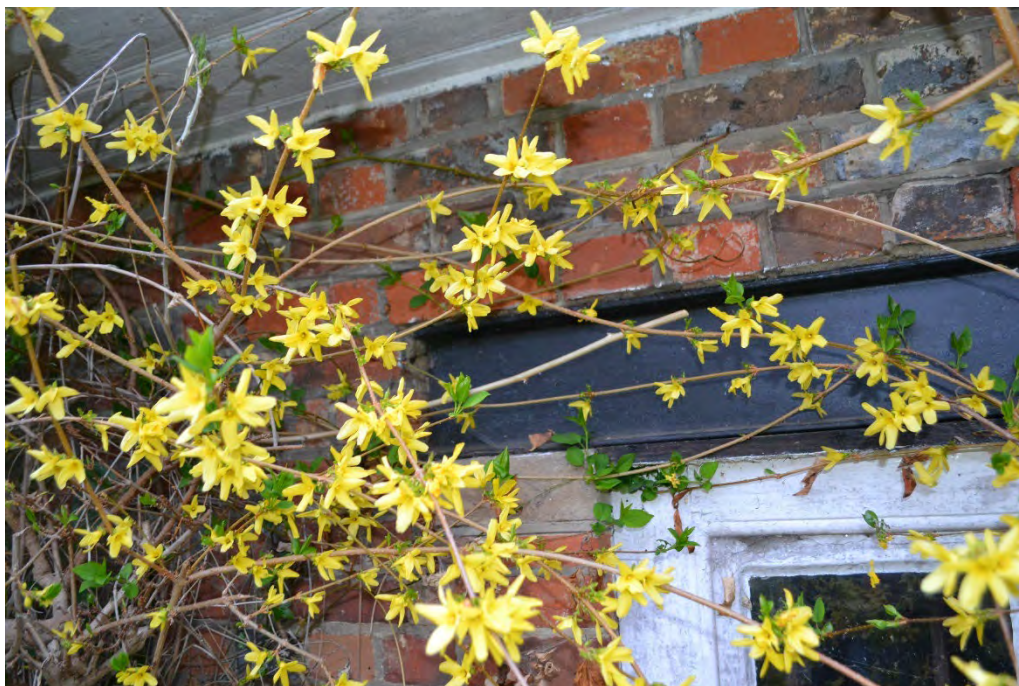
**P46 Replacement steel lintel above rear window below bay**

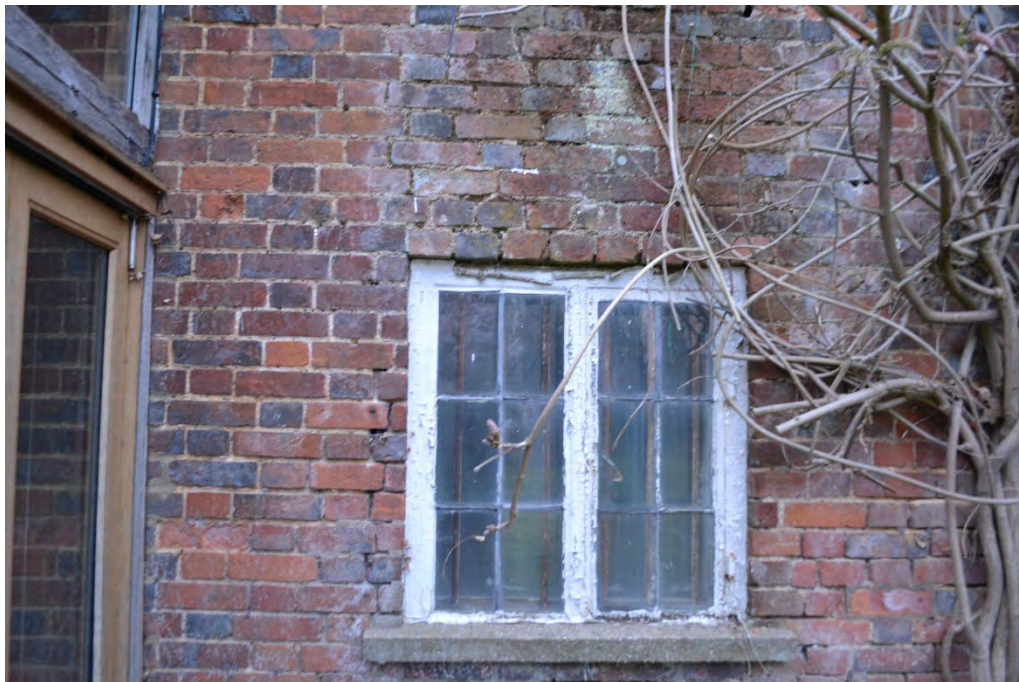
**P48 Eroded and displaced brickwork**

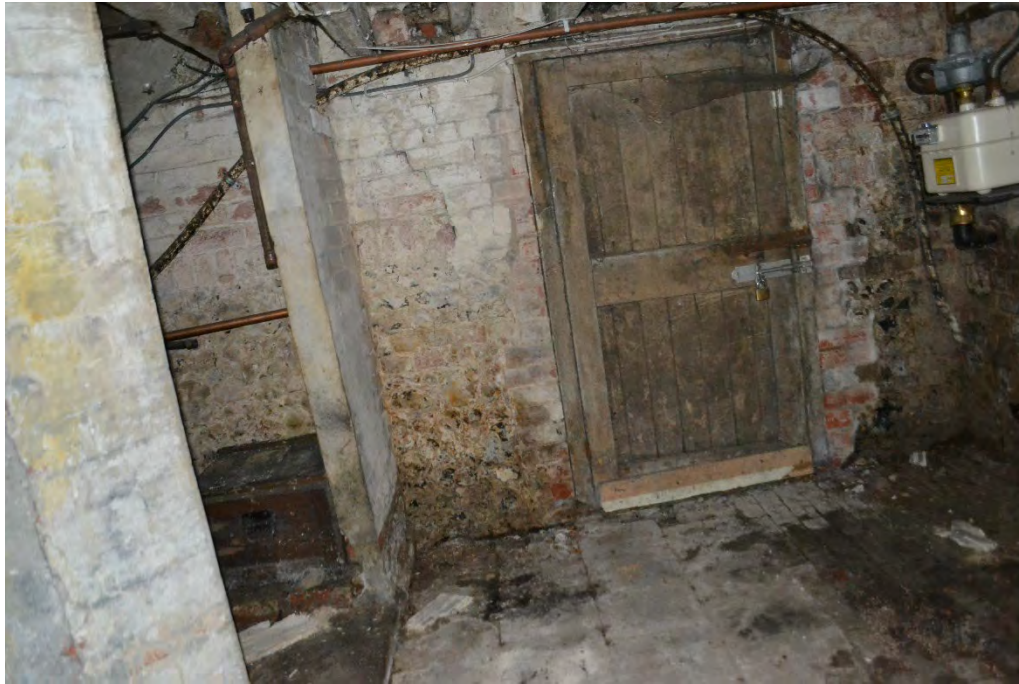
**P49 External door – front right-hand flank wall into basement – note cracking**

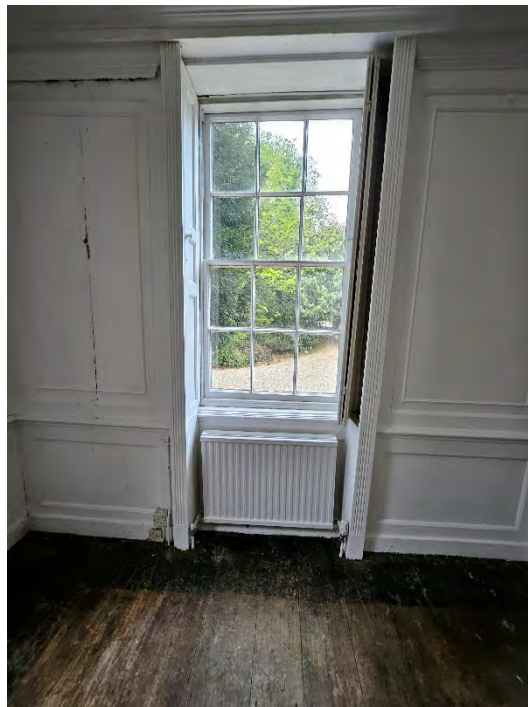
**P62 Front right-hand corner – crack in panelling coincident with crack externally**

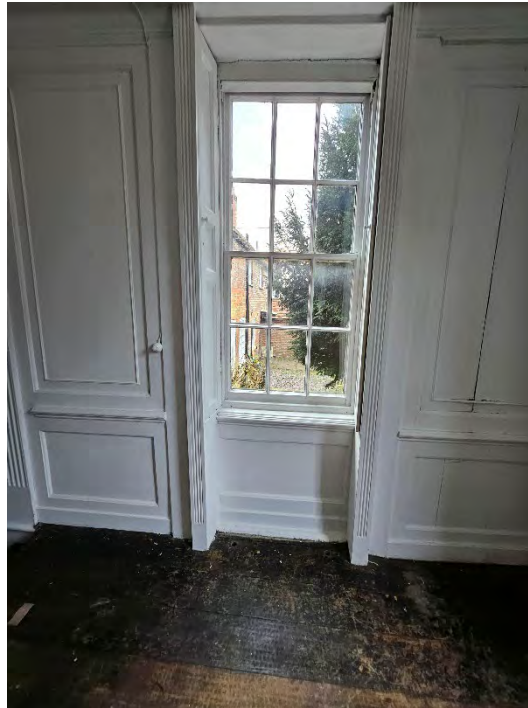
**P63 Flank wall – front right-hand – cracking to panelling and distortion to window**

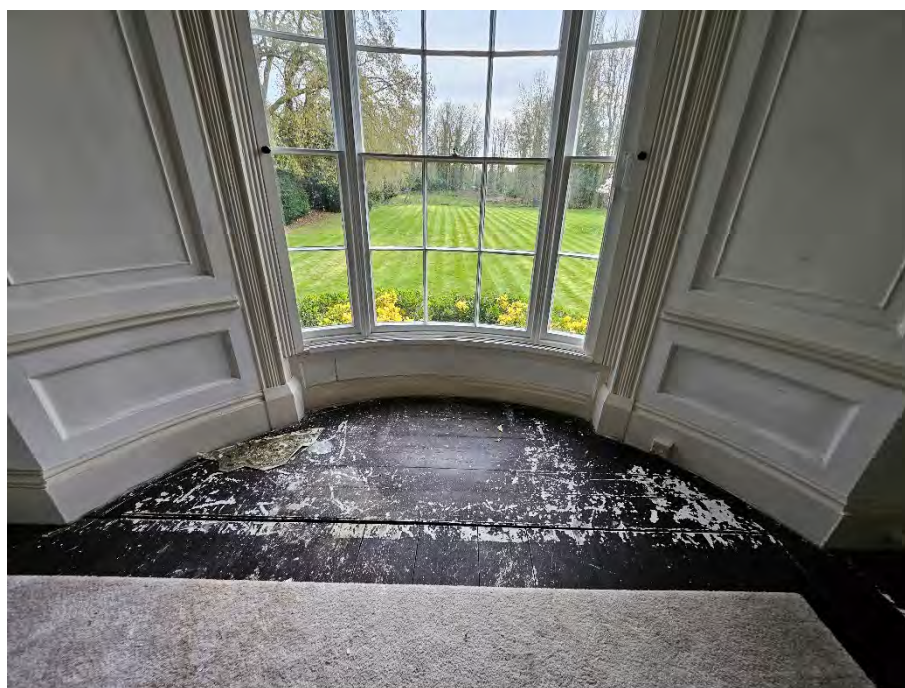
**P68 Rear left-hand bay – note displacement at floor level**

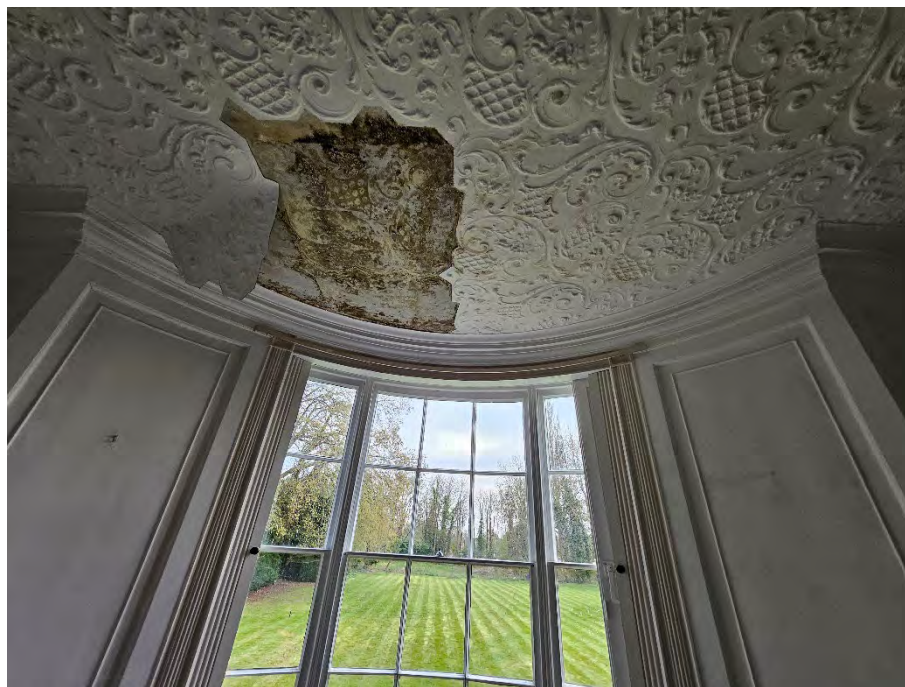
**P69 Rear left-hand bay – loss of ceiling finish**

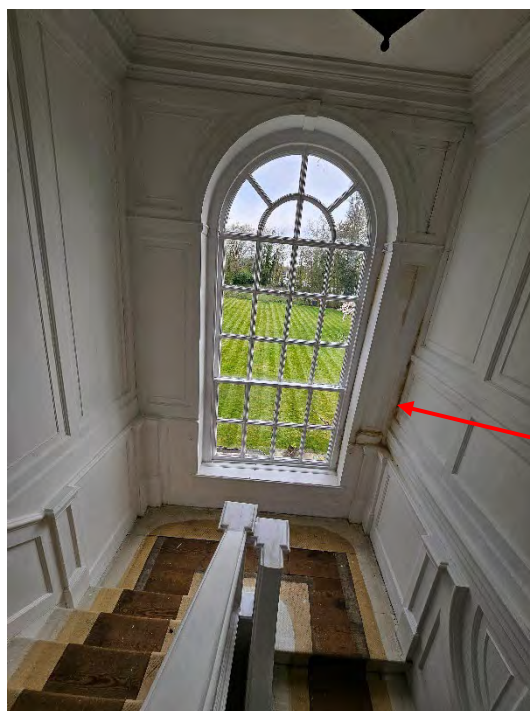
**P71 Main stairway – rear elevation**

In relation to this, further investigation will be necessary to determine the cause of the movement and appropriate rectification. It is likely that the lintel may be of timber and this would have been sensitive to moisture causing wet rot decay. The risk in relation to this is water penetration from above together also with the canopy roof over the doorway.

Damp  
and  
cracking

Opening up will be necessary to determine the cause and appropriate measures to be taken.

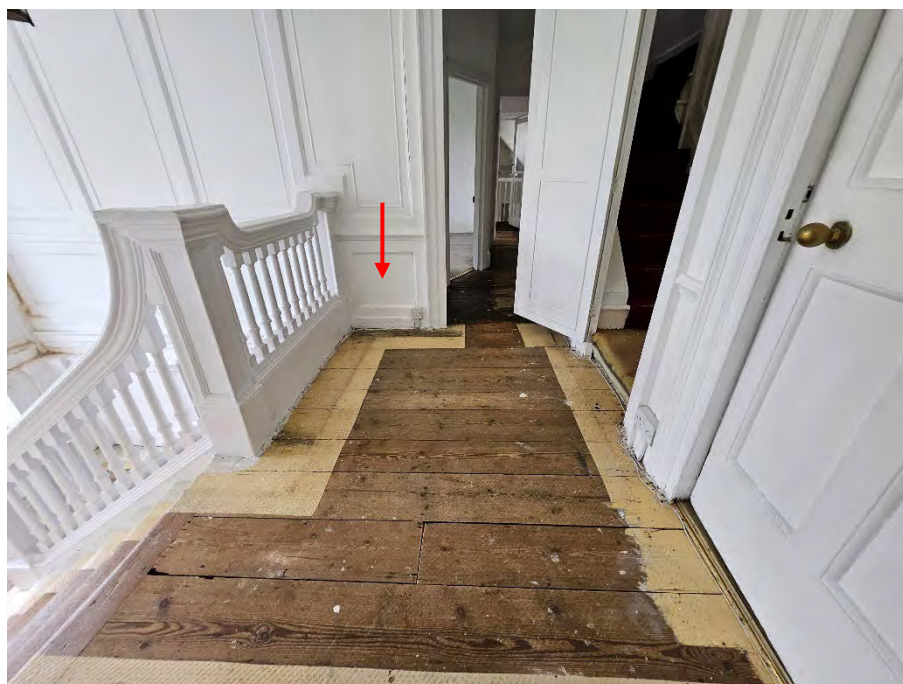
**P72 First floor landing – slope to landing**

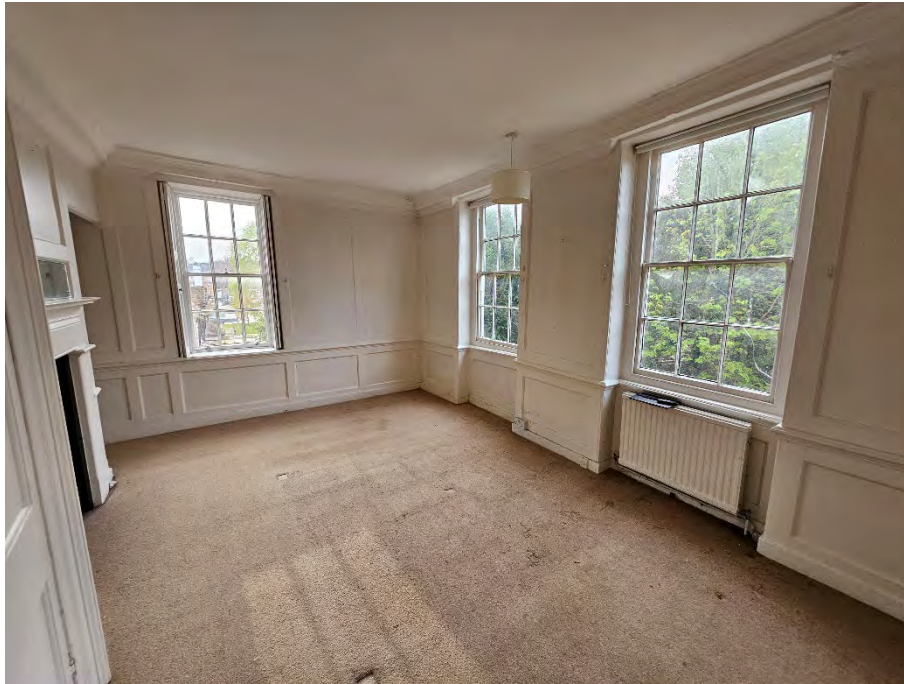
**P73 First floor – right-hand corner – front.  
Note settlement to corner area.**
