# **DETAILED TREE HAZARD ASSESSMENT**

Mill Green  
Wargrave  
Berkshire  
RG10 8EU

**April 2024**

Addendum to Duckworths Arboriculture Report (Tree Condition Survey)

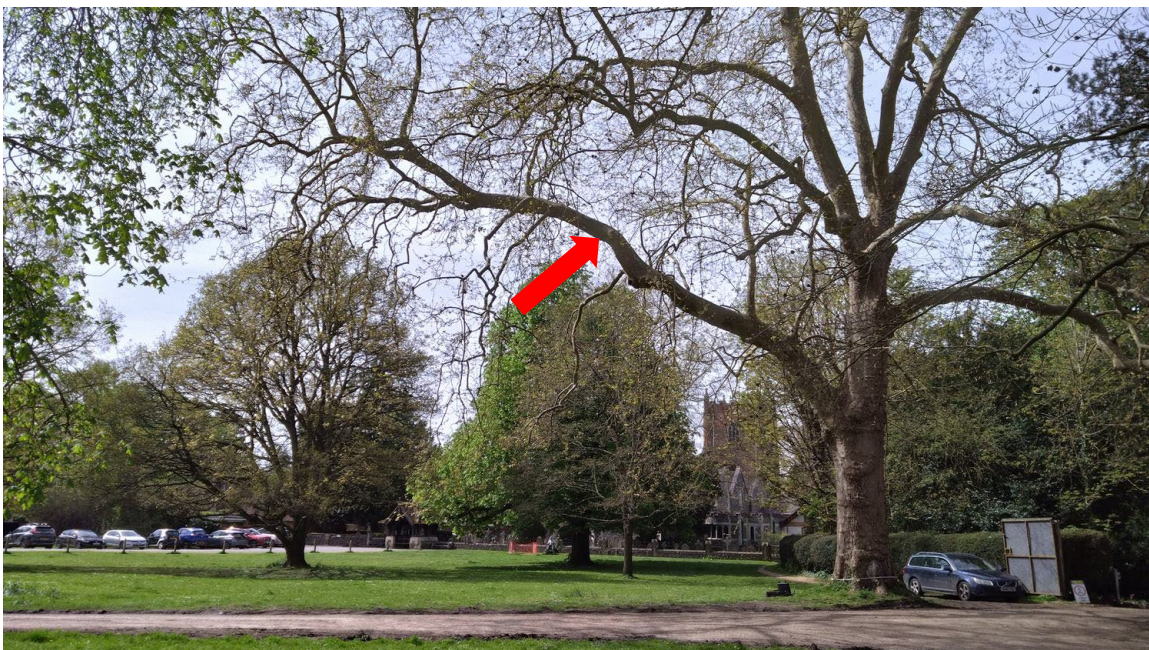
The tree has a very large branch growing southwards over the green, that extends out beyond the main canopy and which presents a moderate hazard.

Figure 1: View of the tree from the east – large southern branch highlighted

The part of the tree that is of more concern is the weight and loading of the southern branch.

| Tree no. | Species | Recommendation | Priority | Reason |
|---|---|---|---|---|
| T009 | London plane | <p>Reduce by way of drop-crotch pruning techniques the large southern branch. Its overall length should be reduced from 17m back to 14.5m (+/- 0.5m), to suitable growth points.</p> <p>Install a 4T cable brace to provide precautionary support for southern branch.</p> <p>Carry out a soil aeration and decompaction exercise around the tree's root zone and install a physical barrier (posts and rope) to prevent vehicular access onto the grass.*</p> | 6 months | Combination of duty of care (safety) and long-term arboricultural management. |

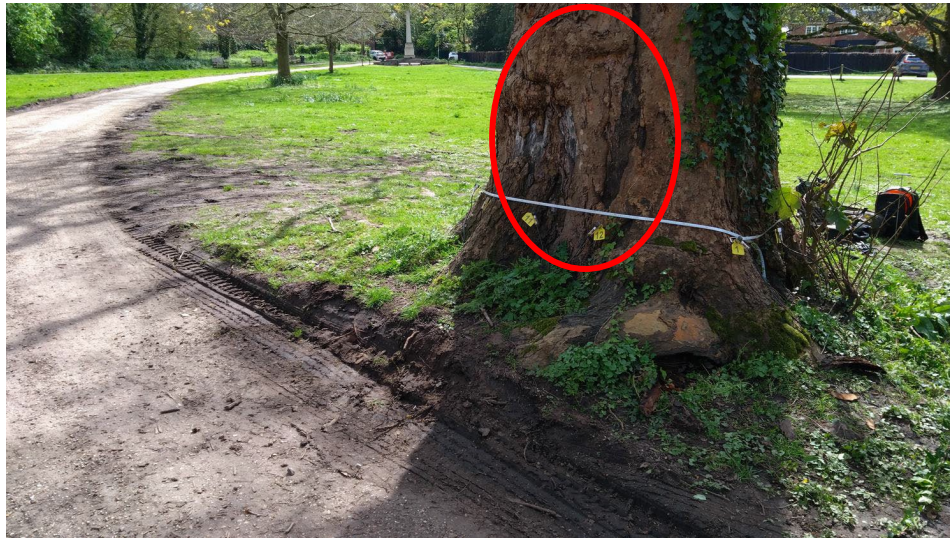
The superficial bark wounding on the eastern side of the trunk base is probably the result of an historic vehicle impact wound. The exposed wood is case hardened and surrounded by callus wood but again no evidence of active decay.

Figure 2: Trunk base, showing old vehicle impact wound

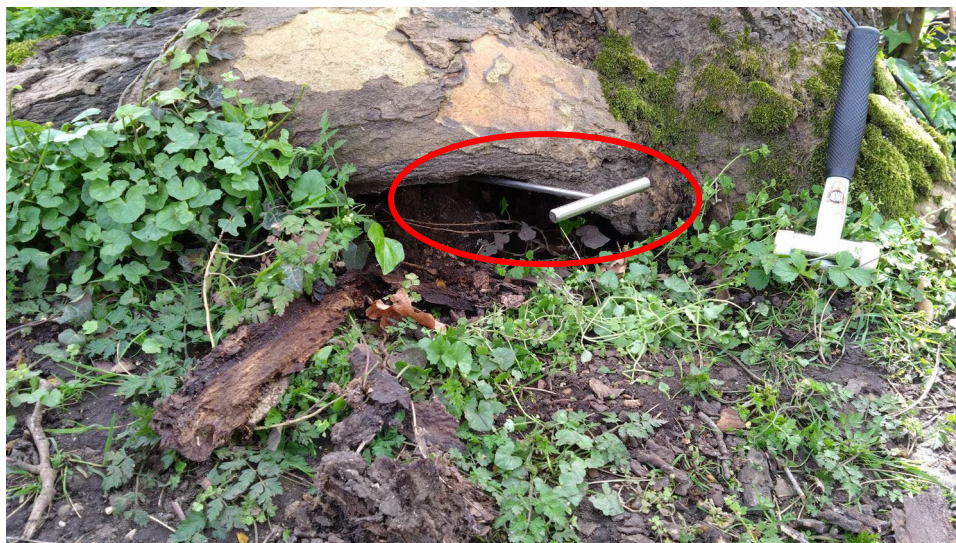
Probing suggests that the extent of the cavities or voids under and between the buttresses appear to be about 20-40cm depth. The probe was prevented from going any further by solid (rather than decayed) wood, suggesting that the voids are well contained.

Figure 3: Void under eastern buttress (50cm probe fully inserted)

The noted voids appear to be well contained and all buttresses appear to be solid with the exception of the one on the eastern side, which has a well contained void on its underside.

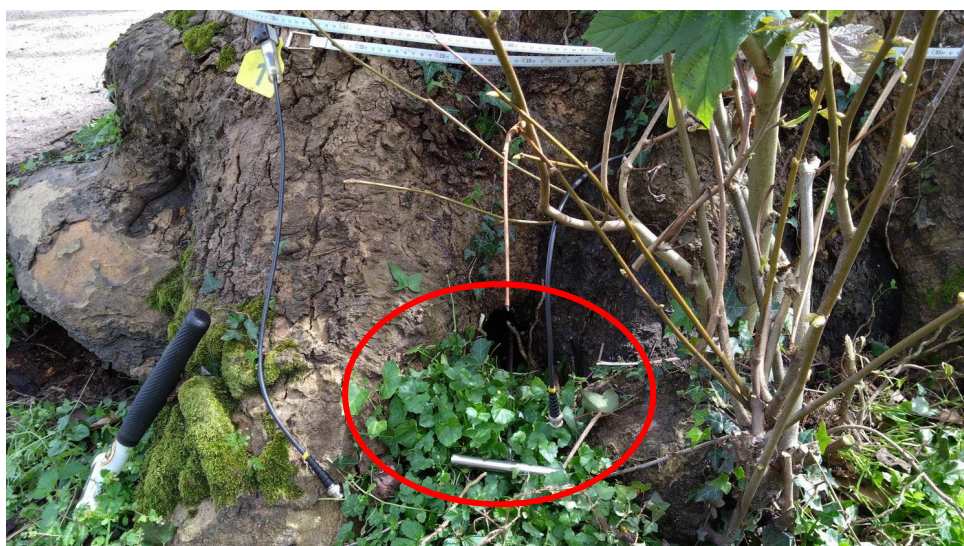
Figure 4: Void between buttresses on north side (50cm probe fully inserted)

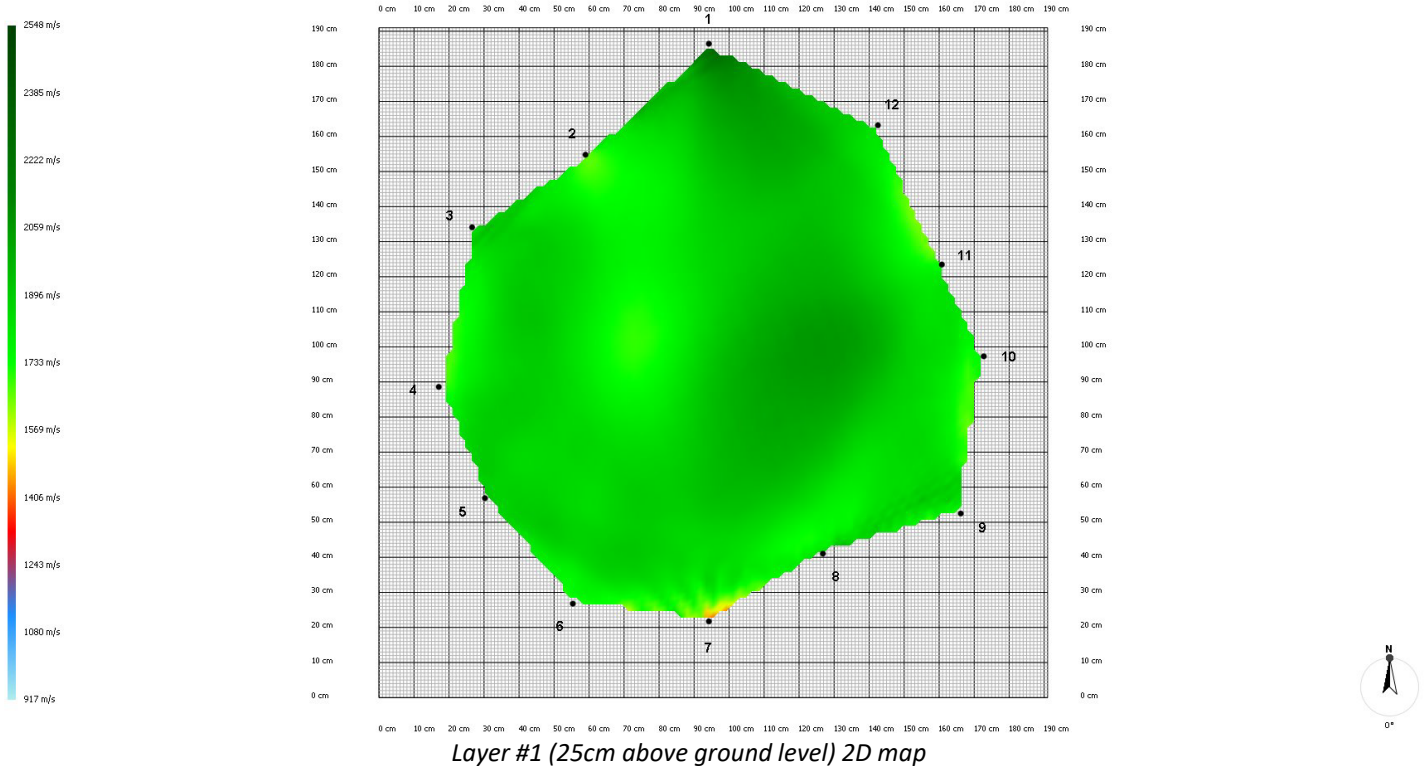
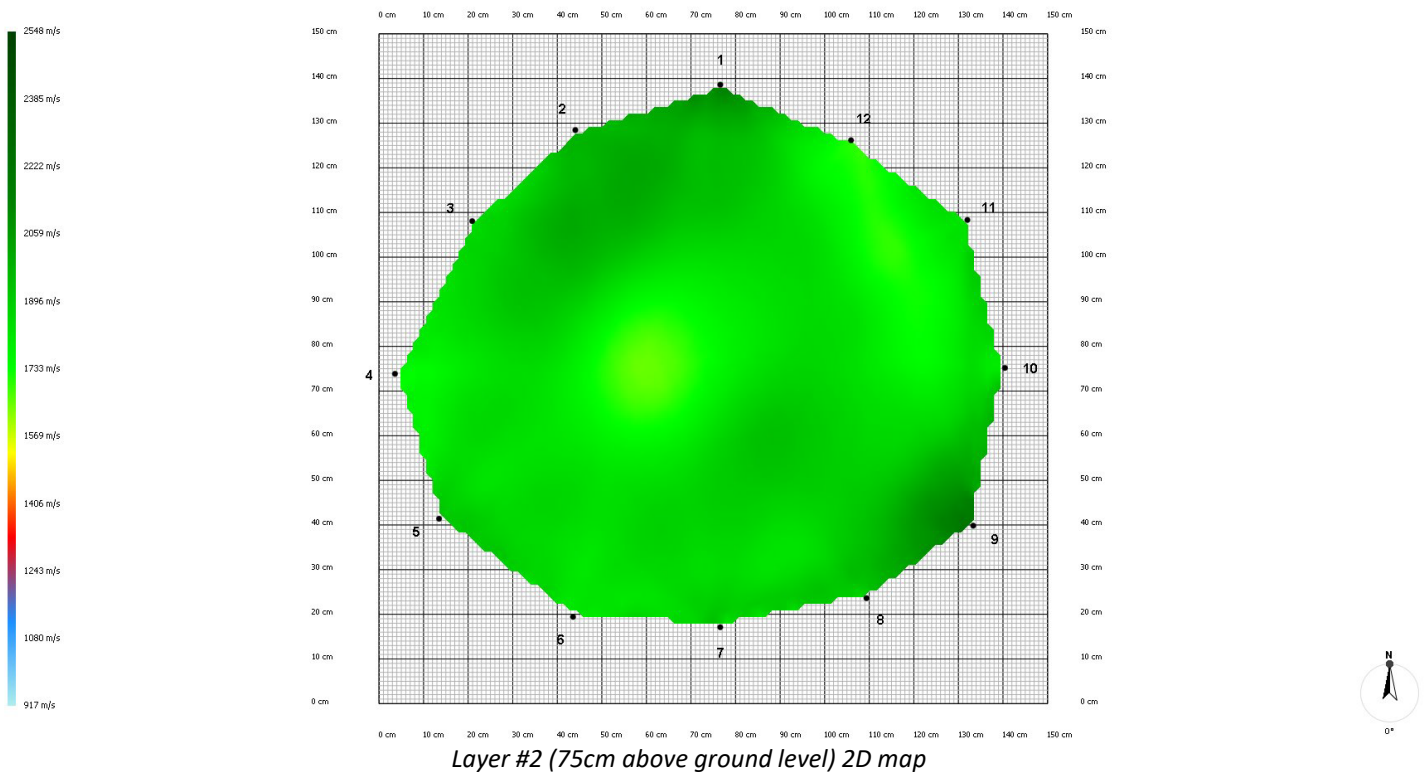
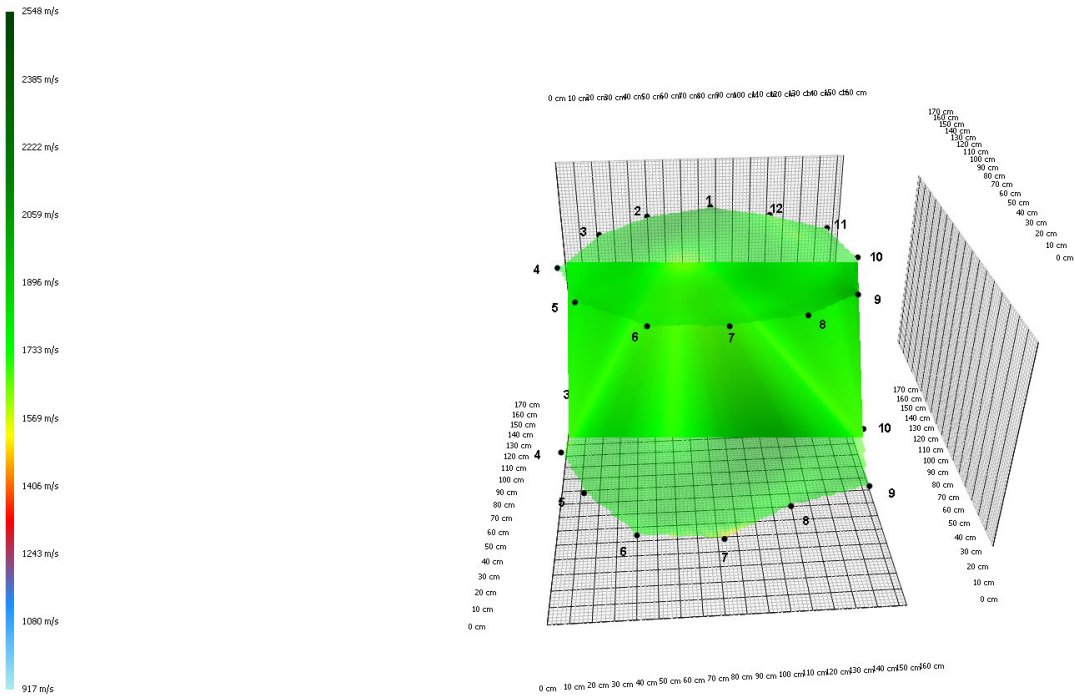
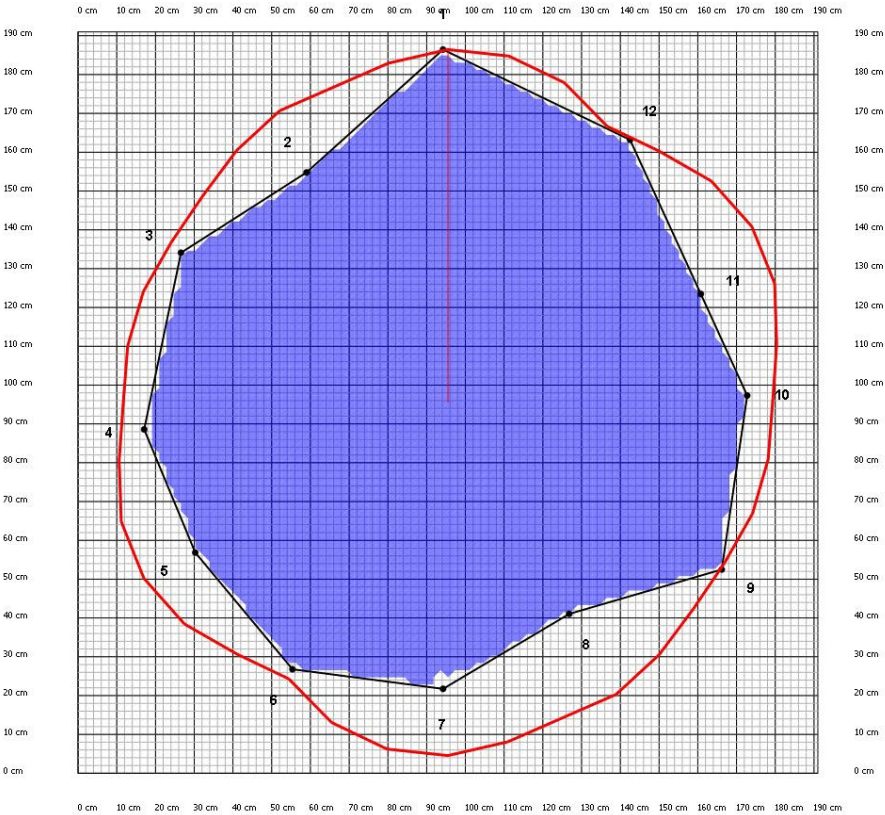
The wood at the two test levels appears to be solid, with no obvious signs or decay or any hollowing.

The likelihood of the tree failing at the trunk base as a result of the noted features is low.
