# ARBORICULTURAL REPORT

TREE CONDITION SURVEY

WELLINGTON MANSIONS  
ARDWELL CLOSE  
CROWTHORNE  
BERKSHIRE  
RG45 6AG

Ref: 07015 / 2026

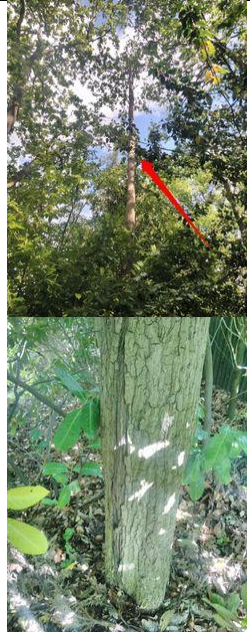
| Ref: | Species | Measurements | Survey Notes | Condition | Other Data | Recommendations | Photo |
|---|---|---|---|---|---|---|---|
| T005 | Pedunculate oak<br>( <i>Quercus robur</i> ) | Height (m): 10-15<br>Crown Radius (m): 0.5N, 2E, 3S, 1.5W<br>DBH (cm): 22<br>Life Stage: Mature<br>Life Exp.: 20+ Years | Slender small tree in low occupancy area.<br><br>Split trunk at base. Historic wounding and decay in slender strip up East side of trunk.<br><br>Slender suppressed small crown largely sheltered by adjacent trees.<br><br>Foliage density normal. | Fair | Public Amenity Value: Low<br><br>Wildlife Value: Low<br>Inspection Limitations: Dense Vegetation | Monitor structural condition of tree due to presence of significant defects.<br><br><b>Timescale:</b><br>Ongoing | |

| Ref: | Species | what3words<br>(Location Identifier) | Recommendations | Work<br>Timescale |
|---|---|---|---|---|
| T005 | Pedunculate<br>oak | ///tunes.pitch.island | Monitor structural condition of tree due to presence of significant defects. | Ongoing |

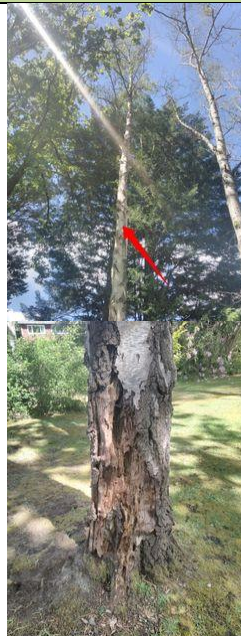
| Ref: | Species | Measurements | Survey Notes | Condition | Other Data | Recommendations | Photo |
|---|---|---|---|---|---|---|---|
| T010 | Silver birch<br>( <i>Betula pendula</i> ) | Height (m): 15-20<br>Crown Radius (m): 3<br>DBH (cm): 32<br>Life Stage: Over Mature<br>Life Exp.: 10+ Years | Historic wounding on North side of trunk.<br>Visible decay in trunk.<br>Bleeding canker around base and lower trunk. Single stem.<br>High crown. Dead branches and dieback in canopy. | Poor | Public Amenity Value:<br>Moderate<br>Wildlife Value:<br>Moderate | Fell to low stump<br><br><b>Timescale:</b><br>14-Nov-2026<br>(6 Months) | |

| Ref: | Species | what3words<br>(Location Identifier) | Recommendations | Work<br>Timescale |
|---|---|---|---|---|
| T010 | Silver birch | ///stole.purple.skills | Fell to low stump | 14-Nov-2026<br>(6 Months) |

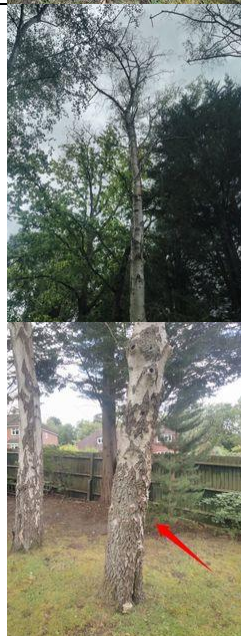
| Ref: | Species | Measurements | Survey Notes | Condition | Other Data | Recommendations | Photo |
|---|---|---|---|---|---|---|---|
| T011 | Silver birch<br>( <i>Betula pendula</i> ) | Height (m): 15-20<br>Crown Radius (m): 3<br>DBH (cm): 34<br>Life Stage: Over Mature<br>Life Exp.: 10+ Years | Saprophytic fungi on lower trunk.<br>High crown. Dead branches and dieback in canopy.<br>Canopy 95% defoliated. Beyond point of reasonable recovery. | Poor | Public Amenity Value:<br>Moderate<br>Wildlife Value:<br>Moderate | Fell to low stump<br><br><b>Timescale:</b><br>14-Nov-2026<br>(6 Months) | |

| Ref: | Species | what3words<br>(Location Identifier) | Recommendations | Work<br>Timescale |
|---|---|---|---|---|
| T011 | Silver birch | ///jolly.trips.voted | Fell to low stump | 14-Nov-2026<br>(6 Months) |

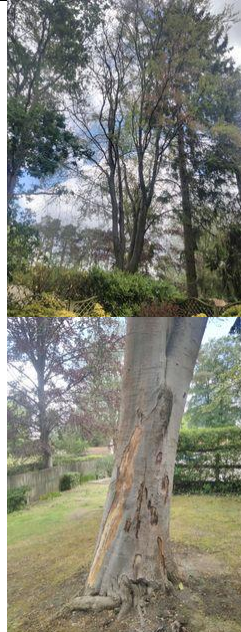
| Ref: | Species | Measurements | Survey Notes | Condition | Other Data | Recommendations | Photo |
|---|---|---|---|---|---|---|---|
| T013 | Common beech<br>( <i>Fagus sylvatica</i> ) | Height (m): 15-20m<br>Crown Radius (m): 8N, 6E, 6S, 7W<br>DBH (cm): 60<br>Life Stage: Mature<br>Life Exp.: 10+ Years | Mechanical damage to exposed surface roots.<br>Girdling root.<br><br>Single stem. Adaptive growth at base. Swept lower trunk West. No sign of root plate movement or instability.<br><br>Historic bark damage at base with large areas of necrotic and stripped, missing bark. Bark has been physically removed likely by deer.<br><br>Large, exposed area of wood on South side of tree has multiple emerging fungal fruiting bodies. Appears to be a type of wood ear fungus.<br><br>Strip of canker on East side of trunk 30mm wide up into crown. Prolific fungal growth from 3.5m to 7m. Twin stem from 2m.<br><br>Included bark in fork. Deadwood/dieback in crown. Large dead branches over low occupancy area. | Poor | Public Amenity Value:<br>Good<br>Wildlife Value: Good | Option 1 - fell to 3m high stump and retain for habitat value.<br><br>Option 2 - immediately protect lower trunk from future deer damage and monitor to see if tree can recover. Review tree condition in 12 months<br><br><b>Timescale:</b><br>14-Aug-2026<br>(3 Months) | |

| Ref: | Species | what3words<br>(Location Identifier) | Recommendations | Work<br>Timescale |
|---|---|---|---|---|
| T013 | Common<br>beech | ///answer.jumps.body | Option 1 -fell to 3m high stump and retain for habitat value.<br>Option 2 - immediately protect lower trunk from future deer damage and monitor to see if tree can recover.<br>Review tree condition in 12 months | 14-Aug-2026<br>(3 Months) |

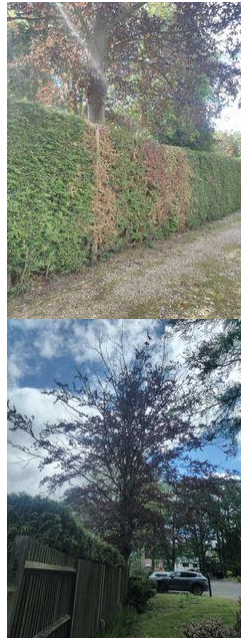
| Ref: | Species | Measurements | Survey Notes | Condition | Other Data | Recommendations | Photo |
|---|---|---|---|---|---|---|---|
| T014 | Copper beech<br>( <i>Fagus sylvatica purpurea</i> ) | Height (m): 10-15<br>Crown Radius (m): 6N, 6.5E, 5S, 5W<br>DBH (cm): 55<br>Life Stage: Mature<br>Life Exp.: 20+ Years | <p>Small tree immediately beyond boundary fence but within chain link historic boundary fence.</p> <p>Manhole cover within rooting area. Restricted access to base due to dense hedge and boundary fence. Where accessible no obvious defects.</p> <p>Western Red cedar hedge dying off immediately adjacent to tree.</p> <p>Twin stem from 2m with crossing fully fused branches immediately above fork and again 3.5m above ground level.</p> <p>Broad crown formed of long slender horizontal branches.</p> <p>Apical dieback throughout crown. Dieback at tips. Epicormic shoots along the upper side of many branches.</p> <p>The cause of this evident decline and physiological stress is unclear. It may be due to something within the rooting area as a similar state of decline is also evident in health of the adjacent conifer hedge.</p> | Poor | <p>Public Amenity Value: Good</p> <p>Wildlife Value: Moderate</p> <p>Inspection Limitations: Dense vegetation &amp; boundary fence</p> | <p>Remove deadwood and reduce dieback in upper crown back to healthy growth.</p> <p>Consider soil amelioration to assist with tree recovery.</p> <p><b>Timescale:</b><br/>14-Nov-2026<br/>(6 Months)</p> | |

| Ref: | Species | what3words<br>(Location Identifier) | Recommendations | Work<br>Timescale |
|---|---|---|---|---|
| T014 | Copper beech | ///shiny.guides.remote | Soil amelioration to assist with tree recovery.<br>Remove deadwood and reduce dieback in upper crown back to healthy growth. | 14-Nov-2026<br>(6 Months) |
