**WAITROSE  
RECTORY ROAD  
WOKINGHAM**

**CONDITION SUMMARY AND WORKS  
REQUIRED TO WALL H1**

**JOHN LEWIS PARTNERSHIP**

**HURST PEIRCE + MALCOLM LLP**

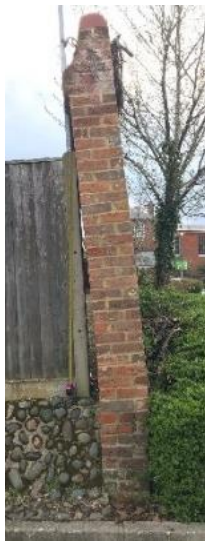
- 3.1 Wall H1 is 3.5m tall, 325mm thick and out of plumb by 260mm at the store end. This is equivalent to 1:10. It is pushing over an adjacent concrete fence post which may be providing support. The centre of gravity of the wall over the end 14m is well outside the middle third so the wall is unstable and at risk of collapse.
- 3.2 The wall would collapse on to the neighbouring car park and would cause serious injury if it landed on anyone. Additionally, if the fence post gave way, the end of the wall would collapse and is likely to pull the remainder of the wall down with it. Waitrose have cordoned off the affected car parking spaces on both sides of the wall.

**Wall H1 at the Waitrose Store End**

- 3.3 The wall is out of plumb for all of its 25m length but the 14m closest to the Waitrose Store is leaning the most and the lean at the store end has increased by approximately 10mm over the past year.

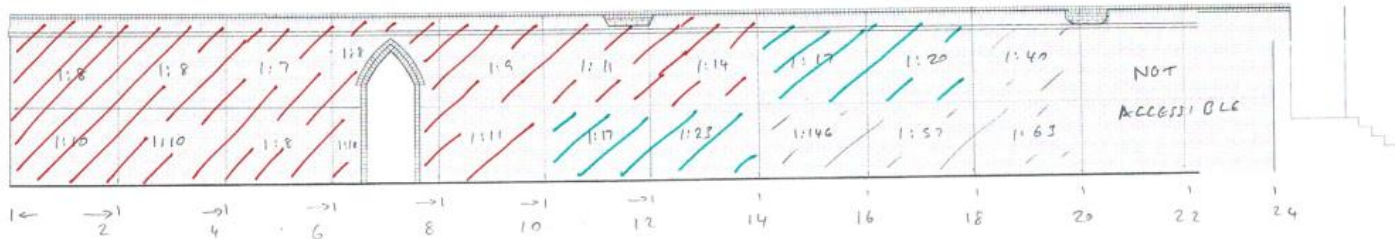
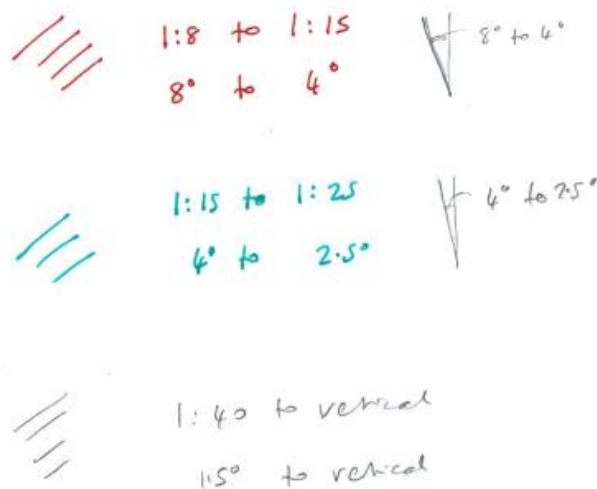
- 3.4 An inclinometer survey was carried out by HPM on 04.04.24 and the results shown below confirm that the lean of the end 14m is between  $4^{\circ}$  and  $8^{\circ}$  (or 1:8 to 1:15). The maximum lean for the wall to comply with building regulations and be considered stable is  $1^{\circ}$  or 1:57.

- 3.4 The lean is within the walls and not likely to be caused by foundation settlement or rotation. The BGS website shows the ground conditions to be alluvial deposits overlying sand (Bagshot formation).
- 3.5 There is an archway at approximately 7m from the store end where the lean of the wall is severe. This arch is bricked up with a rough,  $\frac{1}{2}$  brick thick, panel that is not original and is not bonded to the arch.
- 3.6 Work required to wall H1 is shown on HPM drawing "25317-01 P4 Proposed Elevations & Details Wall H1".
- 3.7 The extent of the works shown on Drawing 25317-01 rev P4 are taken from the Morton partnership letter report to Waitrose dated 23.05.24. These works were agreed on site between Waitrose and the planners. HPM are not taking design responsibility for this work as agreed by Waitrose June 2024.
