# ARBORICULTURAL REPORT

## TREE CONDITION SURVEY

16 ERICA DRIVE  
WOKINGHAM  
BERKSHIRE  
RG40 2DU

Ref: 06721 / 2025

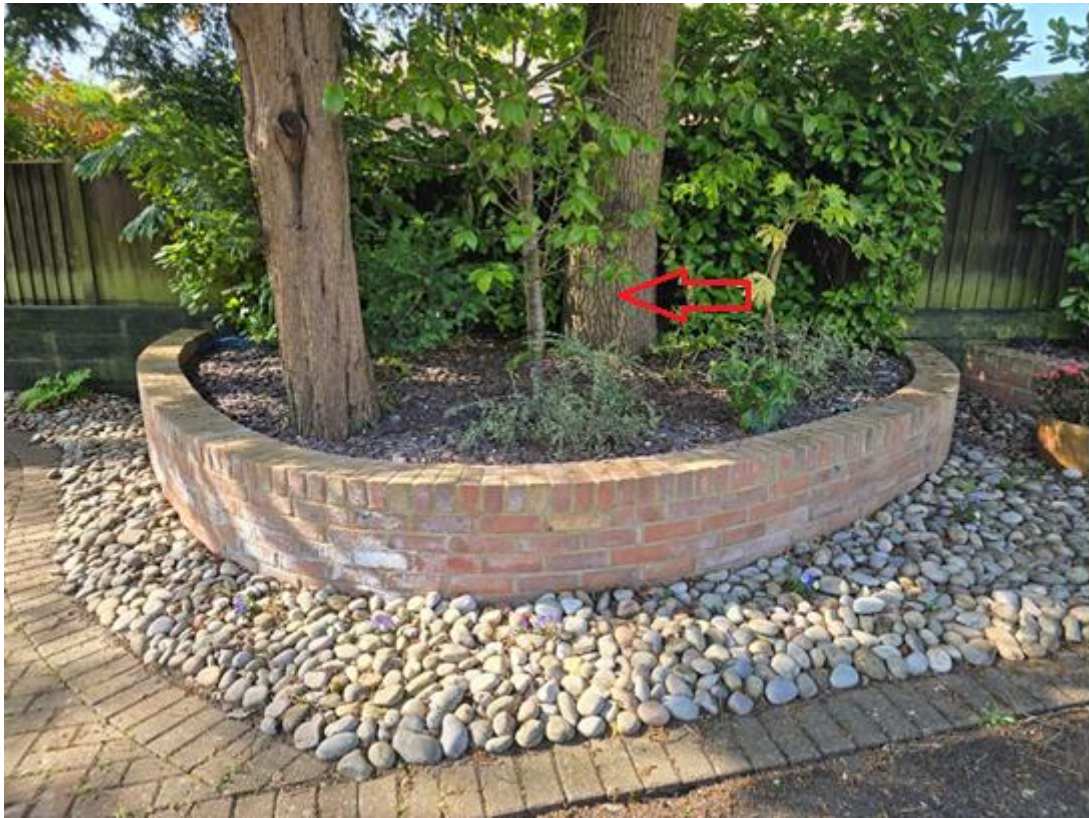
An early mature tree growing on the far side of an unadopted private road. The tree is 12m from the front of the dwelling. There is a significant amount of development and hard landscaping within the tree's immediate rooting area. T3 (Oak) is growing within a semi-circular raised planter around 1.5m diameter supported by a low-level brick retaining wall which has recently been constructed to replace rotting timber sleepers. Beyond the retaining wall there are cobbles and block paved parking areas.

Possible ground level changes at base. The root-flare of the Oak is not visible and may have been obscured by a buildup of soil levels within the raised planter.

Photo 1 – Raised brick retaining wall at base

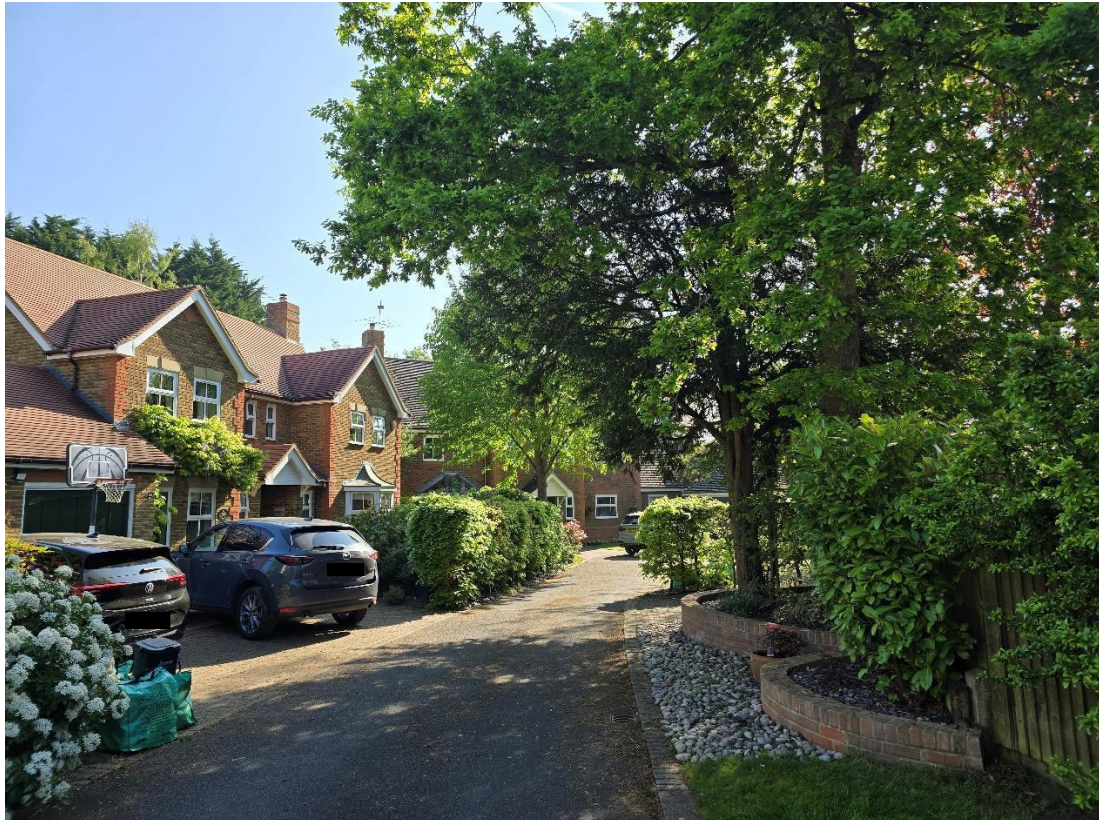
Light epicormic growth on many branches throughout the tree's canopy, some of which is dead or dying back. Minor dead twigs and occasional dead/declining branches in crown. Foliage dense, slightly clustered. Low branches to 2m over the private road. Slight asymmetry in lower crown due to Yew.

Photo 2 – Low canopy over highway

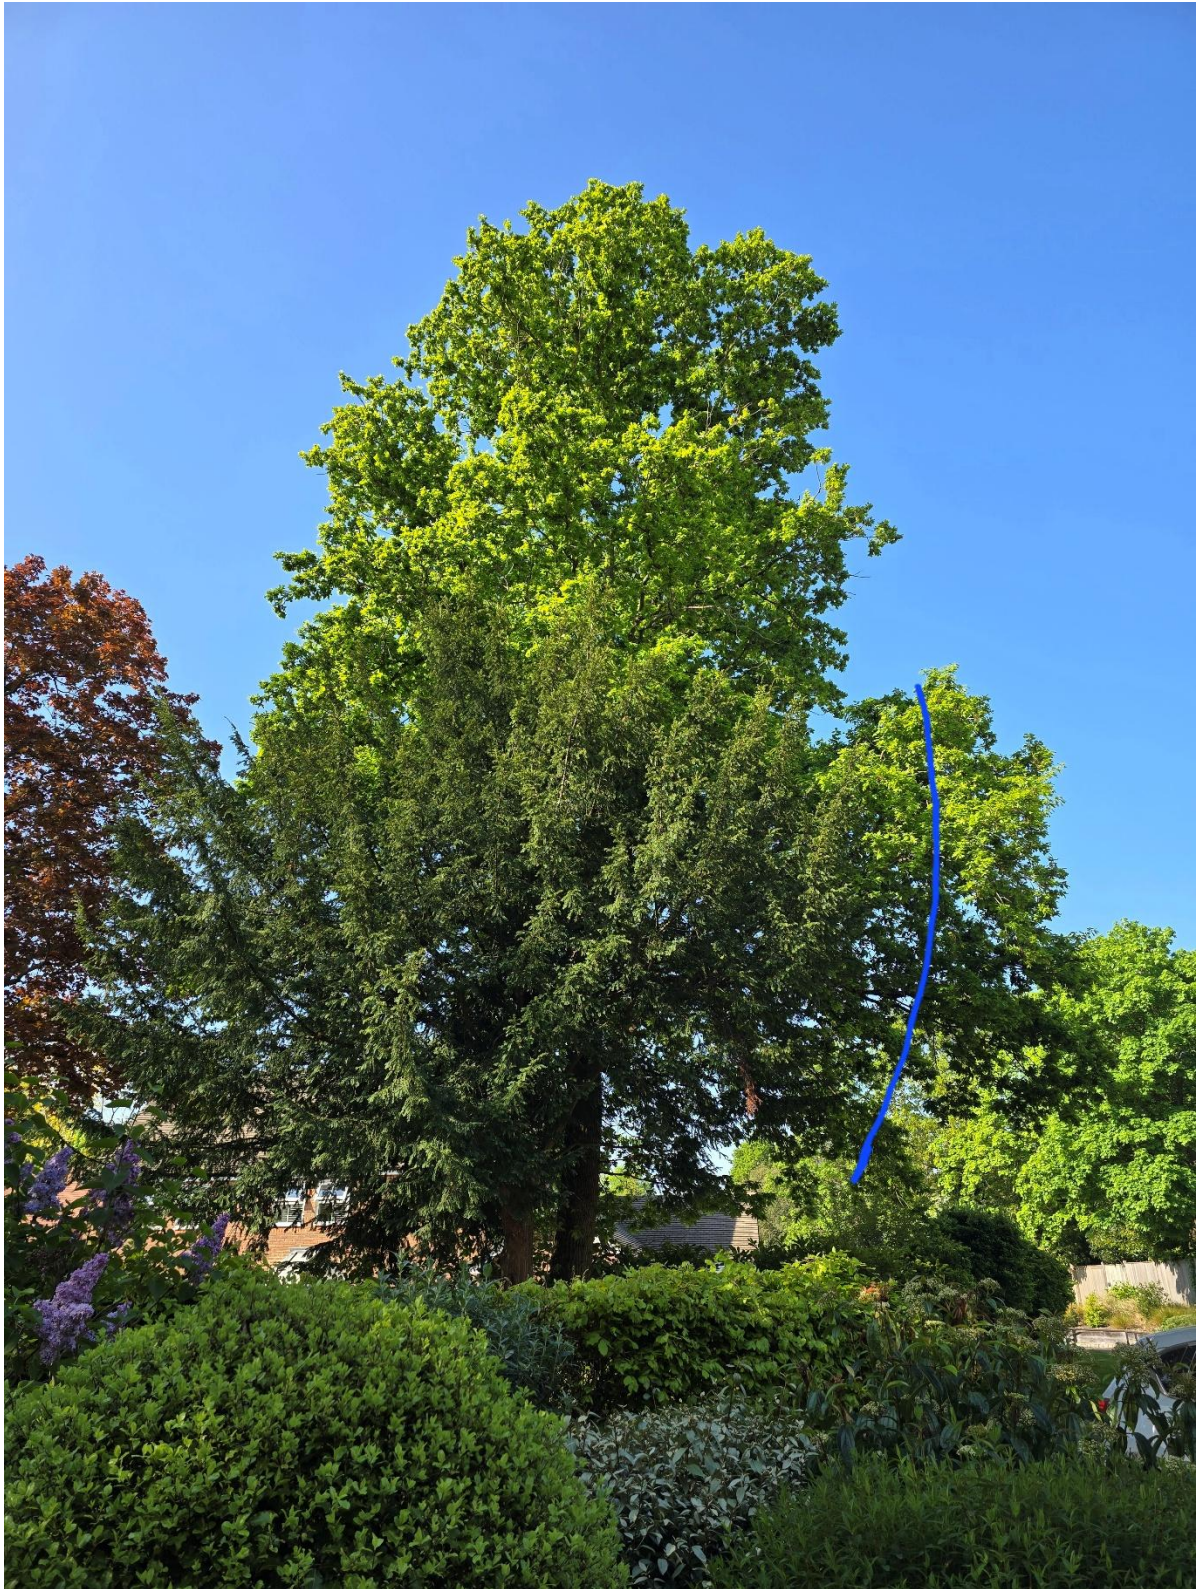
Well-formed crown, slightly asymmetrical on the lowest 8m around the northwest quadrant. Tips of branches in this area are elongated extending low over the road and beyond the outline of the main crown by 2-3m (see photo 3).

Photo 3 – Indicative line of proposed lateral reduction of low branch on northwest side of tree canopy

| <b>Recommended Tree Works:</b> <ul style="list-style-type: none"> <li>Gently excavate around base with hand tools / brush to reveal natural root flare taking care not to damage tree bark.</li> <li>Crown lift to create 4m crown clearance above ground level to create adequate canopy clearance over road and gardens.</li> <li>Reduce tips of one/two main branches on the lower northeast quadrant of the crown by 2-3m to reduce lateral spread back in line with the surrounding canopy (see photo 3).</li> </ul> | Priority | Within 6 months |
