DUCKWORTHS  
ARBORICULTURE LTD.

## TREE CONDITION SURVEY

8-12 DENMARK ST  
WOKINGHAM  
BERKSHIRE  
RG40 2BB

JULY 2026  
Ref: 07044 / 2026

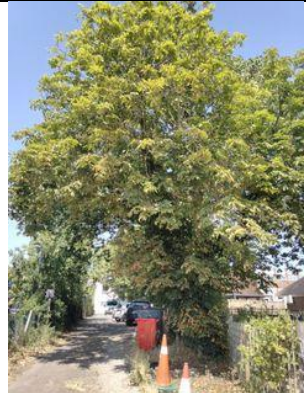
| Ref: | Species | Measurements | Survey Notes | Condition | Other Data | Recommendations | Photo |
|---|---|---|---|---|---|---|---|
| T001 | Horse chestnut<br>( <i>Aesculus hippocastanum</i> ) | Height (m): 10-15m<br>Crown Radius (m): 4N, 5.5E, 5S, 1.5W<br>DBH (cm): 68<br>Life Stage: Mature<br>Life Exp.: 40+ Years | Ivy clad tree. Base and lower trunk obscured by ivy and dense epicormic growth. Where visible, deeply fluted lower trunk. Swept stem south. Twin stem from 2.5m. Low, suppressed, asymmetrical canopy. Foliage slightly sparse. Canopy lacks vigour.<br><br>Pests and Diseases:<br>Horse Chestnut Leaf Blotch ( <i>Guignardia aesculi</i> )<br>Horse Chestnut Leaf Miner ( <i>Cameraria ohridella</i> ) | Fair | Public Amenity Value:<br>Good<br>Wildlife Value:<br>Moderate<br>Inspection Limitations:<br>Prolific Ivy | Sever ivy.<br><br>Remove epicormic growth and crown lift to create 4m canopy clearance above ground level<br><br><b>Timescale:</b><br>29-Jan-2027<br>(6 Months) | |

| Ref: | Species | what3words<br>(Location Identifier) | Recommendations | Work<br>Timescale |
|---|---|---|---|---|
| T001 | Horse chestnut | ///cans.those.engage | Remove epicormic growth and crown lift to create 4m canopy clearance above ground level<br>Sever ivy. | 29-Jan-2027<br>(6 Months) |

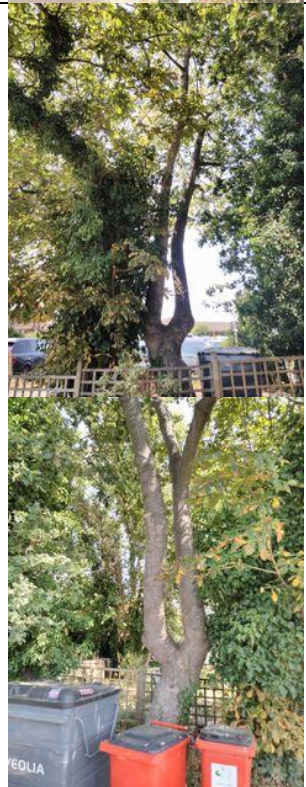
| Ref: | Species | Measurements | Survey Notes | Condition | Other Data | Recommendations | Photo |
|---|---|---|---|---|---|---|---|
| T002 | Sycamore<br>( <i>Acer pseudoplatanus</i> ) | Height (m): 10-15m<br>Crown Radius (m): 4N, 5E, 6S, 6W<br>DBH (cm): 58<br>Life Stage: Mature<br>Life Exp.: 20+ Years | Lower trunk partially obscured by ivy. Where accessible, base clear, bark intact. No fungal fruiting bodies evident or audible decay. Single stem swept south. Twin stem from 1.7m fork structure satisfactory. Historic cuts on main trunk where lower branches removed. Limited wound wood formation. High crown<br>Foliage sparse and clustered at tips. Tree canopy lacks vitality. Minor Deadwood over adjacent community garden under 2m long and 40mm diameter. | | Public Amenity Value:<br>Wildlife Value:<br>Inspection Limitations: | No works identified | |

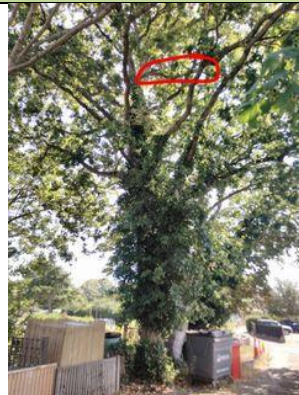
| Ref: | Species | Measurements | Survey Notes | Condition | Other Data | Recommendations | Photo |
|---|---|---|---|---|---|---|---|
| T003 | Pedunculate oak<br>( <i>Quercus robur</i> ) | Height (m): 15-20m<br>Crown Radius (m): 7N, 5E, 3S, 6.5W<br>DBH (cm): 65<br>Life Stage: Mature<br>Life Exp.: 40+ Years | Base and lower trunk obscured by dense ivy growth. Where accessible bark intact. No visible defects. Twin stem from 2m. Swept stem northwest. Epicormic growth on trunk from 2m above ground level. Asymmetrical canopy due to suppression from T001 and T002. Prolific ivy on trunks and branches throughout crown. Powdery mildew on lower leaves. Foliage dense and even. Good vitality. Partially split branch on West side of canopy, 7m above ground level 50mm diameter and 3m long. | Fair | Public Amenity Value:<br>Wildlife Value:<br>Inspection Limitations: | Sever ivy and remove epicormic growth to create 4m canopy clearance above ground level<br><br>Remove split /broken branch<br><br><b>Timescale:</b><br>29-Jan-2027<br>(6 Months) | |

| Ref: | Species | what3words<br>(Location Identifier) | Recommendations | Work<br>Timescale |
|---|---|---|---|---|
| T003 | Pedunculate oak | ///stable.hang.clap | Sever ivy and remove epicormic growth to create 4m canopy clearance above ground level<br>Remove split /broken branch | 29-Jan-2027<br>(6 Months) |

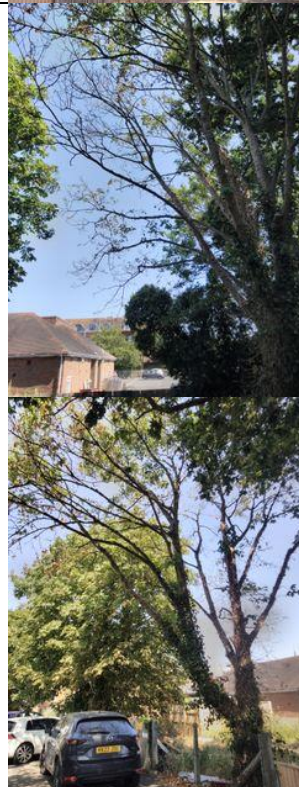
| Ref: | Species | Measurements | Survey Notes | Condition | Other Data | Recommendations | Photo |
|---|---|---|---|---|---|---|---|
| T004 | Sycamore<br>( <i>Acer pseudoplatanus</i> ) | Height (m): 10-15m<br>Crown Radius (m): 5N, 5E, 1S, 6W<br>DBH (cm): 60<br>Life Stage: Over Mature<br>Life Exp.: 20+ Years | Off-site tree. Ivy clad. No access to base. Twin stem from 1.6m. broad open crown 70% defoliated. Live growth sparse and chlorotic or brown and hanging in tree. Dead branches in crown within falling distance of highway. Tree in an advanced state of decline and not expected to recover. | Poor | Public Amenity Value:<br>Moderate<br>Wildlife Value:<br>Moderate<br>Inspection Limitations:<br>Access | Offsite tree - Fell to ground level (subject to owner consent). If consent is not forthcoming from the owner, tree should be cut back to boundary (subject to Council consent)<br><br><b>Timescale:</b><br>29-Oct-2026<br>(3 Months) | |

| Ref: | Species | what3words<br>(Location Identifier) | Recommendations | Work<br>Timescale |
|---|---|---|---|---|
| T004 | Sycamore | ///expect.moral.mime | Offsite tree - Fell to ground level (subject to owner consent). | 29-Oct-2026<br>(3 Months) |

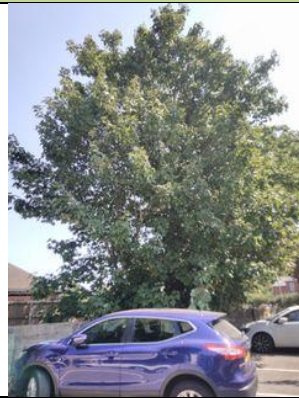
| Ref: | Species | Measurements | Survey Notes | Condition | Other Data | Recommendations | Photo |
|---|---|---|---|---|---|---|---|
| G005 | Sycamore x2<br>( <i>Acer pseudoplatanus</i> )<br>Horse chestnut x2<br>( <i>Aesculus hippocastanum</i> ) | Height (m): 10-15m<br>Crown Radius (m): 4<br>DBH (cm): 30<br>Trees: 4<br>Life Stage: Early Mature<br>Life Exp.: 20+ Years | Linear group of off-site trees growing directly adjacent to breeze block boundary wall. Hairline crack visible in wall. Ivy clad stems. Base and trunks obscured by ivy and vegetation. Combined crowns create a single canopy profile. Foliage dense and even. Low branches to 1m restrict access over parking areas.<br><br>Pests and Diseases:<br>Horse Chestnut Leaf Blotch ( <i>Guignardia aesculi</i> )<br>Horse Chestnut Leaf Miner ( <i>Cameraria ohridella</i> ) | Fair | Public Amenity Value: Good<br>Wildlife Value: Good<br>Inspection Limitations: Access | Remove epicormic growth and crown lift to create 4-5m canopy clearance over parking bays. Reduce overhang in upper crown on West side over car park by 1-1.5m to alleviate nuisance of debris falling on parked vehicles.<br><br><b>Timescale:</b><br>29-Jan-2027<br>(6 Months) | |

| Ref: | Species | what3words<br>(Location Identifier) | Recommendations | Work<br>Timescale |
|---|---|---|---|---|
| G005 | Sycamore x2<br>Horse chestnut x2 | ///decide.wage.editor | Remove epicormic growth and crown lift to create 4-5m canopy clearance over parking bays.<br>Reduce overhang in upper crown on West side over car park by 1-1.5m to alleviate nuisance of debris falling on parked vehicles. | 29-Jan-2027<br>(6 Months) |

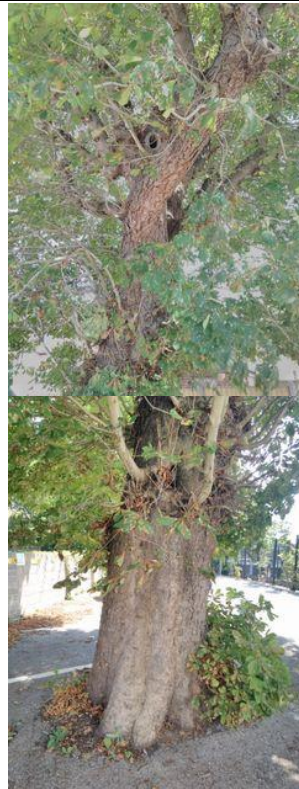
| Ref: | Species | Measurements | Survey Notes | Condition | Other Data | Recommendations | Photo |
|---|---|---|---|---|---|---|---|
| T006 | Horse chestnut<br>( <i>Aesculus hippocastanum</i> ) | Height (m): 10-15m<br>Crown Radius (m): 4N, 5E, 5S, 6W<br>DBH (cm): 110<br>Life Stage: Mature<br>Life Exp.: 20+ Years | Mature tree. Rooting area tarmacked directly up to list trunk. Light ivy growth and epicormic shoots on trunk. Where accessible bark intact. Sound intonation even and satisfactory. Bleeding canker on north side of trunk 1m above ground level. Old nails in trunk also on north side. No fungal fruiting bodies evident or audible decay. Swept trunk South with limited tapering. Cavity on north side of trunk 2m above ground level. 100mm diameter. Good wound wood formation. Decay likely in central trunk. Trunk forks 4m above ground level. One or two large open cavities in brands associated with previous pruning cuts. Heavily reduced crown. 3-4m new growth on previous reduction points. Foliage dense and even although slender branches in central crown suppressed and died off. Two short stumps in central canopy approximately 2m long appear dead. Polypore fungus at tips. Lower branches in direct contact with parked vehicles.<br><br>Fungus:<br><i>Cerioporus squamosus</i> (Dryad's saddle)<br><br>Pests and Diseases:<br>Horse Chestnut Leaf Blotch ( <i>Guignardia aesculi</i> )<br>Horse Chestnut Leaf Miner ( <i>Cameraria ohridella</i> ) | Fair | Public Amenity Value:<br>Wildlife Value:<br>Inspection Limitations: | Remove epicormic growth and crown lift to create 4m canopy clearance above ground level<br><br>Pollard back to previous reduction points -a reduction of 3-4m.<br><br><b>Timescale:</b><br>29-Jan-2027<br>(6 Months) | |

| Ref: | Species | what3words<br>(Location Identifier) | Recommendations | Work<br>Timescale |
|---|---|---|---|---|
| T006 | Horse chestnut | ///rescue.send.vague | Pollard back to previous reduction points -a reduction of 3-4m.<br>Remove epicormic growth and crown lift to create 4m canopy clearance above ground level | 29-Jan-2027<br>(6 Months) |

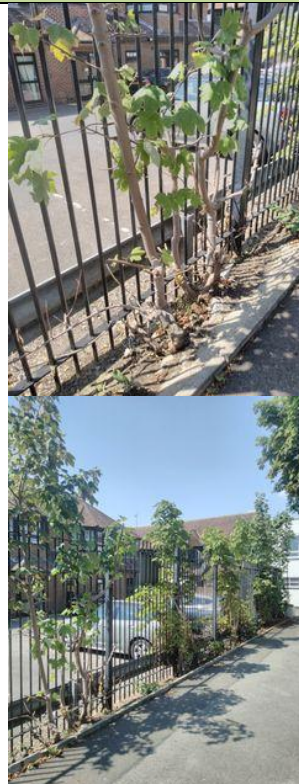
| Ref: | Species | Measurements | Survey Notes | Condition | Other Data | Recommendations | Photo |
|---|---|---|---|---|---|---|---|
| G007 | Sycamore<br>( <i>Acer pseudoplatanus</i> )<br>Pedunculate oak<br>( <i>Quercus robur</i> )<br>Horse chestnut<br>( <i>Aesculus hippocastanum</i> ) | Height (m): 0-5m<br>Crown Radius (m): 0.5<br>DBH (cm): 5<br>Life Stage: Young<br>Life Exp.: 20+ Years | Young saplings seeded in narrow strip between car parks and growing through iron fence.<br><br>Poor form trees having been cut back on many occasions in the past.<br><br>Young trees with the potential for significant future growth - unsustainable in this location. | Poor | Public Amenity Value: Low<br>Wildlife Value: Low | Fell to ground level<br><br><b>Timescale:</b><br>29-Jul-2027<br>(1 Year) | |

| Ref: | Species | what3words<br>(Location Identifier) | Recommendations | Work<br>Timescale |
|---|---|---|---|---|
| G007 | Sycamore<br>Pedunculate oak<br>Horse chestnut | ///rides.over.barks | Fell to ground level | 29-Jul-2027<br>(1 Year) |

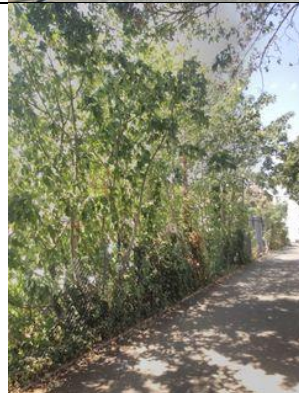
| Ref: | Species | Measurements | Survey Notes | Condition | Other Data | Recommendations | Photo |
|---|---|---|---|---|---|---|---|
| G008 | Common ash<br>( <i>Fraxinus excelsior</i> )<br>Sycamore<br>( <i>Acer pseudoplatanus</i> ) | Height (m): 5-10m<br>Crown Radius (m): 2<br>DBH (cm): 10<br>Life Stage: Young<br>Life Exp.: 20+ Years | Slightly older saplings seeded in narrow strip between car parks.<br>Multi-stem, linear group. Ivy clad lower trunks.<br><br>Some amenity value in terms of screening car parks. Generally poor form. | Poor | Public Amenity Value: Low<br>Wildlife Value: Low | Crown lift cutting back overhanging branches to create 4m canopy clearance over car park.<br><br>Top at 3m and retain in a reduced form for screening - subject to owner consent<br><br><b>Timescale:</b><br>29-Jul-2027<br>(1 Year) | |

| Ref: | Species | what3words<br>(Location Identifier) | Recommendations | Work<br>Timescale |
|---|---|---|---|---|
| G008 | Common ash<br>Sycamore | ///certified.counts.edges | Crown lift cutting back overhanging branches to create 4m canopy clearance over car park.<br>Top at 3m and retain in a reduced form for screening -subject to owner consent | 29-Jul-2027<br>(1 Year) |
