Tree Consultancy Ltd

## HEALTH AND SAFETY ARBORICULTURAL REPORT

Site Address: 32 Heathermount Drive, Crowthorne, Berkshire, RG45 6HN

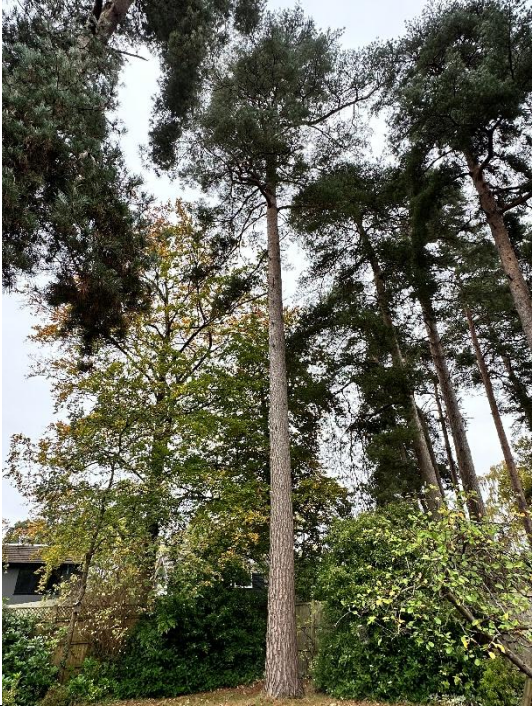
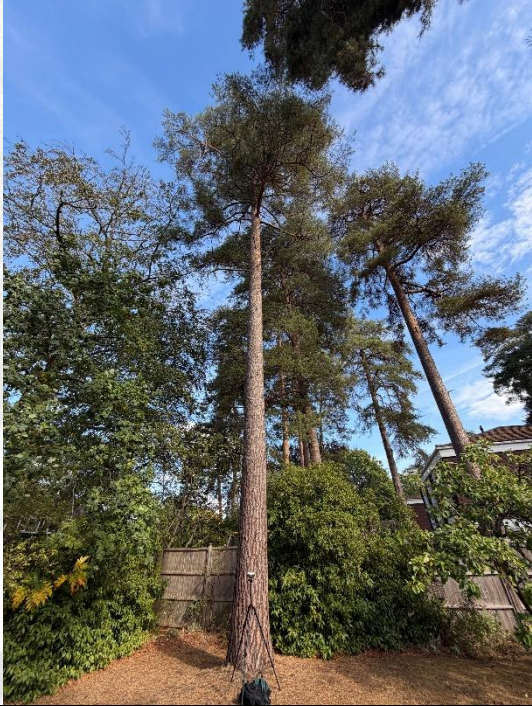
| 2024 | 2026 |

T3 is situated in the rear garden, close to the boundary with 30 Heathermount Drive. The tree is showing slight defoliation, estimated at less than 15% when compared with the previous inspection. Foliage appears comparatively denser within the inner crown, while the outer crown and peripheral branch structure display a lower foliage density. Although the observed change is currently limited, the variation in foliage distribution should continue to be monitored during future inspections. This will help establish whether the reduction in foliage remains stable, improves over time, or shows evidence of further progression.

A hammer test was conducted around the accessible stem and produced no audible indications of internal decay or dysfunction.

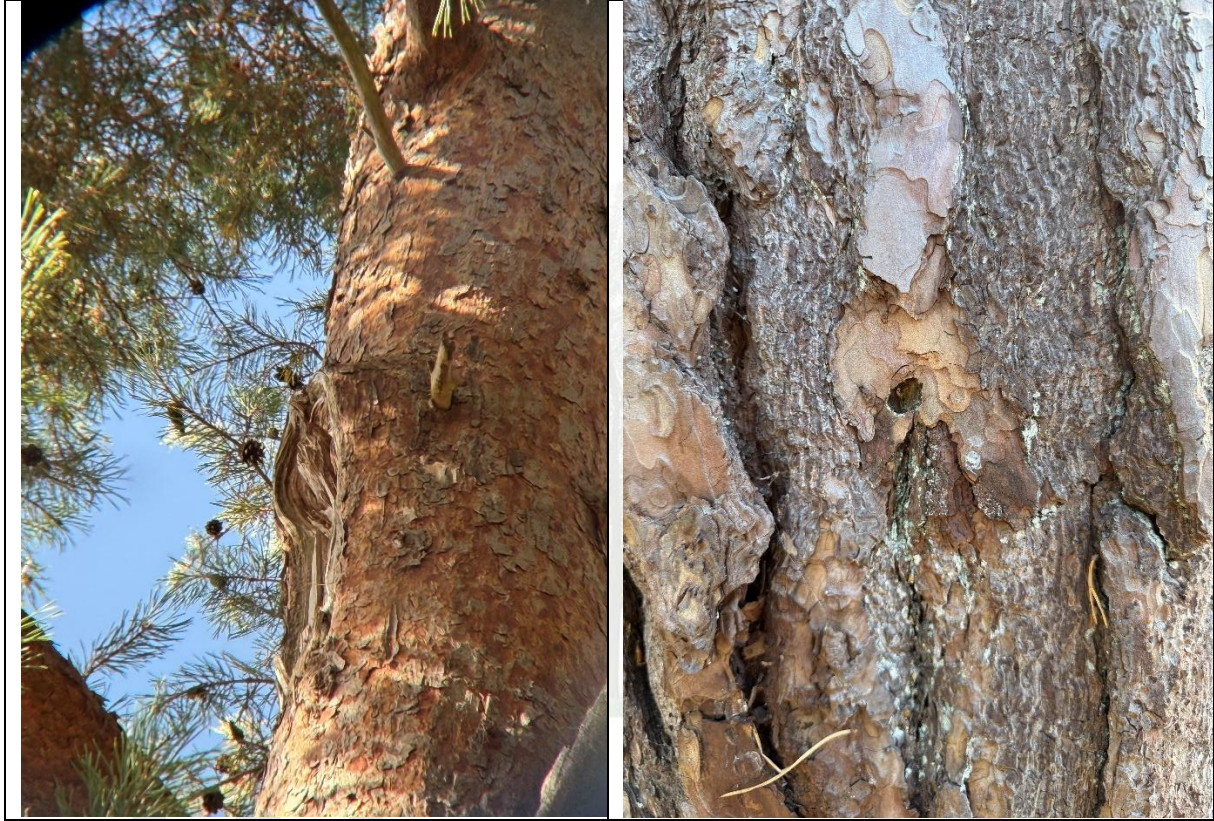
T4 is located approximately 6m from Mr & Mrs Spink’s house, with the crown notably biased towards the east. Major deadwood and damaged branches are present throughout the crown, the identified defects that should be addressed through the removal of the deadwood and damaged branches as part of the recommended remedial works.

A relatively recent tear wound is present on the main stem at approximately 10m above ground level, on the south-east side. At present, the wound appears to have only a minor effect on the tree’s structural condition. However, the affected area should be monitored during future inspections for any increase in decay, deterioration, or reduction in structural integrity. It is also strongly recommended that the tree be re-inspected following any major storm event so that its ongoing structural condition can be reassessed.

At present, there are no immediate concerns regarding failure of the tree. However, as the identified decay advances, removal of the tree is likely to become necessary to

manage the developing risk appropriately. A small borehole, presumed to have been caused by an insect, is present on the north-west side of the stem at approximately 1m above ground level. This feature is not currently considered likely to cause structural concern, but it should be included in future inspections and monitored for any enlargement, associated deterioration, or further evidence of decline.
