## **VISUAL TREE ASSESSMENT AND DECAY DETECTION AT 178 READING ROAD WOKINGHAM**

**Prepared for:  
Mr & Mrs Morrell  
178 Reading Road  
Wokingham  
RG14 1LH**

**19 February 2026**

**Ref: SPH/VTa-26/11.02**

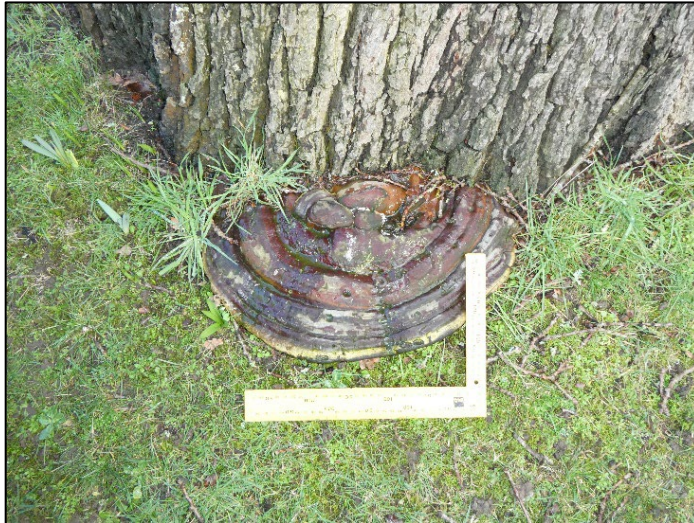
- 6.1 The tree is located in the front garden, 19 meters from the front elevation and 6 meters from Reading Road to the north.
- 6.2 There were no visible signs of movement in the root plate. No soil cracks or heave were observed, and the root plate appears to be stable within the surrounding soil. Fungal fruiting bodies were observed on the north and south sides of the main stem at ground level and appear similar to those of the *Ganoderma species*, see Figure 2 on page 6. The remains of a bracket fungi were visible on the south side and the bracket can be seen in the photograph taken in 2019 see Figure 3 on page 6.

Figure 2: South side 2026

- 8.1 In making these recommendations consideration has been given to the tree's amenity and landscape values versus the location, distance from the target areas.
- 8.2 The tree should be felled in sections to ground level and the stump ground out to a minimum depth of 300 millimetres, within 6 months of the date of this report and a suitable replacement planted in close proximity to the original location.

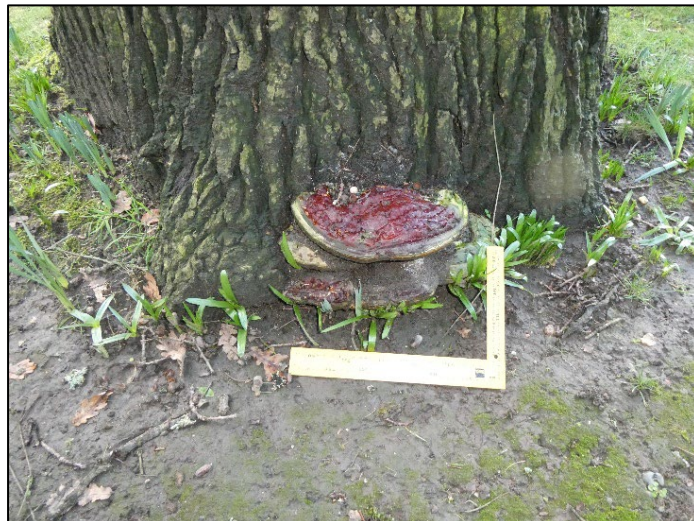
North side: 2026

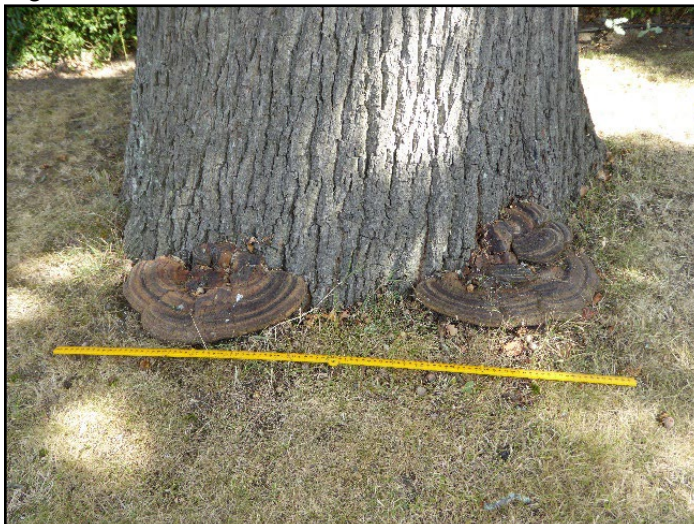
Figure 3: brackets in 2019

- 7.1 Ganoderma fungi occur on a broad range of deciduous trees. They are frequently found at buttress level but may also be found on the main stem several metres above ground level. In the advanced stages of decay, it is difficult to differentiate between *G. applanatum* and *G. adspersum*. We were unable to differentiate the brackets on the site visit. The decay detected in the tree extends into the vascular tissues and indicates that the lignin has decomposed and the spongy mass that remains is cellulose. Decay of the stem cross section at ground level and below ground level on the north, west and southeast side is extensive. When we compared the drillings with those taken in 2019, advanced decay was also detected on the north side. There has been a significant change in wood density and extent of decay in the south and east sides with little change on the west side at the test heights, 5 and 10cm respectively.

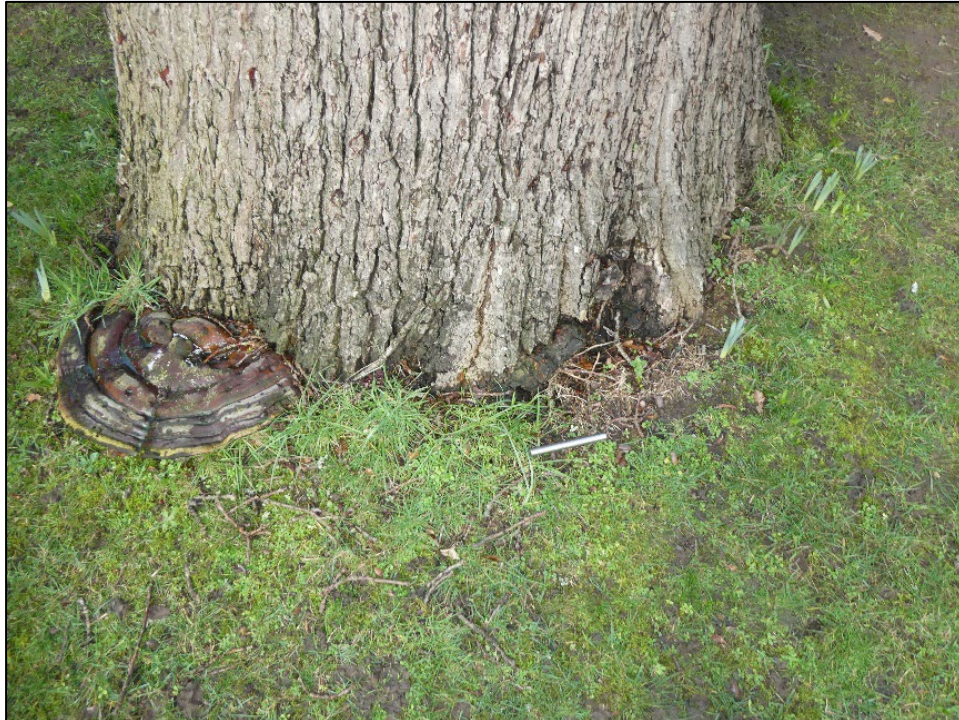
- 6.3 The base of the stem was tested with a nylon mallet, and hollow intonations were heard on the southeast to south sides and north to northeast sides at ground level. Testing the stem with a stainless-steel probe revealed several areas of decay on the north and southeast sides below ground level, see examples at Figure 4 on page 7. The bark was true to type and firmly attached. The main stem has a natural taper and otherwise unremarkable. Pruning wounds are evident at 5.5 metres AGL and they are fully occluded. Epicormic growth has developed at 4 metres AGL and the main stem union is at 6 metres AGL with no obvious structural defect, see Figure 5 on page 8.

Figure 4. Probe southeast side 400mm deep

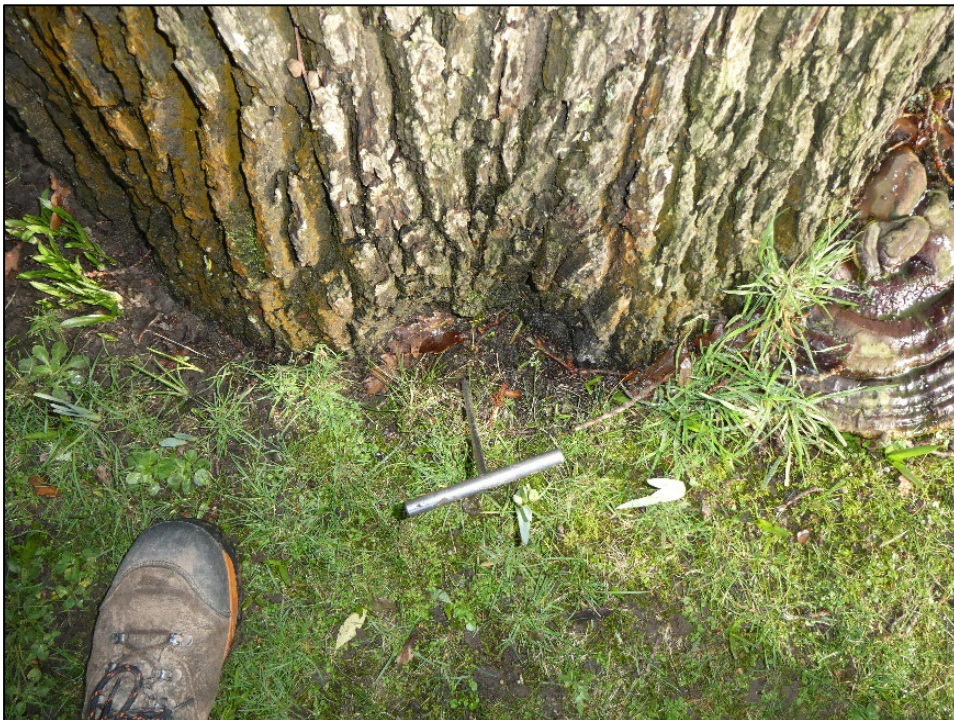
Probe north 375mm deep

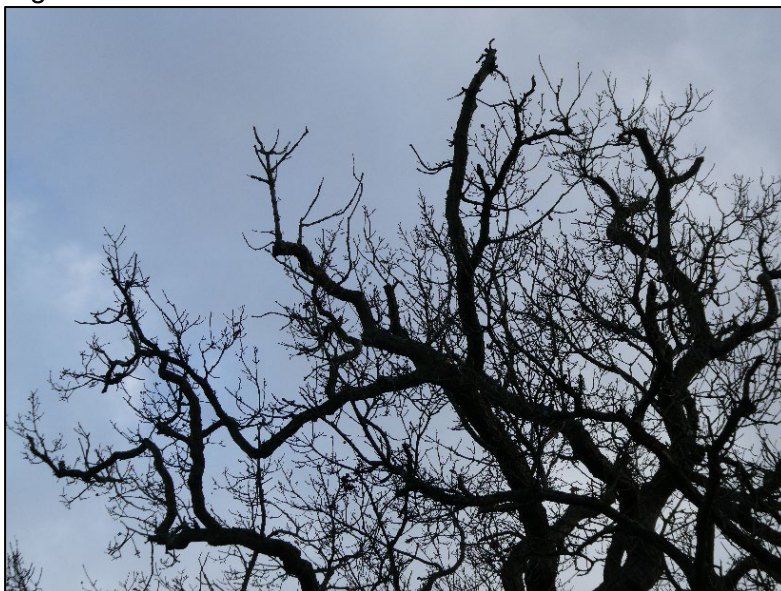
Figure 6.

- 6.4 The canopy has been reduced and there is very little callous development at the pruning wounds is poor. The tree has a stressed appearance exhibiting signs of secondary and peripheral die-back throughout the canopy, see Figure 6 below.

- 7.2 Secondary and peripheral dieback is best described as the dying back of the growing points and supporting branches. This die-back often occurs as a result of root loss, stress or as the result biotic or abiotic pathogens. The presence of *Ganoderma sp.* may also be exacerbated by secondary pathogens such as Honey fungus that can speed up the rate of decay and decline. The tree is not dead but there is no possibility of recovery and no treatment for the fungal pathogen. Previous pruning combined with the physiological and structural decline has resulted in poor secondary growth and a lack of suitable pruning points, making it unsuitable for further reduction. Further reduction is not recommended as this will result in added stress, a lack of leaf surface area and reduced photosynthetic capacity.

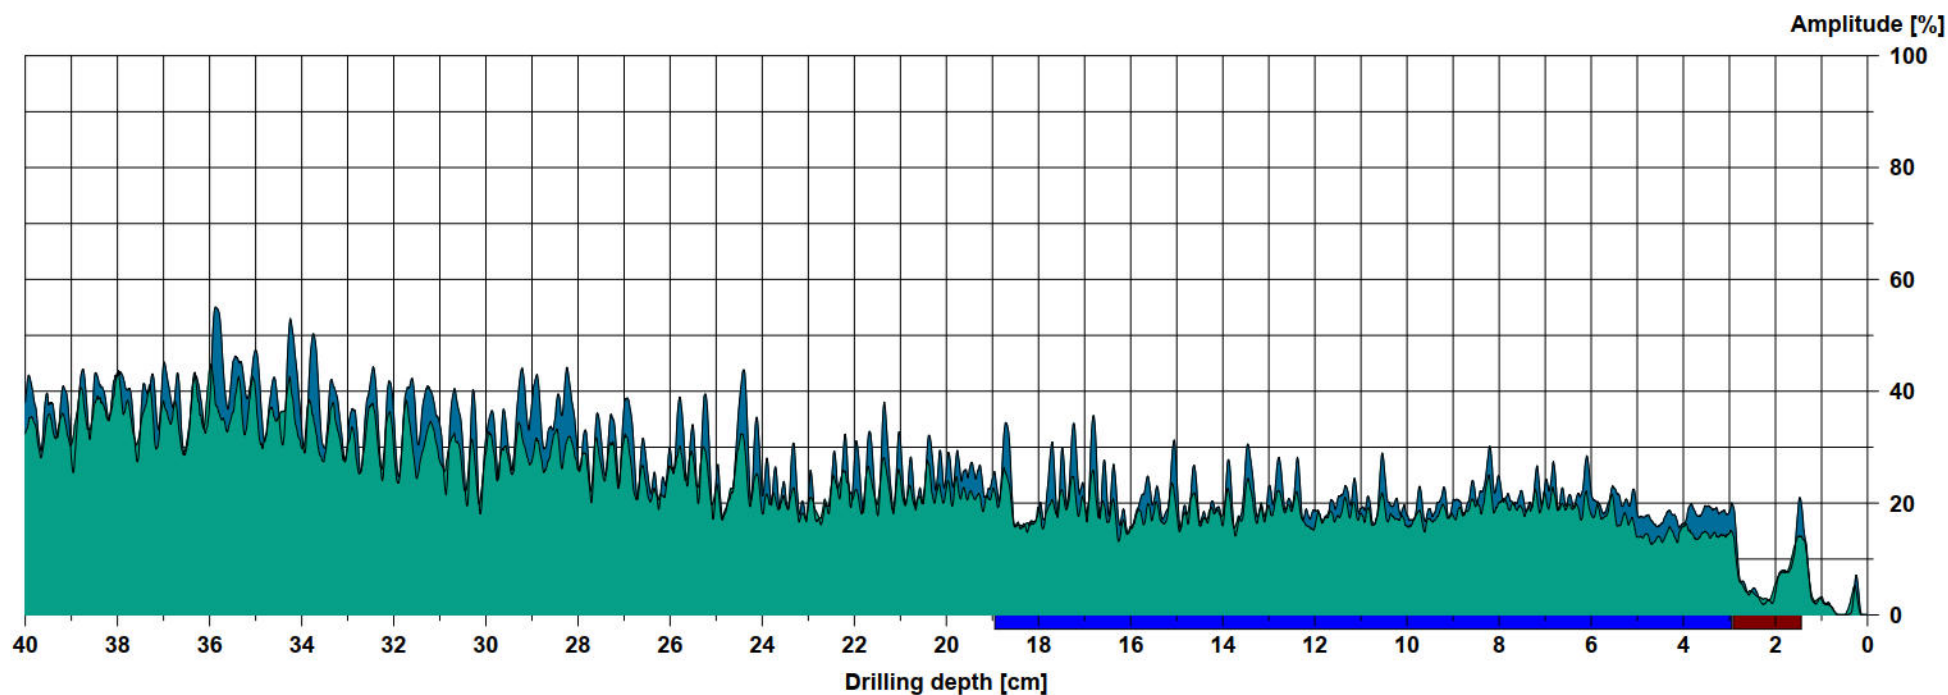
From 1,44 cm to 2,92 cm : Decay  
From 2,95 cm to 18,95 cm : Incipient decay

Control test north side 1.5m AGL.  
Bark has low density and some decay behind the bark at 2cm. Low amplitude recorded from 3cm to 19cm indicative of incipient decay.

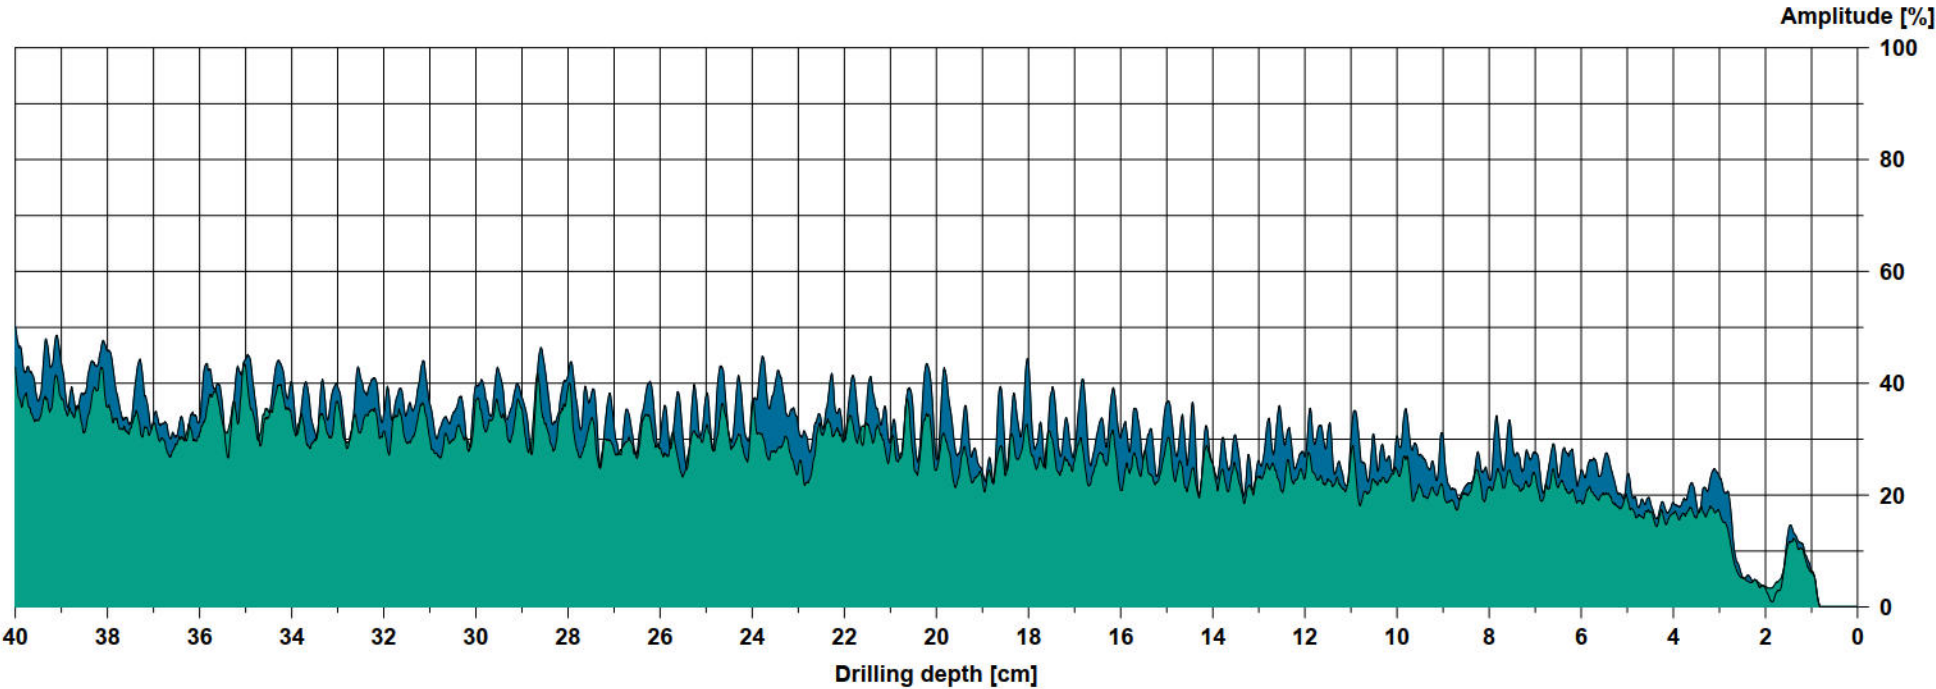
Control test at 1.5m AGL south side.No significant decay at the test location.

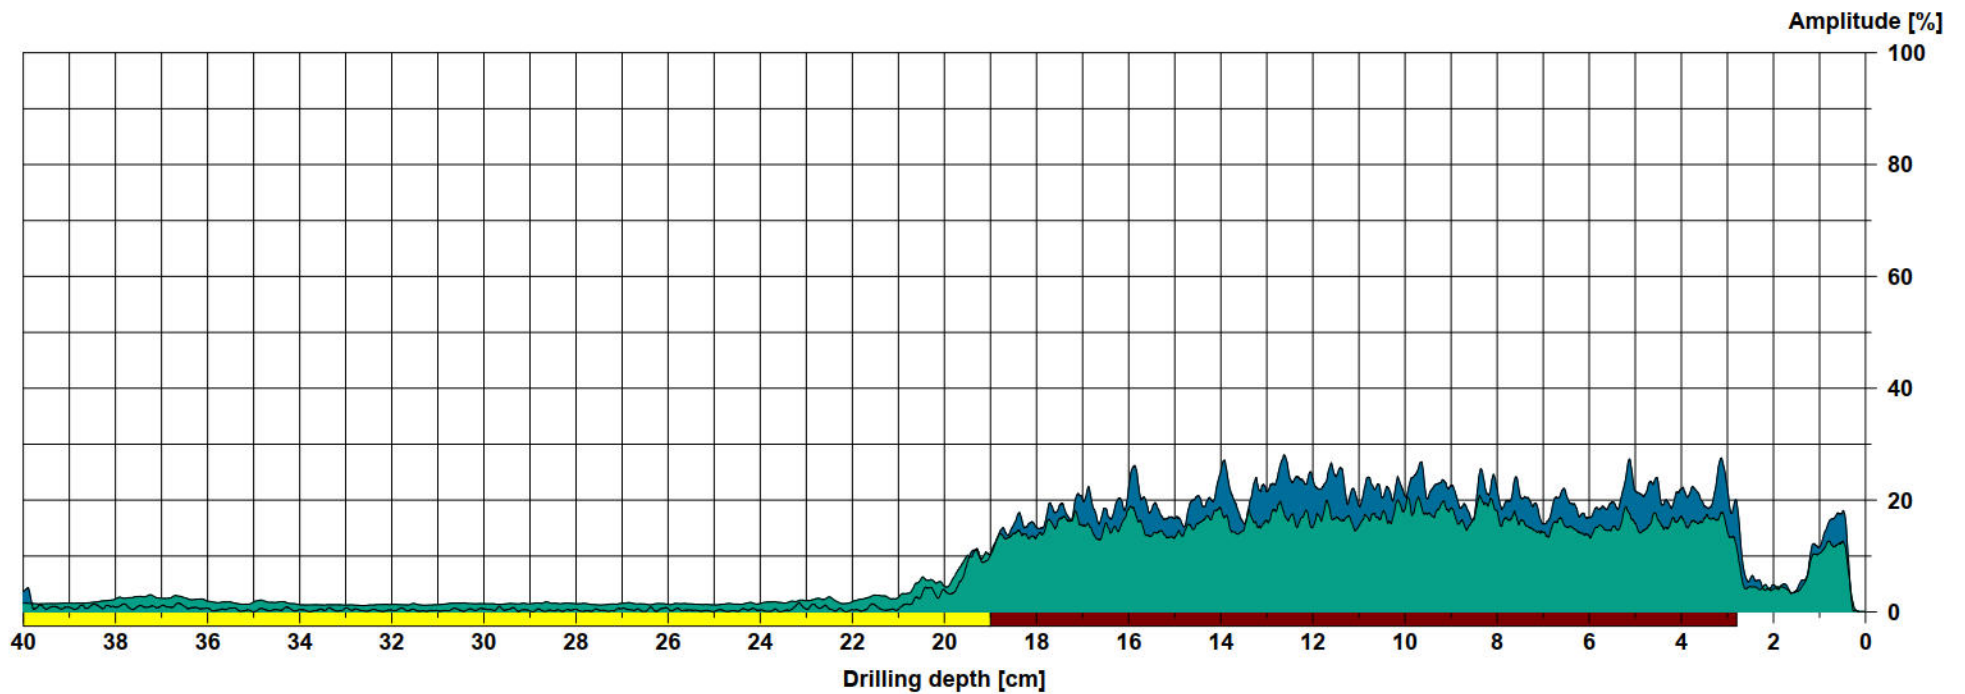
From 2,80 cm to 19,02 cm : Decay  
From 19,00 cm to 40,00 cm : Cavity

Test at 45 degrees into the root plate west side.  
Poor annual ring definition indicating decay and cavity from 19cm.

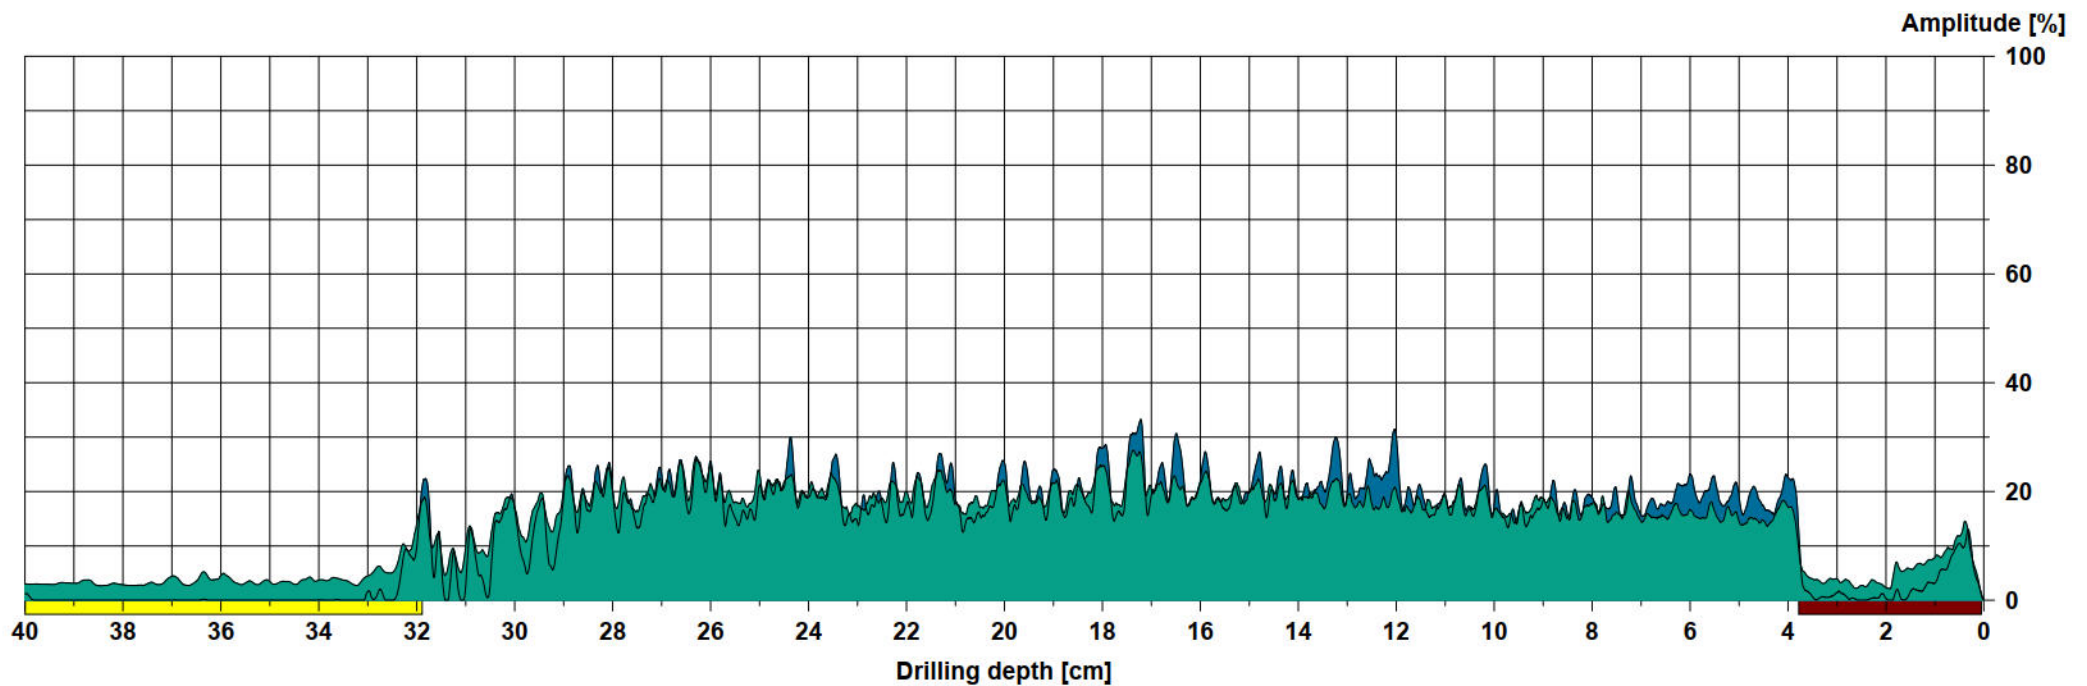
From 0,05 cm to 3,78 cm : Decay  
From 31,89 cm to 40,00 cm : Cavity

East side.  
Bark and vascular system decaying, wood density from 4cm to 29cm shows incipient decay with poor ring definition and cavity from 32cm.

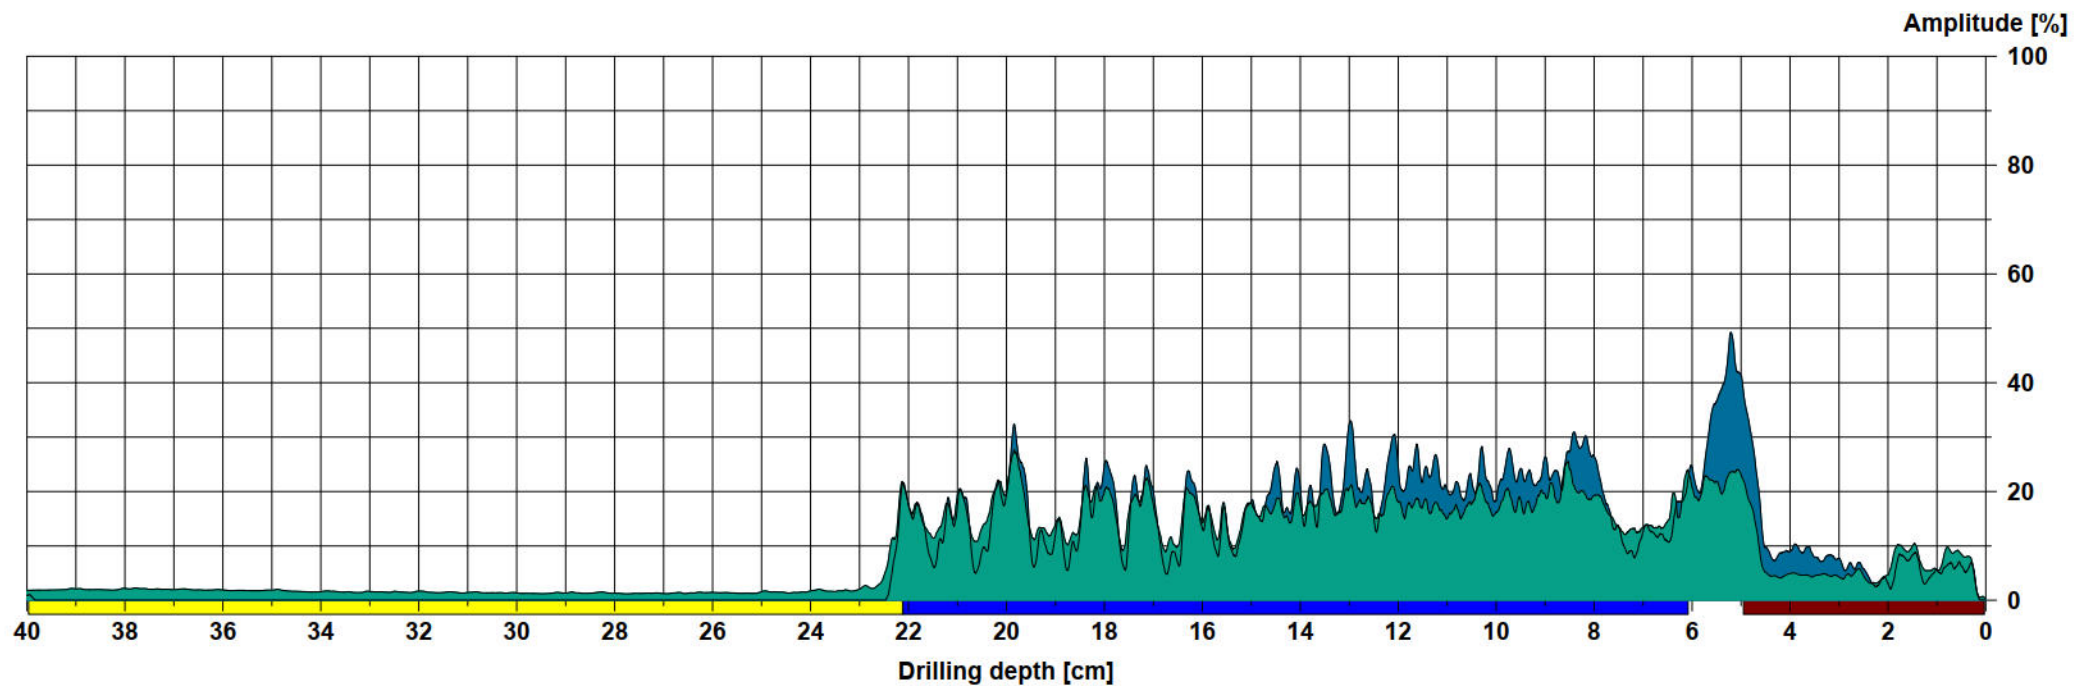
| From | 0,03 cm to | 4,95 cm | : Decay |
| From | 6,08 cm to | 22,11 cm | : Incipient decay |
| From | 22,12 cm to | 39,97 cm | : Cavity |

North side.  
Bark and vascular system decaying, wood density from 5cm to 22cm shows incipient decay with cavity from 22cm.

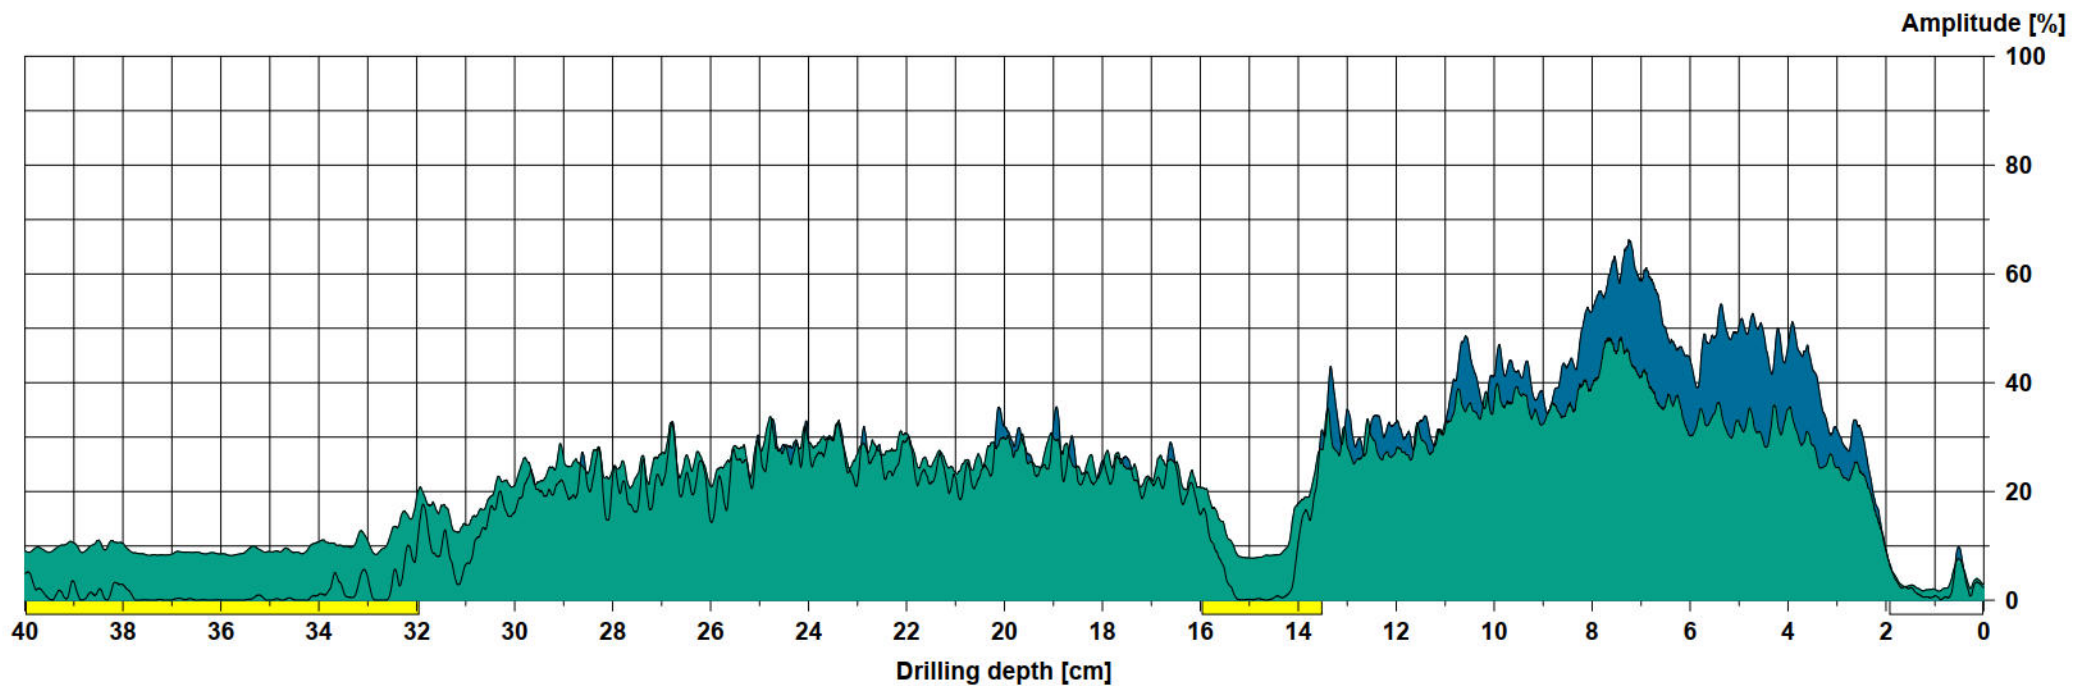
| From | 0,02 cm | to | 1,92 cm | : | Bark |
| From | 13,52 cm | to | 15,96 cm | : | Cavity |
| From | 31,96 cm | to | 39,98 cm | : | Cavity |

South side.  
Bark has low density up to 2cm. Isolated cavity at 14cm, with poor ring definition from 16 to 32cm, cavity from 32cm.

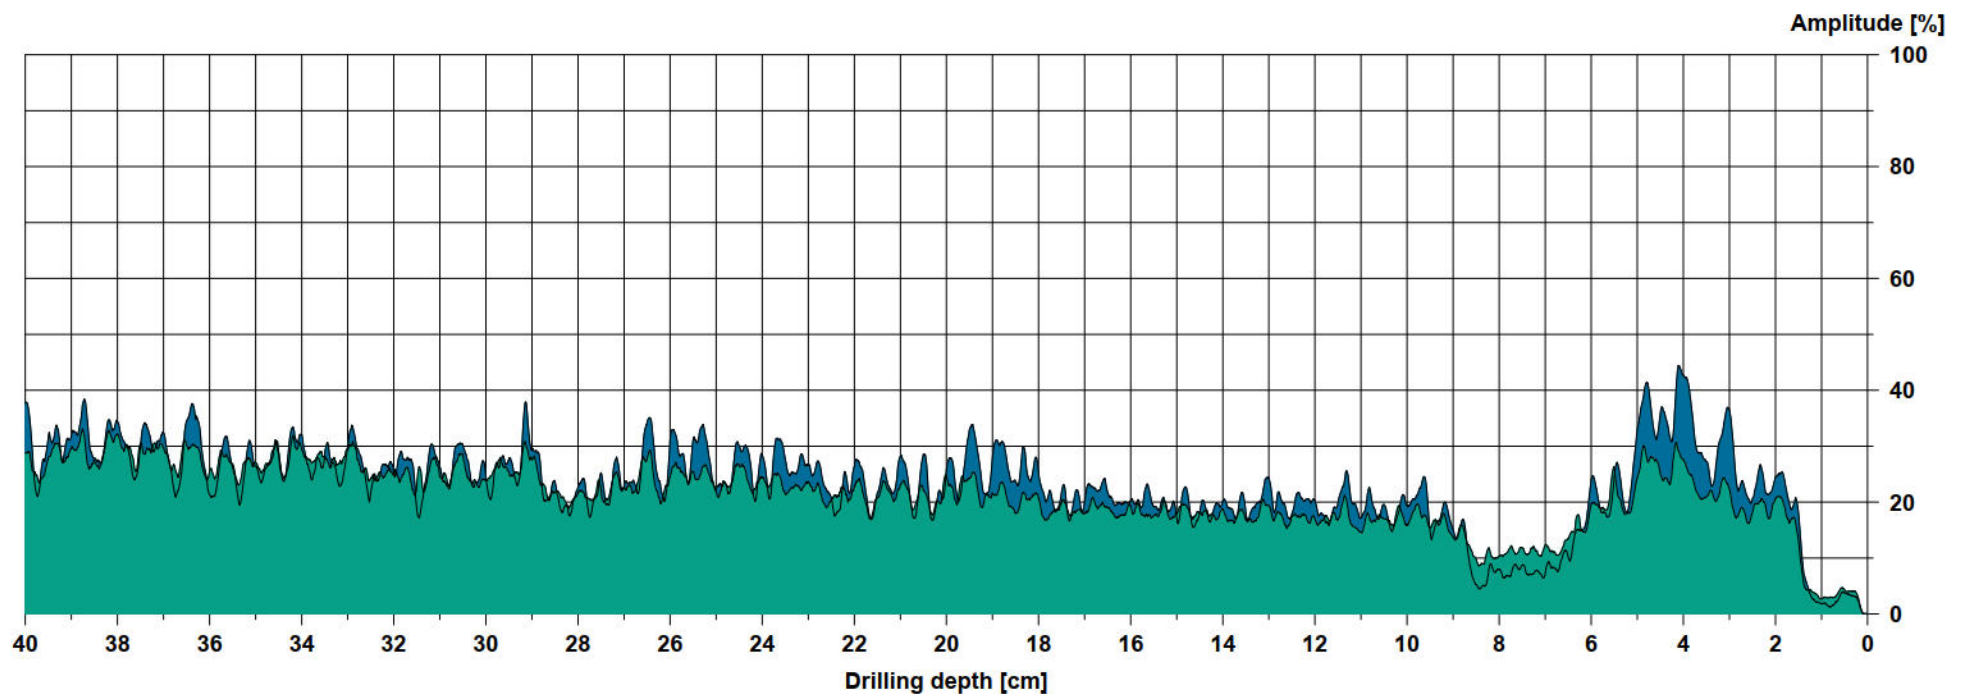
West side.  
Bark has low density as expected. Sudden change in amplitude at 5cm and low amplitude with irregular annual ring definition from 9 to 18cm.
