## HERIOTS, WOKINGHAM ROAD, HURST, BERKSHIRE

### Heritage Note – Assessment of unauthorised works

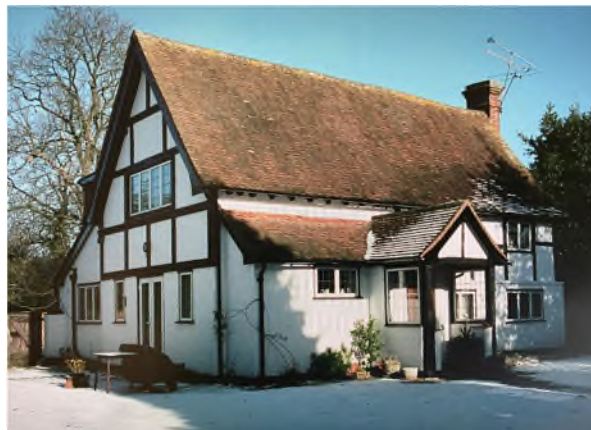
Figure 1: Oblique view of the south and west elevations of Heriots in 2004

- 3.3.9 **Additional alterations** - It was also noticed that the form of the window opening on the south elevation of the lean-to has been altered (compare with the 2004 photo). Subject to the materials of the existing window, this change could be regularised through a retrospective application.

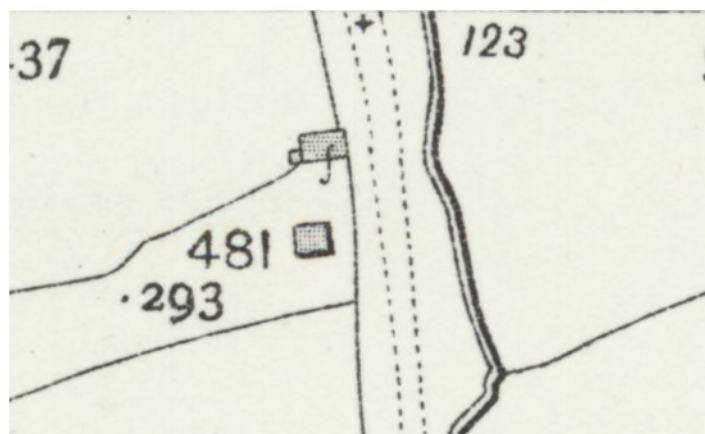
- 2.1.1 The 1911 edition of the 25-inch Ordnance Survey map shows Heriots with a roughly square footprint. There is what appears to be an outbuilding to the north of the cottage.

Figure 2: Extract from the 1911 edition of the Ordnance Survey map

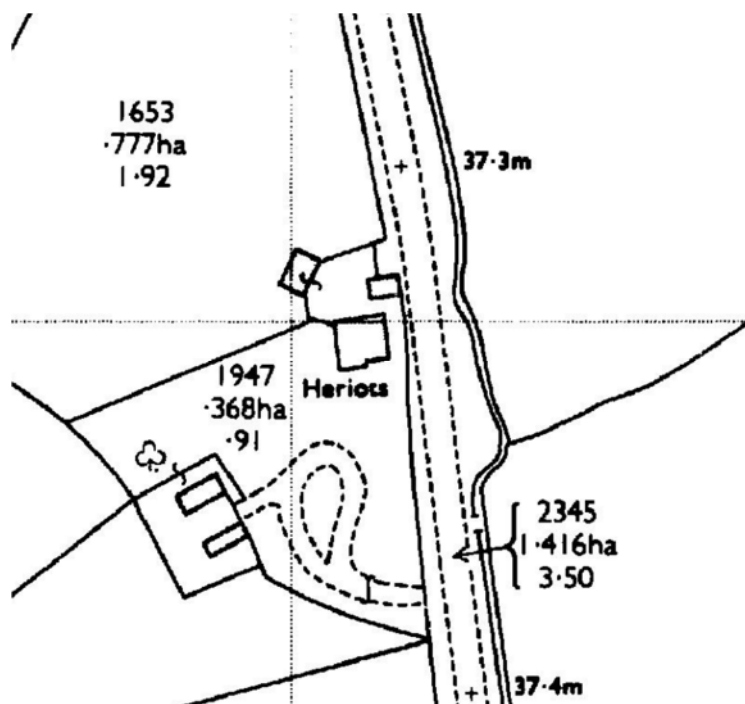
- 2.1.2 The 1965-72 edition of the 25-inch Ordnance Survey map shows an enlarged footprint to the north and west and with a shallow projecting element on the south-west side. The footprint of the outbuilding to the north appears to have been reduced in size, suggesting that it had been rebuilt.

Figure 3: Extract from 1965-72 edition of the 25-inch Ordnance Survey map

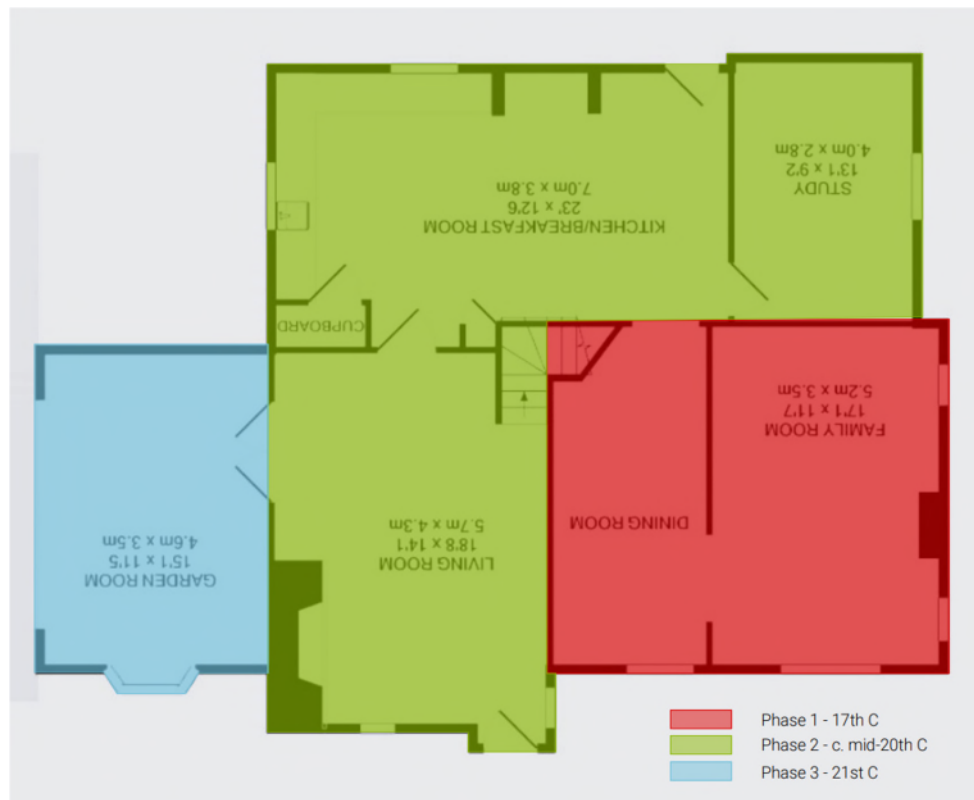
- 2.2.2 The wall frames include a mix of straight and slightly curved head braces. The roof structure is queen strut with clasped purlins. Weathered finishes on the north and west sides of the frame (viewed internally) demonstrate the extents of the Phase 1 house.
- 2.2.3 Historic map regression and the evidence of the fabric, e.g. Fletton bricks, mock timbers, demonstrate a c. mid-20<sup>th</sup> century date for the enlargement of the original Phase 1 house. The 2-storey rear wing may be slightly earlier but is post-1911. The western side extension appears to have incorporated reused timbers into the structure. It also appears that the outbuilding to the north of the house was rebuilt at around the same time.

Figure 4: Suggested ground floor phase plan
