## Church Lane Junction

### Ecological Appraisal & Bat Building Inspection Report

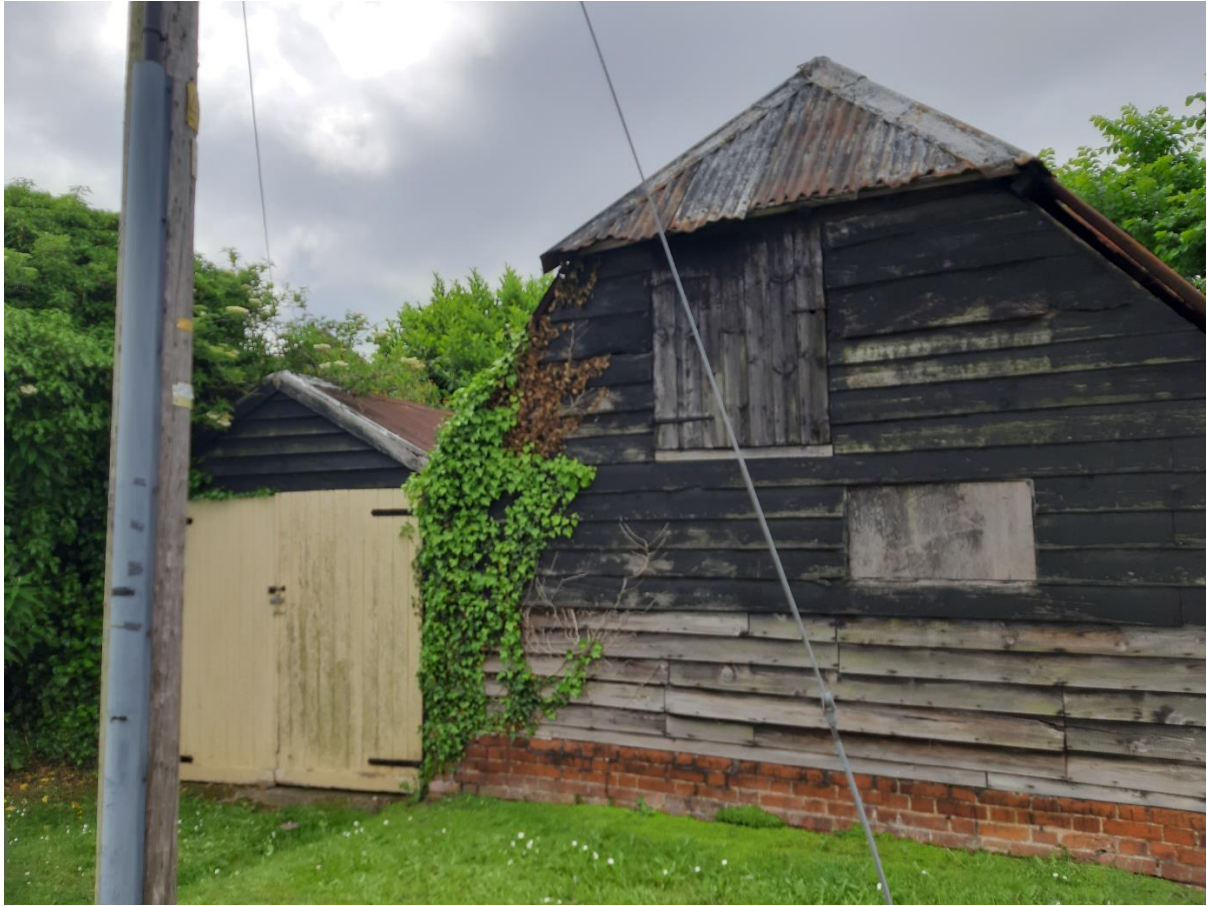
- 3.9 The adjacent barn was not fully accessible for survey but is provisionally considered to have at least a low level of suitability for bats, given the occurrence of occasional gaps under weatherboarding and an apparent cavity between the outer boarding and an inner timber wall.

*Front (north) elevation of garage (left) and barn*

- 4.2 The garage has negligible suitability for roosting bats and can be removed without further ecological consideration.
- 4.3 The neighbouring barn appears to have at least a low level of suitability for roosting bats. However, the risk of bats incurring harm or significant disturbance during the removal of the adjacent garage is considered to be low. Any bats occupying the barn will be habituated to a certain degree of disturbance due to its adjacency to the roundabout. Moreover, notwithstanding ecological considerations, the removal of the garage will need to be carefully and sensitively undertaken to avoid damage to the adjacent building, and this will be facilitated by the garage's lightweight and insubstantial structure.

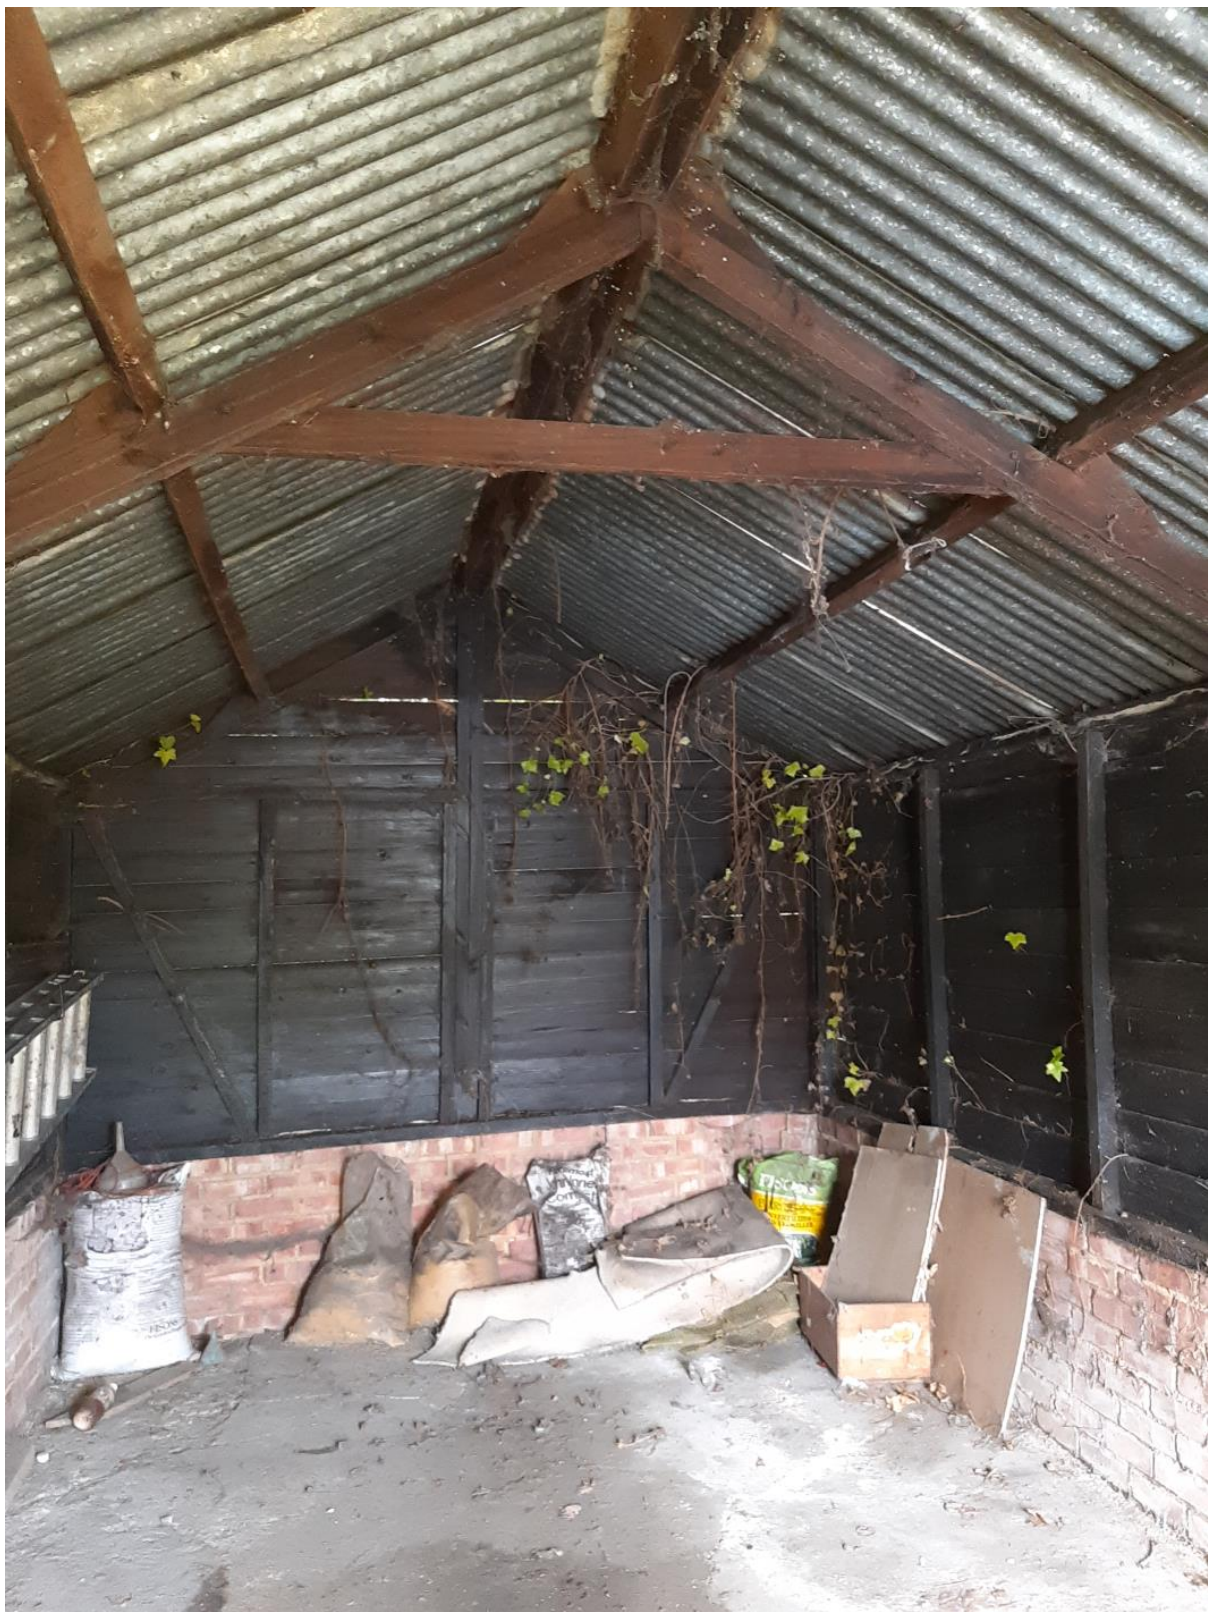
- 3.4 The roof is pitched and constructed of corrugated tin sheets supported by a square-sawn timber frame. The interior was largely bare but did not appear to have been recently swept or cleaned.

- 3.5 No droppings, feeding remains, or other evidence of bats was found.
- 3.6 The adjacent, off-site barn is a larger and more antiquated structure, although similarly constructed. The boards which form the external walls of the barn are more substantial, presenting larger gaps, and there appears to be a second timber wall inside the boarding. Potentially suitable gaps under boards on the elevation facing the garage were endoscopically inspected, as far as the intervening bramble would permit: no bats or evidence thereof was observed.

*Interior of garage*

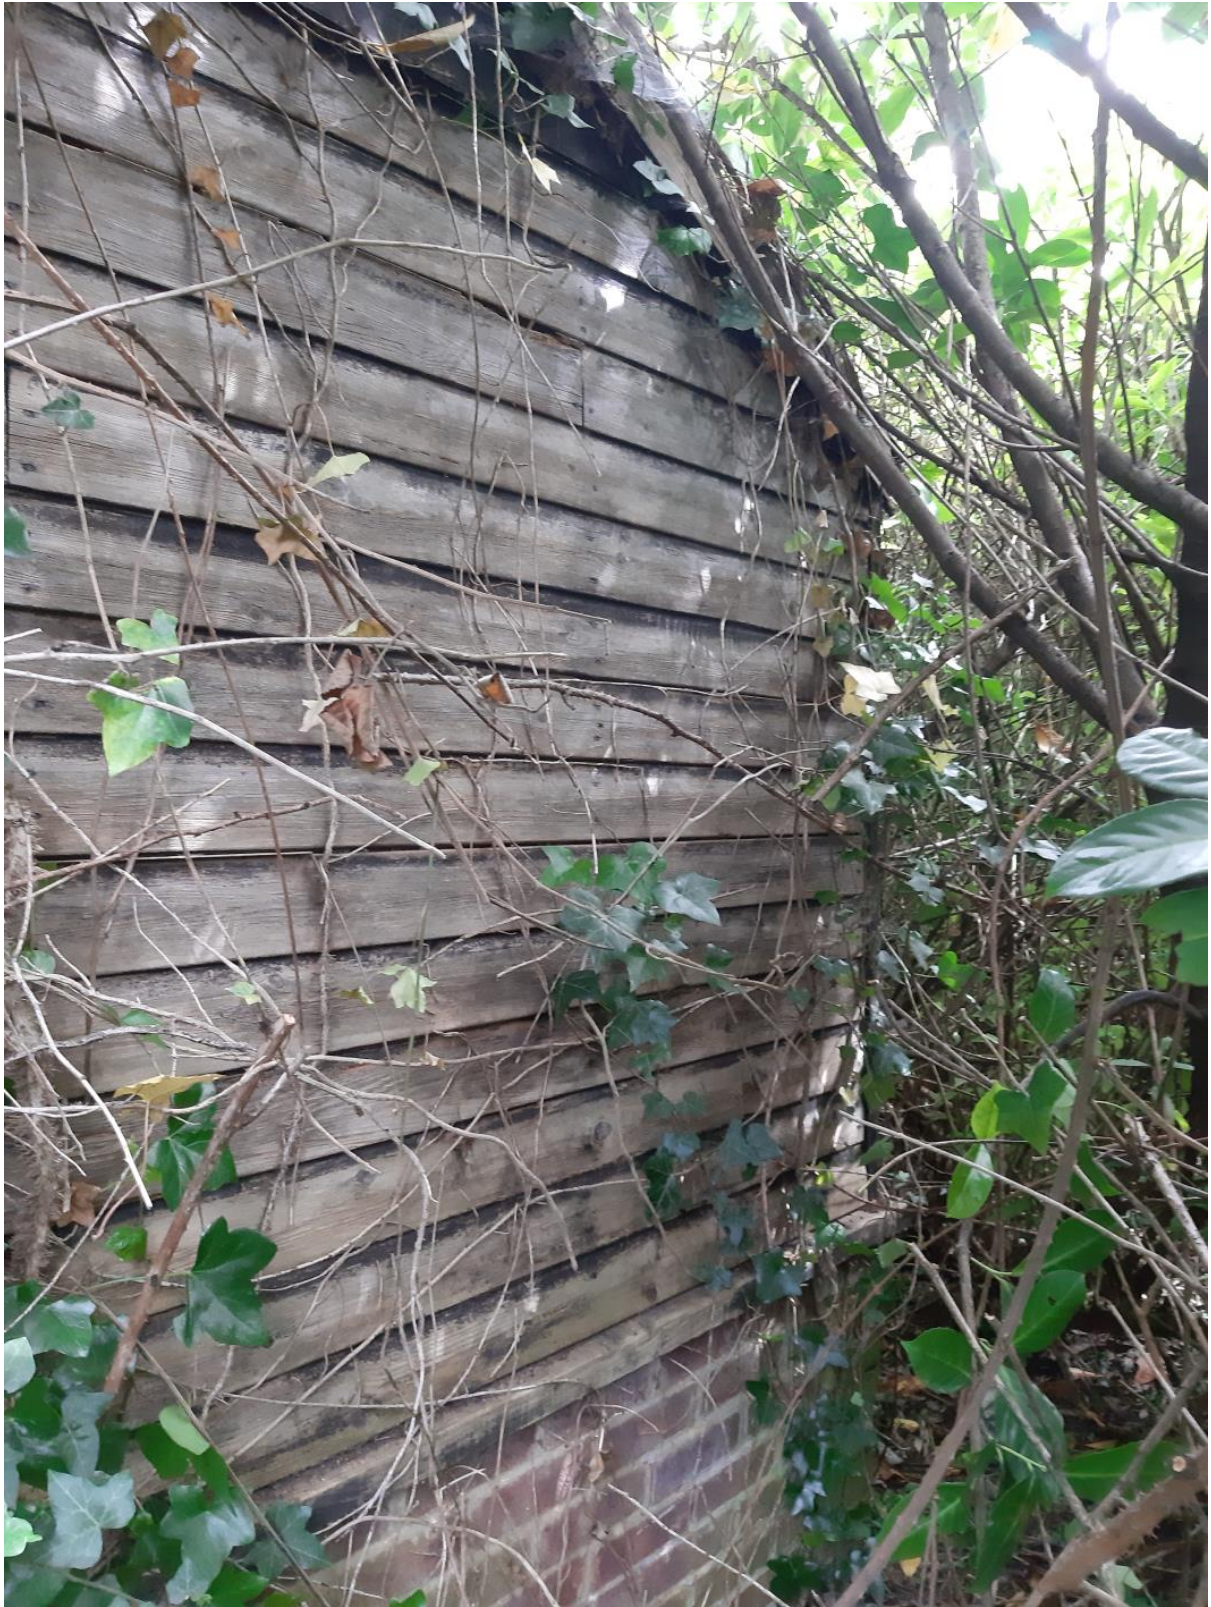
- 3.3 The garage appears to be a late twentieth century structure. The walls are constructed from a single skin of wooden boards (in the style of a garden shed) resting on a low, single-skin brick base. There is no overlap between the boards and the brick base, and only a very slightly overlap, insufficient to accommodate roosting bats, between the individual boards.

- 3.8 The garage has negligible suitability for roosting bats: no potentially suitable bat roosting features were observed.

*Detail of boarding at rear (south) elevation of garage*

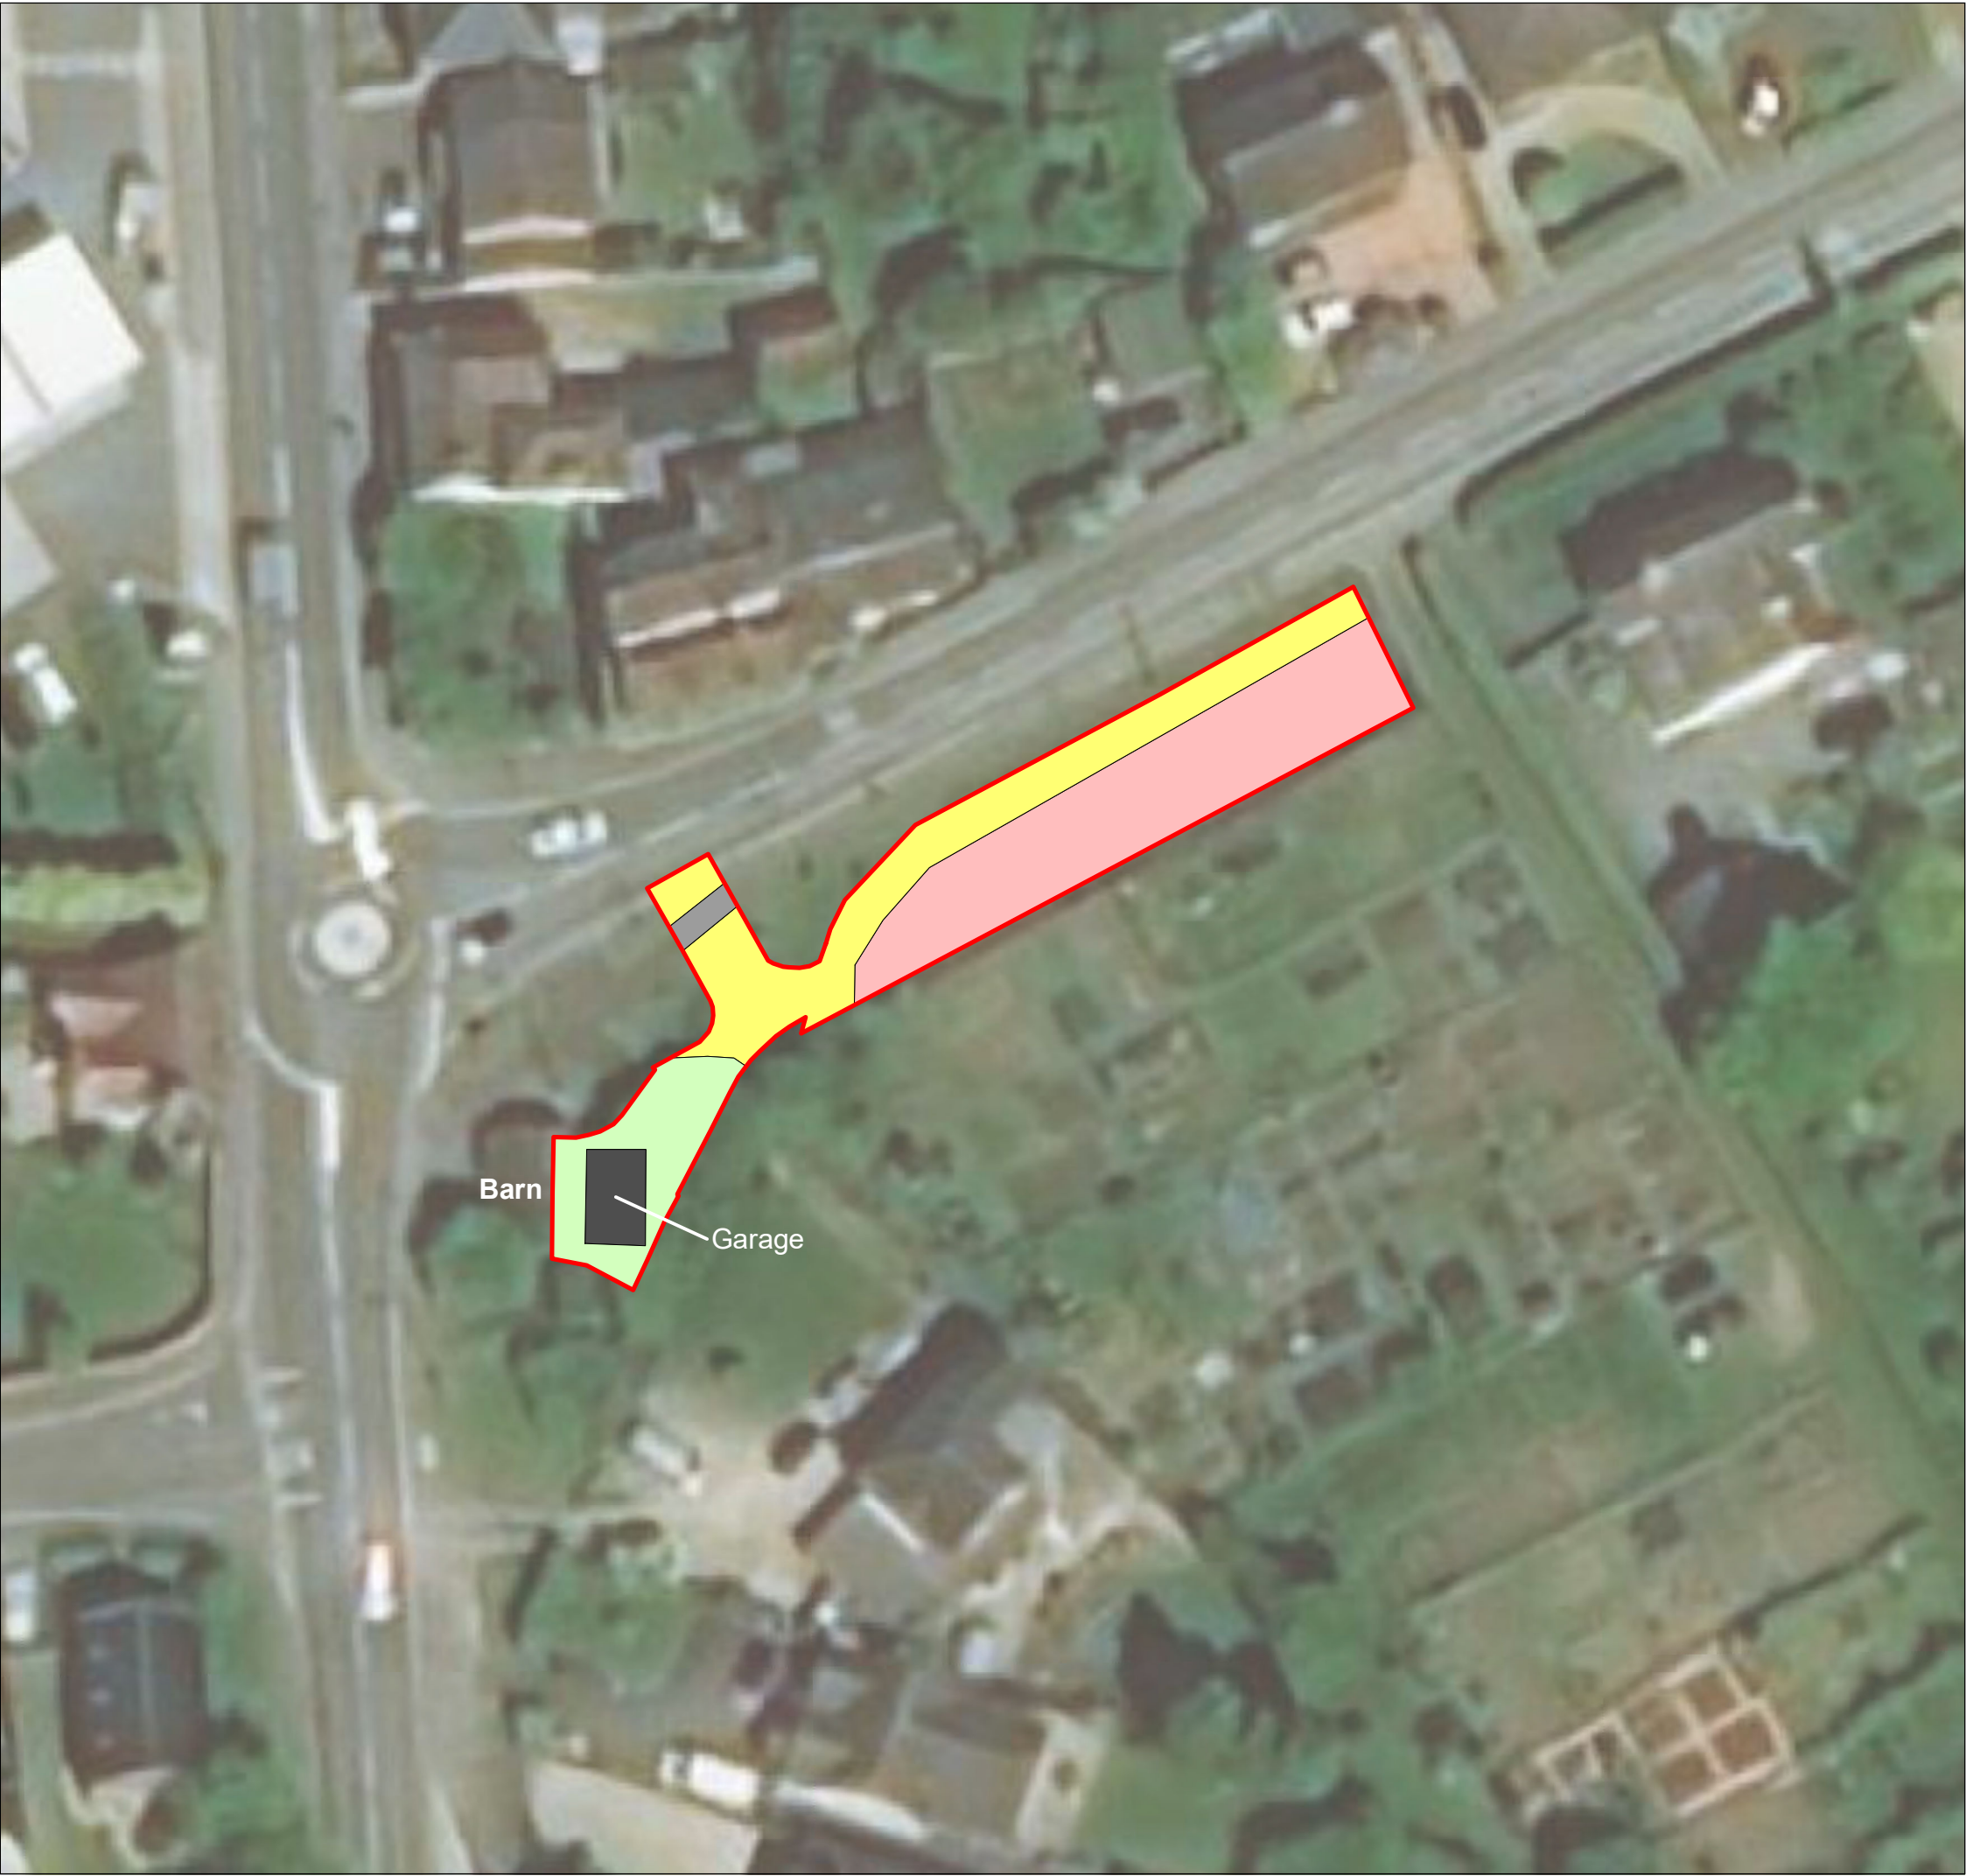
MAP 2 Habitats

- 3.1 **Map 2** represents the distribution of habitats within the application site. These include a tightly-mown verge of roadside amenity grassland and an adjacent surfaced play area. The garage structure is surrounded by dense ornamental shrub planting, principally including laurel, and overgrown in places with bramble.

- 3.2 The habitats present within the site boundary are of very low inherent ecological importance. The shrub planting may present nesting opportunities for common garden bird species, although no evidence of breeding behaviour was recorded during the survey.

- 4.1 The shrub planting in the vicinity of the barn and garage presents potentially suitable nesting opportunities for garden bird species. Clearance of this vegetation should either be timed to avoid the breeding bird season (which occurs from March to August inclusive) or immediately preceded by a nesting bird check undertaken by a suitably experienced ecologist. In the event that an active nest is found, it should be retained *in situ* within a suitable buffer until such time as the nestlings fledge or the nest otherwise naturally ceases to be active.
