**RE: WAITROSE, RECTORY ROAD, WOKINGHAM - BOUNDARY WALL**

It was nice to meet you on 8<sup>th</sup> May 2024, when I carried out an inspection of a boundary wall in the car park of Waitrose, Wokingham.

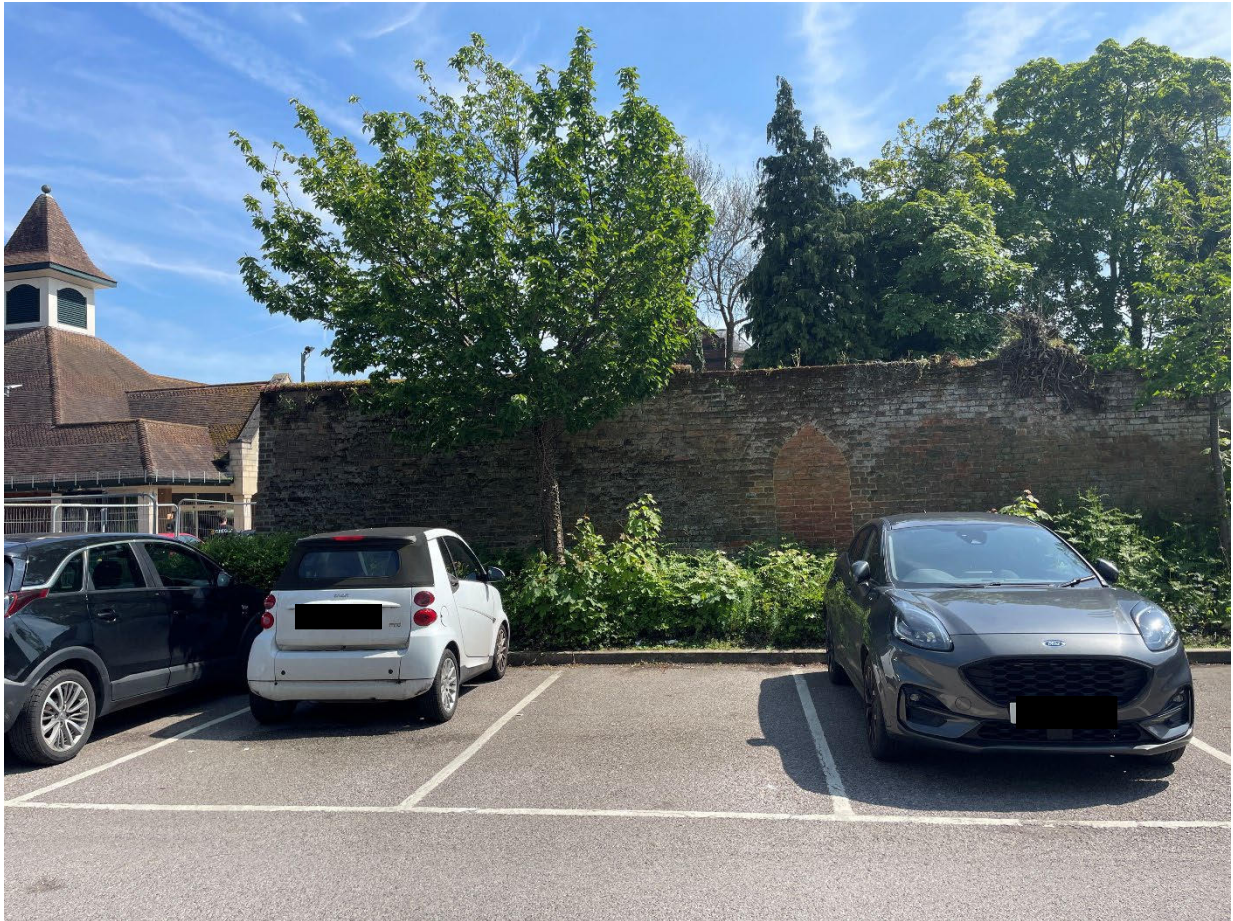
Photograph 1 – Elevation from north side of wall

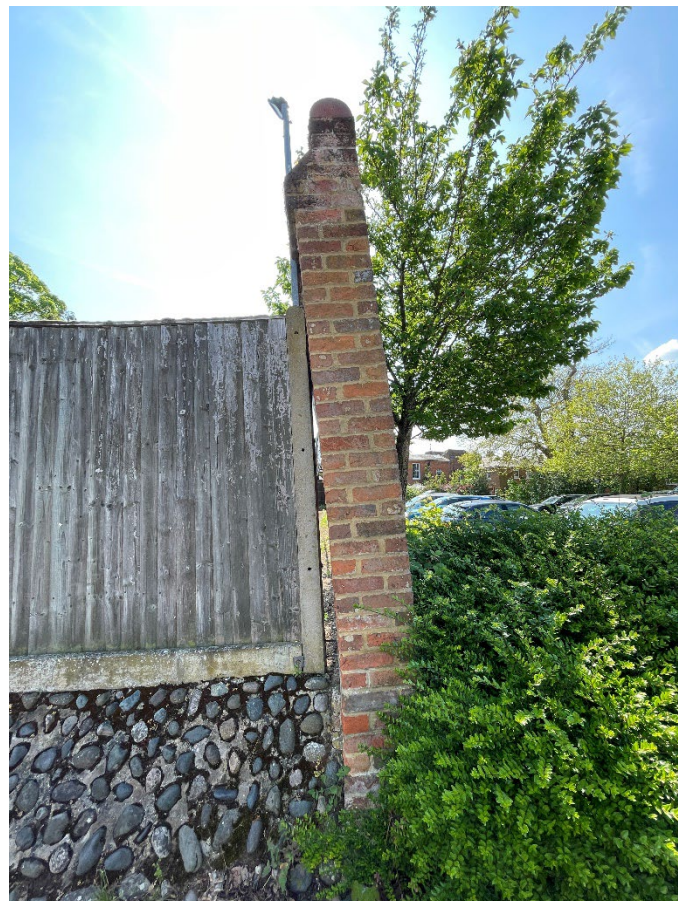
The wall has been truncated from its original length and left with a free-standing end to the northeast that is not restrained by a buttress or pillar.

- The lean to the northeast end of the wall (between the former opening through the wall and the free end is significant, noted in the HPM report to be 1:10 (not measured during our inspection). The end of the wall appears to be now taking support from the concrete post to the adjacent (perpendicular) fence. Intervention is required to stabilise the wall.

Photograph 2 - North east end where wall has been truncated, now leans on concrete post

- o Construct new brick buttresses on new foundations to the southeast side of the wall within the adjacent property's land to directly resist the lean of the wall, plus a buttress or return on the northeast end of the wall.

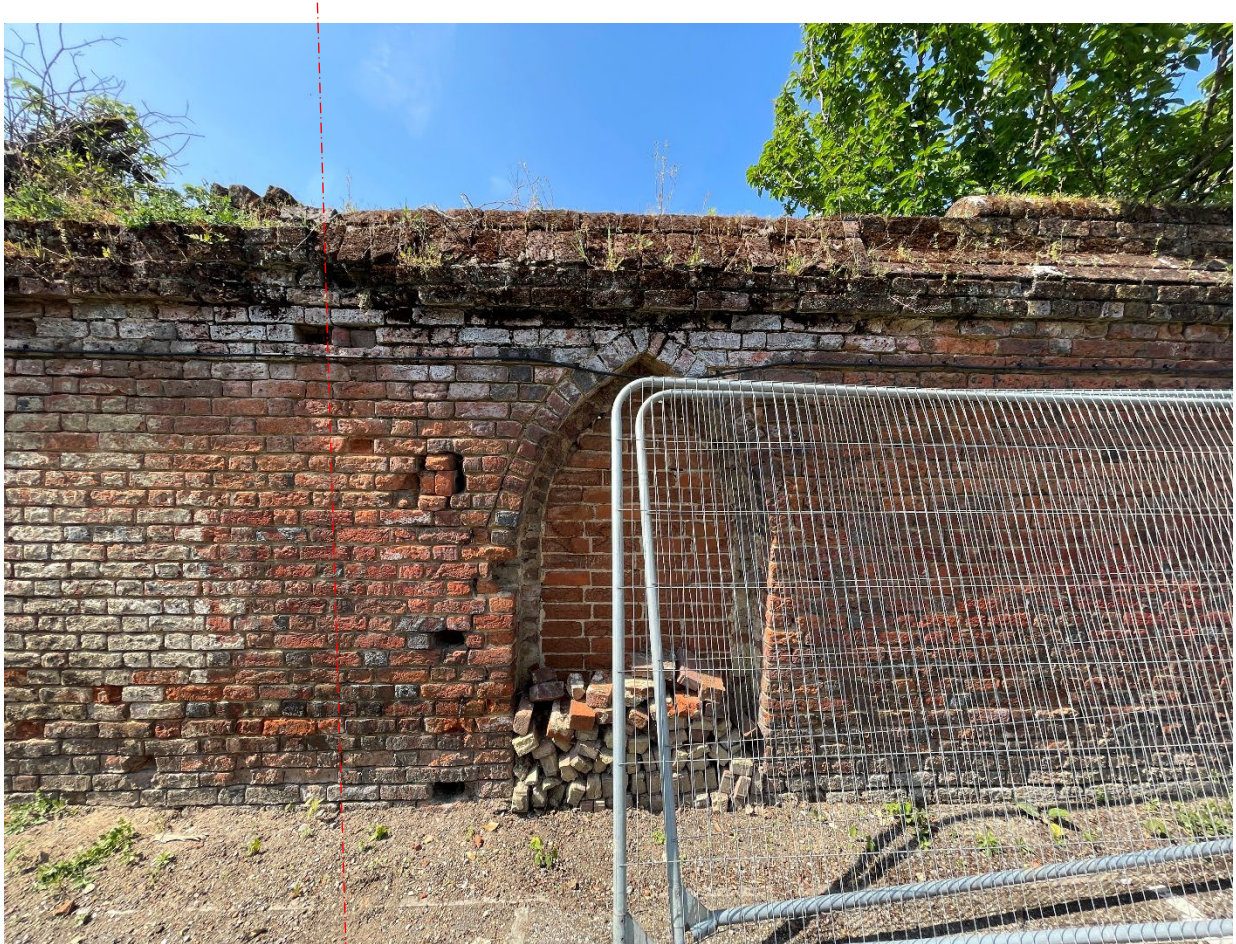
**Photograph 3 – View of wall from southeast – wall starts to lean significantly to RHS of line**

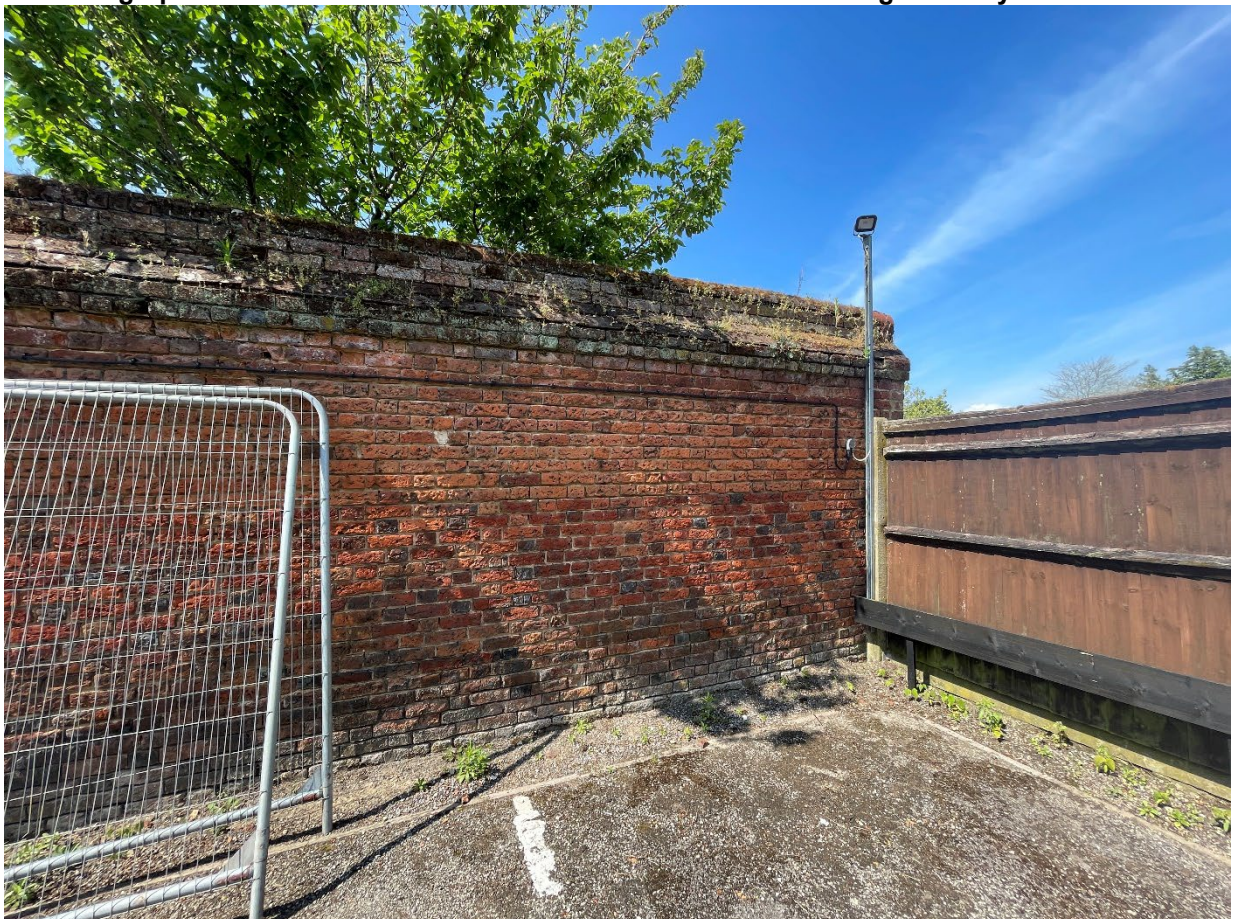
**Photograph 4 - View of wall from southeast – corner to NE is propped by adjacent fence post**
