# ARBORICULTURAL REPORT

## TREE CONDITION SURVEY

41 CHIVERS DRIVE  
FINCHAMPSTEAD  
BERKSHIRE  
RG40 4EW

Ref: 06514 / 2024

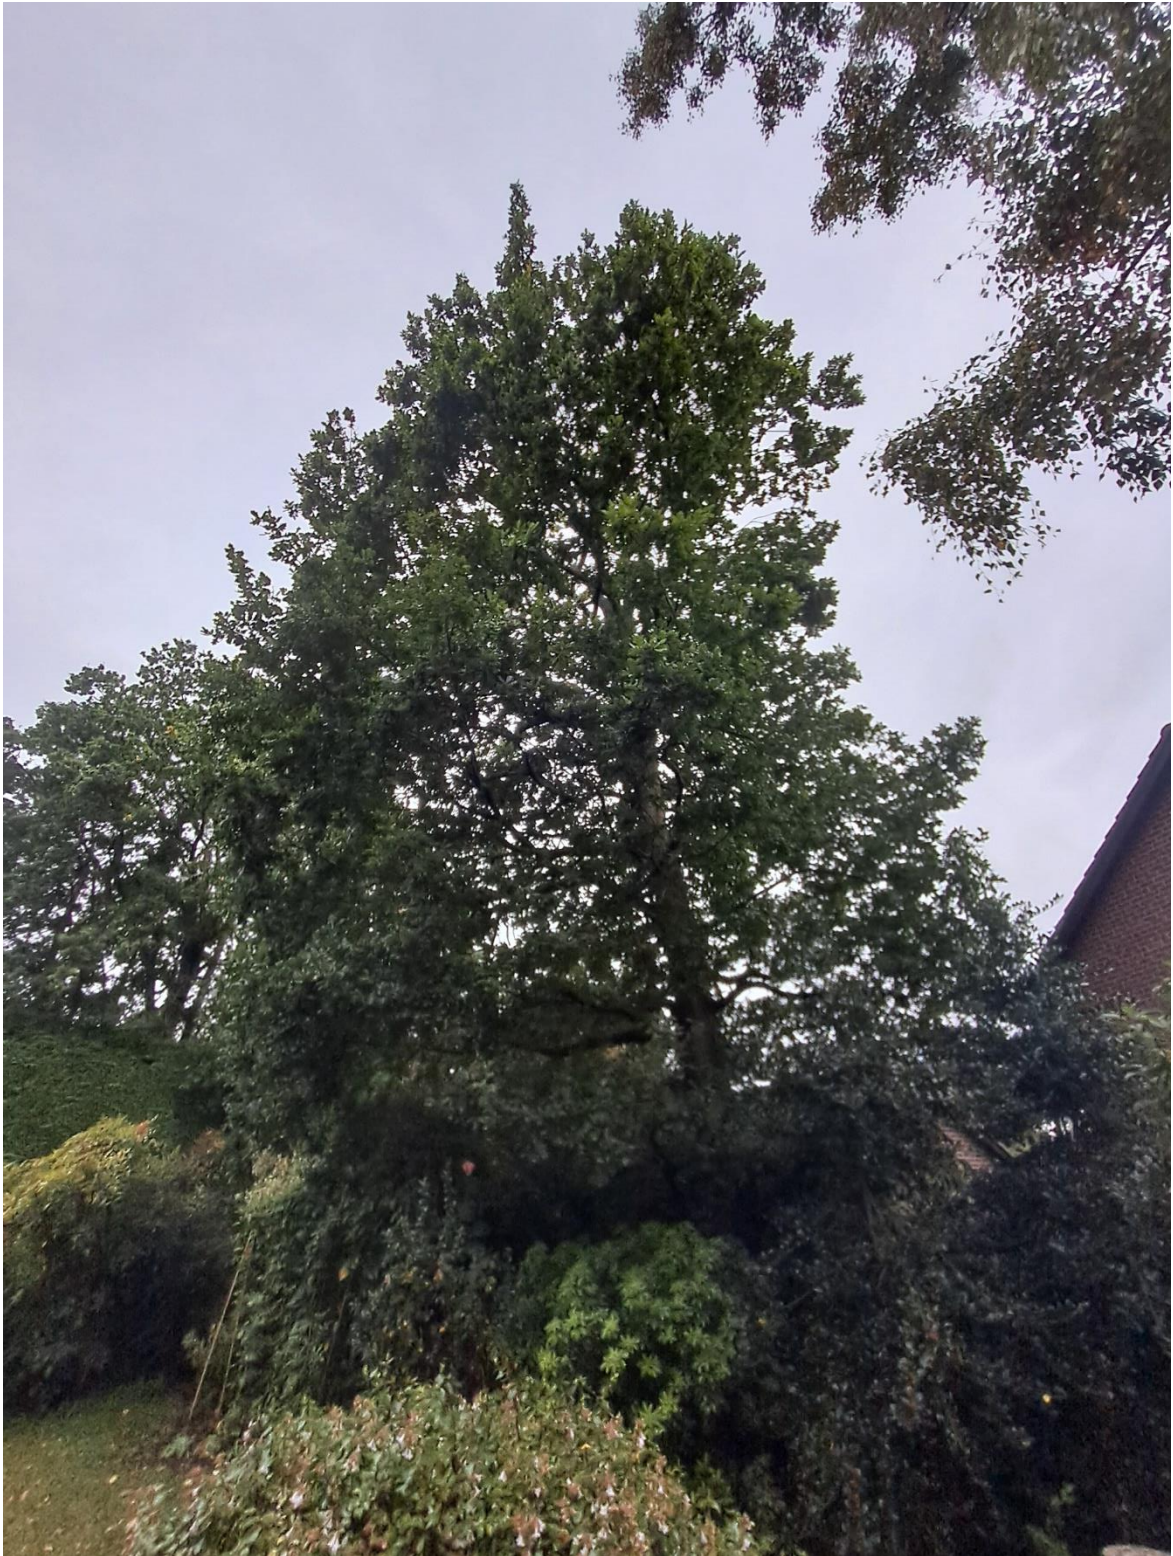
Photo 1 – T1 (Oak)

Base clear, bark intact, pronounced buttress roots on east side. Sound intonation even and satisfactory, no fungal fruiting bodies evident, no audible decay. No defects at base or signs of rootplate movement.

Single stem (feathered form) with small side branches, mostly under 200mm diameter. Nesting box east side at 3.5m above ground level. Stem and branch forks / unions well-formed and satisfactory. The upper trunk sweeps slightly to the east, towards 41 Chivers Drive.

T1 is a healthy mature Oak growing in the garden of 41 Chivers Drive. The tree has a slight lean on the stem and an asymmetrical crown as a result of having grown adjacent to another Oak which has since been removed. With the second Oak felled, T1 will over time produce more additional canopy growth on the north of the crown to reduce this aesthetic imbalance.

| <b>Recommended Tree Works:</b> <ul style="list-style-type: none"> <li>Crown lift to create 1.5-2m clearance over neighbouring garage &amp; reduce lateral spread on north side to create 2m clearance to neighbouring dwelling back to nearest suitable reduction points.</li> <li>Crown lift to create 3.5m canopy clearance above ground level by removing epic growth from lower trunk and shortening secondary and tertiary branches in the outer crown.</li> <li>Selectively reduce regrowth of previously reduced, elongated lateral branch east side of canopy by 1-2m back to within prevailing canopy outline (see photo 3). This will require the thinning out of two of the longer shoots (approximately 2m long) and reducing other tips off the same branch by up to 1m to bring the elongated branch back to within the surrounding canopy profile.</li> </ul> | Priority | Within 1 year |

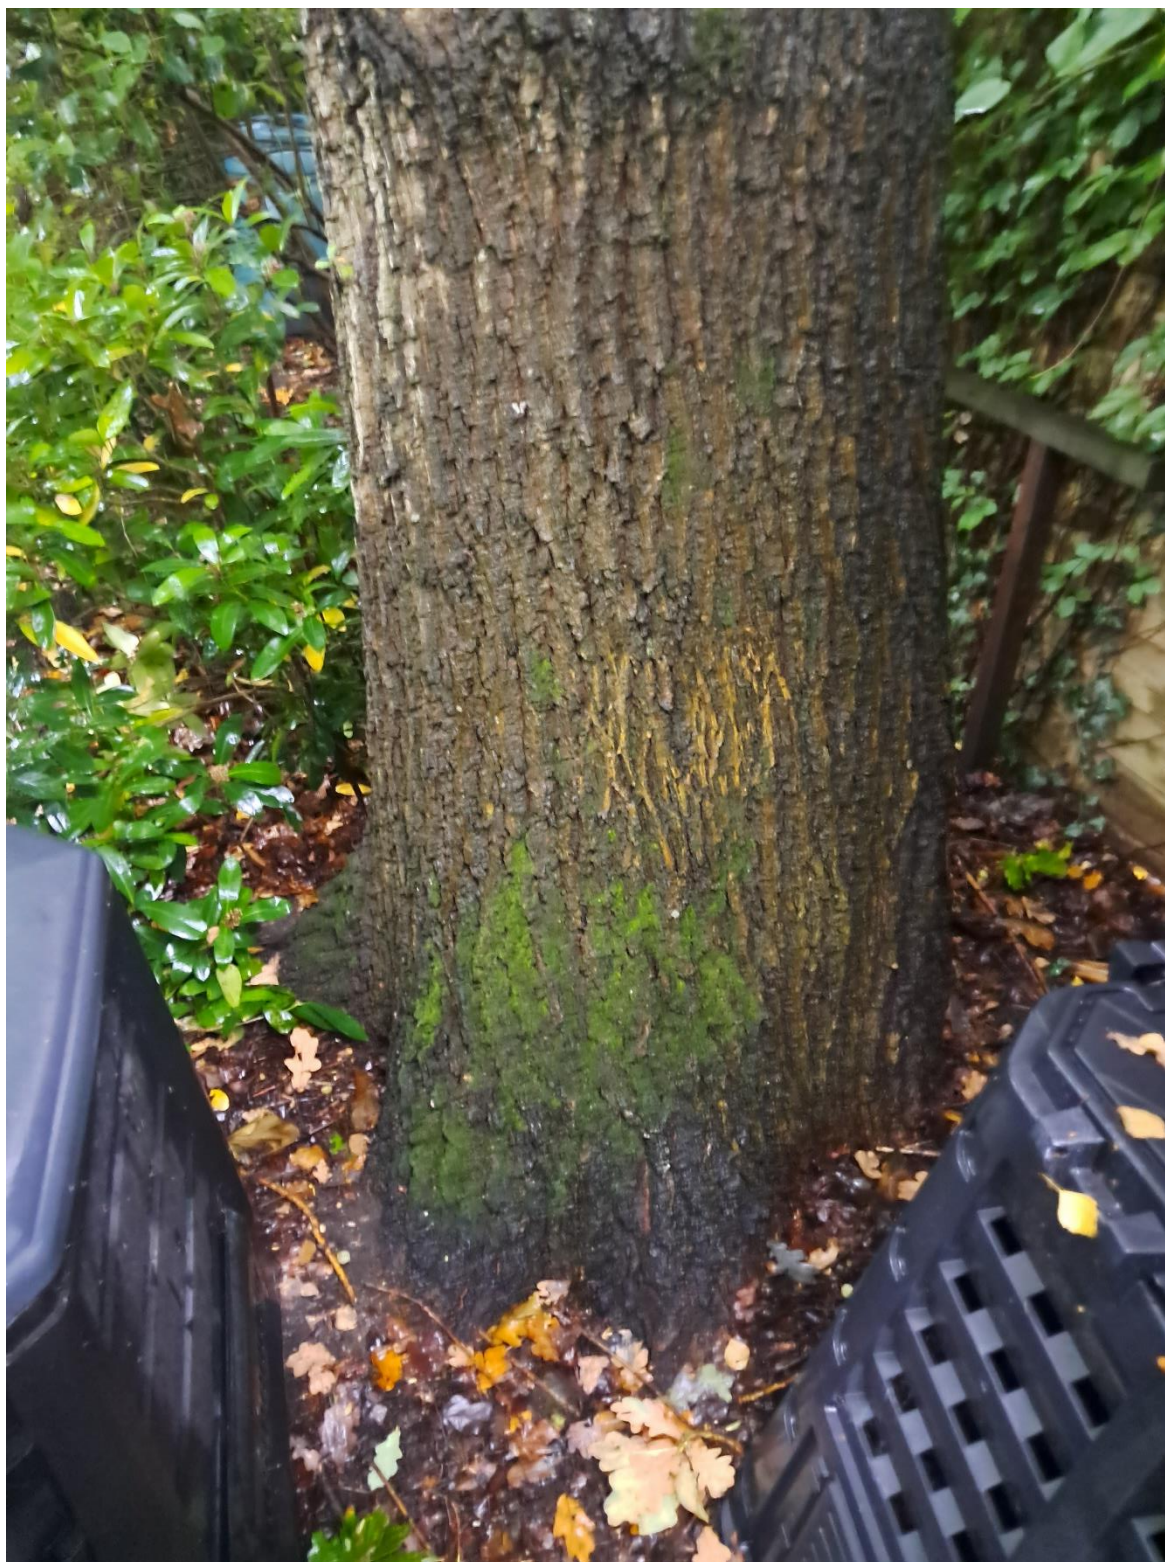
Photo 2 – Base of T1 (Oak)

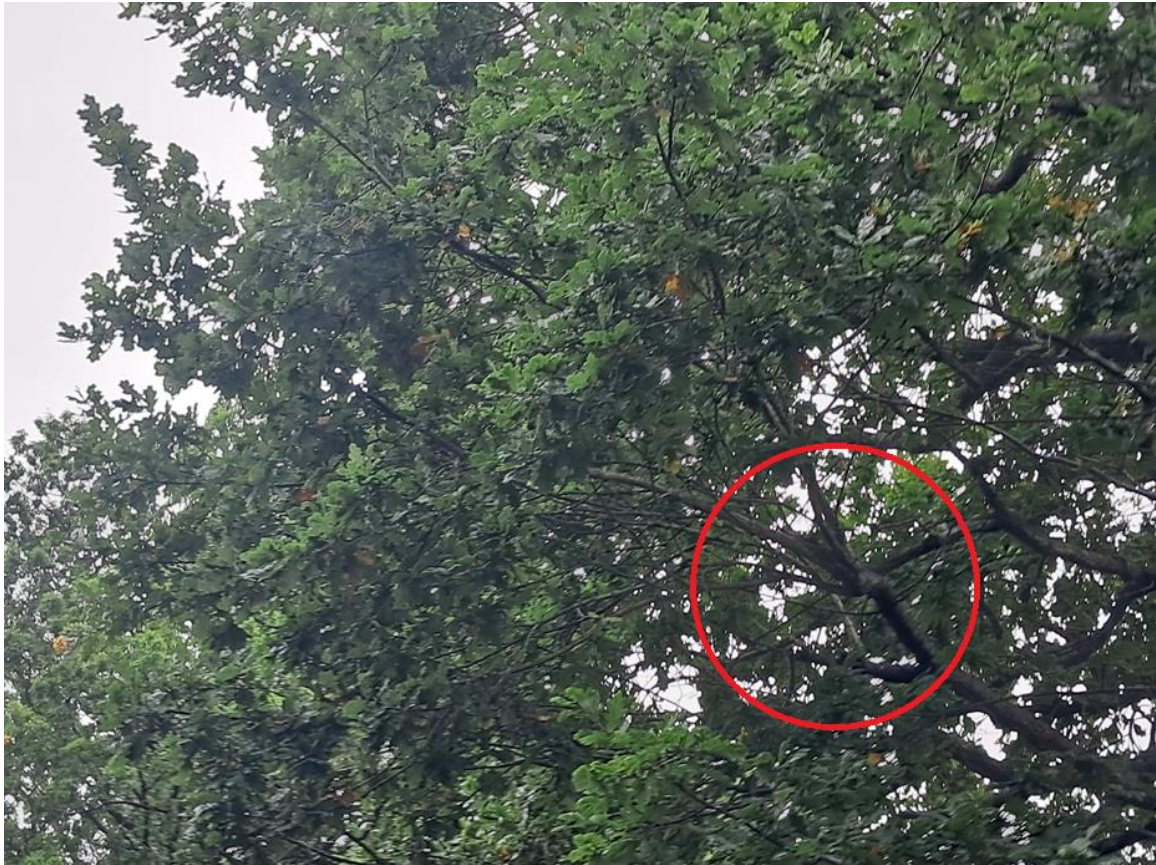
The canopy of T1 has previously been reduced and there is now around 3-4m new growth on previous reduction points. Re-growth is not overly dense, around 3-5 shoots from most average cuts. Canopy more sparse on the north side where previously crowded out by the second Oak.

The tree is in good health and appears structurally sound. Minor works are recommended to create reasonable clearance to neighbouring property and gardens. A light reduction of the tips off an elongated branch over the garden of 41 Chivers Drive will also improve the form of the tree and reduce the risk of exposed elongated branches breaking in high wind. These are minor works, and the health and visual amenity of the tree will not be affected.

Photo 3 – Previously reduced, elongated lateral branch east side of canopy to be thinned / reduced

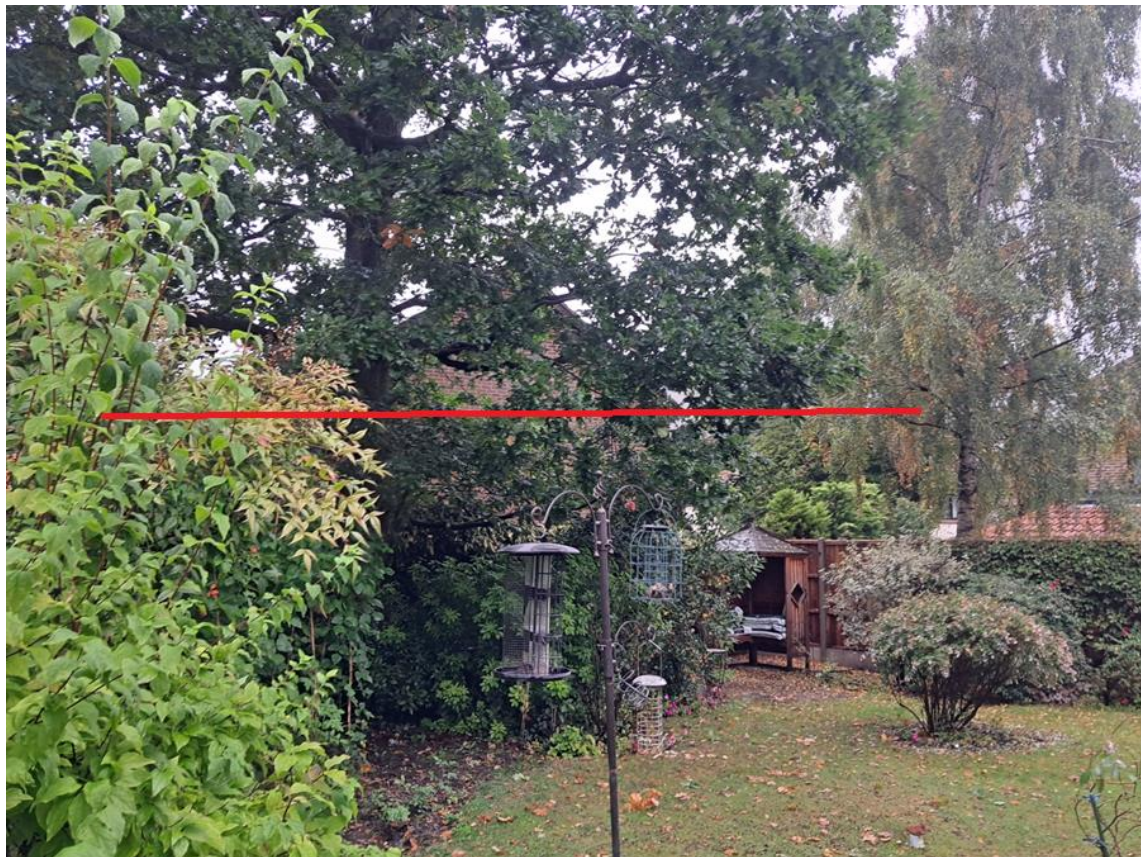
Photo 4 – Indicative line of proposed 3.5m canopy lift.
